September 13, 2017

PROPERTY INSPECTION REPORT

Concerning: 2870 Oakdell Tr, New Braunfels, TX 78130
(Address or Other Identification of Inspected Property)

By: B. J. Lange, Lic #20796 09/13/2017
(Name and License Number of Inspector) (Date)

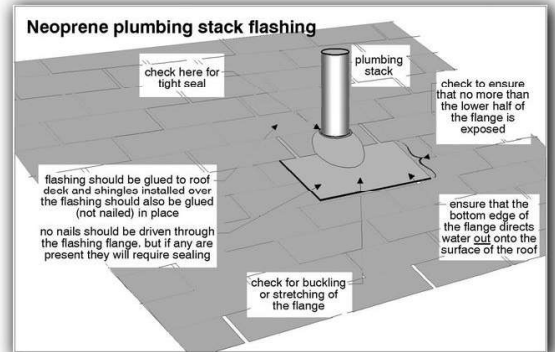
- One or more of the roof level plumbing vent stack flashing details that need repair. i.e: have rubber that is pushed down, need sealant. The existing condition could allow water penetration at this point. Repair.

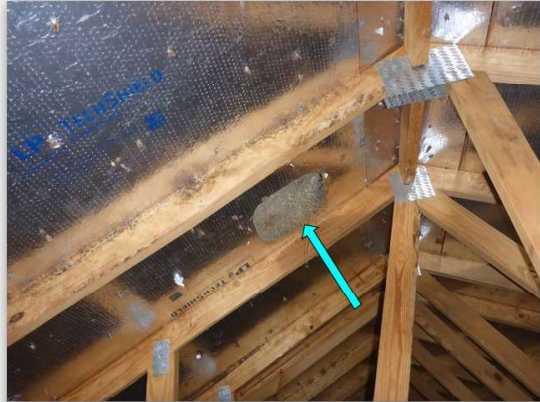
- Bird nest was observed in attic vent. Recommend cleaning to help improve attic ventilation.

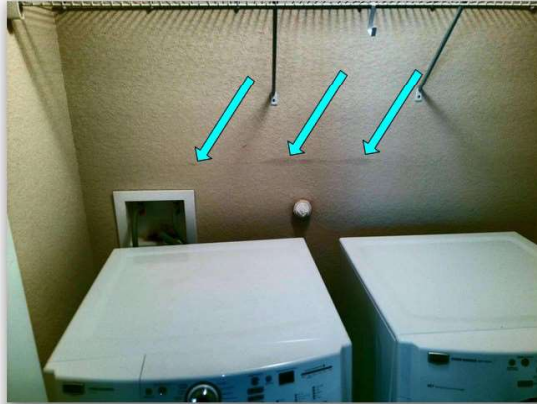
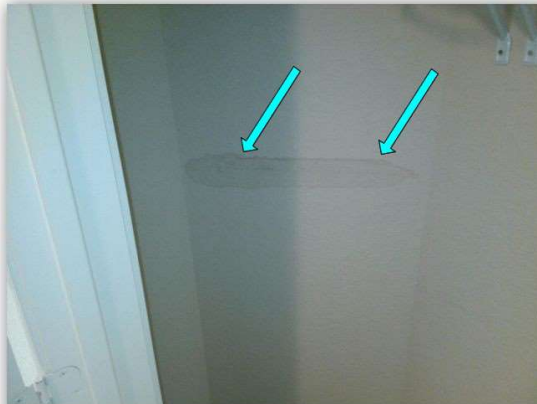
- Water stains/moisture damage/bubbling paint/evidence of water intrusion observed on the walls in the laundry room, hallway closet. The cause and remedy should be further evaluated and corrected as necessary.
- Protimeter (moisture meter) did NOT indicate a high moisture reading in the laundry room, hallway closet.

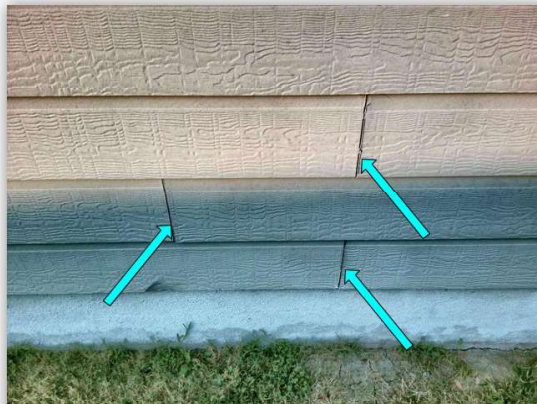
- Caulking improvements are recommended between the exterior cladding/siding junctures &/or trim junctures. It is recommended to use an elastomeric caulking.

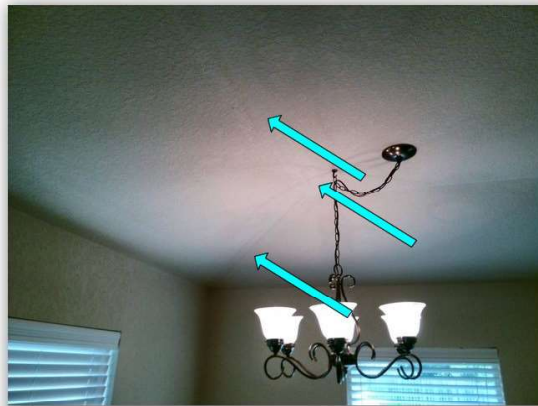
- **Note:** There is evidence of painting and patching to the interior finish and prior interior finish repairs in the kitchen, master bedroom. This condition could limit the Inspectors visual observations and ability to render accurate opinions as to the performance of the structure.
- Ceiling joint cracks were observed in the kitchen, master bedroom.

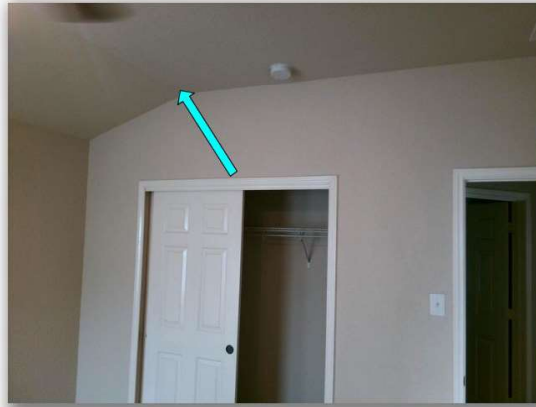
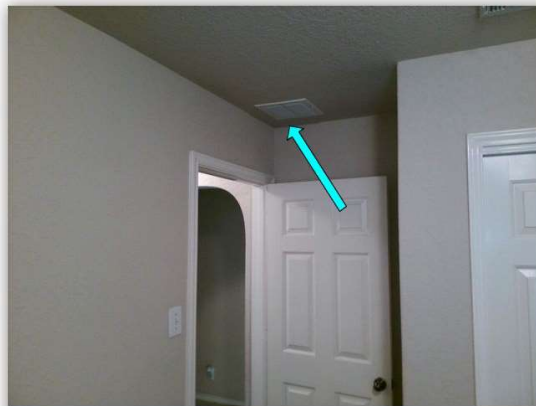
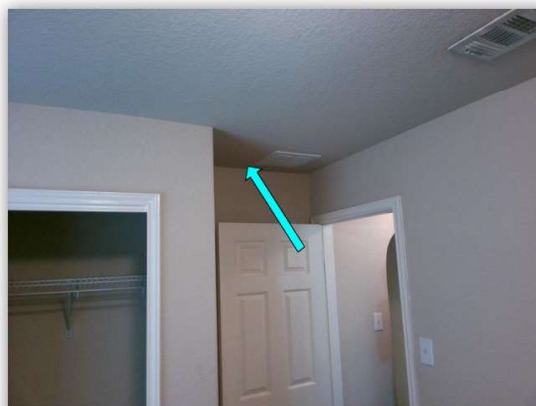
- Nail heads were observed to be pushing through the interior finish in master bedroom, side middle bedroom, front corner bedroom, hallway.

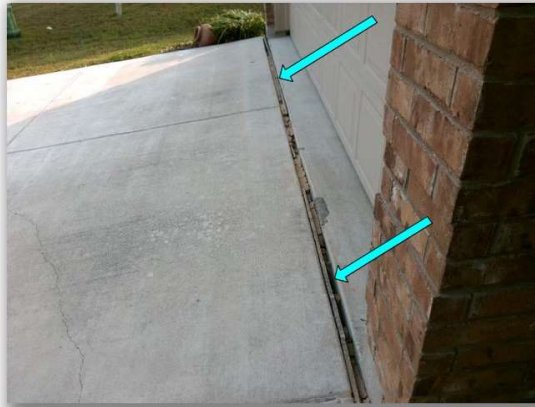
- The driveway appears to have settled more than normal. Repairs are recommended to improve drainage/further damage of driveway.

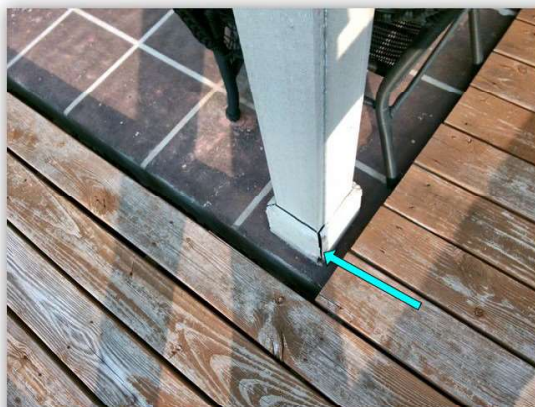
- One or more of the porch support posts have some deterioration, rot, and/or damaged at the base of the post.

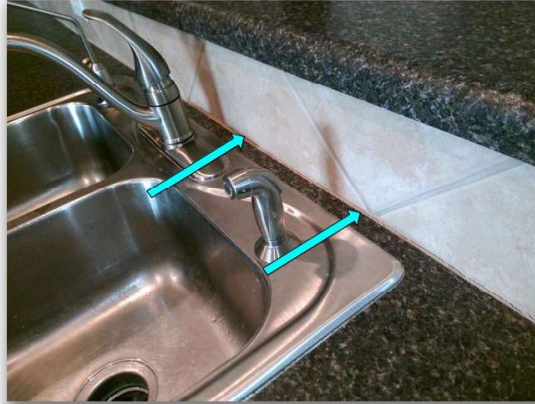
- Deteriorated caulking/sealant at junctures. Re-sealing recommended.

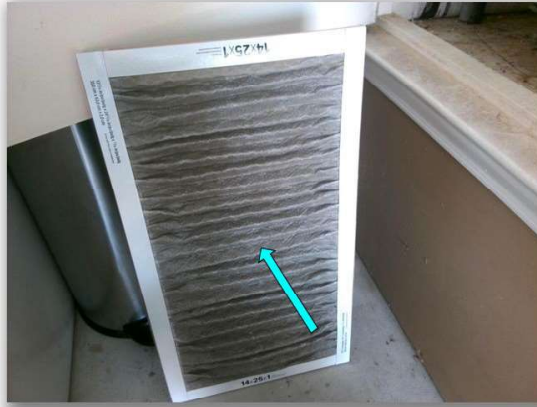
- Recommend replacement of dirty air filter(s).

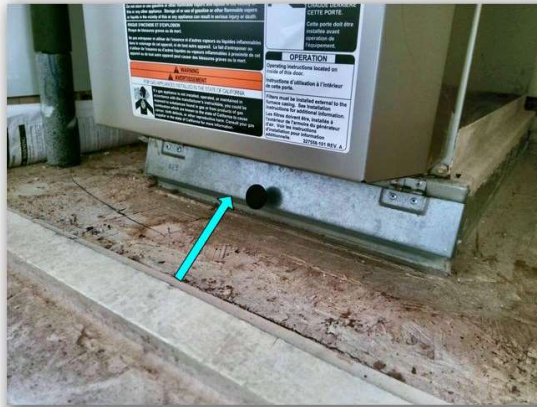
- The air filter enclosure door will not close completely and/or function properly.

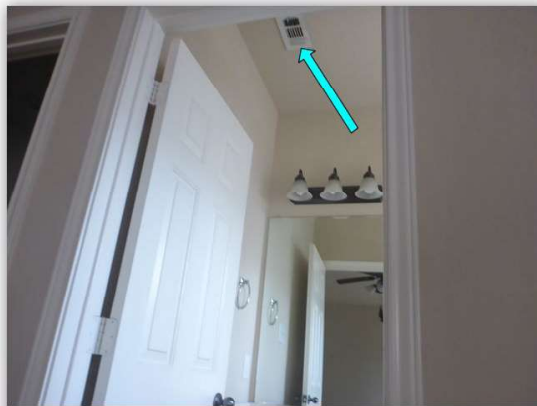
- >5 degree difference in register's air temperature in the master bathroom compared to other registers in the house. Recommend further investigation/repair as necessary.

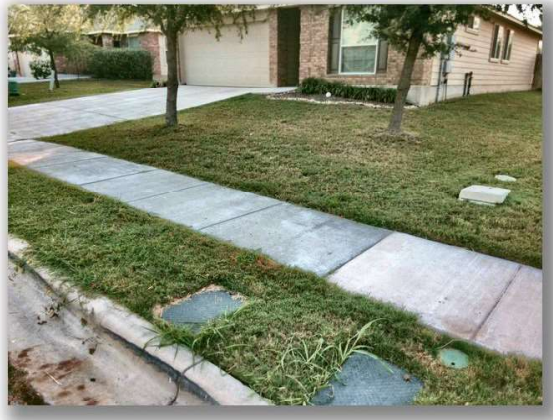
- The water pressure was observed to be above 80 psi at the time of this inspection. Under current plumbing standards the maximum water pressure should be 80 psi. This condition should be further evaluated and corrected as necessary and may require the installation of a pressure reducing valve next to the meter if it is not already equipped with one.

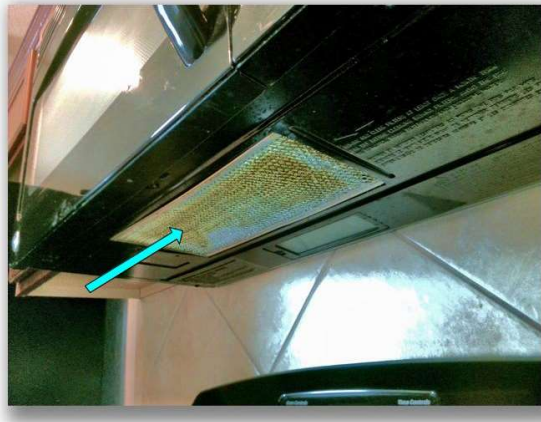
- The range exhaust vent is dirty and requires cleaning.
