GCH Inspections, LLC

Property Inspection Report

1042 W 23rd St, Unit D, Houston, TX 77008

Date of Inspection: 4/22/2018 Time: 1:00 PM

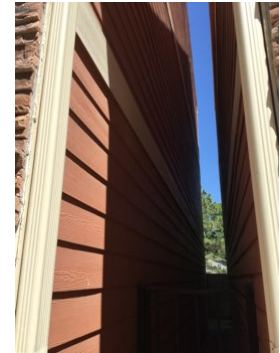
Unable to inspect

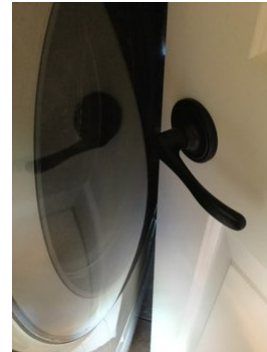
Door blocked by washer

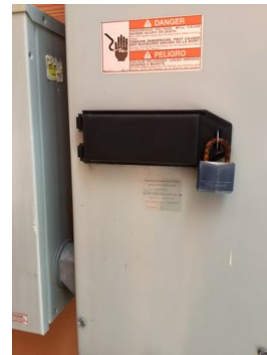
Master switch locked

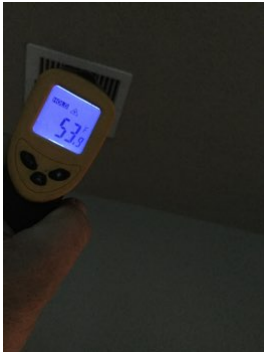
Downstairs supply vent - 53%

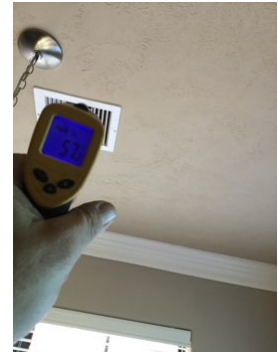
2nd floor supply vent 57%.

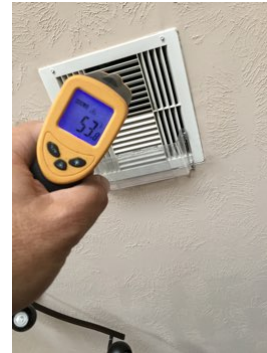
3rd floor supply vent 53%
