WILLCOX INSPECTIONS LLC™

PROPERTY INSPECTION REPORT

Concerning: 1505 Detering, Houston, TX 77007
(Address or Other Identification of Inspected Property)

By: Shavauna Higgins Professional Inspector #3472 08-17-16
(Name and License Number of Inspector) (Date)

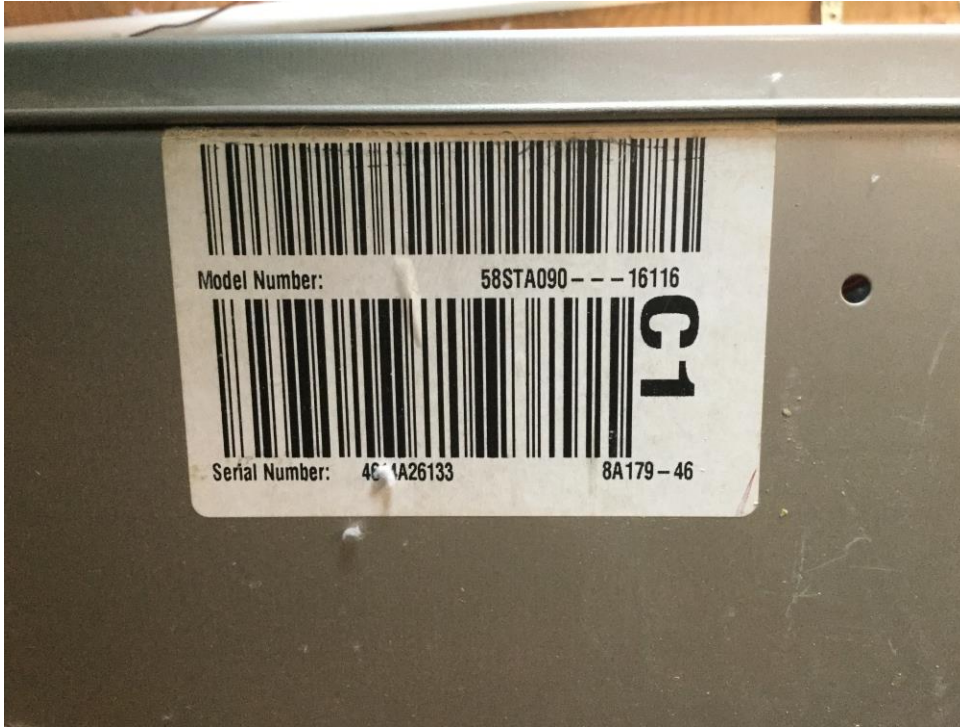
Deficiency: The upper furnace had not been placed into service at the time of the inspection.

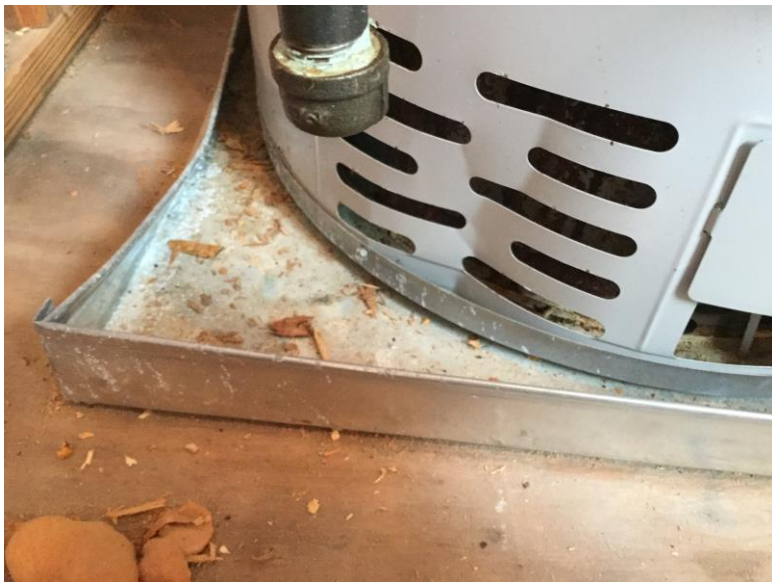
Deficiency: The tank was damaged.

Information: The interior lining of a water heater is usually glass. Rough handling of the tank normally causes the glass to crack. While the unit may not actively leak, the life expectancy of the unit may have been decreased by the damage. In my opinion, the water heater appeared to be in need of replacement at the time of the inspection.

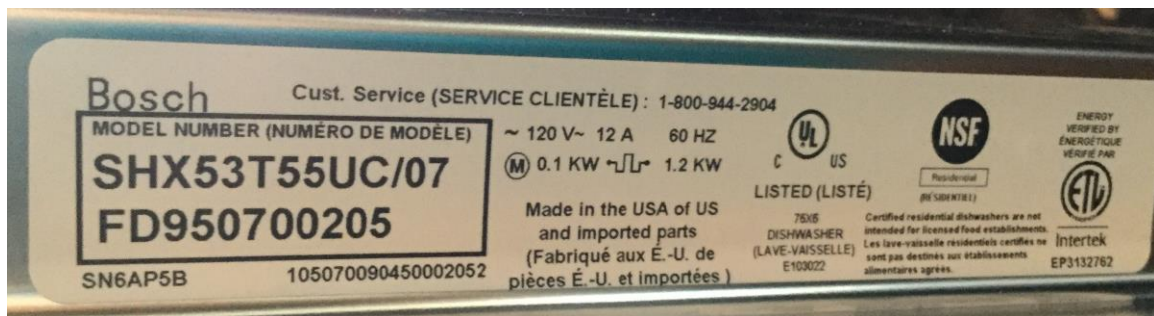
Deficiency: Installation of the dishwasher appeared incomplete and the unit had not been placed into service at the time of the inspection.

Information: The unit should be placed into service and tested for proper and safe operation prior to the termination of any due diligence investigation period.

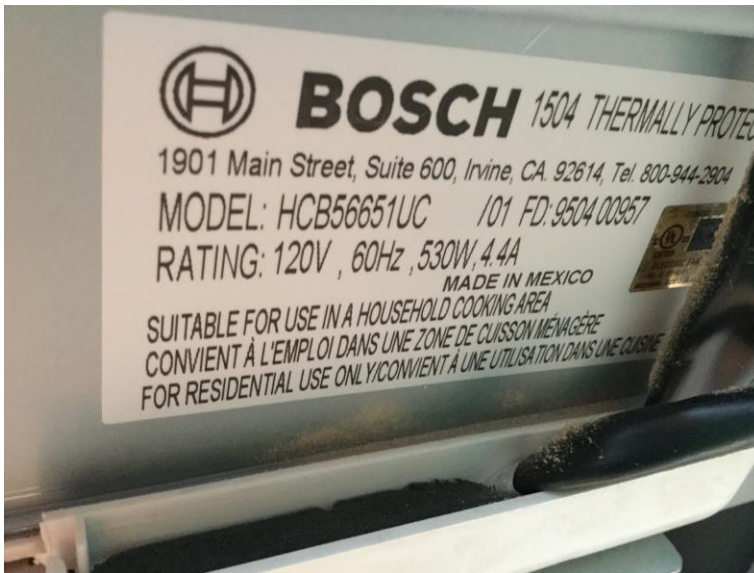
Information: There were no visible defects noted in the range hood or vent system at the time of the inspection that appeared to require immediate repair at the time of the inspection, in my opinion.

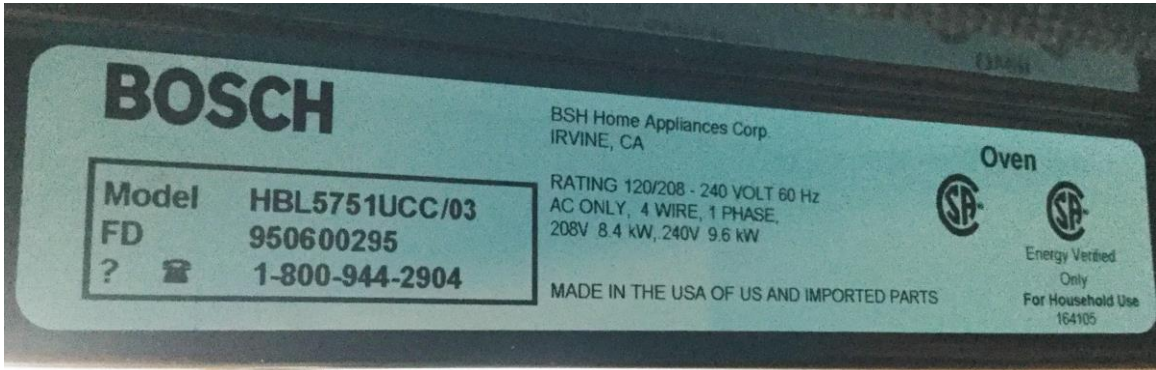
Deficiency: The oven had not been placed into service at the time of the inspection.

Information: The unit should be placed into service and tested for proper and safe operation prior to the termination of any due diligence investigation period.
