## PROPERTY INSPECTION REPORT

**Concerning:** 3611 Windbriar Ct., Houston 77068

**By:** Greg Genser – TREC Professional Inspector License #2962 6/17/19; 1:45-6:15pm

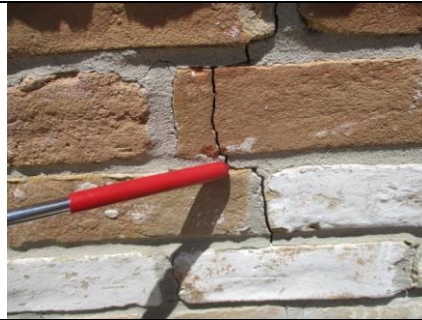
1. **Deficient:** Exterior brick cladding crack was observed at some locations. Exterior trim separation from brick was observed at the NE corner.

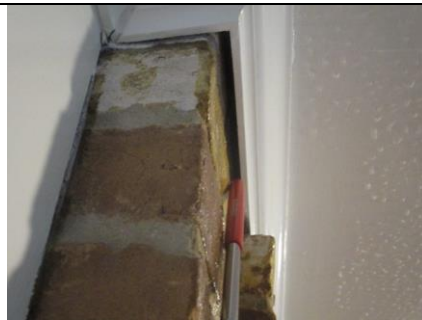
2. **Deficient:** Evidence of separation-settlement to the fireplace and chimney was observed.

1<sup>st</sup> floor elevation interior brick separation from crown molding

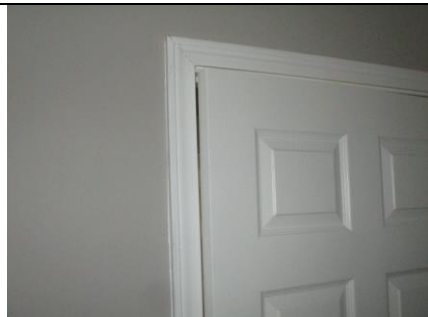
3. **Deficient:** Interior wallboard tape rippling was observed at in the stairway.
4. **Deficient:** Doorway-walkway-window frame opening is not square at some locations. Door is self-closing; binds to the doorframe at one or more locations.

2<sup>nd</sup> floor elevation NE bedroom door binds to doorframe

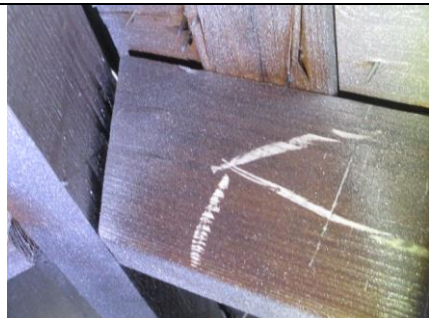
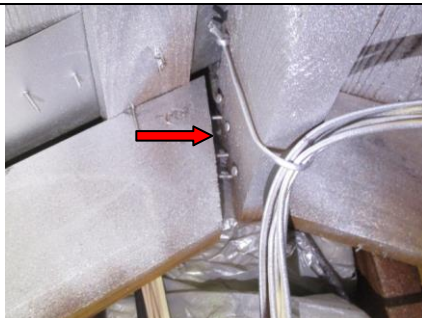
5. **Deficient:** Roof structure rafter separation from ridge board was observed at some locations.

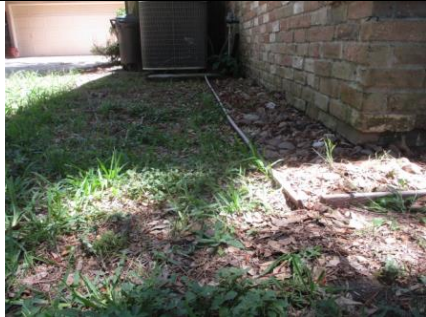
1. **Deficient:** Finished grade along foundation perimeter is too high at some locations. Proper foundation exposure-grade clearance provides termite protection and minimizes the chance of decay resulting from moisture migrating to the wood framing.

Grade too high; one of several locations

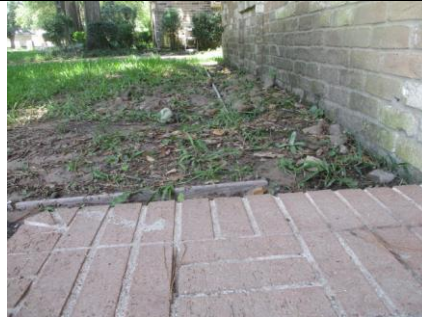
Grade too high; one of several locations

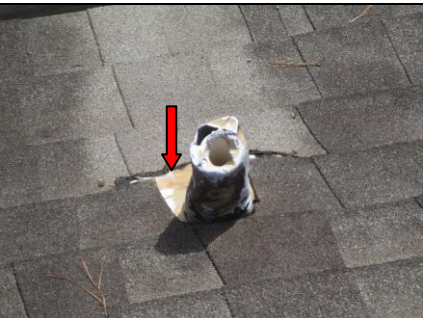
1. Information: According to seller's disclosure notice, roof cover is 10 years old. Evidence of repair to roof cover-penetration-flashing was observed at some locations. Additional information about repairs should be obtained from homeowners.

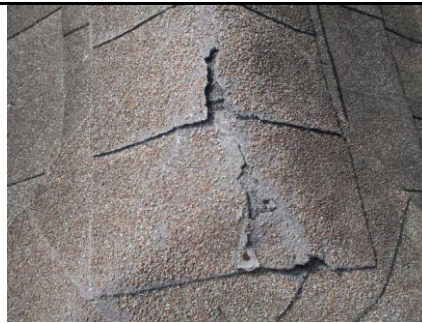
2. **Deficient:** Deterioration to the roof cover was observed; as evidenced by shingle damage, aggregate-granule lose and lack of adhesion. Shingle adhesion is important in preventing shingle uplift, blow-off and water penetration.

Shingle damage

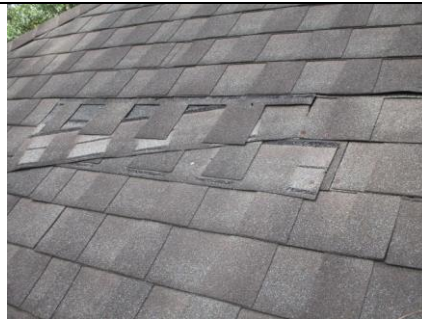
3. **Deficient:** By random observation, shingle fastening is incorrect at some locations. Proper fastening is important in preventing shingle uplift, blow-off and water penetration. See illustration below for example of proper nail installation.

Shingles incorrectly fastened, sliding off the roof

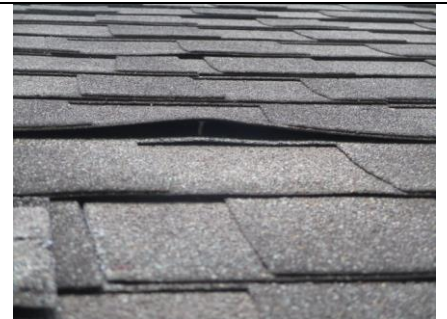
Nail pop

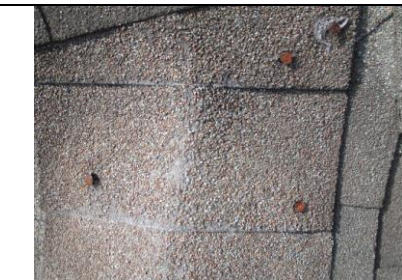
4. **Deficient:** Fastener head on ridge cap shingle(s)-flashing(s) is exposed.

Information: Exposed fasteners will corrode, loosen and can become a path of water penetration into materials and the building. Approved roofing asphalt cement should be applied to seal the exposed fastener(s).

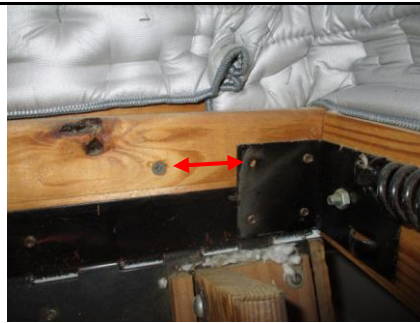
1. **Deficient:** Pull down attic stairways is damaged-incorrectly installed. A properly functional-installed stairway is an important safety requirement. Garage attic access opening cover is not labeled as, and does not appear to be a fire-rated cover. A fire-rated cover is an important safety requirement.  
Information: All nuts and bolts should be firmly secured. 16-16d nails or 16-1/4" x 3" lag screws should be installed in the pull down attic stairway brackets-frame-pivot plate to safely secure the frame to the structure. Stairway should properly open; close and should be flush to the floor. Stairway should be 350 lbs. rated.

Incorrect fastener(s); fastener(s) not installed.

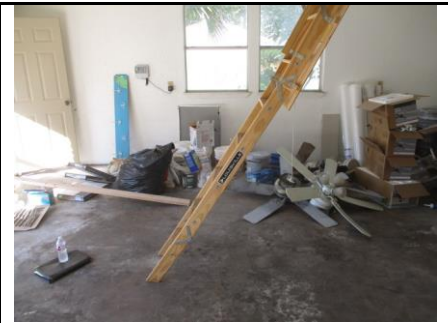
Stairway opens incorrectly

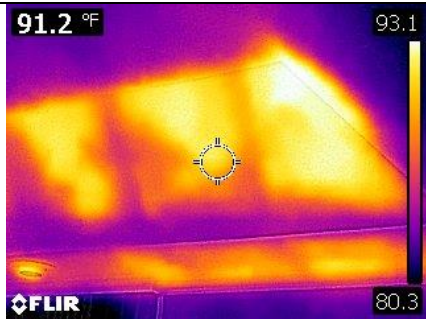
4. **Deficient:** Ceiling insulation is missing; thickness is insufficient at some locations. The residence walk-in attic access opening door is not insulated and weather-stripped. Proper insulation thickness is an important energy saving requirement.

With thermal imaging, bright yellow areas indicate ceiling insulation not installed for game room sloped ceiling.

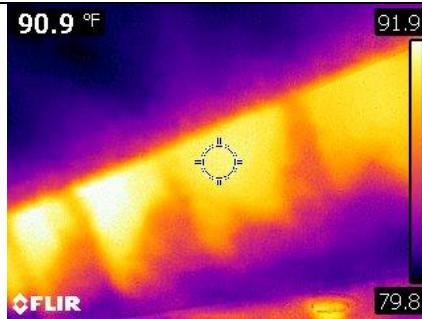
With thermal imaging, bright yellow areas indicate ceiling insulation not installed for game room sloped ceiling.

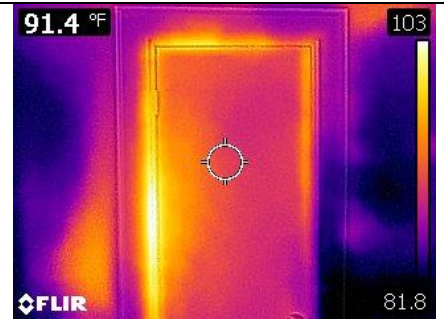
With thermal imaging, bright yellow areas indicate walk-in attic door not insulated.

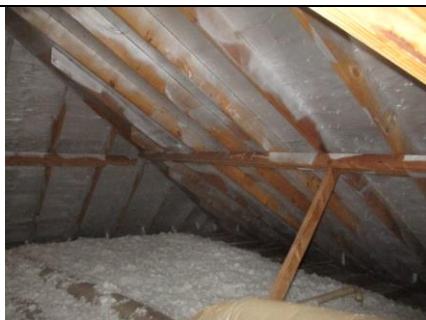
5. Information: A foreign substance has been applied to the underside of the roof structure and deck, which appears to be a radiant heat barrier, in the inspector's opinion. Further information as to this substance should be obtained from the homeowner.

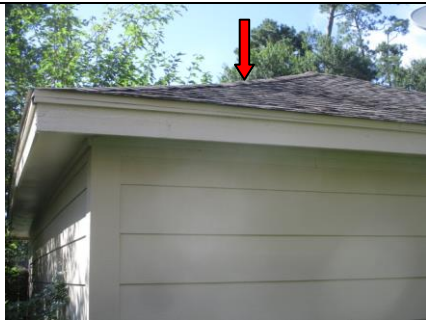
8. **Deficient:** Evidence of deflection-settlement to the garage roof structure was observed. Dwelling rafter separation from ridge was observed at some locations; ridge-hip-valley rafter is undersized for attached rafter at some locations; roof structure support is incorrect-not installed at some locations.

Evidence of deflection-settlement to the garage roof structure

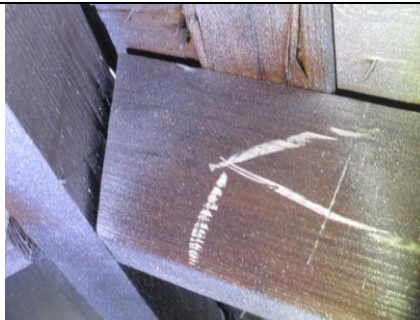
Rafter separation; one of some locations

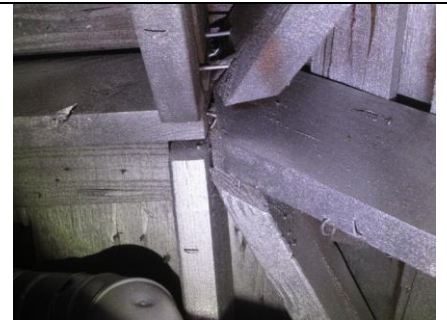
Support not installed; one of some locations

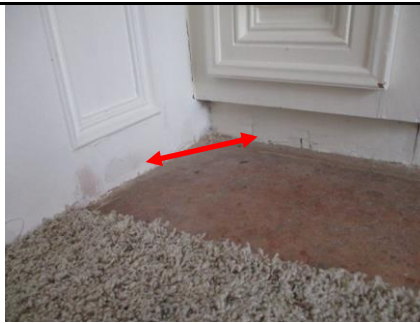
1. **Deficient:** Evidence of interior wallboard water damage was observed behind the dishwasher. Evidence of interior wood paneling water damage was observed in breakfast and family rooms.  
Information: Source of water damage should be located and repaired prior to replacement of water damaged materials. If damage was from previous water penetration-leak that has been repaired, one would assume the water-damaged material(s) would have been repaired-replaced.

Water damage in breakfast area

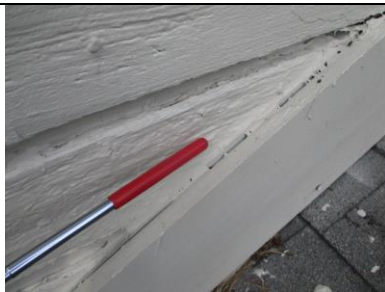
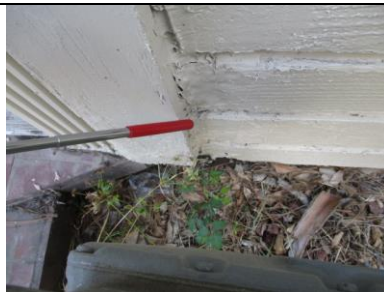
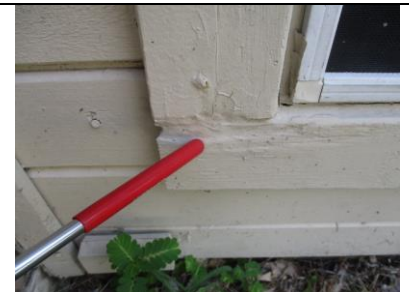
2. Information: Evidence of interior wood paneling repair was observed in the stairway.
3. Note: A tire stop is not installed in garage to prevent automobile impact-damage to the wallboard and structure.
4. **Deficient:** Evidence of deflection-sagging to the span above the garage vehicle door opening was observed.
5. **Deficient:** Evidence of water damage to exterior cladding siding-trim was observed at numerous locations. Water-damaged materials should be replaced to minimize the chance of decay resulting from moisture migrating to the wood framing.

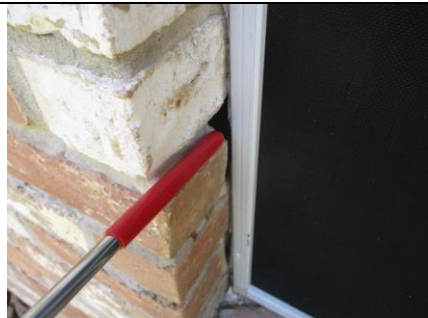
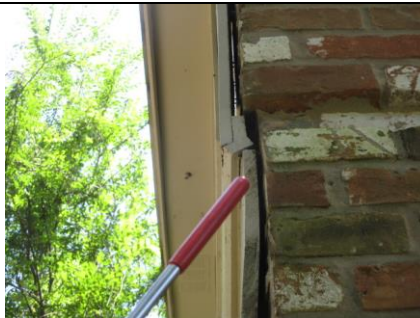
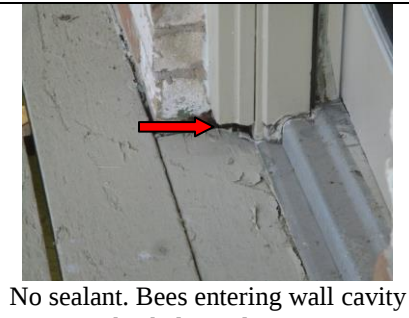
7. **Deficient:** Exterior sealant is not installed-insufficient at some locations. Properly installed sealant is to prevent direct water penetration through an open joint within the cladding system.  
Information: Exterior sealant should always be properly installed at many locations including; brick cladding cracks, expansion joints, intersection to trim; siding cladding joints and intersection to trim; around pipe penetrations, electrical outlets (A/C equipment disconnect, service equipment; lighting & receptacle), cable penetrations, wall covers; door and window frames.

No sealant. Bees entering wall cavity at this balcony location.

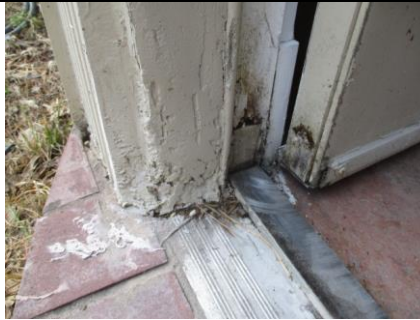
1. **Deficient:** Water damage, damage to exterior door was observed at several locations. I was unable to open the secondary master bedroom door.

Water damage at master bedroom door

Information: Water-damaged materials should be replaced and door should be installed to prevent water penetration. This defect was not listed in the seller's disclosure notice.

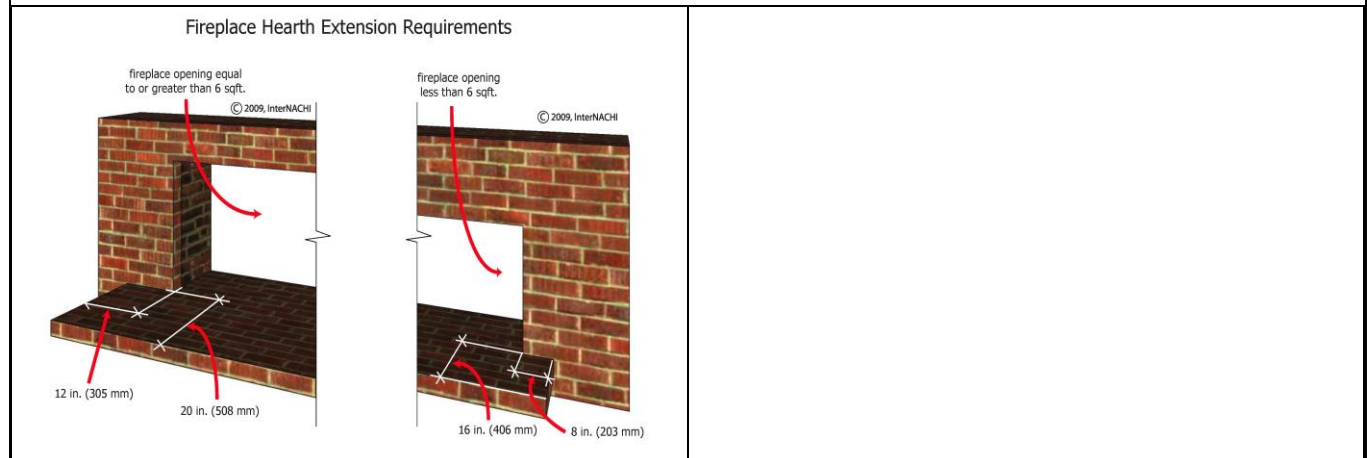
5. **Deficient:** Hearth is incorrect. Proper hearth is an important safety requirement.

Information: Hearth extensions shall extend at least 16 inches in front of and at least 8 inches beyond each side of the fireplace opening. Where the fireplace opening is 6 square feet or larger, the hearth extension shall extend at least 20 inches in front of and at least 12 inches beyond each side of the fireplace opening.

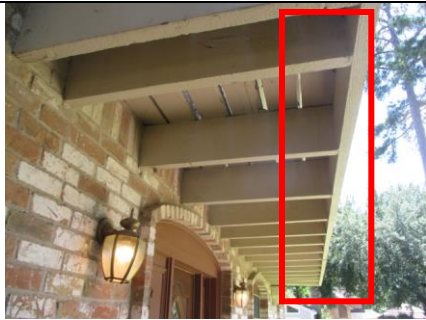
2. **Deficient:** Exposed joist installation-support is incorrect.

Information: The ends of each joist, beam or girder shall have not less than 1.5 inches of bearing on wood or metal and not less than 3 inches on masonry or concrete except where supported on a 1-inch-by-4-inch ribbon strip and nailed to the adjacent stud or by the use of approved joist hangers.

Joist hangers not installed

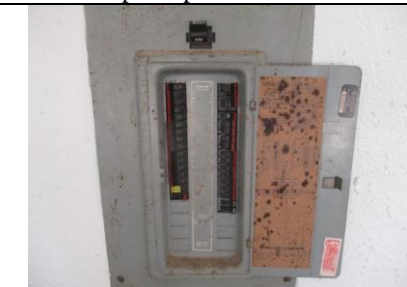
1. **Deficient:** Panelboard is Federal Pacific brand, which is no longer manufactured. Many light fixtures, ceiling fans and receptacles did not operate.

Information: In the inspector's opinion, older equipment-systems may have inherent dangers, including overloaded circuits, overcurrent devices (breaker) that are easily defeated and the likelihood that improper modifications may have been performed. Panelboard and overcurrent devices may be near the end of their intended purpose and usefulness. Client should perform due diligence and consult with their homeowner insurance company prior to the expiration of any time limitations such as an option period to confirm insurability of dwelling with a Federal Pacific panelboard.

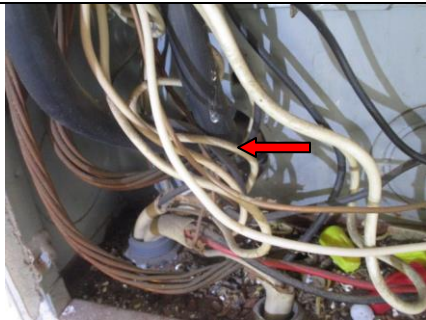
3. **Deficient:** A conduit with bonding-type locknut is not installed on conduit nipple between the utility meter and panelboard enclosures. Conduit and bonding is an important safety requirement.

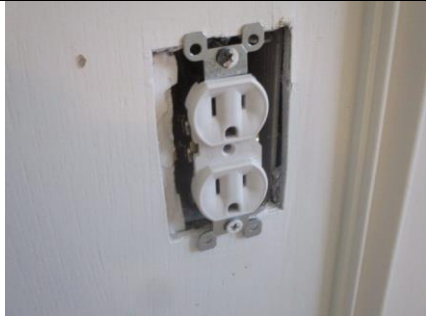
4. **Deficient:** By random observation, outlet box is set back too far in wood paneling wall. Proper box installation is an important safety requirement.

Outlet box set back too far in kitchen cabinet

Information: An approved extension ring can be installed to provide proper outlet box installation. Locations where outlet box typically is set back to far include; wood paneling; kitchen cabinets and kitchen back splash. In walls or ceilings with a surface of concrete, tile, gypsum, plaster, or other noncombustible material, boxes employing a flush-type cover or faceplate shall be installed so that the front edge of the box, plaster ring, extension ring, or listed extender will not be set back of the finished surface more than ¼ in. In walls and ceilings constructed of wood or other combustible surface material, boxes, plaster rings, extension rings, or listed extenders shall be flush with the finished surface or project therefrom.

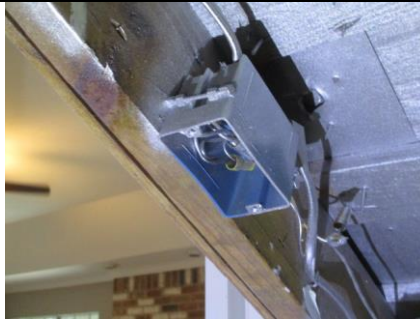
10. **Deficient:** Exposed 120/240-volt conductor splices were observed beneath the cook top. Junction box-outlet box cover is not installed at one or more locations. A proper wiring installation is an important safety requirement.

No cover in attic

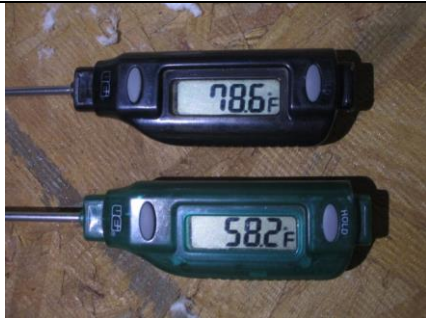
In the inspector's opinion, the system appears to be performing its intended function of cooling. Using TREC SOP as a minimum standard, the temperature differential between supply and return air systems (Delta T) should be between 15°F-20°F and nearer to 20°F. The temperature differential detected with a thermometer at either side of the evaporator coil is 20.6°F. However, one or more deficiencies were observed including;

System temp. differential 20.6°F

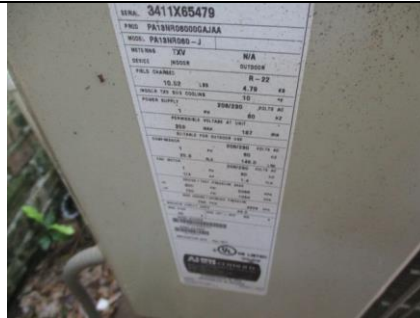
System Condenser information  
Manufacturer - Carrier  
Year manufactured - 2011  
Refrigerant type - R-22

1. Information: According to equipment manufacturer labels, system uses R-22 refrigerant. Per The US Environmental Protection Agency beginning January 1, 2020, R-22 refrigerant will no longer be imported or produced; only stockpiled and recycled R-22 refrigerant will be available for maintenance. In the inspector's opinion, equipment using R-22 refrigerant is near the end of its intended purpose-usefulness.

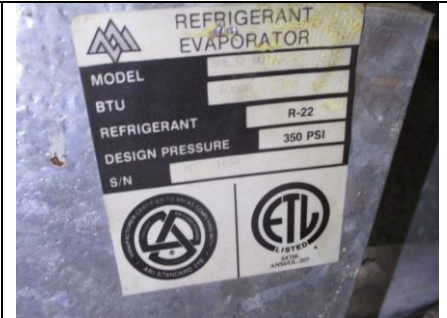
System Evaporator information  
Manufacturer - Appears to be Aspen  
Year manufactured - appears 1997  
Refrigerant type - R-22

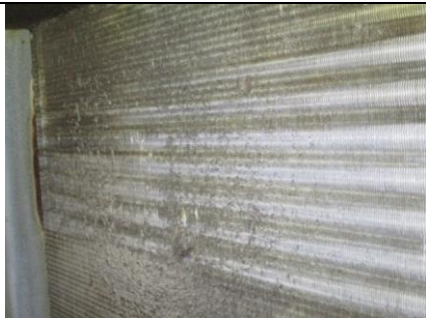
2. **Deficient:** Evaporator coil is dirty.

Information: Servicing-cleaning of the coil appears necessary. A clean coil is more efficient and helps reduce air flow resistance through the coil.

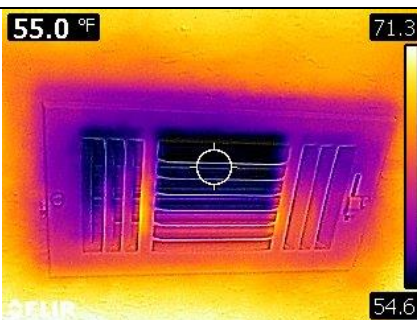
2. **Deficient:** Poor air flow to the game room was detected.

Other air supply detected much lower.

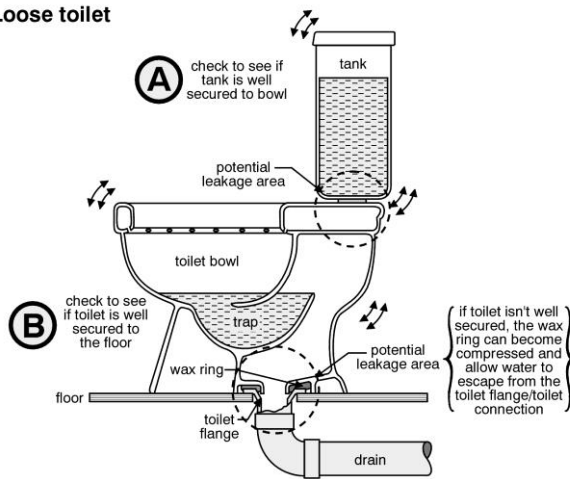
2. **Deficient:** All 3 toilet bases are loose.

**Loose toilet**

Information: Wax seal ring and drainpipe flange appear in need of replacement prior to base being securely fastened in place.

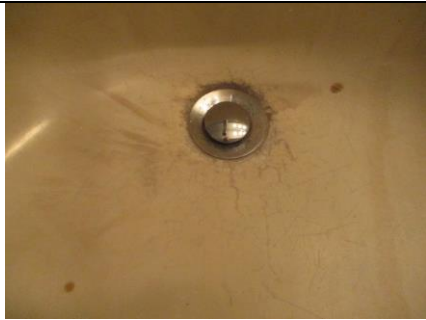
3. **Deficient:** Master bathroom – Sink basin surface is cracked. 1 of 2 sink drain stops is not installed. Bathtub drain stop did not operate. Evidence of electrolysis-oxidation was observed to water supply pipe behind the bathtub.

Basin surface is cracked

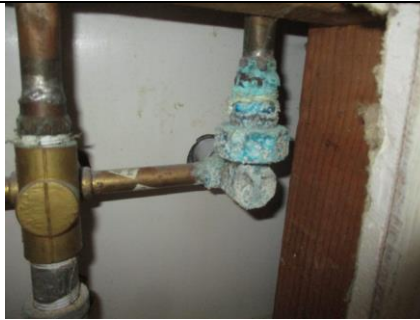
Evidence of electrolysis-oxidation

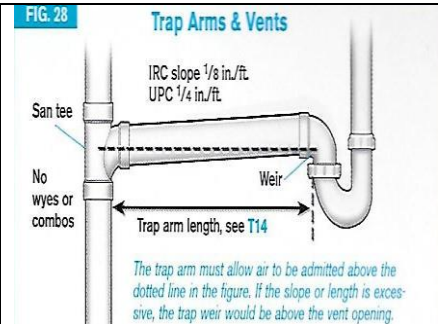
5. **Deficient:** Powder bathroom – Sink trap arm drainpipe is incorrectly installed.

Information: Drainpipe should slope in direction of wastewater travel.

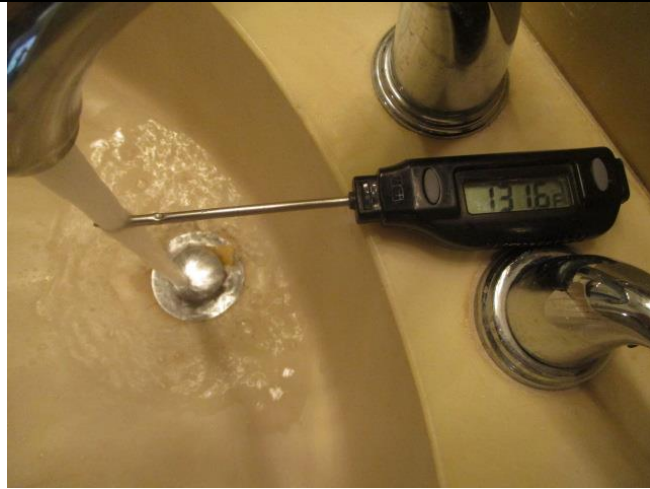
3. **Deficient:** Hot water temperature is 131.6°F. Water temperature over 120°F can cause scalding-severe burns. Proper hot water temperature is an important safety requirement.

Water temperature recorded at 131.6°F

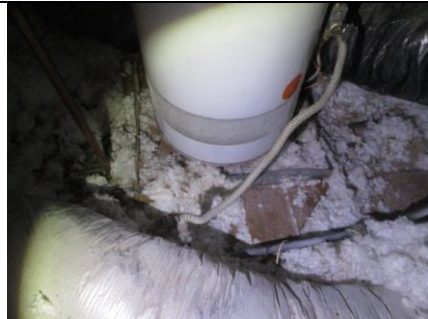
4. **Deficient:** There is insulation in the drain pan; which is incorrect and can obstruct the drainpipe. A pan free from defect is important in preventing potential water damage to the residence-structure.

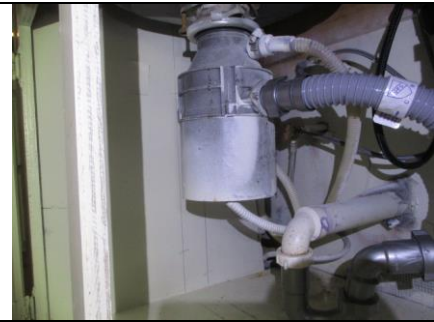
☒ ☐ ☐ ☒ **B. Food Waste Disposers**
*Comments:***1. Deficient:** Wastewater leakage occurred from equipment and equipment did not operate.

Information: This defect was not listed in the seller's disclosure notice.

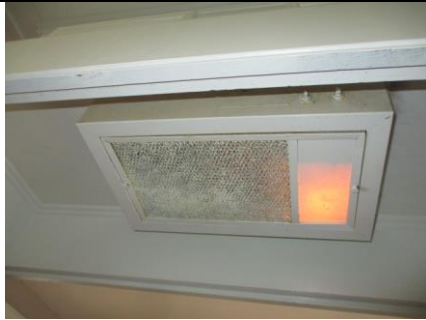
**1. Deficient:** Filter is partially obstructed with paint. Exhaust duct does not terminate to the outdoors.

Filter partially obstructed by paint

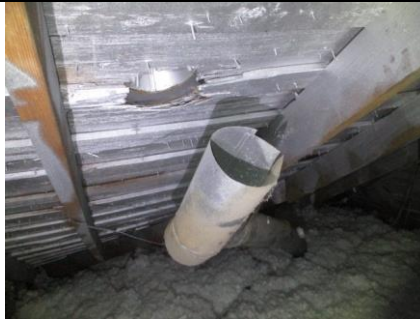
Exhaust duct terminates into attic

Information: Range hoods shall discharge to the outdoors through a single-wall duct. The duct serving the hood shall have a smooth interior surface, shall be airtight and shall be equipped with a backdraft damper. Ducts serving range hoods shall not terminate in an attic or crawl space or areas inside the building.

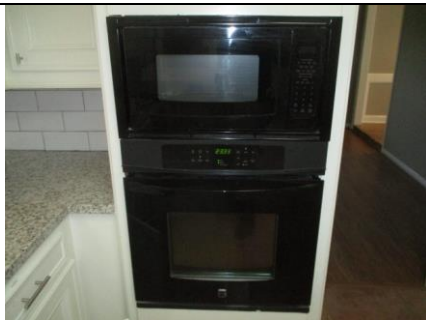
1. **Deficient:** Equipment did not operate.

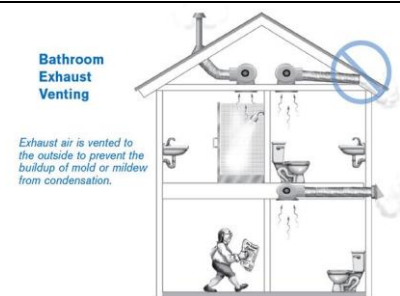
1. **Deficient:** Bathroom exhaust does not vent to the outdoors.

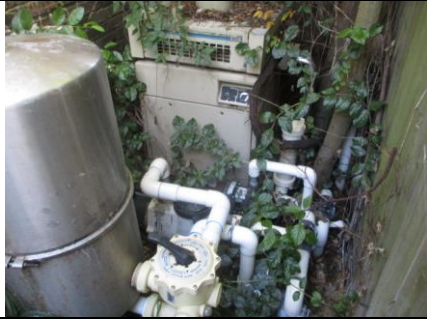
6. **Deficient:** Pool cleaner pump did not operate. Due to vegetation and improper clearance, I could not access water heating equipment and air blower. Gas supply is off to the water heating equipment.

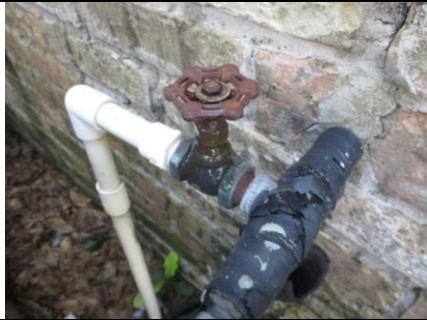
7. **Deficient:** Atmospheric vacuum breaker is not installed for water supply to swimming pool. An atmospheric vacuum breaker is an important health safety requirement.

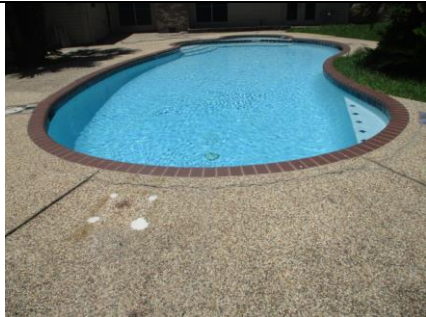
12. **Deficient:** A proper barrier is not installed, which poses a potential drowning hazard for children and pets. A proper barrier is an important safety requirement.

Separate fence is not installed around pool-spa

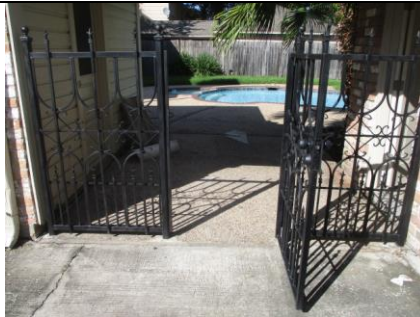
Fence gate are not self-closing, self-latching
