# PROPERTY INSPECTION REPORT

**Concerning:** 4820 Milwee Street, Houston, TX 77092

**By:** David Gibbs, Lic #7406 TREC Professional Inspector

07/25/2019

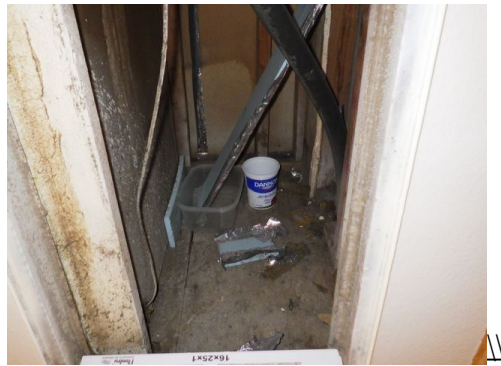
Observed 120 volt electrical wiring improperly located in return air chase. According to today's standards (code) 120 volt wiring should not be located in, or pass through chases to minimize potential fire hazard. We recommend repair as necessary.

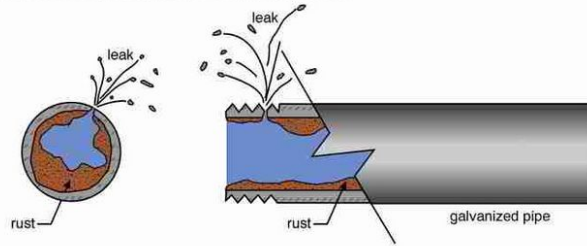
Insulation was missing from some attic and/or exterior water supply pipe. We recommend insulate where exposed to prevent freeze damage as required according to today's standards (Ref: IRC P2603.5).

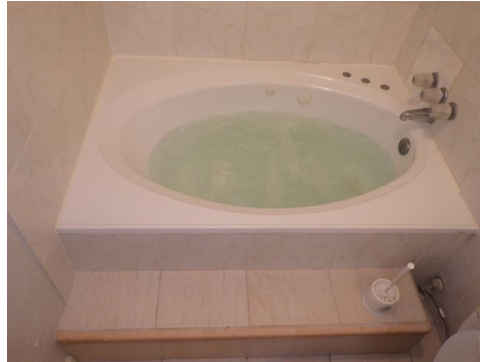
**GFI protection was not found at the hydrotherapy pump motor which is required by present standards. Whether or not this was required at the time of installation we recommend the circuit be protected with the installation of a GFI receptacle at the motor or a GFI circuit breaker in the subpanel.**

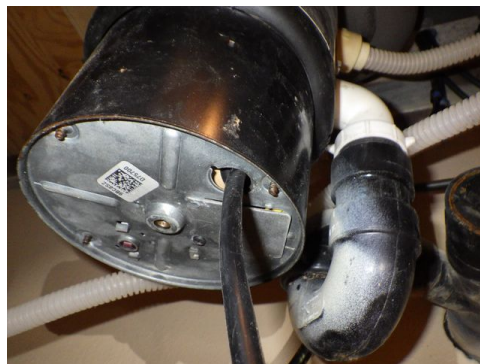
The disposal was missing the wiring clamp / fitting at bottom that secures power cord to casing. This can result in wiring connections being damaged and/or pulled lose exposing live wires. We recommend repair by installing wiring clamp.
