August 2, 2019

# PROPERTY INSPECTION REPORT

Concerning: 35 Penway St., Houston, TX 77022  
(Address or Other Identification of Inspected Property)

By: Edgar Gonzalez, Lic #TREC #5782 08/02/2019  
(Name and License Number of Inspector) (Date)

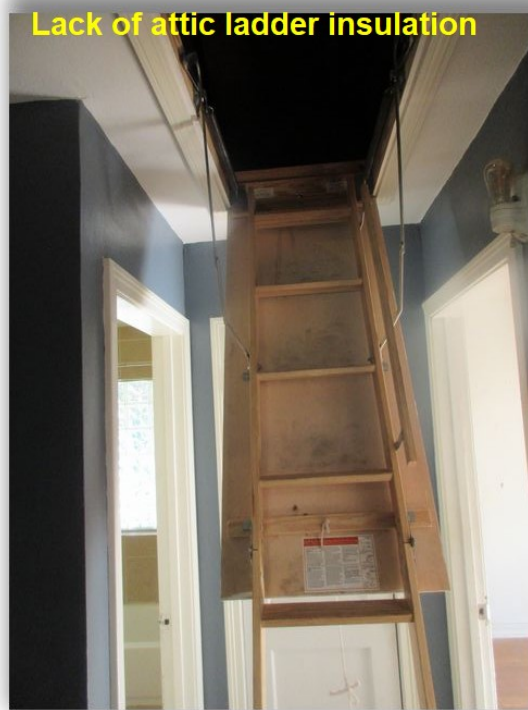
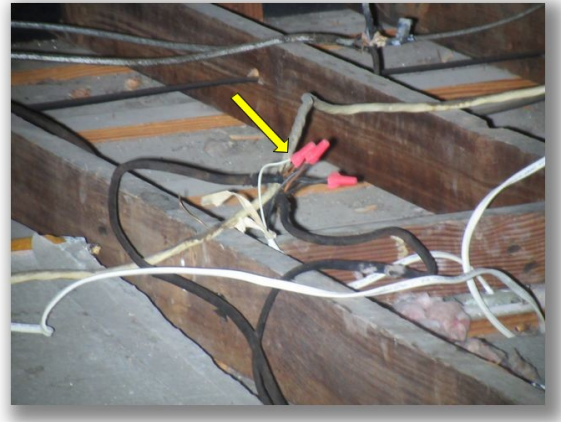
**Note:** Not all areas of the attic were accessible for inspection. Insulation covered some structural, electrical and mechanical components in the attic. This precluded an inspection of these components.
