Total Home Inspection

Property Inspection Report

615 E Cypresswood Dr, Spring, TX 77373
Inspection prepared for: Wemberth Ferraz
Real Estate Agent: Sophia Yapo -

Date of Inspection: 10/7/2019 Time: 9:00 AM
Age of Home: 1971 Size: 2658
Weather: Cloudy - 80s/90s

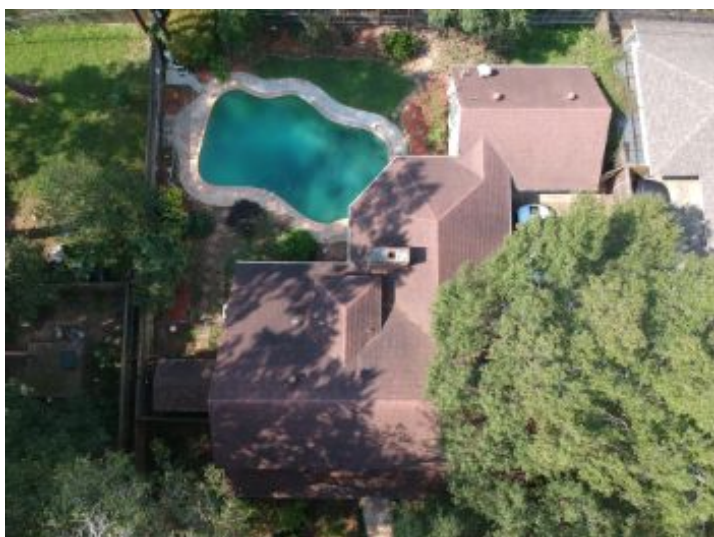
• PVC is not intended for exterior exposure to UV light. PVC vent pipes were not painted above the roof surface and may deteriorate.

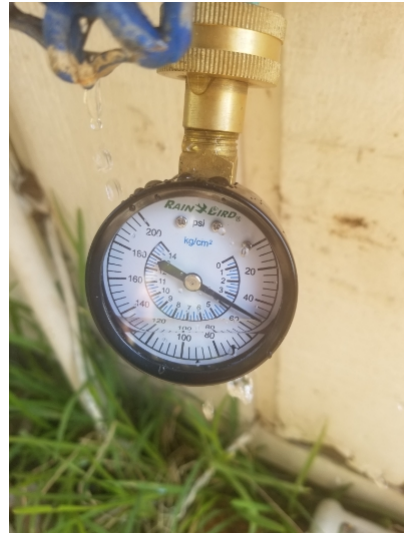
Water was running continuously at back yard exterior spigot. Shut off valve may be in need of repair.

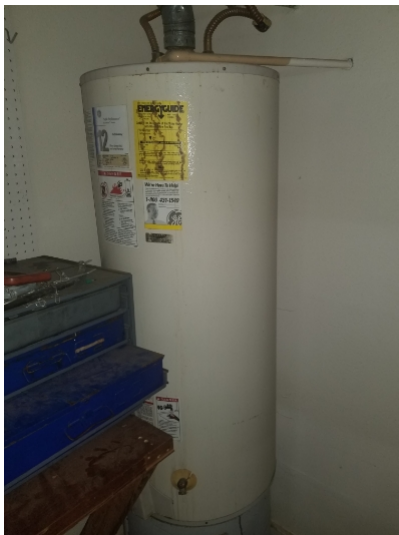
- Water heater is gas powered and appeared to be manufactured by GE in 2000.
- In our opinion, there should be a drip leg on the gas line. Most manufacturers recommend drip legs be installed.
- Water stains were observed on the top surface of the water heater.
- Water heater flue was not proper distance from combustibles in attic and should be at least 1 inch from wood or other combustible material.
- Flue vent collar is not secure at the ceiling.
- Unit was percolating and noisy. Unit may need to be flushed , consult with a qualified licensed plumber for further evaluation.
