Inspection Report

Property Address:
615 E. Cypresswood
Spring Tx 77373

PROPERTY INSPECTION REPORT

11/9/2019

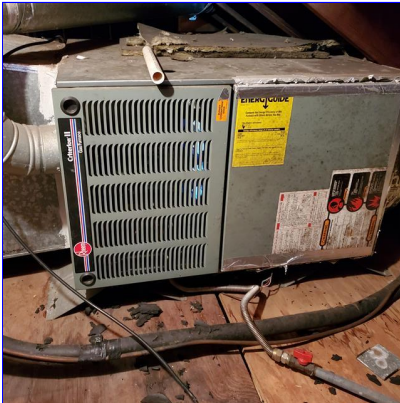
A. Item 1(Picture) General view.

Gas flex line entering directly into furnace cabinet can possibly cause damage to gas line and should be repaired for safety.

The thermostat does not appear to be keeping consistent temperatures and needs further evaluation.

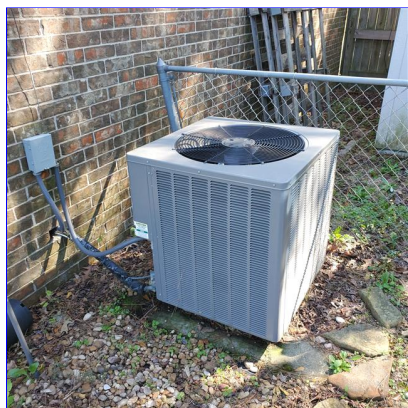
B. Item 1(Picture) General view.

Cooling equipment appeared to be operating as intended at time of inspection and the return and supply air was at a proper operating differential, between 14 and 22 degrees, as recommended. Recommend contacting a licensed HVAC professional if system does not appear to be cooling home adequately, or if noise is noticed to be coming from the unit.

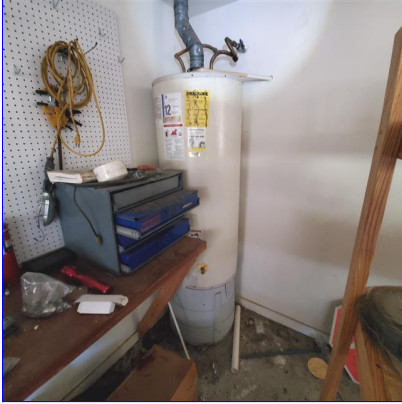
C. Item 1(Picture) General view of water heater.
