Brad Leland
Inspections you can Trust

Inspection Report

PROPERTY INSPECTION REPORT

Concerning: 4521 Coronado St., Seabrook, TX
(Address or Other Identification of Inspected Property)

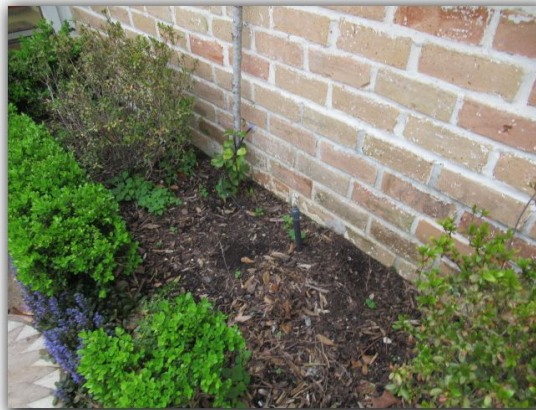
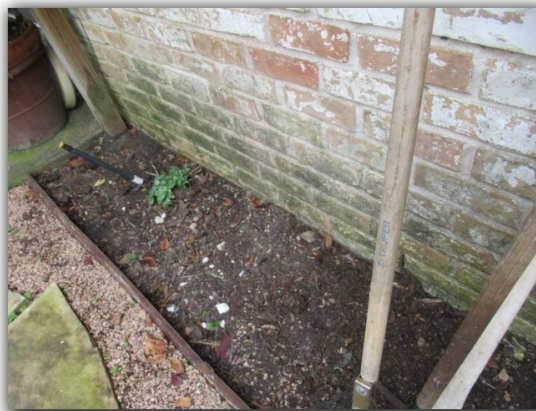
The soil levels are high in relationship with the interior in several areas. When soil levels are high against the face of the foundation it promotes water penetration of the structure and insect infestation. This item should be corrected so there is some exposure of the foundation face without creating reverse drainage. It is generally accepted that in an ideal situation, a brick veneer house should have about 4-6 inches of clearance.

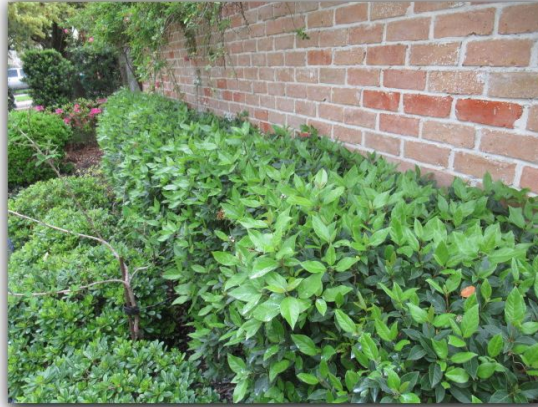
There was heavy foliage in several areas , therefore the face of the foundation and the brick walls in these areas were not visible. This condition will also hold moisture in these areas and may be

conducive for insect activity. Cutting back the foliage in these areas is recommended.

Foliage has been removed along the outside of the home, inspector recommended that it not be in direct contact with the home/foundation. All foliage contacting home was removed to prevent potential issues in the future.

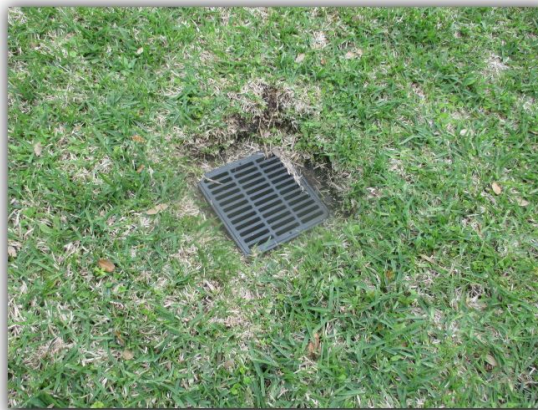
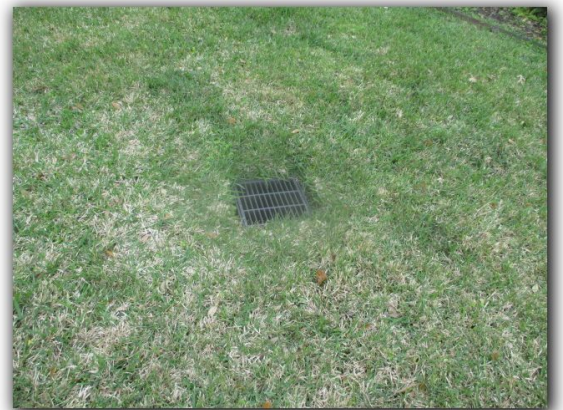
There appears to be a sub surface drain system. This drain system should assist in diverting rain water to the street or storm sewer. The overall effectiveness of this system was not determined. Underground drains can become clogged or obstructed.

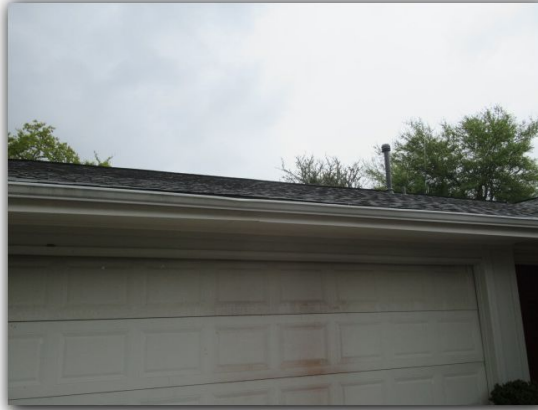
Comments: The gutter system was not sloped adequately to allow for proper drainage at the front of the home. Water loading can cause a gutter system to pull away from the roof structure. This condition makes it easier for water to pass in between the gutter and the fascia board and is considered a conducive condition for wood decay and water penetration.

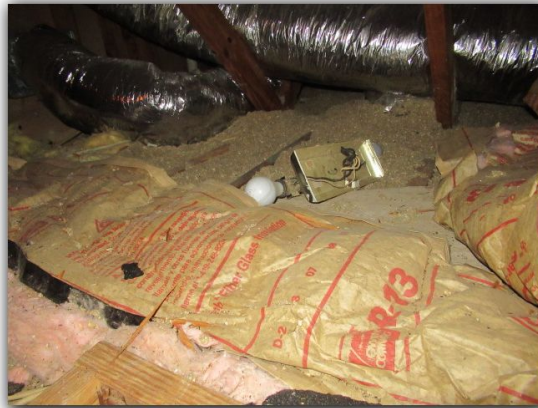
The insulation on the attic floor was thin to meet minimum current standards (r-30, 113/4"). It is recommended that additional insulation be added for energy efficiency.

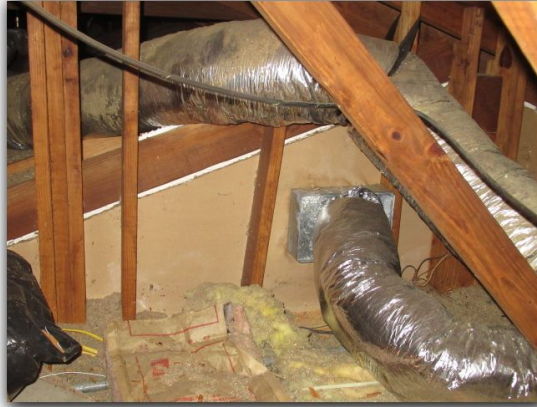
The insulation on the interior attic wall/walls was not complete where visible. It is recommended

that additional insulation be added for energy efficiency.

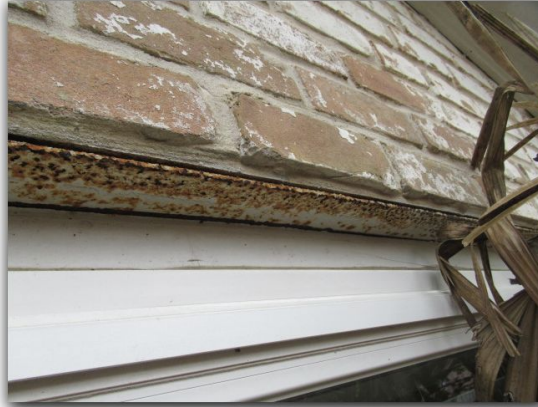
should be used to prevent further oxidation. These lintels are commonly found over window and door openings that have brick/stonework above the opening.

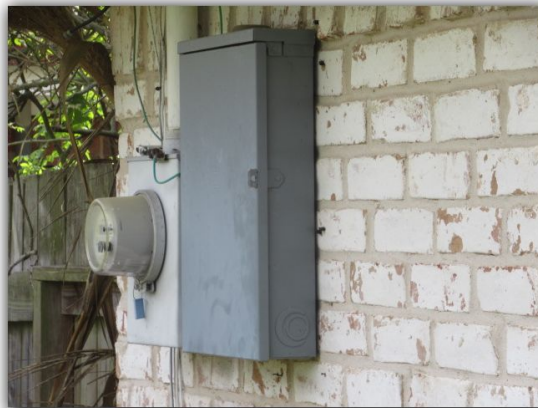
It is necessary to seal around the electric breaker box, electric meter box and the air conditioning compressor quick disconnect box to prevent moisture intrusion and corrosion to the metal boxes.

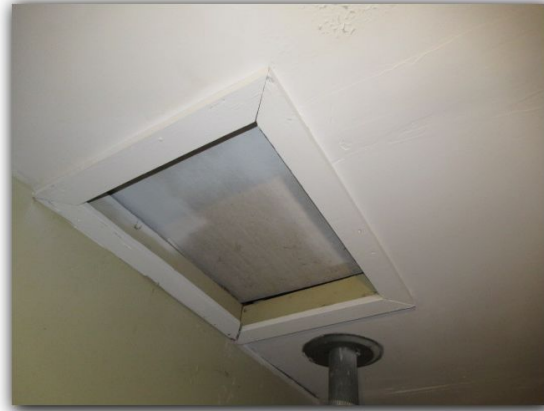
The attic access ladder panel does not seal tight when closed and is not insulated The attic ladder panel should seal tightly against the frame when closed and be insulated to prevent radiant heat from transferring from the attic to the living quarters. It is recommended that the assembly be replaced do to some of the hardware not being secured.

Attic ladder has been replaced and professionally installed and no longer has a gap when it is closed.

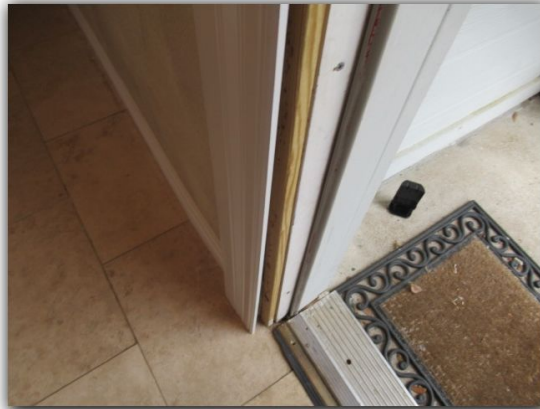
The plunger in the door knob assembly of the door from the house to the garage has been installed backwards.

Home to garage door and hardware have both been replaced and professionally installed. Issue is now resolved.

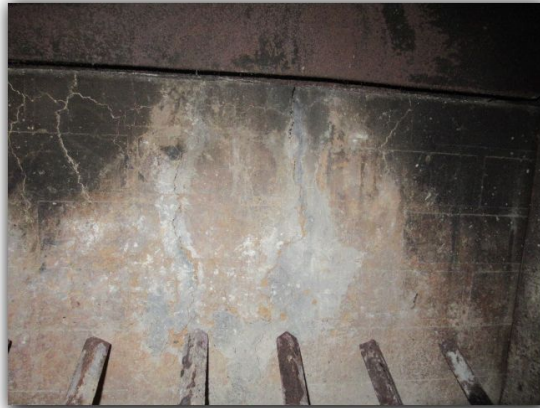
There was corrosion on the damper assembly. This condition is an indication of moisture intrusion.

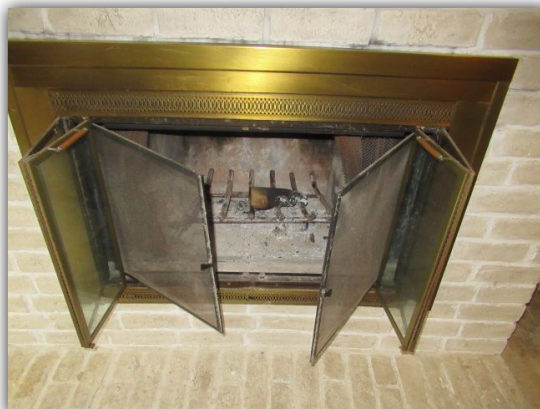
The igniter tube has been removed and the gas line has not been capped off.

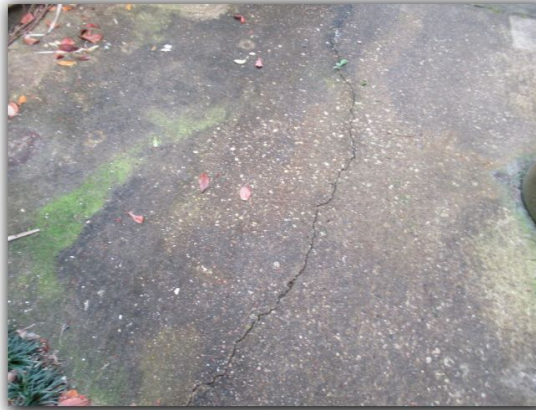
Comments: There were cracks in the north side back patio and it has settled unevenly.

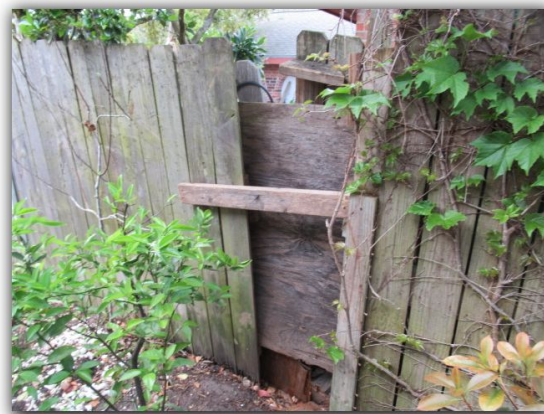
The fence was not complete behind the garage.

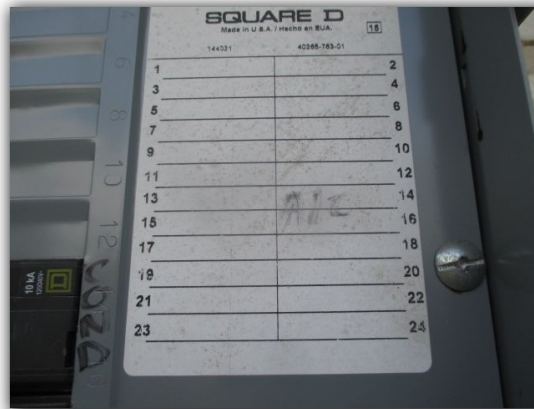
Comments: The breakers were not labeled at the service box as required.

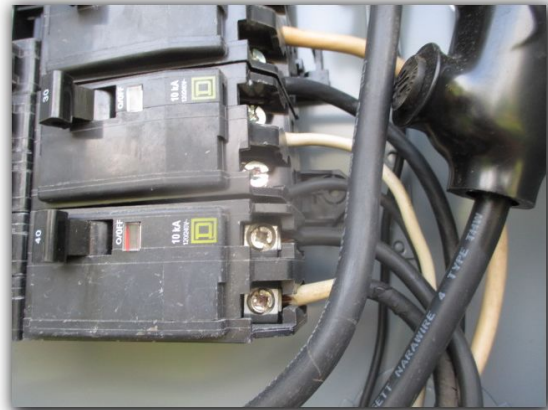
White wires were used as a "hot" wire and are connected to a circuit breaker. In most instances the white wires are the grounded conductors, and if they are used as a "hot" wire, they must be wrapped with black or red tape to identify them as a "hot" wire.

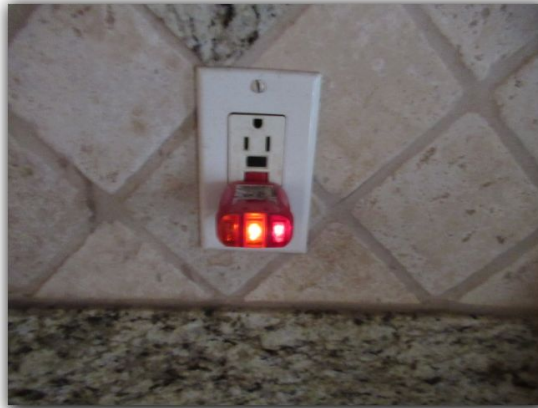
Some of the electrical outlets are loose and need to be secured to avoid possible loose connections/electric shorts.

Electrical outlets were replaced by professional electrician and are no longer loose. issue resolved.

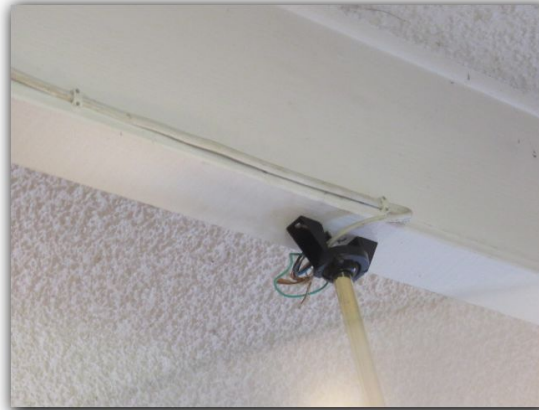
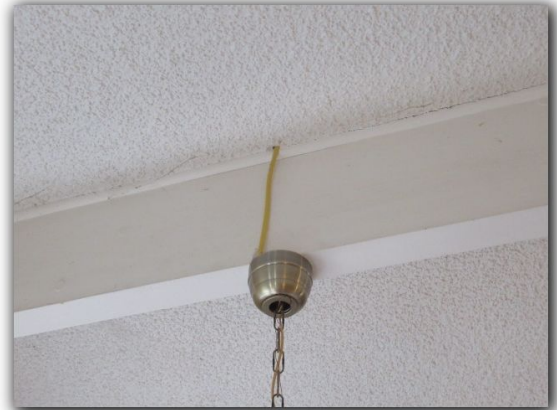
Several of the lights were not working. This condition may be a result of a need for light bulb replacement.

New light fixtures and light bulbs were professionally installed by an electrician. Issue has been resolved.

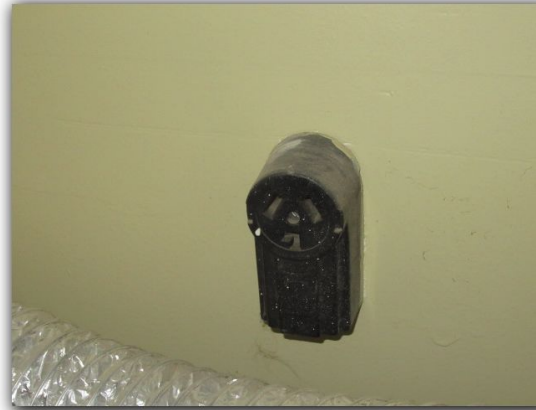
The 220 outlet for the dryer is not a 4 prong type as is necessary for newer appliances.

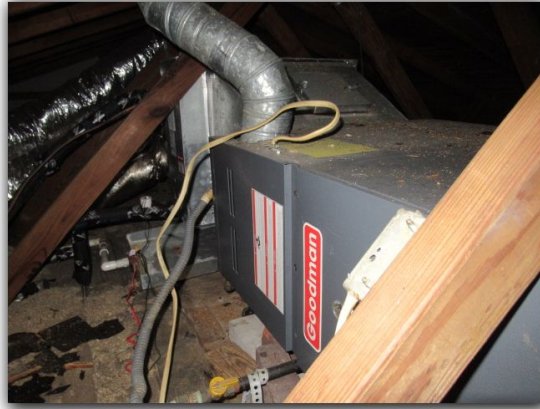
Comments: There is no condensate drip leg/sediment trap installed on the furnace gas supply line as is now required.

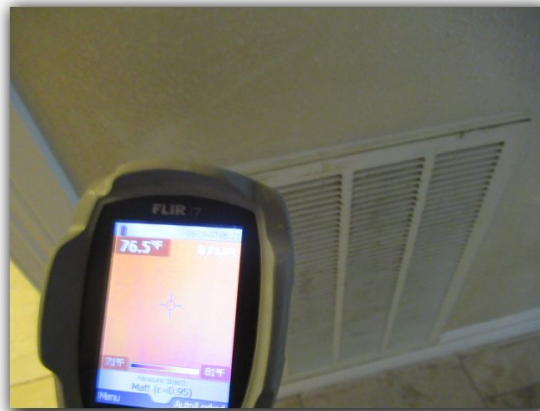
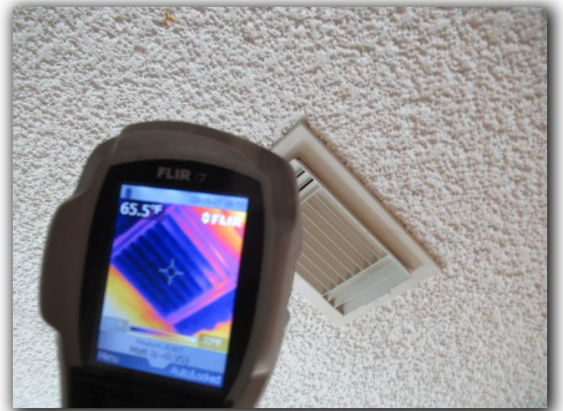
Differential Air Temperature Drop During Operation:
Air Going Into System: 76 f Returned Air: 65 f

Comments: The system did not operate within the allowable tolerances. The air coming out of the vents should be 14 to 21 degrees cooler than where it goes into the cold air return. It is recommended that a qualified contractor be consulted regarding this matter.

Contractor was hired for this issue, and an Air conditioning service was completed by previous owner prior to sale closing. It was confirmed to be in working order by time of closing. Issue has been resolved.

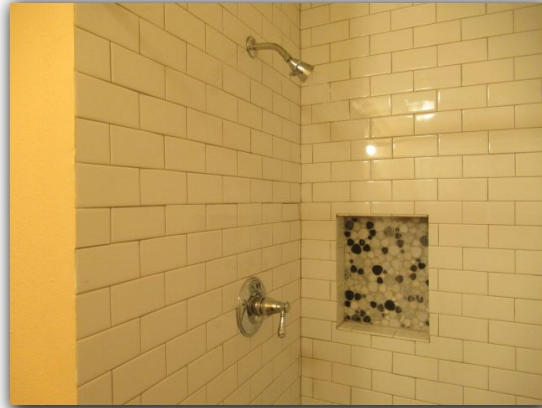
The cold water supply valve for the hall bathtub/shower does not have a positive stop.

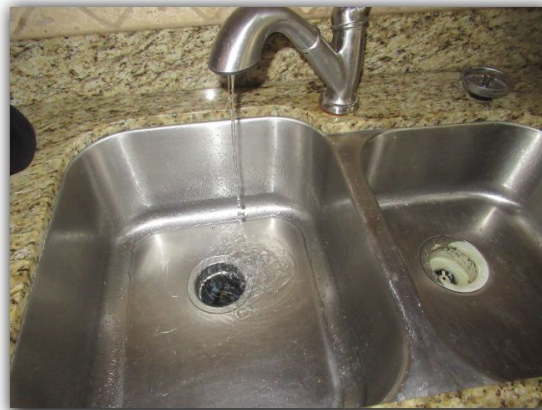
Comments: The left side of the kitchen sink was slow to drain. This is an indication that there is an obstruction in the drain line.

Sink has been serviced by professional plumber. The sink now drains at a normal rate. Issue resolved.

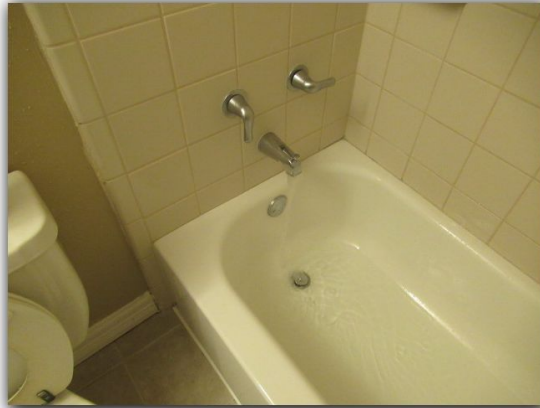
It is necessary that there be an inspection ports provided for the hall bathtub/shower so that it is possible to check for leaks, as well as for service to be performed on the plumbing if needed.

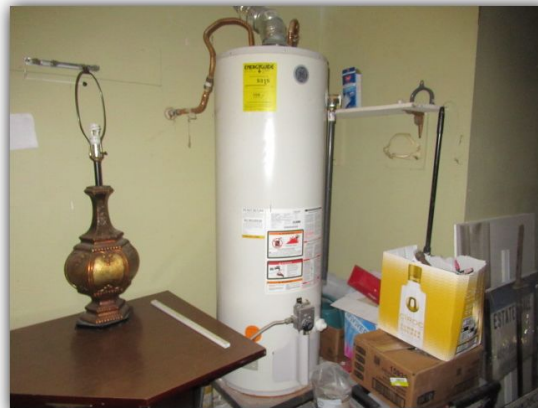
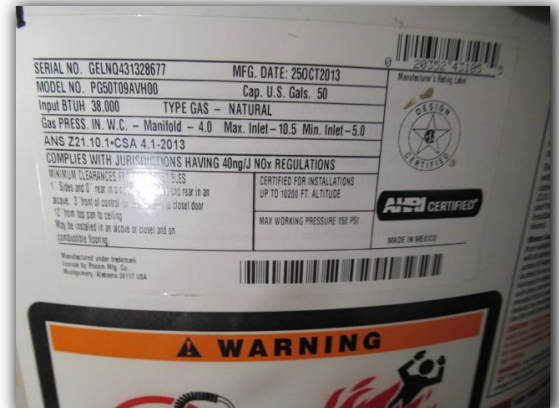
Comments: The temperature and pressure relief valve should drain into a line that is plumbed to the outside. This line can be 3/4" C.P.V.C Plastic (not reduced in size) and should terminate from 2 to 6 inches from the ground.

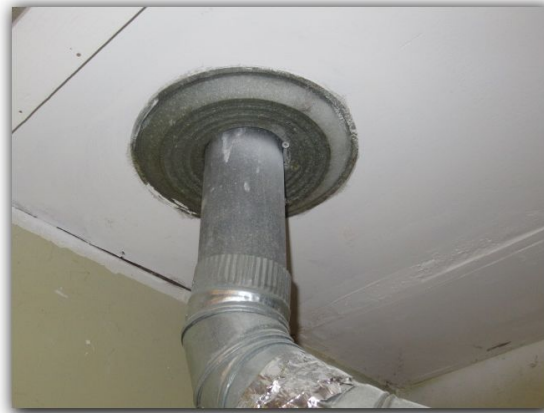
The water heater flue pipe did not appear to be completely of the double walled type as is required for gas appliances.

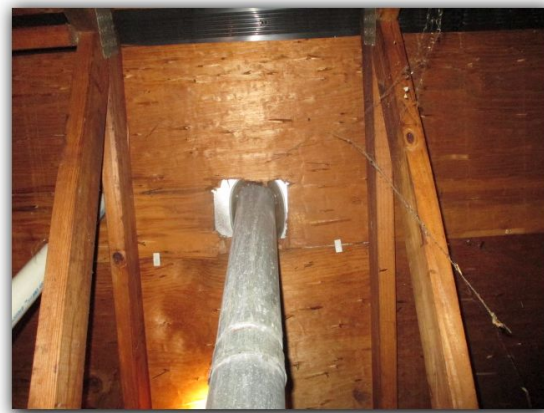
The water heater flue pipe was not secured/strapped to the rafters.

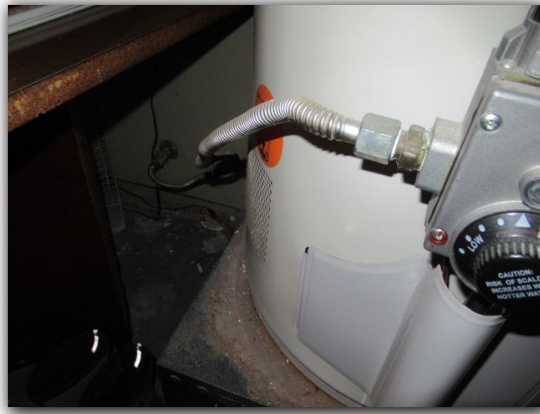
There was no condensate drip leg/sediment trap installed on the water heater gas supply line as is now required.

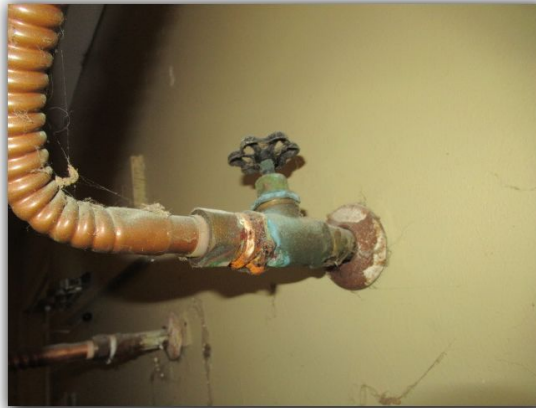
There was corrosion at the water supply lines and a slow drip leak. It is recommended that these fittings be replaced.

A qualified plumber should be consulted regarding the repair of the above items as well as check the entire water heating system for any other possible defects.

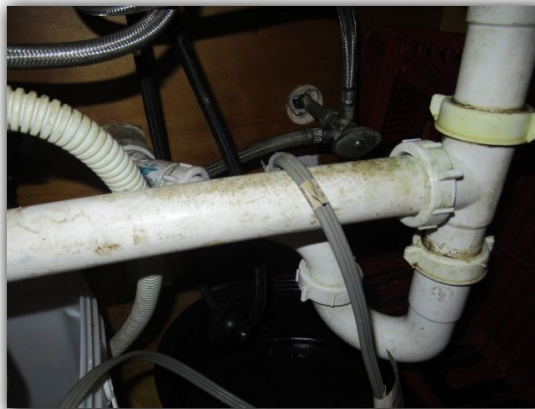
Comments: The dishwasher was not operational as the water supply was turned off to it at the time of the inspection.

Brand new stainless steel dishwasher has been installed and is now in normal working order. Issue resolved.

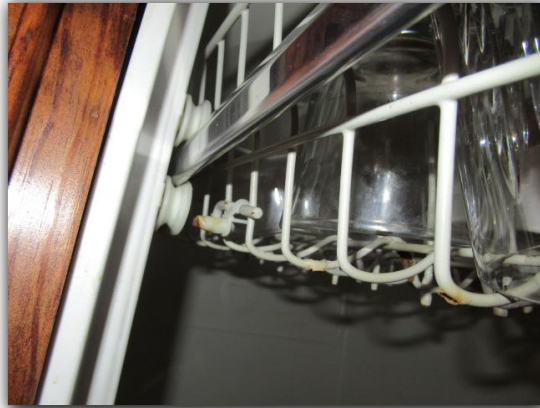
The upper basket is not secured to the left side slide rail.

New dishwasher installed (See above comment)

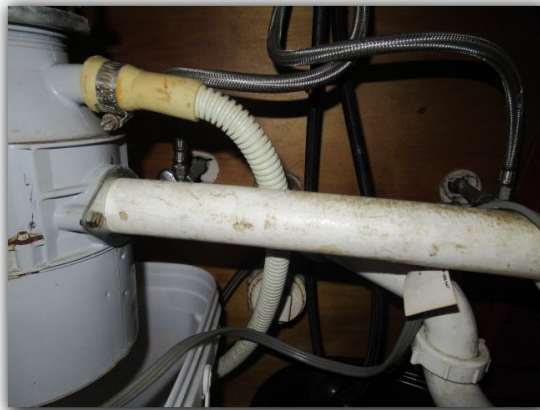
The dishwasher drain line (discharge hose) did not have an anti-siphon valve or a vacuum break. The dishwasher drain line usually attaches to the garbage disposal. The drain line should arch above the level of the sink drain, have an anti-siphon valve, or have a vacuum break. This keeps debris in the disposal from siphoning back to the clean dishes. The drain lines should be elevated or a back flow device installed.

New dishwasher installed (See above comment)

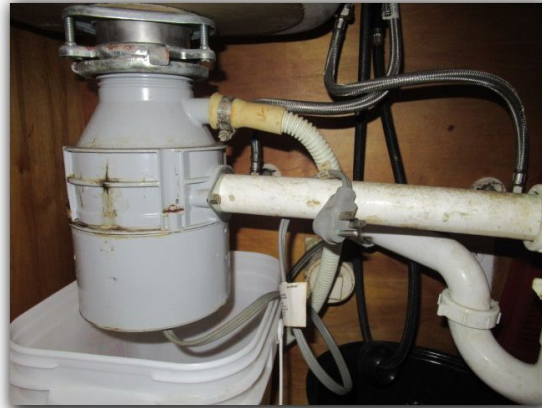
Comments: The garbage disposal was not operational as it has been disconnected from the power supply.

New garbage disposal was purchased and professionally installed and is now in normal working order. Issue resolved.

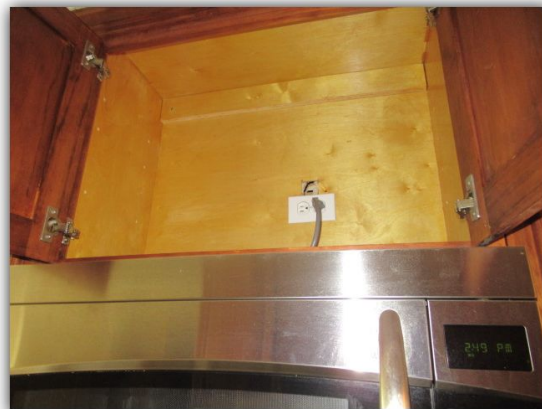
The range top has a re-circulating vent hood. The air is filtered, and then it is re-deposited in the kitchen. Most vent-hood appliances, especially ones that use gas, will have a flue which is terminated outside of the house to remove combustion products, moisture, grease, and heat. The installation of a flue will also lower your electric bill during the hot months.

New kitchen appliances were professionally installed to resolve these issues.

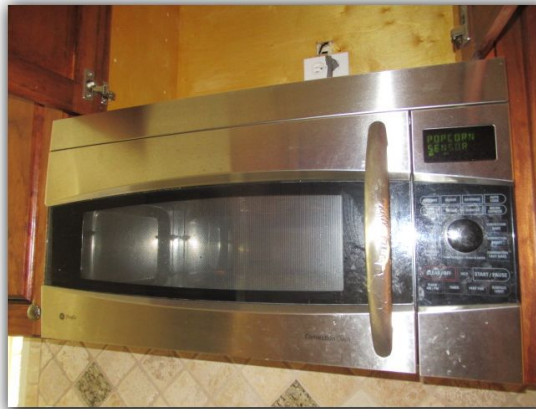
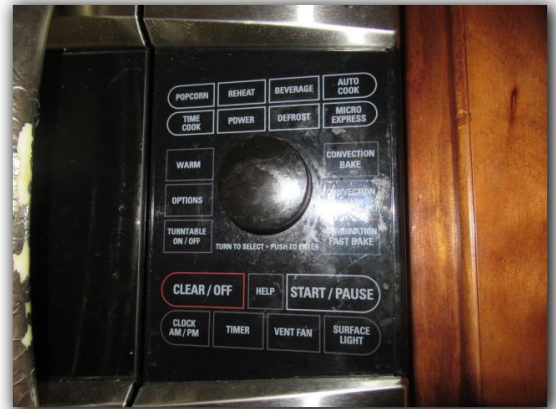
Comments: The microwave control knob did not operate when tested.

New microwave has been professionally installed. Issue resolved.

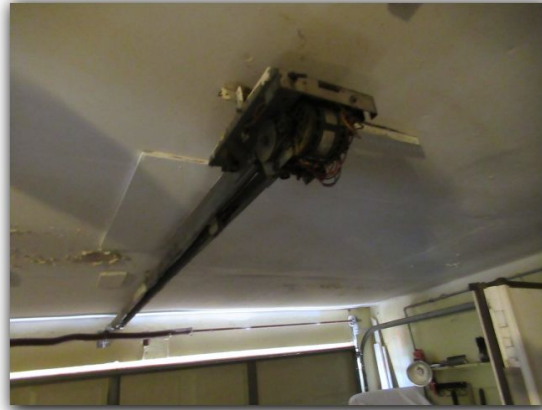
Comments: The garage door operator was not in working condition at the time of the inspection.

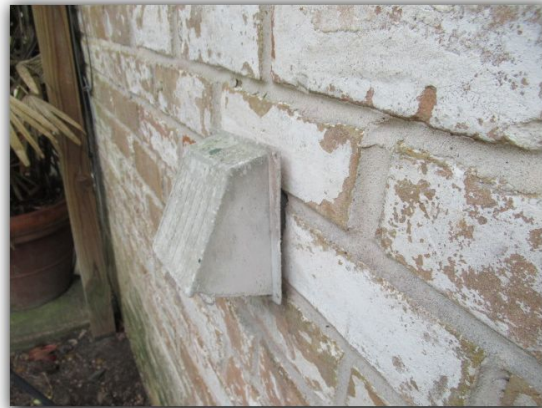
Comments: The exterior dryer vent wall cap was not sealed to the wall as it should be in order to prevent possible water penetration.
