PROPERTY INSPECTION REPORT

Concerning: 106 Laurel St, Lake Jackson, TX 77566

By: Brad Summers TREC#22343 TREC#22343 / SumTex Inspections

6/29/2019

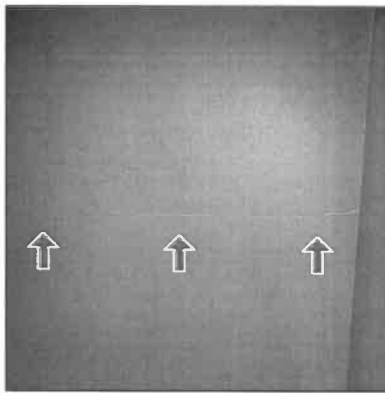
A. Item 7(Picture) front left secondary bedroom closet

(4) Settling cracks in drywall throughout home. Cracks in drywall is a sign of foundation movement.

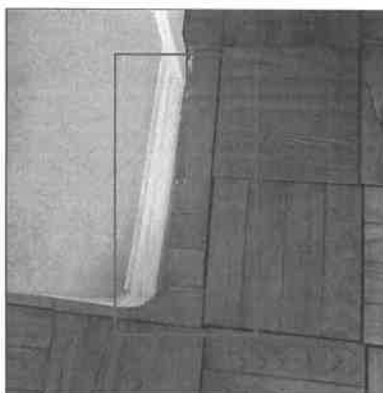
A. Item 16(Picture) main living area

(5) The wood flooring in multiple locations has separated and appears to be caused by foundation movement.

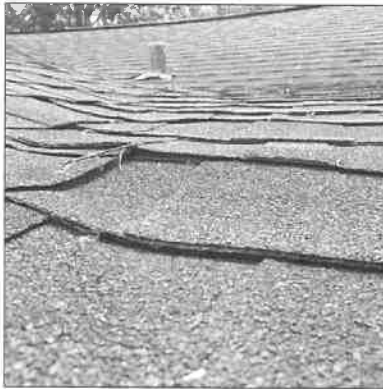
C. Item 6(Picture)

(4) Lifted shingles at the valley at the rear of the home. Shingles that are lifted in no longer secure to the decking.

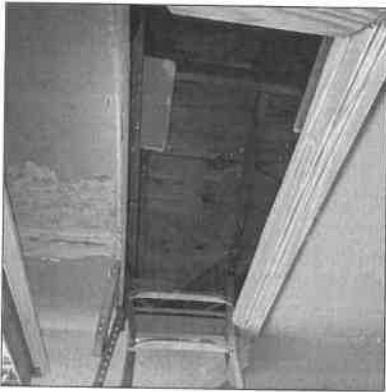
F. Item 4(Picture)

(3) Opening in ceiling of garage to attic. The garage shall be separated from the residence and its attic area by not less than 1/2-inch (12.7 mm) gypsum board applied to the garage side.

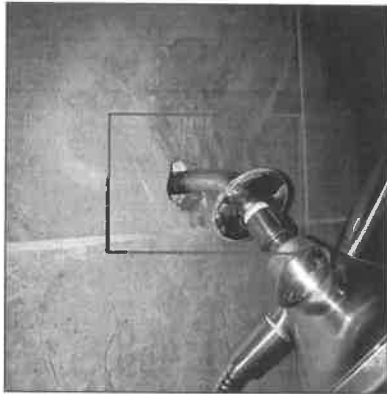
A. Item 6(Picture)

(2) Washer should be secured at the shower head in the master bath.

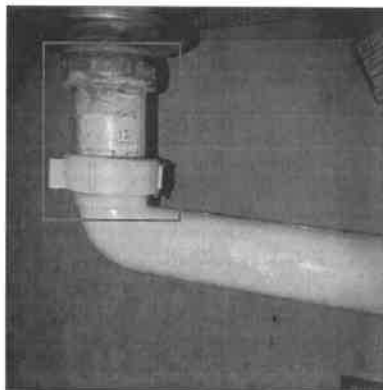
B. Item 2(Picture)

(1) Multiple plumbing leaks under kitchen sink at the time of the inspection.

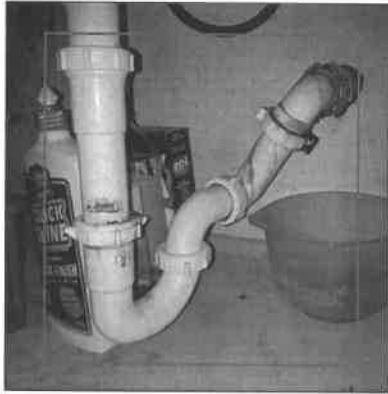
B. Item 3(Picture)

(2) Incorrect P-trap located underneath kitchen sink at the time of the inspection. Each fixture trap must have a liquid seal of not less than 2 in and not more than 4 in deep.

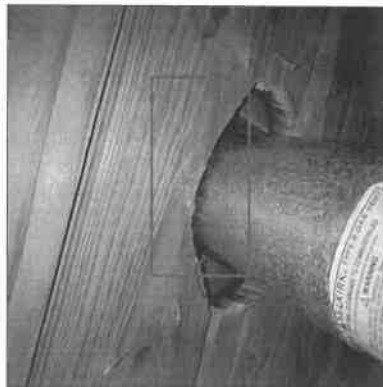
C. Item 2(Picture)

(2) The exhaust flue for this gas-fired water heater had inadequate clearance from combustibles. This type of exhaust flue requires 1-inch clearance from combustible materials.
