# A-Action Home Inspection Group

## PROPERTY INSPECTION REPORT

Concerning: 4810 Wedgewood Dr., Bellaire, TX 77401  
(Address or Other Identification of Inspected Property)

By: David Schmeck, Lic #22972 04/11/2019  
(Name and License Number of Inspector) (Date)

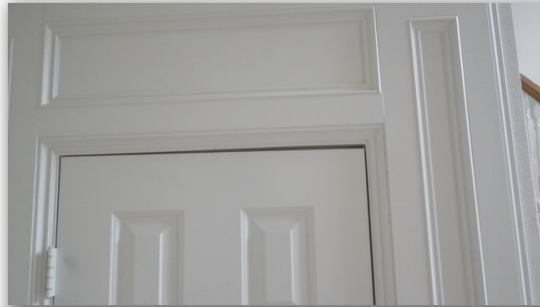
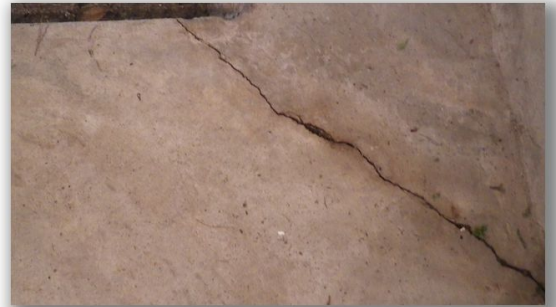
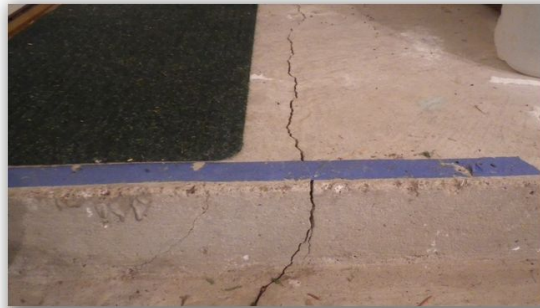
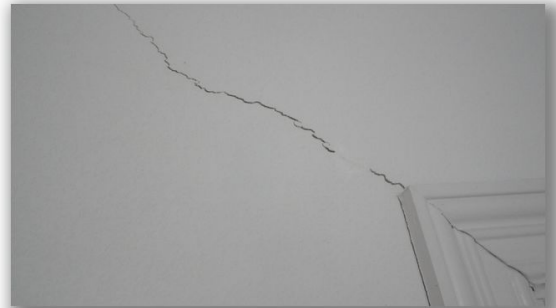
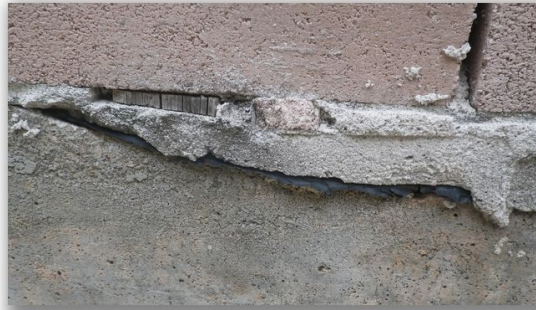
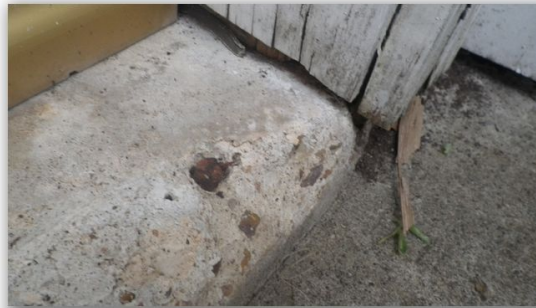
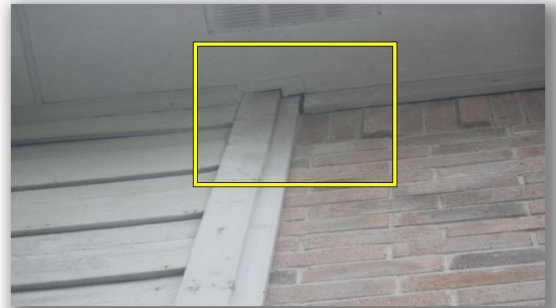
#### Foundation Needs Further Evaluation

The foundation appears to have had movement that may be beyond normal. A Professional Engineer licensed by the State of Texas should be consulted on the current integrity of the foundation and any repairs that may be necessary (If Any). The observations made to support the rendering of this opinion are listed but not limited to the following:

- In my opinion, this foundation is showing signs of movement that exceeds normal tolerances. The changes in the floor elevation of the house were greater than would normally be expected.
- Deflection cracks were observed in the exterior veneer.
- Misalignment of interior doors due to foundation movement.
- Interior door(s) stick and/or not closing due to foundation movement.
- Separations of the exterior veneer and window frames were observed.
- Frieze board separations were observed.
- Cracks were observed in the floor of the foundation.
- Floor slopes and/or unlevelness were observed.
- Interior drywall cracks and/or stress indicators.

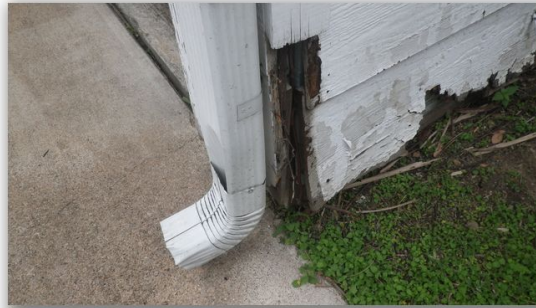
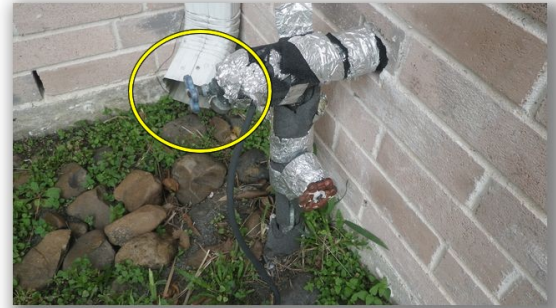
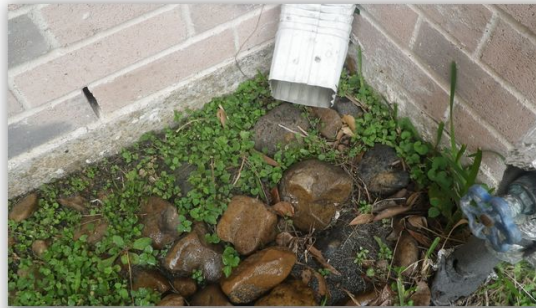
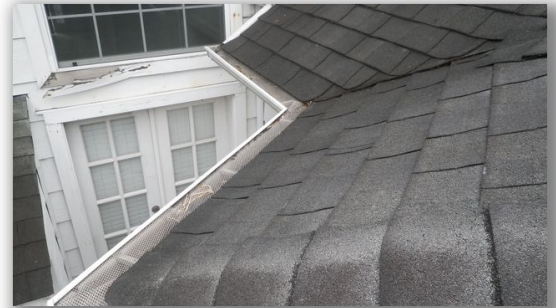
**Gutter & Downspout System**

- **Note:** The gutter downspouts should discharge water at least thirty-six inches (36") away from the foundation perimeter beam. Storm water should be encouraged to flow away from the structure at the points of discharge.

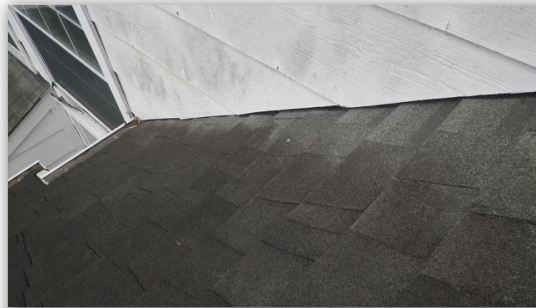
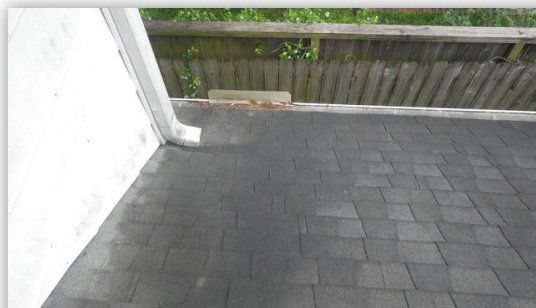
- One or more of the shingles were observed to be lifting on the east side, west side of the roof structure.
- The composition roofing material has experienced considerable granular loss in various locations throughout the roof.
- Some blistering of the roofing material was observed at the time of this inspection.
- Tree and shrub branches need to be trimmed away from the roofing material at all times to help prevent damage to the roofing material. It is the opinion of this Inspector that there are some branches too close to the roofing material at this time and corrective measures are needed.
- Shingle fasteners (staples and/or nails) were observed to be pushing through the roofing material in various locations.
- **Note:** Roof fasteners (nails and/or staples) were observed to be exposed and should be properly sealed at the ridge caps and flashing areas.

You are strongly encouraged to have a properly certified roofing contractor to physically inspect the roof, prior to the expiration of any time limitations such as option or warranty periods, to fully evaluate the condition of the roofing material. The observation made to support the rendering of this opinion are listed but not limited to the following:

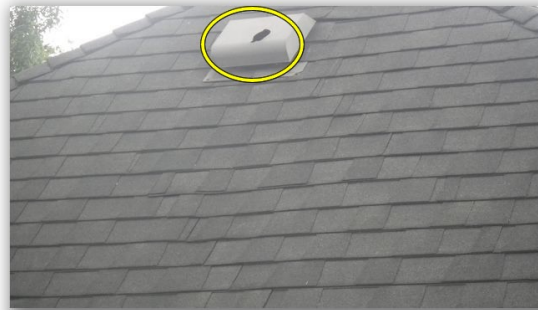
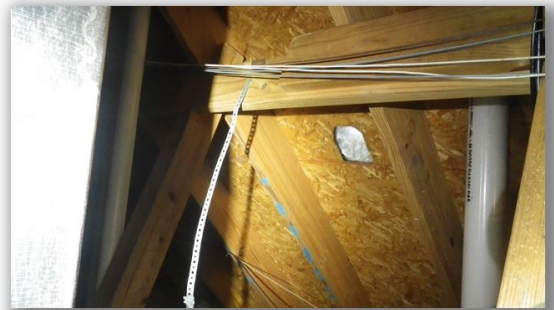
#### Attic Ventilation

- One or more of the roof vent covers were observed to be damaged on the east side of the roof structure.

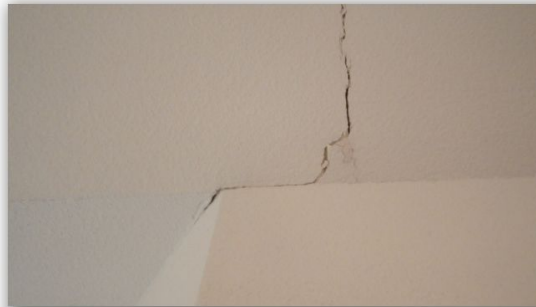
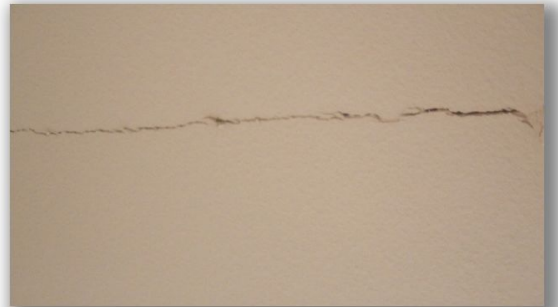
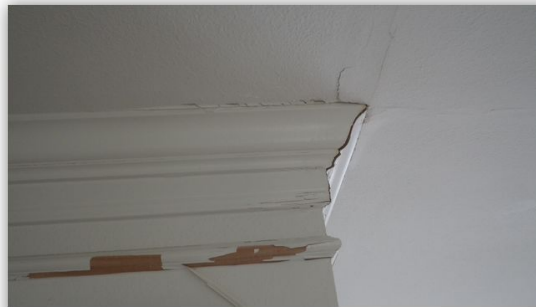
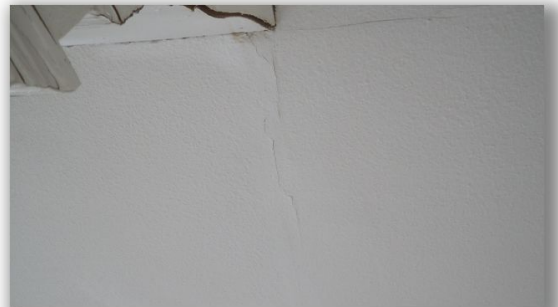
- The ceiling was observed to be water damaged in the upstairs bedroom hallway, Jack and Jill bathroom and the rear corner family room area..
- Some of the ceiling finishing material was observed to be sagging in the upstairs bedroom hallway.

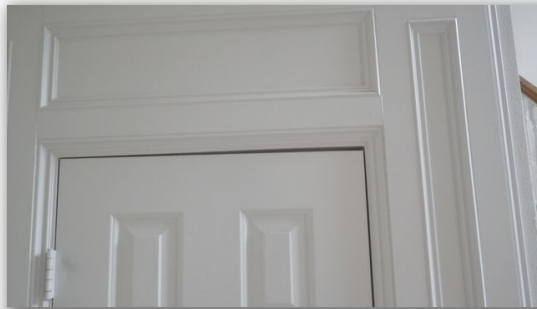
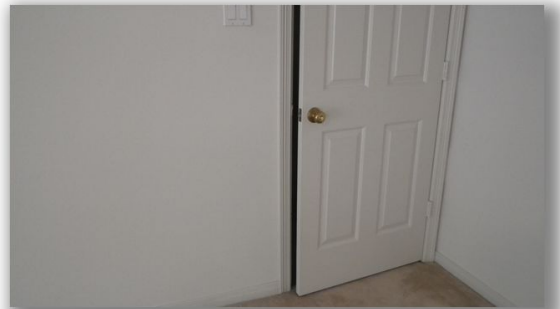
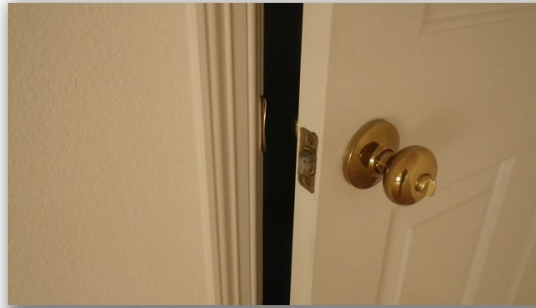
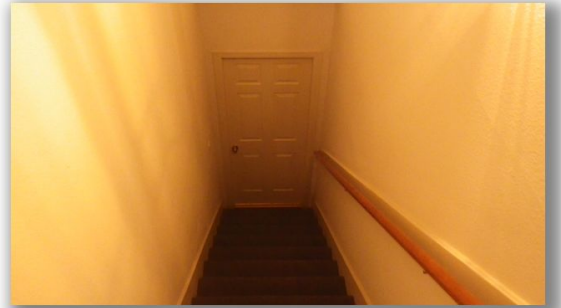
- The door is not latching properly to the various locations throughout the house.
- The door is sticking to the various locations throughout the house.

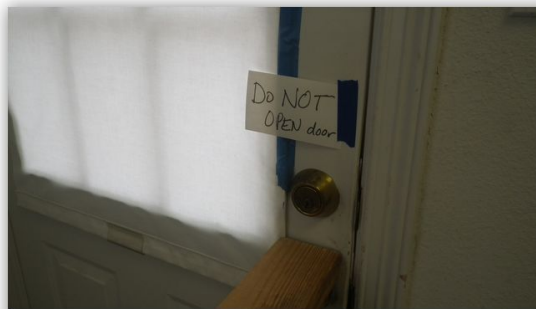
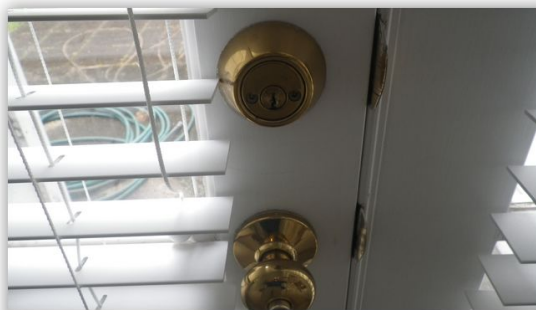
- The exterior door threshold has some deterioration and/or damage to the side driveway entry.
- Double cylinder locks were observed on one or more of the exterior exit (egress) doors. All exterior egress doors should be readily operable from the side from which egress is to be made without the use of a key or special knowledge or effort.
- The door is sticking to the backyard entry door, garage entry door.

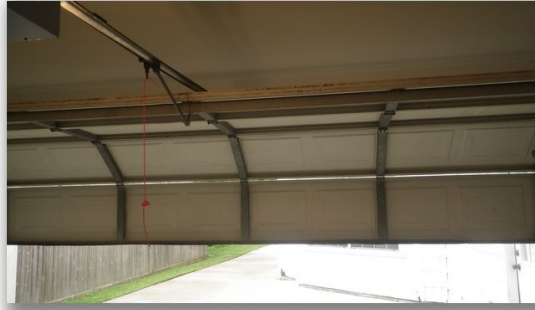
- It is recommended to lubricate the overhead garage door components, such as rollers, tracks and hinges.
- The weather-stripping at the bottom of the overhead garage door is damaged and repairs or replacement may be necessary.

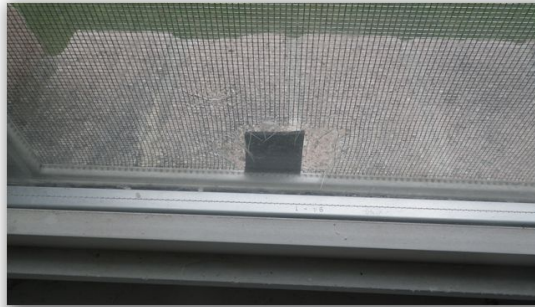
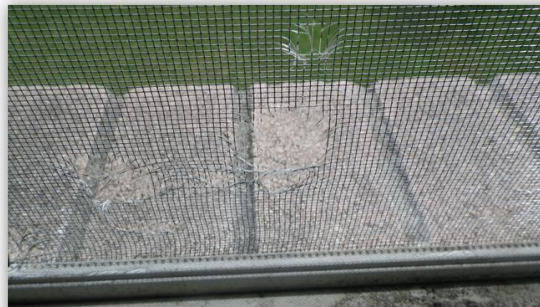
- One or more of the window screens were observed to be damaged.

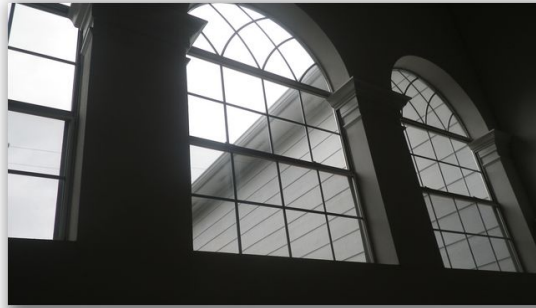
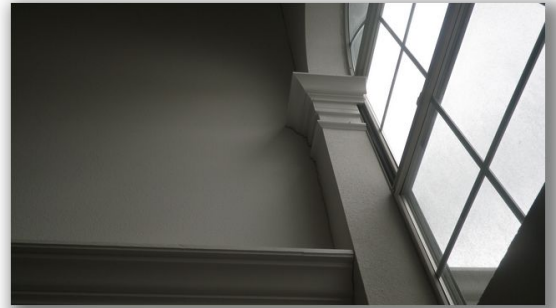
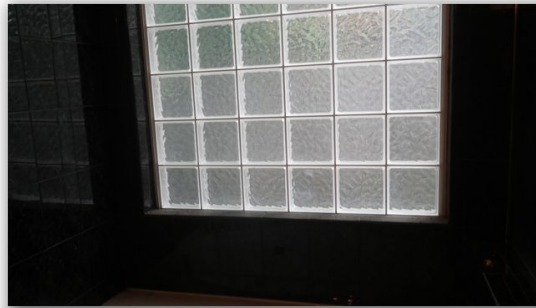
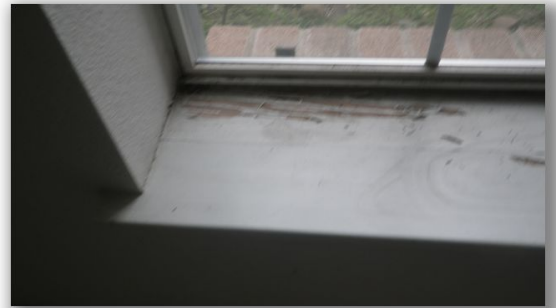
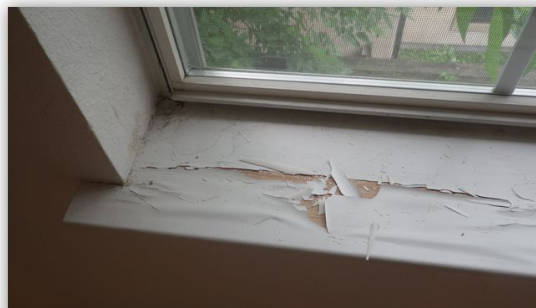
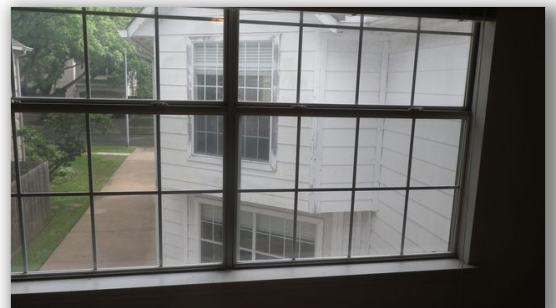
- Visible evidence of water intrusion was observed at and/or around the window(s) in the various locations throughout the house. The cause and remedy should be investigated and corrected as necessary.
- Window lock(s) were observed to be damaged and/or missing in the front entry hallway.
- The window weather-stripping is damaged and/or missing at one or more of the windows and improvements are recommended.

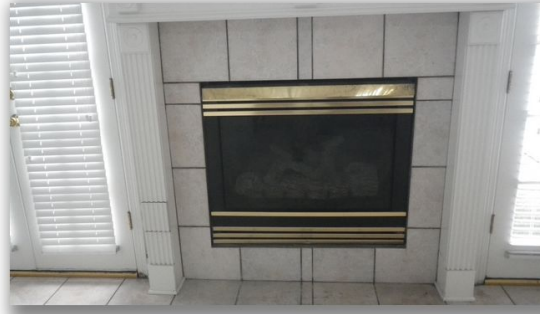
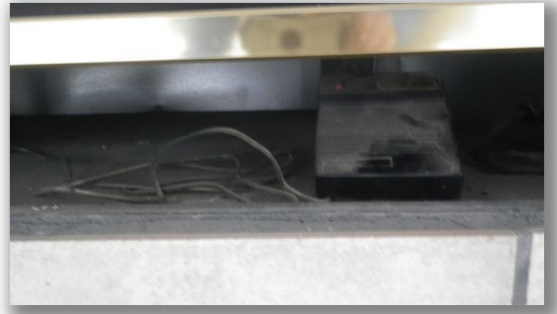
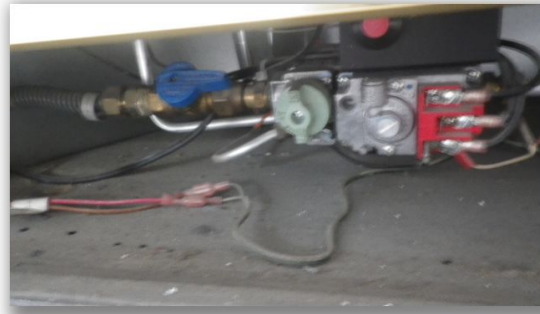
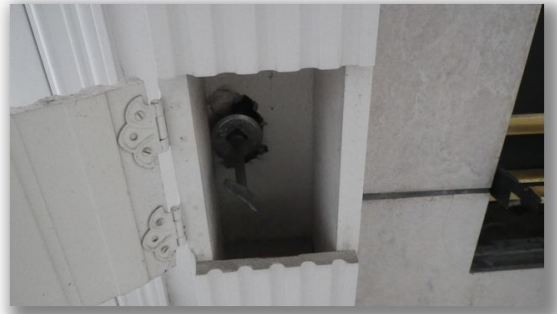
- The gas log assembly appears to be inoperative at the time of this inspection. I was unable to get the gas logs to respond to the pilot assembly / controls. This condition needs to be further evaluated and corrected as necessary.
- The chimney flue needs to be cleaned by a Qualified Chimney Sweep. A creosote / soot build-up was observed in the visible flue area.

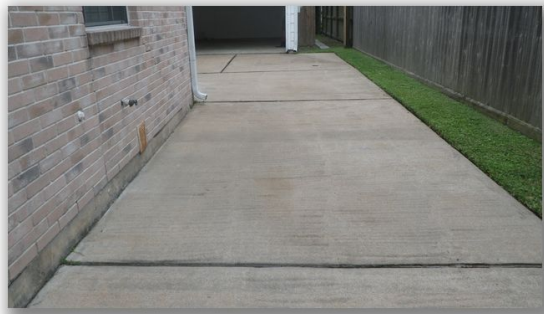
**Driveway**

- Minor cracks and/or deficiencies were observed in the driveway.

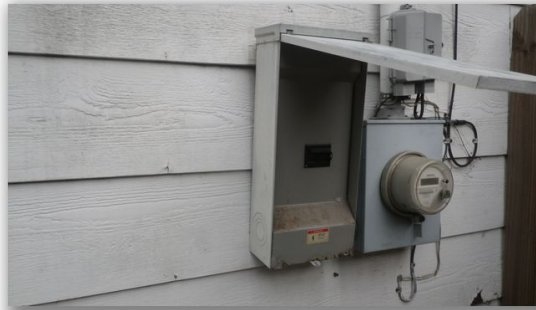
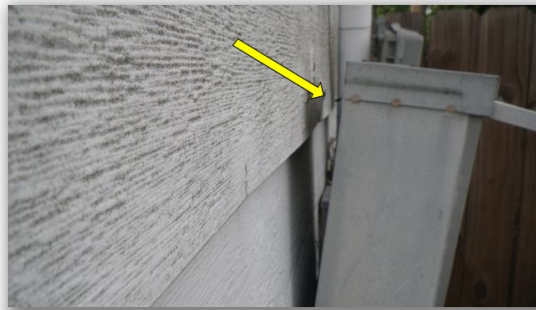
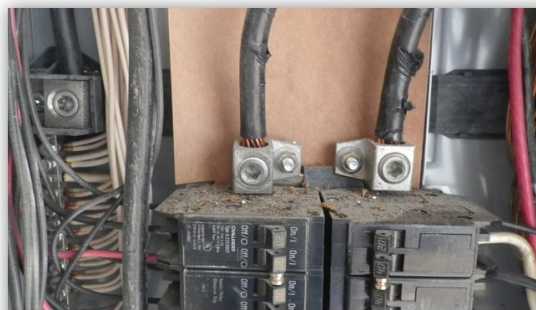
- The electrical cabinet has pulled loose at the wall mount and should be better secured.
- One or more of the neutral wires in the electrical cabinet were observed to be double lugged (i.e. two wires under one screw). The neutral wires need to be separated to prevent damage to the panel box and electrical system.

The buyer should have the electrical system checked by a Qualified Licensed Electrician. The observations made to support the rendering of this opinion are listed but not limited to the following:

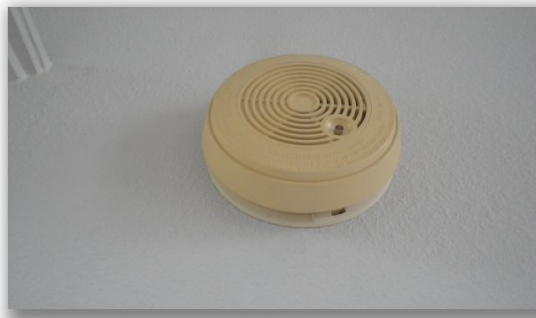
**Smoke Alarms**

- An audible sound can be heard from one or more of the smoke detectors, indicating that the batteries need to be changed. It is recommended to replace the batteries in all of the smoke detectors once a year for reasons of safety.

**Note:** It is recommended to replace the batteries in all of the smoke detectors once a year for reasons of safety.

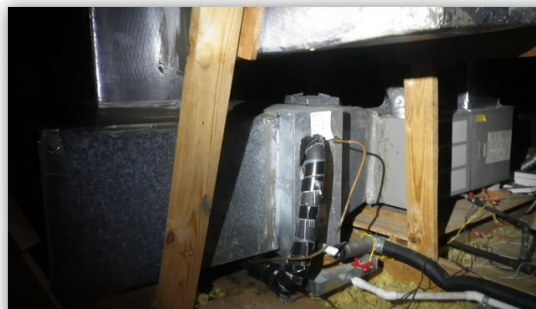
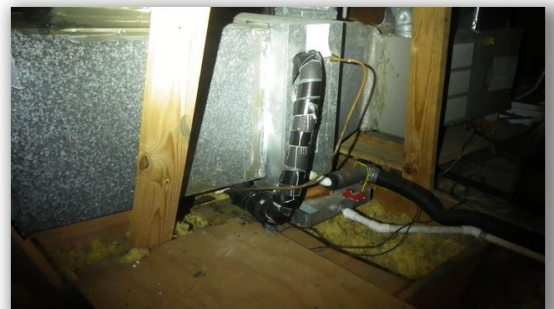
- The heating equipment, both units appear to be inoperative at the time of the inspection.
- The integrity of the heat exchanger is questionable and should be further evaluated by a Qualified HVAC Technician.
- The heater gas supply line is not equipped with a sediment trap just before the gas appliance connector. This condition does not meet current installation requirements and should be corrected.

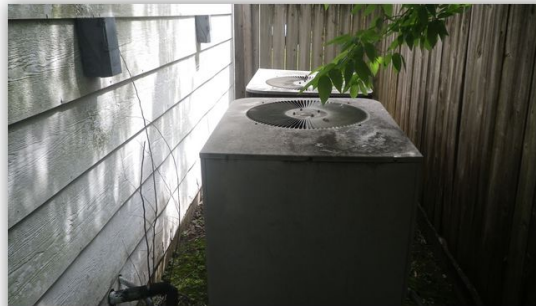
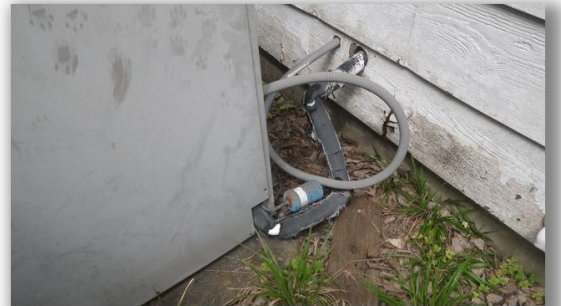
- The air conditioning system was inoperative at the time of the inspection.
- There is poor access to the service side of the attic coils.
- **Note:** The auxiliary/secondary drain pan under the coil housing should be free of all debris. The debris in the pan could clog the drain line and cause water to leak to the interior of the house.

The HVAC system and equipment needs to be checked and serviced by a Qualified / Licensed HVAC Technician. The observations made to support the rendering of this opinion are listed but may not be limited to the following:

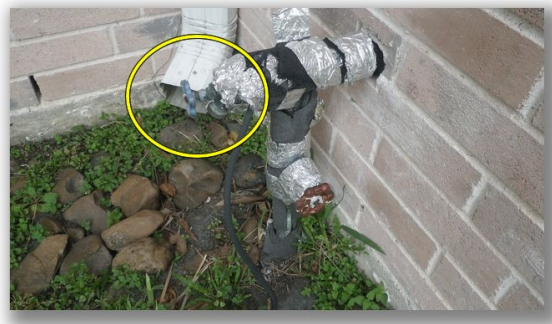
##### Exterior Faucets/Fixtures

- One or more of the exterior water hose bibbs (faucet) do not have a back-flow or anti-siphon device (Vacuum Breakers) in place. **Note:** *This is not uncommon to observe with a home of this age.*
-

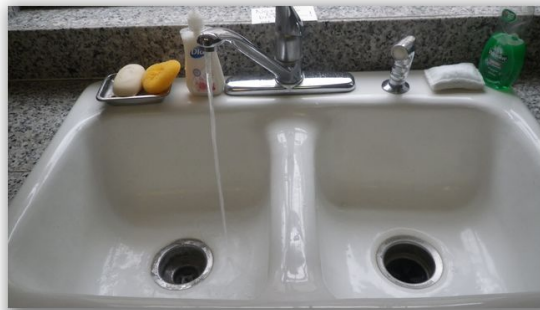
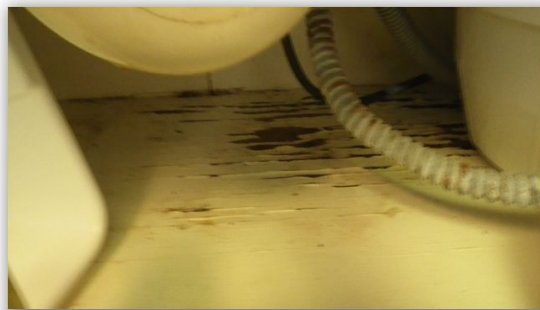
**Kitchen Sink**

- The shelf in the cabinet under the sink has had previous water damage.

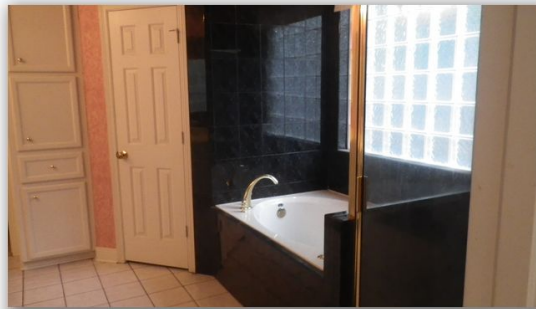
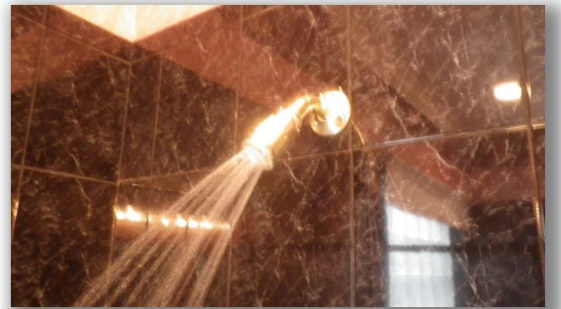
**Upstairs Hall Bathroom**

- Cracked, deteriorated and/or missing bathtub enclosure grout and/or caulking should be repaired or replaced as necessary.

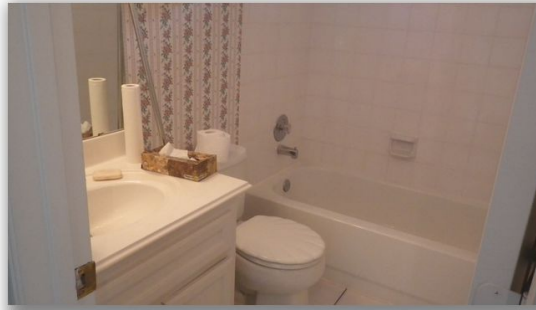
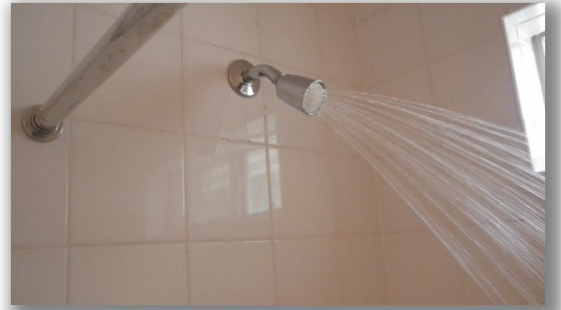
**Bath Between Rooms – “Jack & Jill Bath”**

- The stopper is damaged.

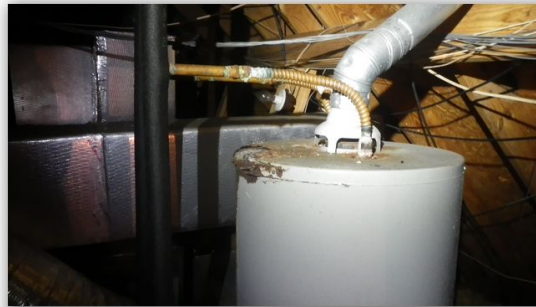
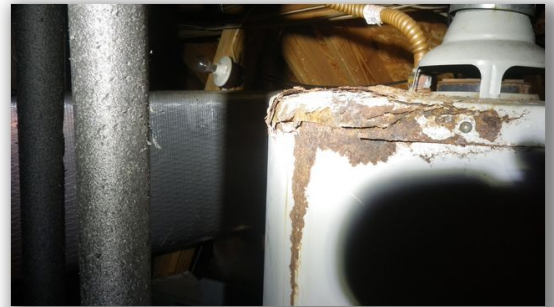
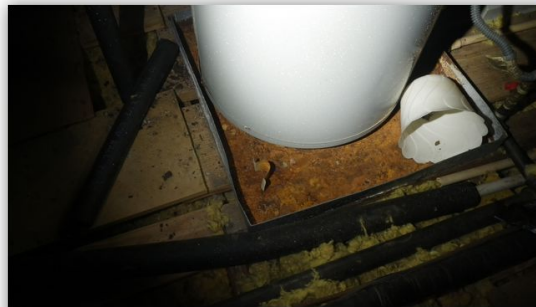
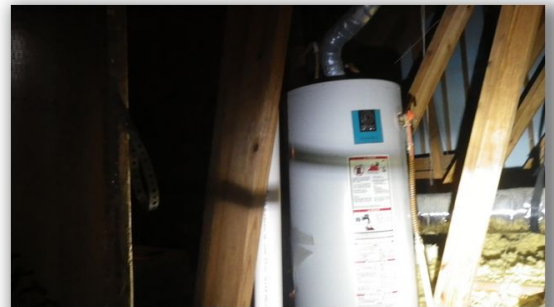
- Some corrosion was observed on the water supply shutoff valve.
- Some corrosion was observed at the water supply connections at the top of the water heater.

- Corrosion was observed on the water heater tank and the tank has been compromised. It is recommended to replace the tank immediately to prevent water damage to the structure.

- There is no proper decked service passage to the attic installed equipment. Under current mechanical installation standards, all appliances (i.e. HVAC Equipment and/or Water Heaters) mounted in an attic space should be accessible with a passageway of continuous solid flooring not less than 24-inches wide. A level service space at least 30-inches deep and 30-inches wide should be present along the side of the appliance where access is required.

- The pan under the water heater was observed to be damaged/rusted through and repairs are recommended.
- Second Unit was shut off and drained.

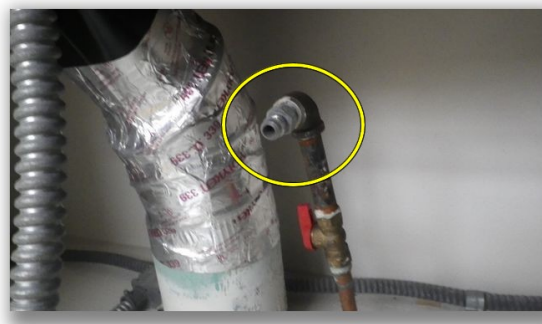
**E. Gas Distribution System**

- All unused gas valve ends should be capped off for safety purposes.

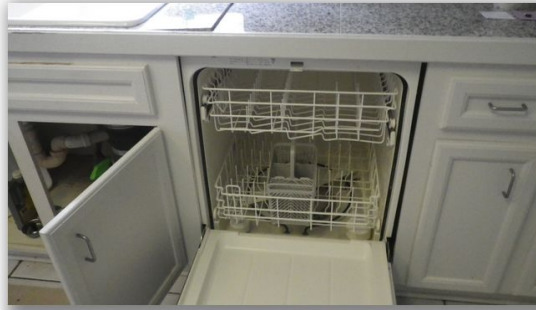
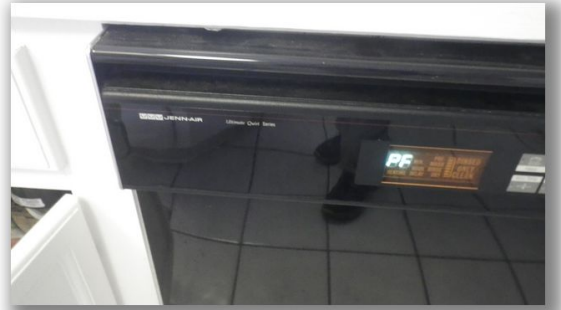
- The dishwasher was not able to be functionally tested due to hot water being turned off.

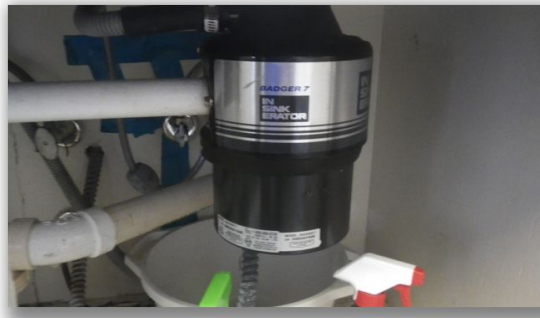
### B. Food Waste Disposers

- The food waste disposer is inoperative.

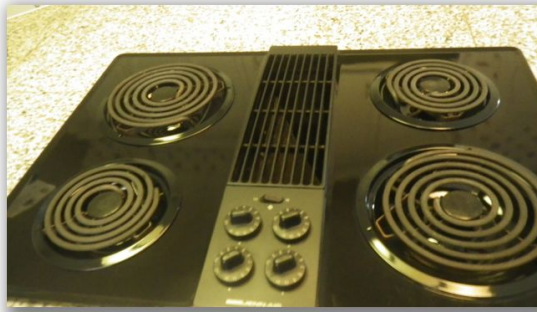
**D. Ranges, Cooktops, and Ovens**

- One or more of the burners do not function properly and should be further evaluated.

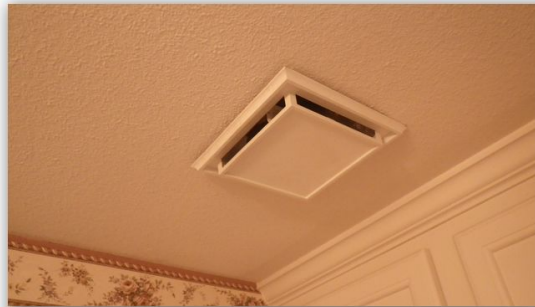
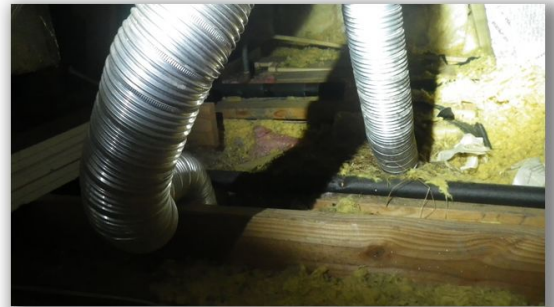
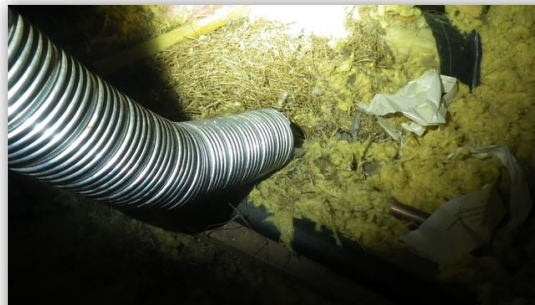
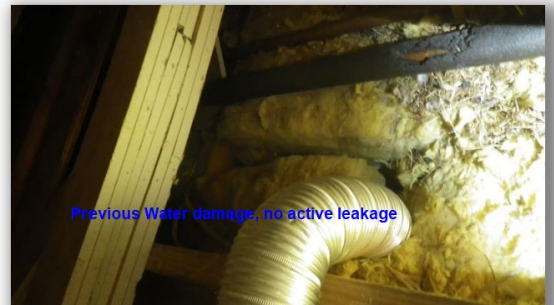
**F. Mechanical Exhaust Vents and Bathroom Heaters**

- The mechanical exhaust vents were observed to be venting into the attic area. Under current building standards, all mechanical exhaust vents should vent to the exterior of the structure. This is an “as-built” condition.

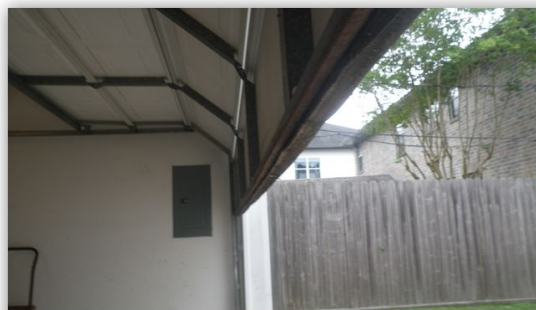
- When an automatic garage door opener is in use, the manual lock should be disabled or removed.
- The garage door opener ***DID NOT*** automatically reverse under reasonable resistance when closing. Improvement may be as simple as adjusting the sensitivity control on the opener.
- The garage door opener does not appear to be functioning properly when operated. The cause and remedy should be further evaluated and corrected as necessary.

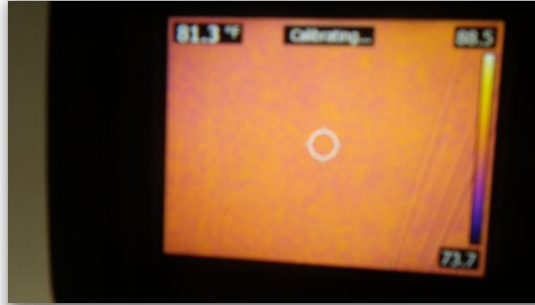
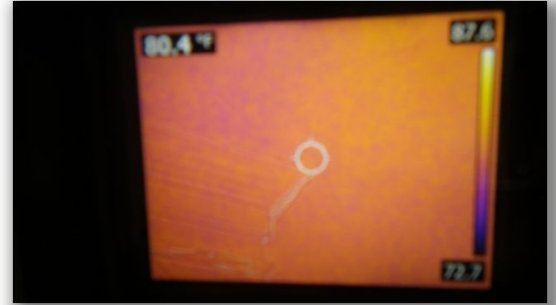
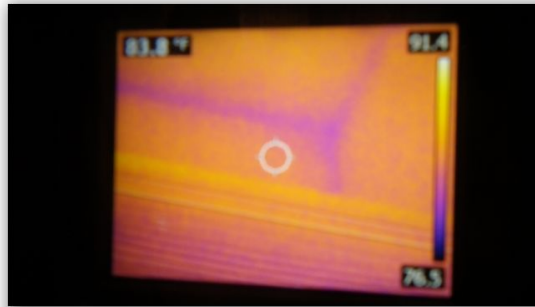
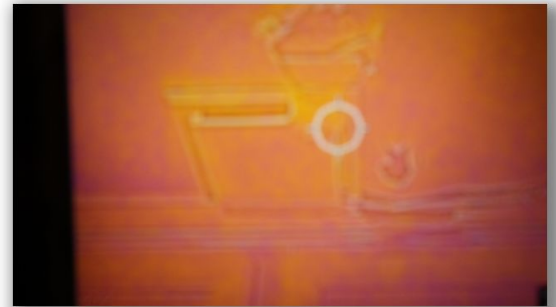
These thermal images were shot under damaged ceiling areas, negative active leakage.
