Report Identification: 5809 Darling Unit B Houston, TX. 77007

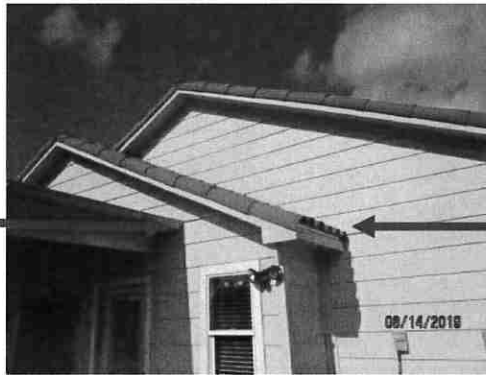
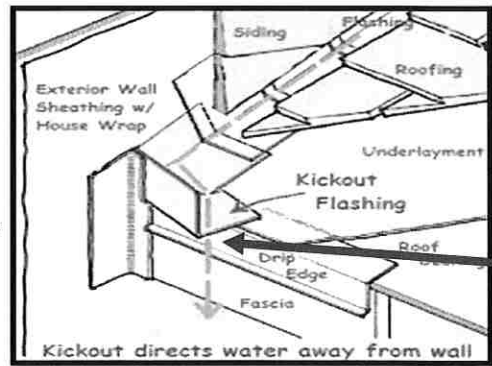
Unable to determine the presence of step flashing at the roof line due to no line of site.

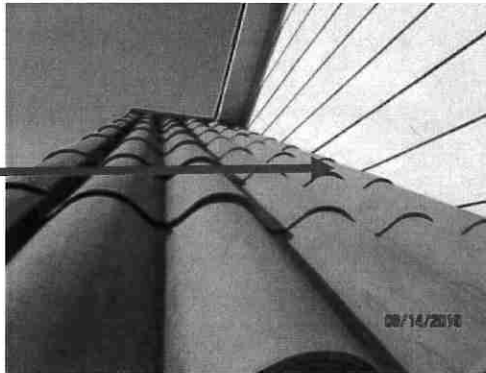
Counter flashing at the roof line off the terrace area has not been painted & the nails have not been properly sealed. Recommend painting the flashing & sealing the nails as required.

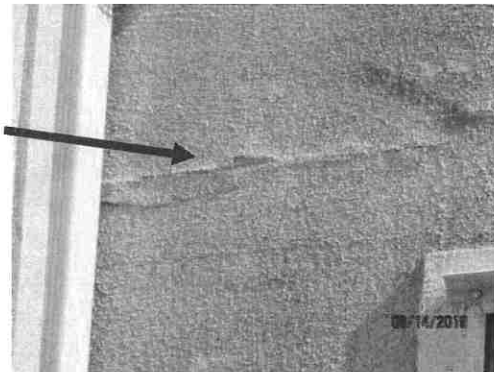
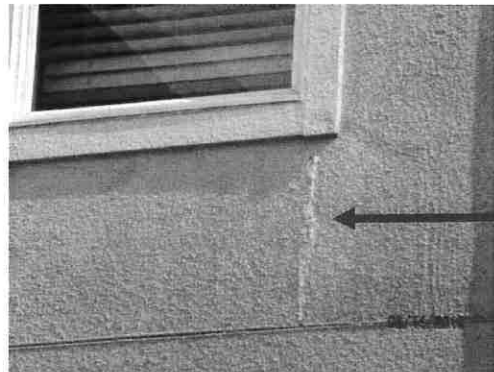
Damage to the siding/substrate at the base of the exterior walls was observed in multiple areas around the perimeter of the structure. Recommend further evaluation to determine the source of the damage & to determine if any hidden structure damage has occurred.

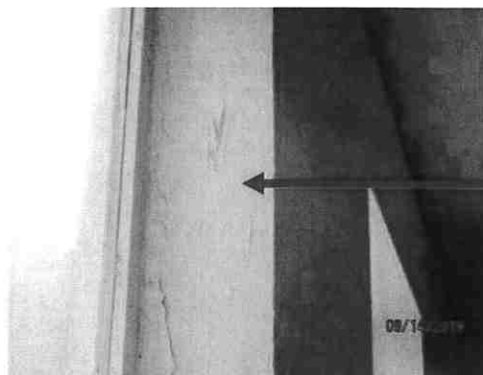
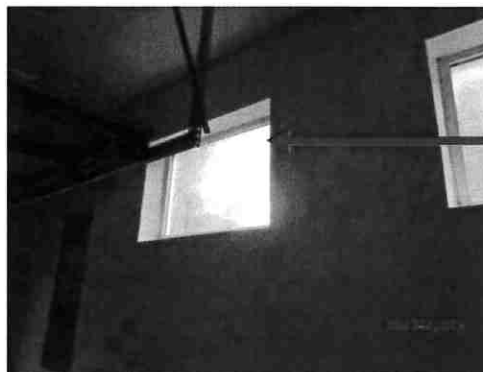
Cosmetic cracks were observed in some areas. This is normal wear & tear that is caused by movement that occurs in any structure of its life. These are considered normal wear & tear items & are not considered to be excessive or unreasonable structural deficiencies. This condition can be easily repaired with the applications of sheetrock mud or caulking.

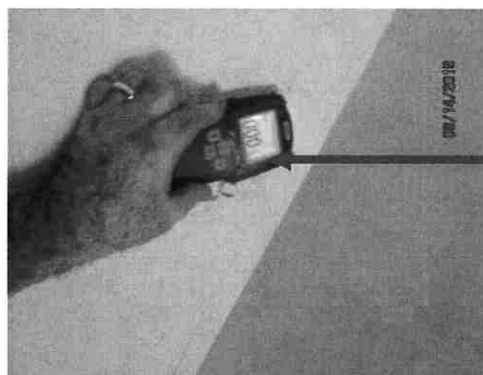
Existing/previous moisture penetration/staining was observed but may not be limited to under the water heater closet area on the floor. The inspector was unable to access the area to take a moisture reading due to limited access. Recommend further evaluation to determine the source of the moisture & to determine if any hidden structure damage has occurred.

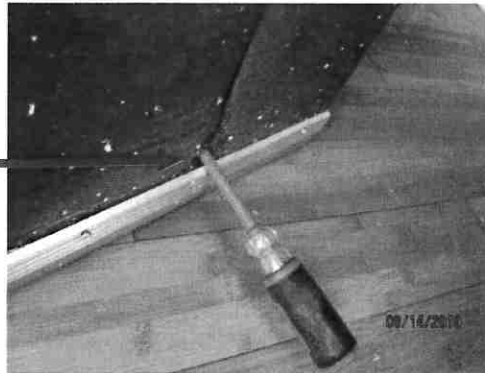
- The front door does not stay in the open position, the door swings back to the closed position when released. Recommend adjusting.
- Some of the exterior doors are missing fasteners at the hinges. Recommend installing.

- The door leading from the interior to the back side of the structure is missing weather stripping & does not seal properly when closed. Recommend repairing.

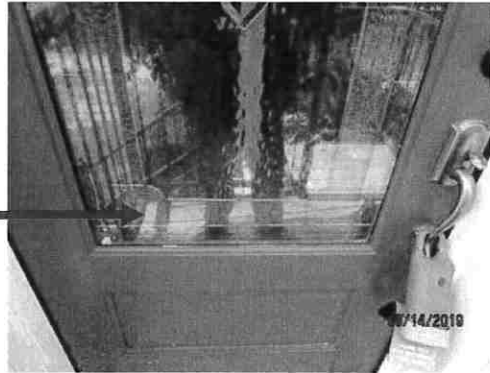
Damage to the trim at the base of the terrace & back doors was observed. Recommend repairing.

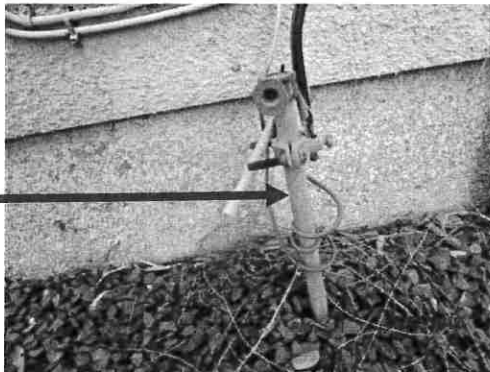
Grounding electrode clamps are pipe clamps & not an acorn clamps as required.

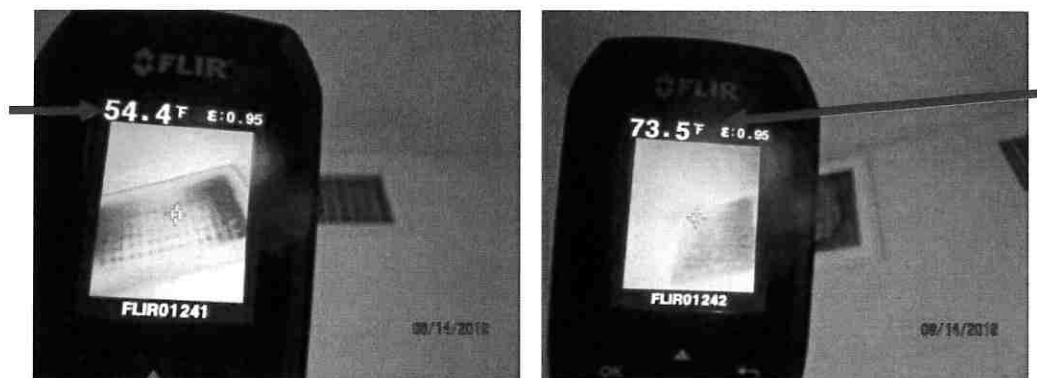
Supply air temp: 54.4 Degrees (1st floor unit as measured at the supply air register) Return air temp: 73.5 degrees (1st floor unit as measured at the return air chase)

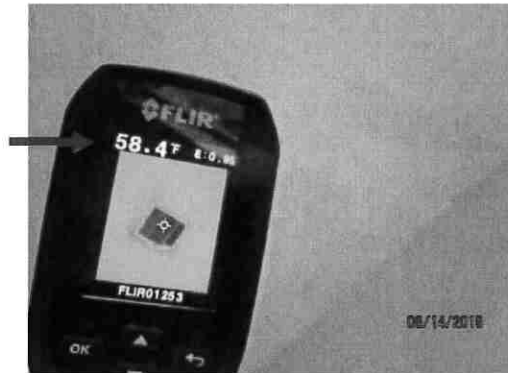
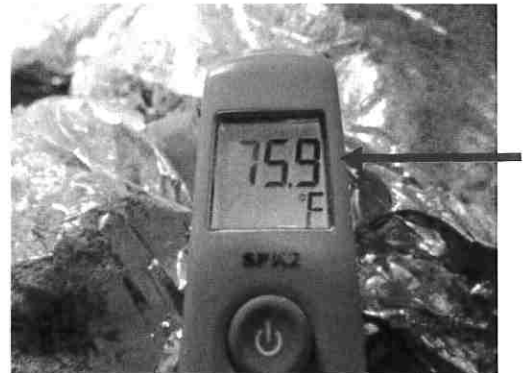
Supply air temp: 58.4 Degrees (2nd – 4th floor unit as measured at the supply air register) Return air temp: 75.9 degrees (2nd – 4th floor unit as measured at the return air chase in the attic)

A variance of 15 - 21 degrees between the supply and return air is considered to be functioning as intended.

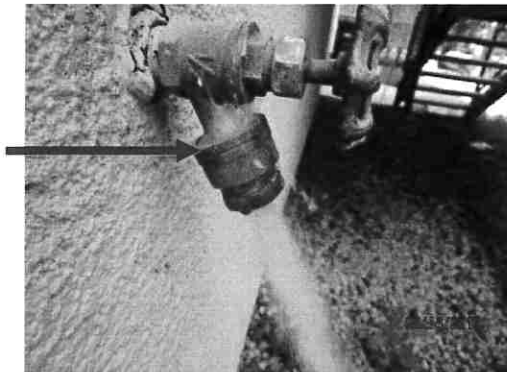
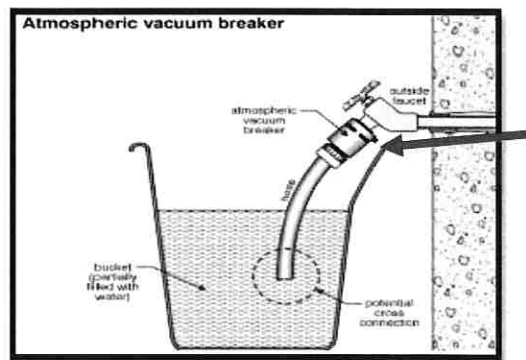
Hose bib on the back side of the structure leaks when turned on.

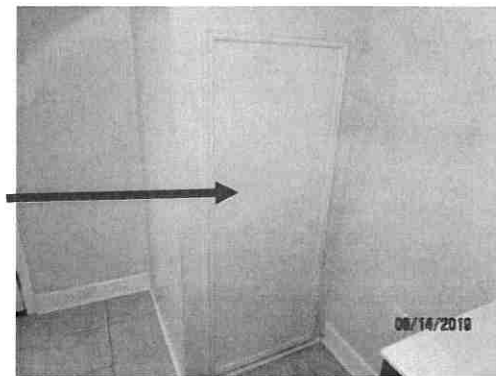
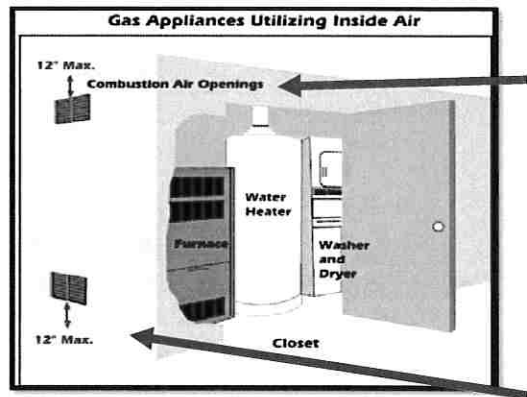
The 4th floor water heater does not have the required ventilation for the combustion air. There should be a minimum of 2 openings between the confined & unconfined space at a minimum of 100 sq. in/ each.

Rust was observed in the drain pan. This is an indication of previous/existing leaking from the water heater tank. Due to not knowing the extent of the rust damage it is recommended that the pan be replaced.

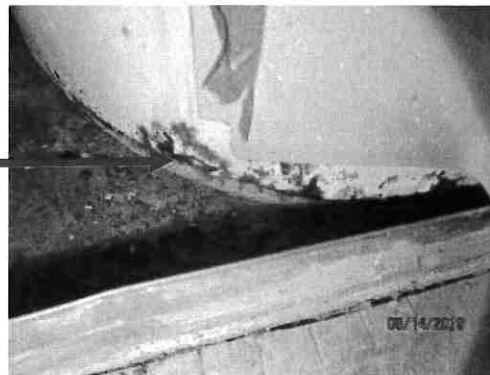
Rusting was observed at the base of the water heater.

The flue vent pipe at the roof line has not been painted. Recommend priming & painting to prevent rusting.

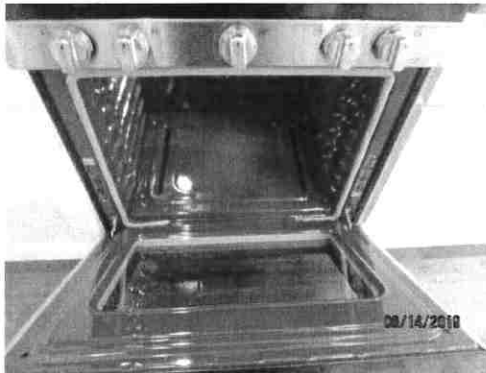
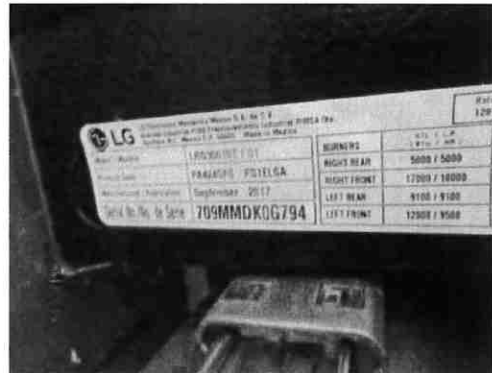
The oven was turned on to 350 degrees and allowed to cycle through the preheat function, a temperature reading was performed and read 420 degrees, a variance of 25 degrees is considered acceptable. Recommend recalibrating the oven to the correct temperature as required. Recommend recalibrating the oven to the correct temperature as required.

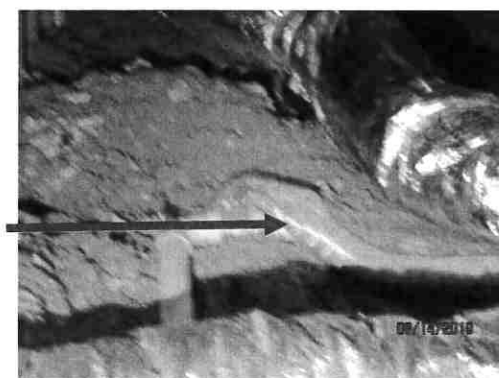
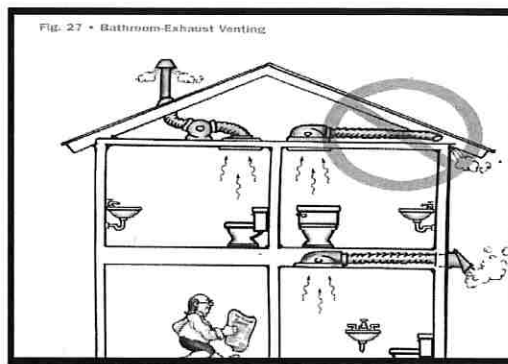
The 3rd floor bathroom exhaust vents appear to be vented to the soffit and not through the roof deck or exterior wall as required.

The bathroom exhaust vent pipe in the main attic has been damaged/crushed. Recommend repairing/replacing.

Exhaust vent is not installed in the master bath shower/tub area.

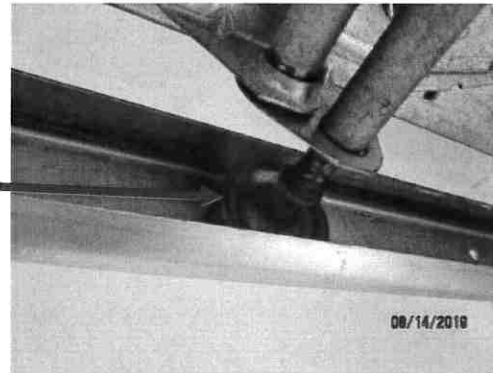
The garage door is noisy when opening/closing. This is typically an indication of roller wear & the rollers may need to be replaced in the future.

Garage door lock is not secured in the open position. This is required when an automatic door opener has been installed.
