RESIDENTIAL INSPECTION REPORT

4518 Sunlit Pass Loop
Humble TX 77396

Lenda Narcisse
AUGUST 6, 2019

PROPERTY INSPECTION REPORT

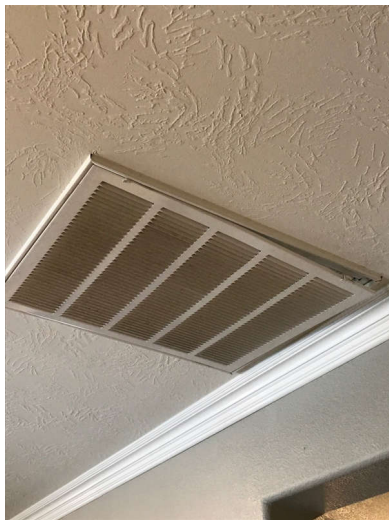
The furnace filter may have been beyond its expected lifespan. Replacement is recommended.

Recommendation: Recommended DIY Project

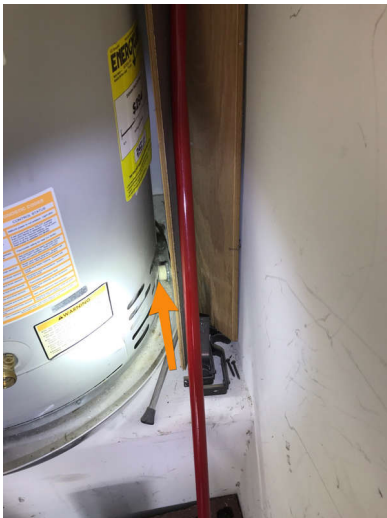
The overflow drain was obstructed by the tank. This could prevent the pan from draining properly if the unit were to leak in the future. Remedy as needed.

Recommendation: Contact a qualified professional.

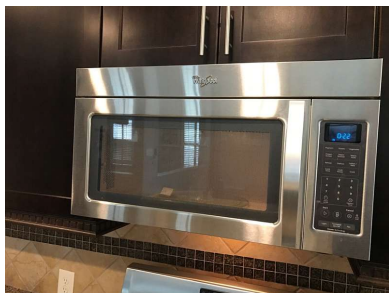
1: Rattling noise was observed while turntable was in operation.

🔴 Recommendation

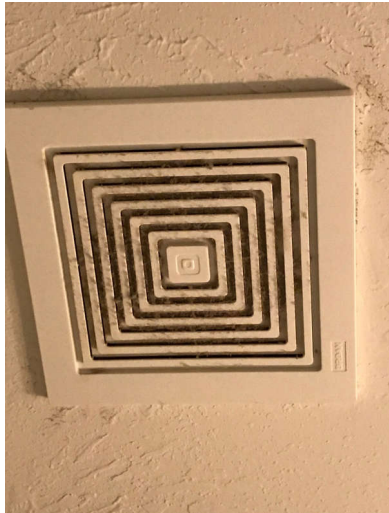
Cleaning of the exhaust vent cover is needed to ensure unrestricted air flow.

Recommendation: Contact a qualified professional.
