# PROPERTY INSPECTION REPORT

Concerning: 3373 Zubin Lane, Katy, TX 77493-6015  
(Address or Other Identification of Inspected Property)

By: Randall E. Keith License # 6339 April 9, 2019  
(Name and License Number of Inspector) (Date)

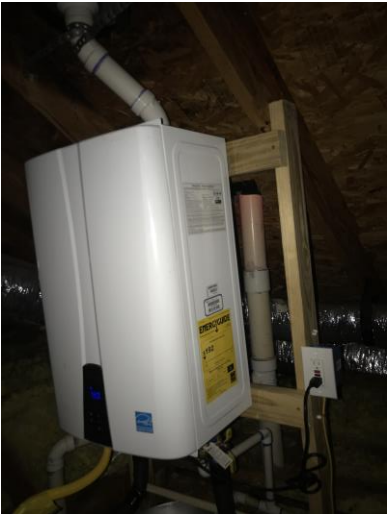
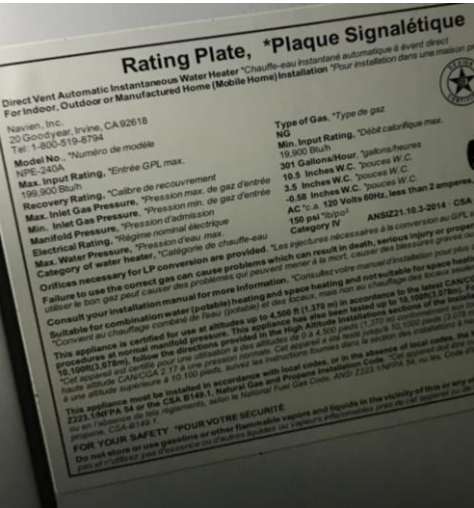
Brand: Navien      Mfr Date:  
 NA      Max Input Rating: 19,900  
 BTU

In the opinion of this inspector, all visible components of the system were in serviceable condition at the time of this inspection.
