Inspection Report

Property Address:
26 South Bethany Bend
Woodlands Texas 77382

PROPERTY INSPECTION REPORT

Concerning: 26 South Bethany Bend, Woodlands, Texas 77382

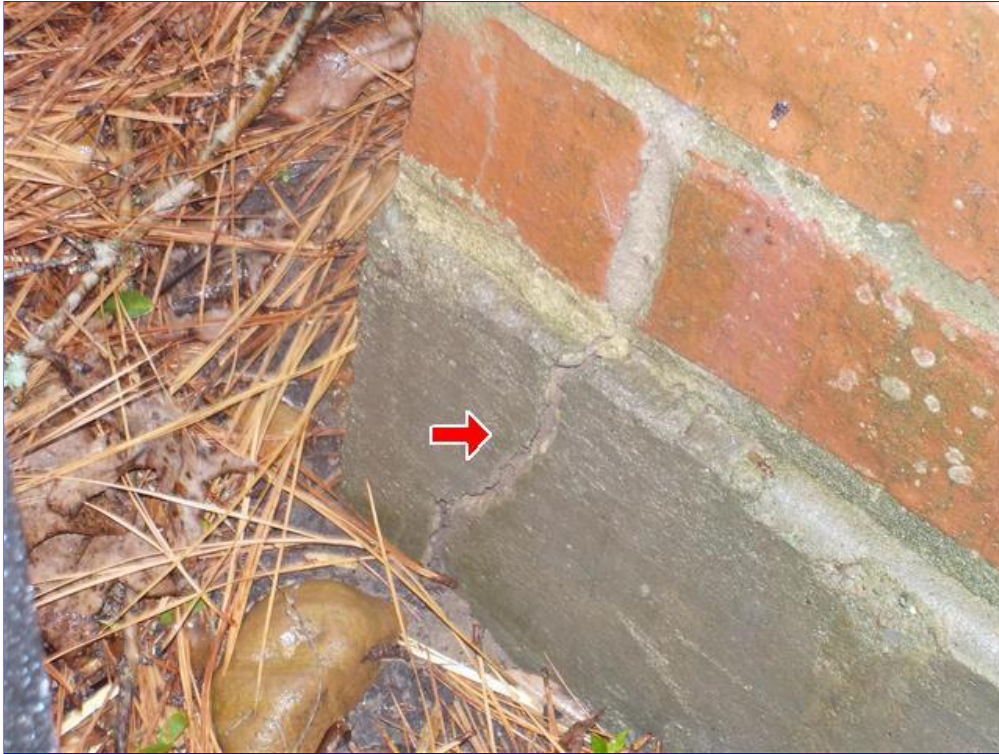
Corner pop are not structural foundation concerns but should be corrected as wood destroying insects sneak up thru cracks and its cosmetically unsightly and concerns buyers and sellers alike as a structural condition which **it is NOT.**

A. Item 1(Picture) Corner of Foundation is popped-out

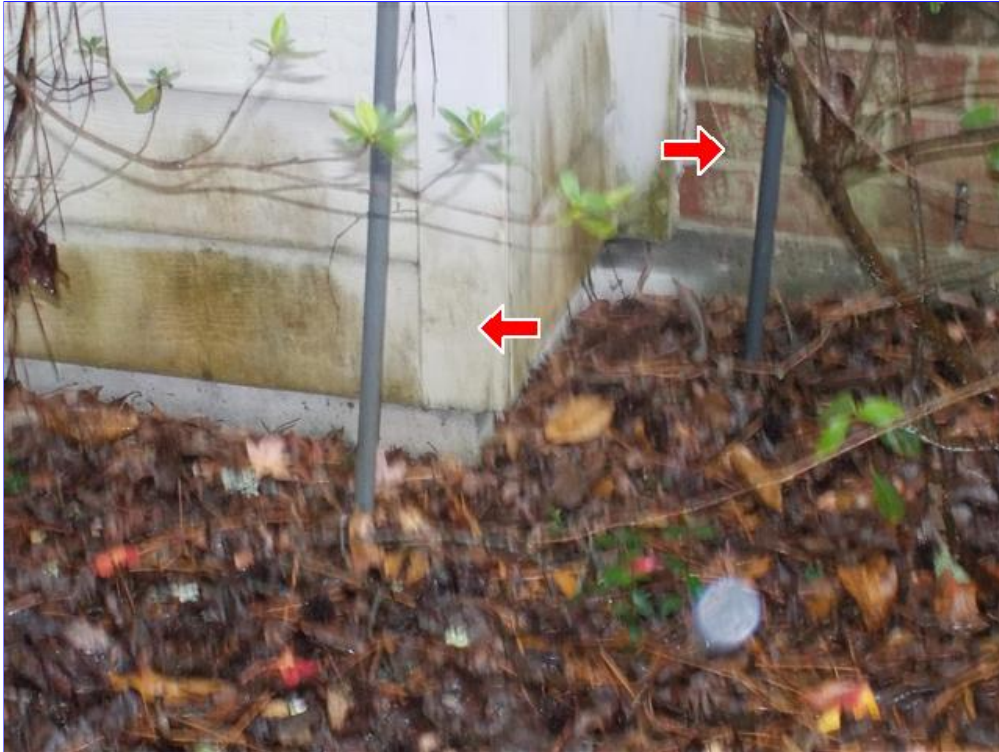
A. Item 3(Picture) Sprinkler heads should be 12in from the foundation

Sprinkler Heads should be at least 12" away from foundation and spraying away from foundation.

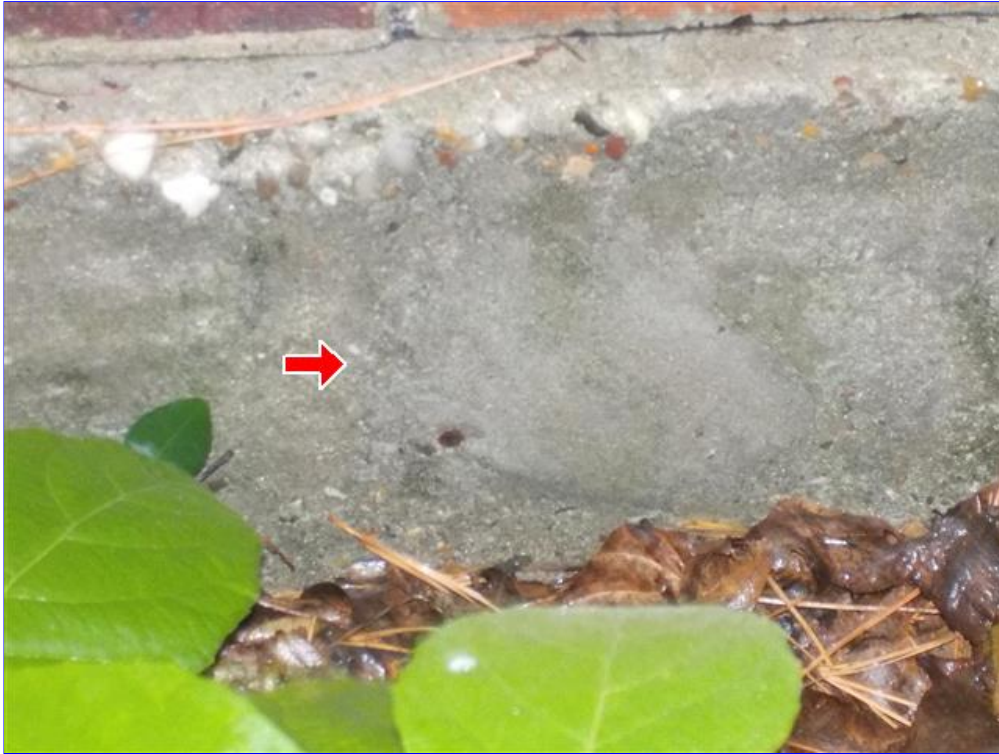
A. Item 5(Picture) Post tension patch(s)

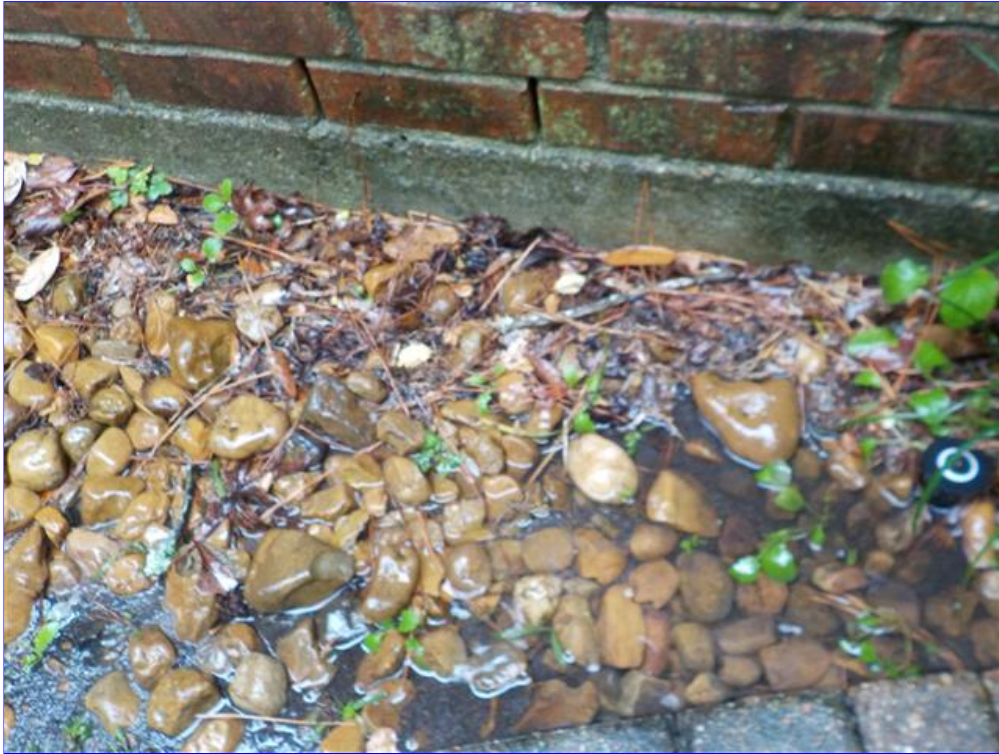
B. Item 3(Picture) Ponding water around the foundation

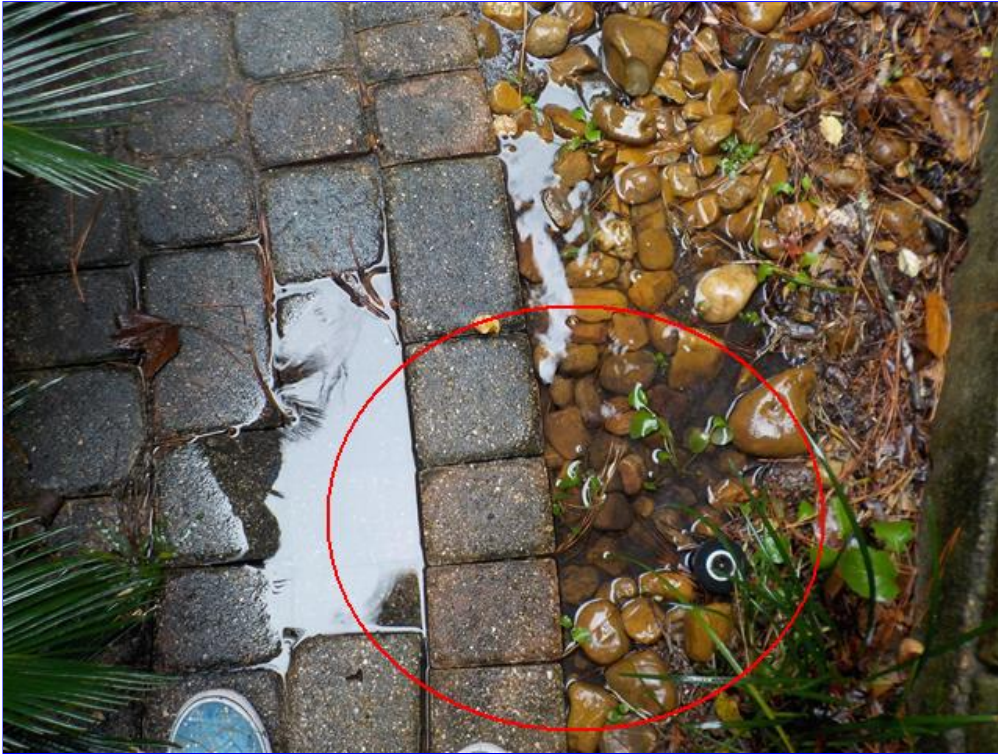
B. Item 5(Picture) Correct ponding issues due to grading

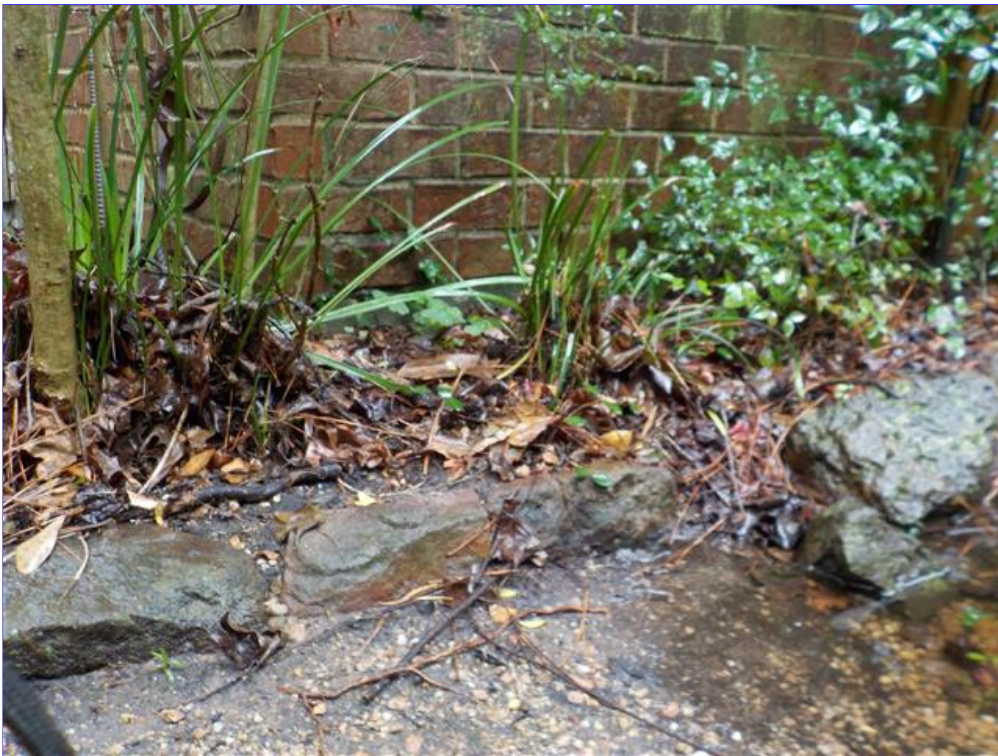
B. Item 8(Picture) Ponding water makes the foundation porous

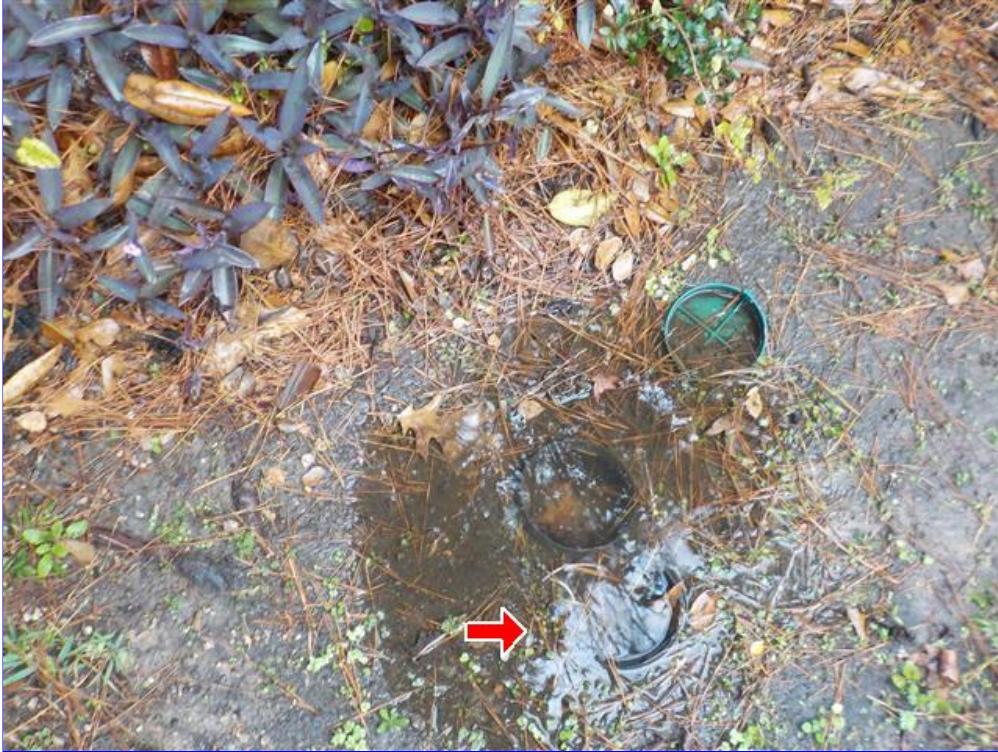
B. Item 9(Picture) Sprinkler equipment should be further evaluated

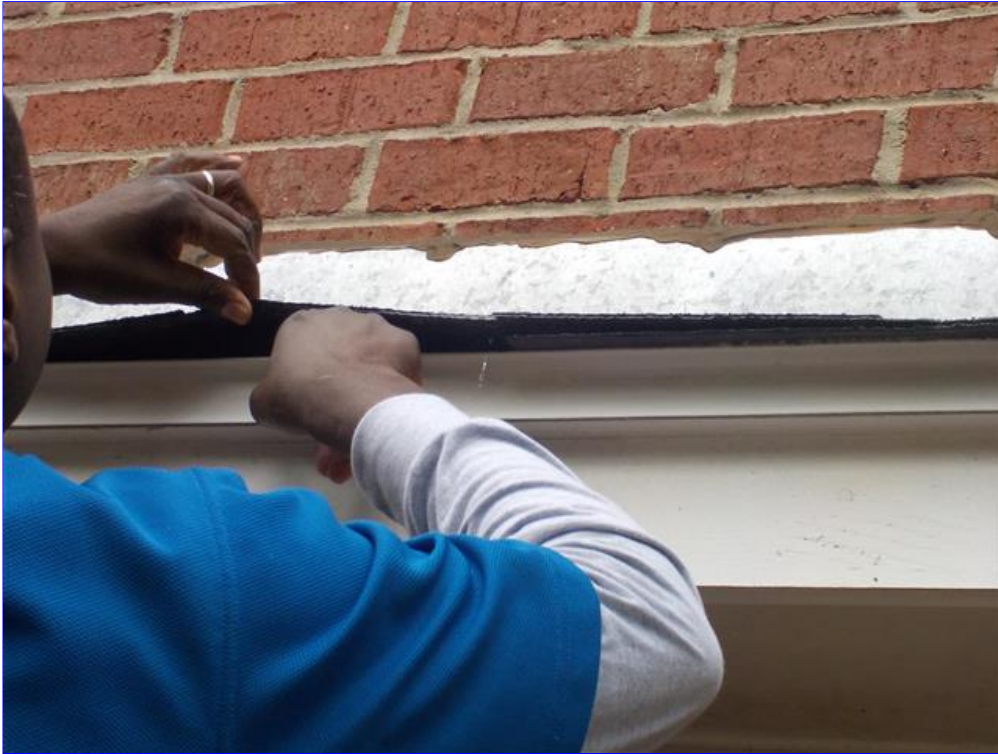
C. Item 1(Picture) Underlayment is correct

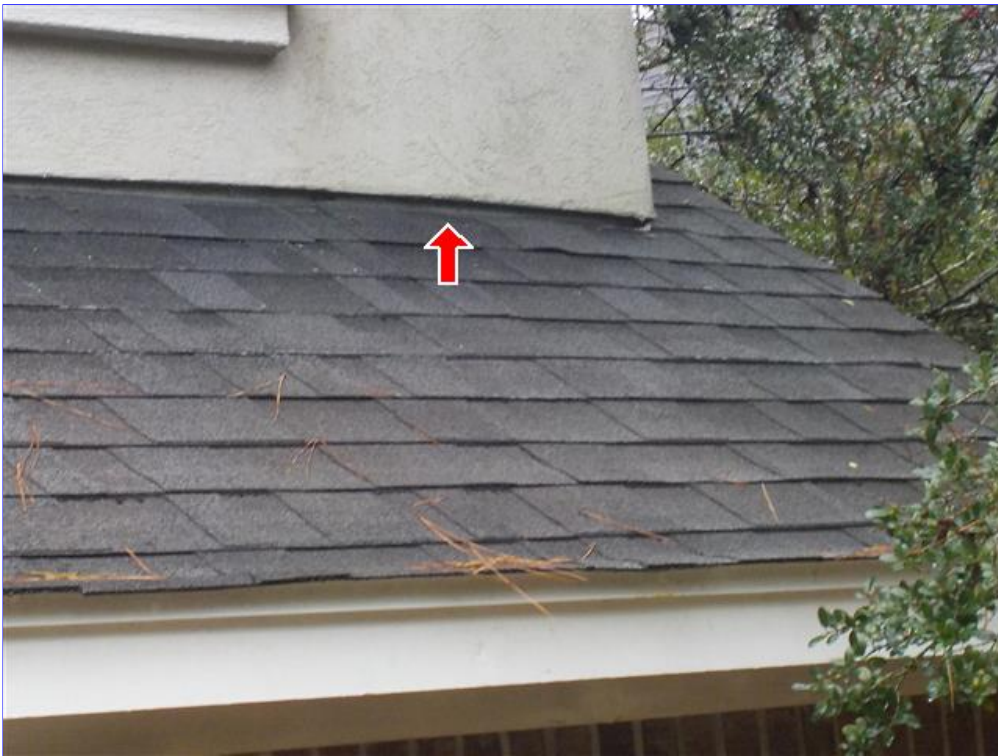
C. Item 2(Picture) Siding should have a 1in gap to the shingles

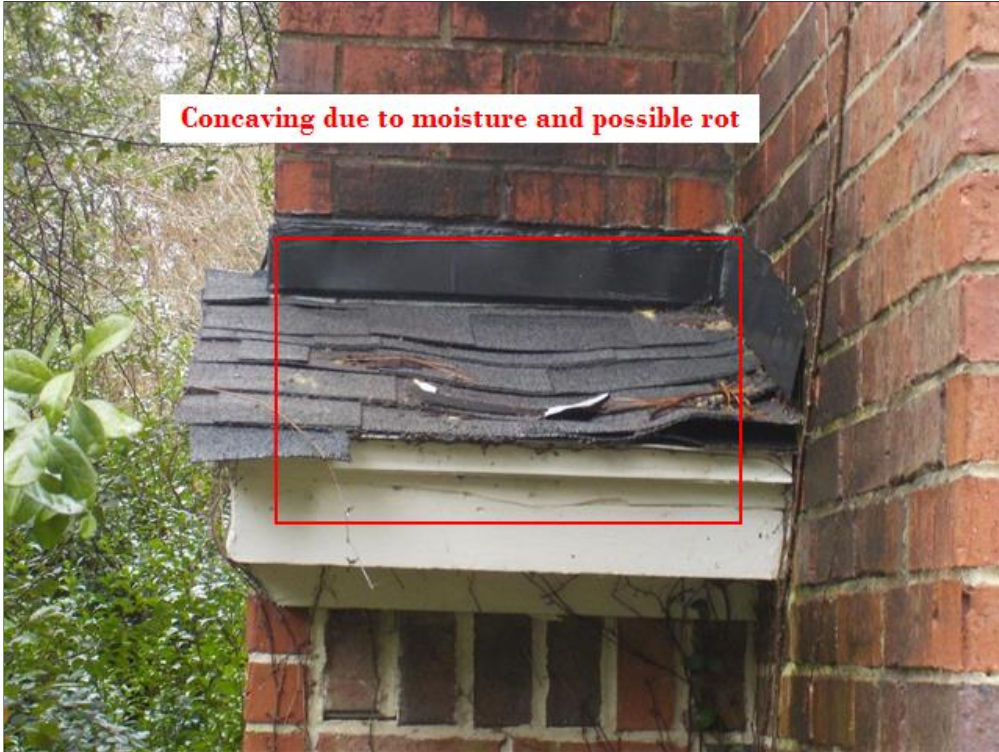
C. Item 5(Picture) Deteriorating

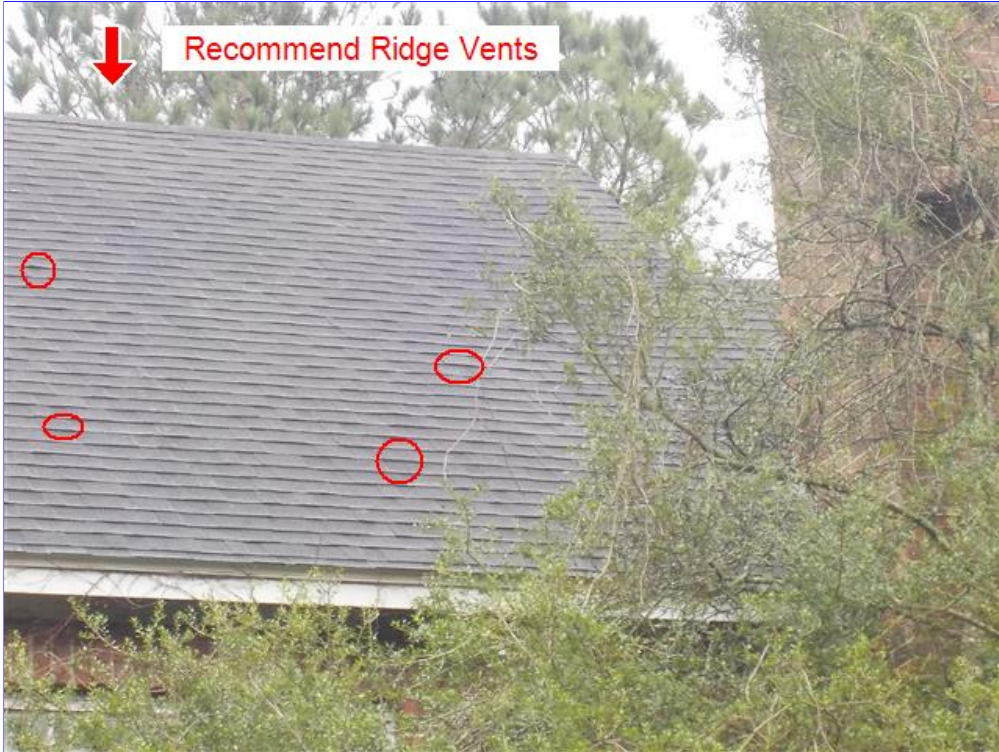
C. Item 7(Picture) Shingles are popped

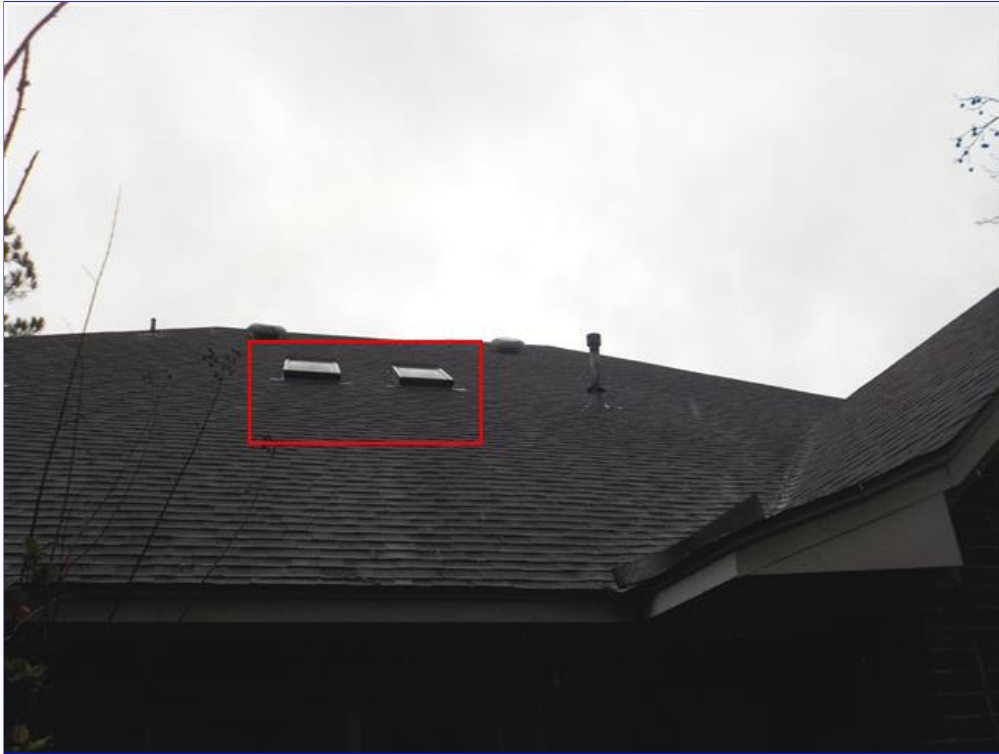
C. Item 9(Picture) Skylights glass is stained and I recommend replacing

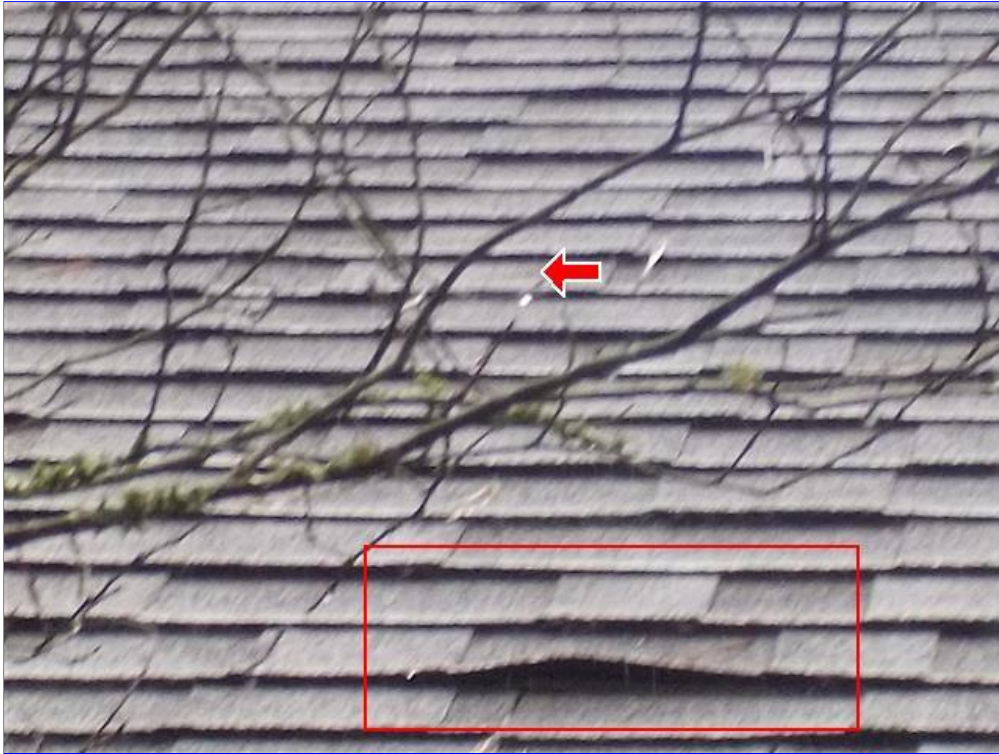
C. Item 11(Picture) Shingle pop and tree overhang

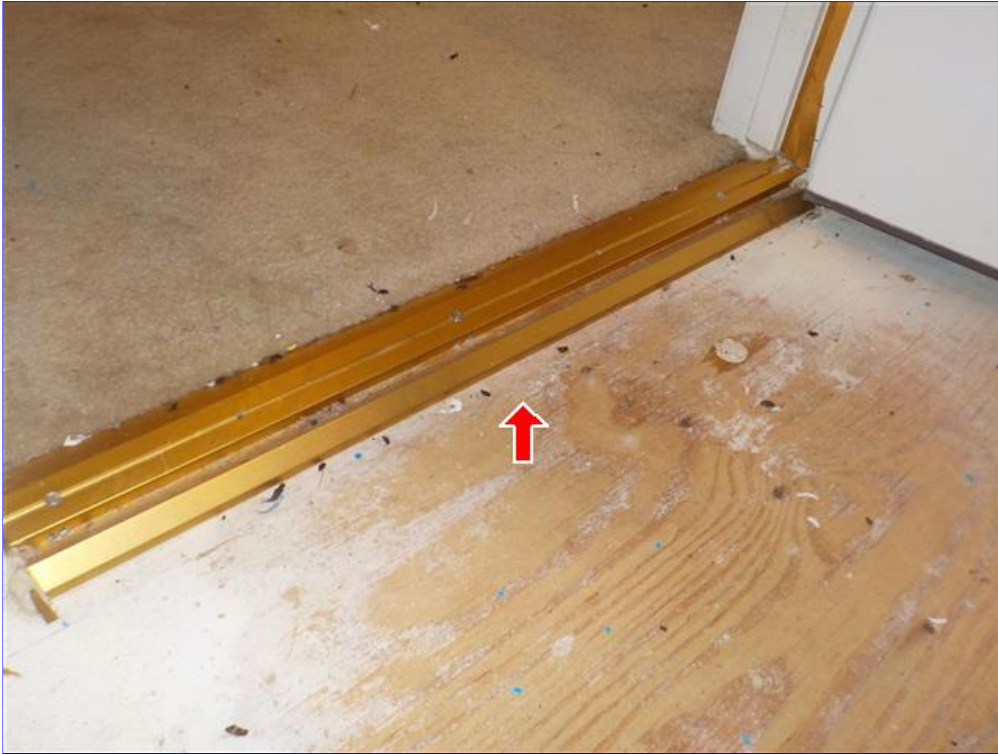
C. Item 13(Picture) Caulk the threshold and rodent feces noted

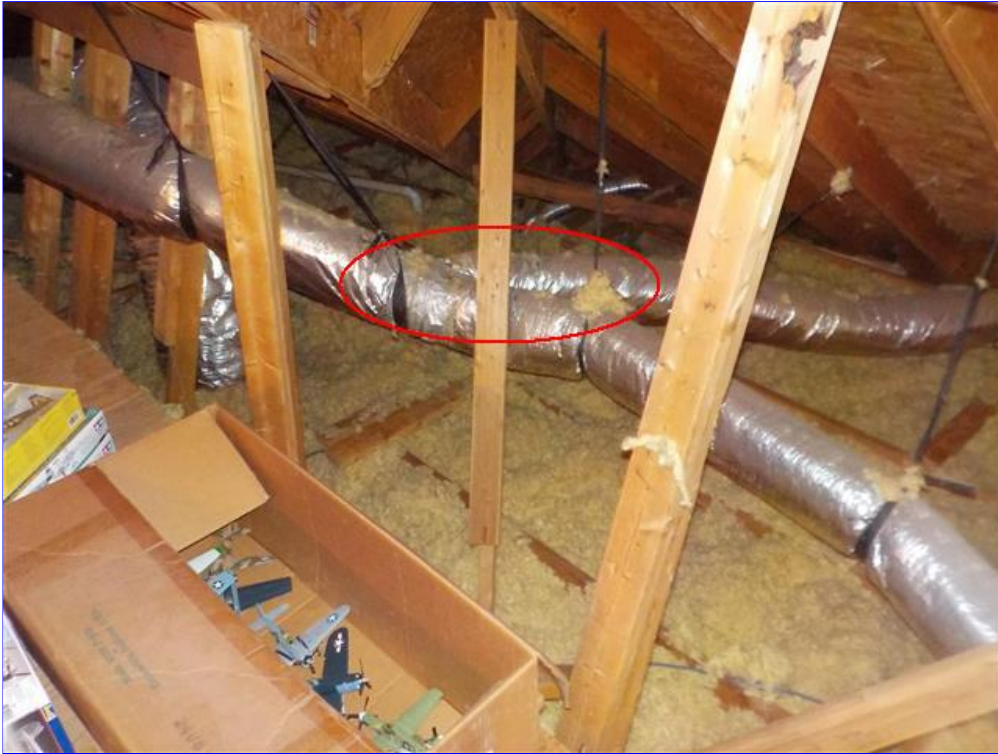
C. Item 15(Picture) Ducts are touching

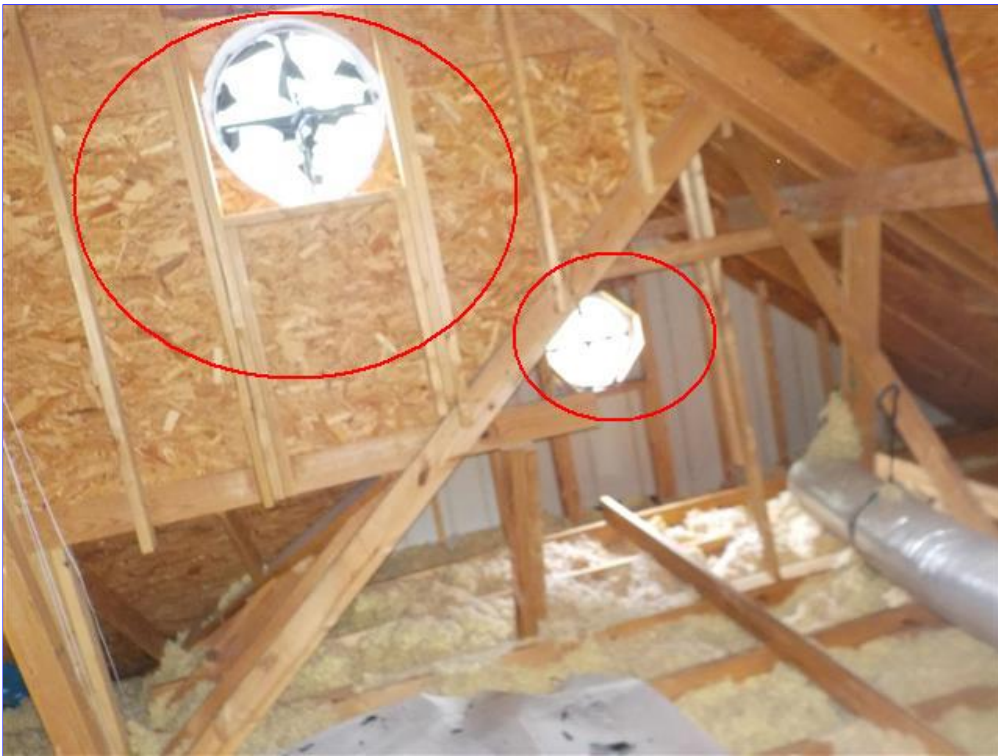
C. Item 20(Picture) Recommend increased venting

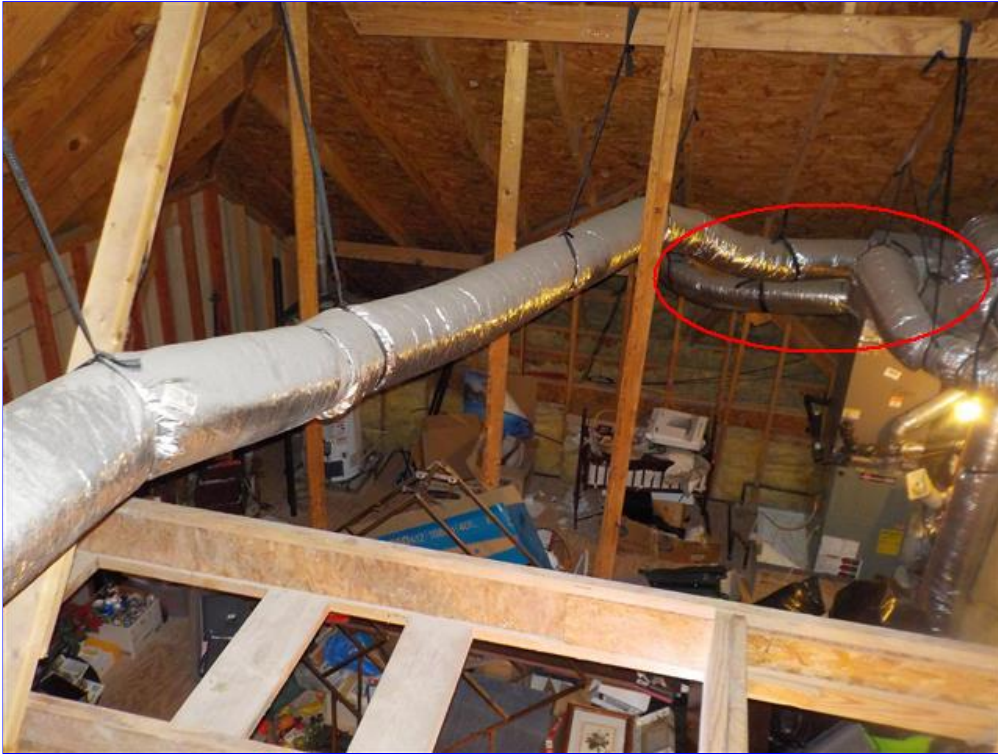
C. Item 21(Picture) Ducts are touching

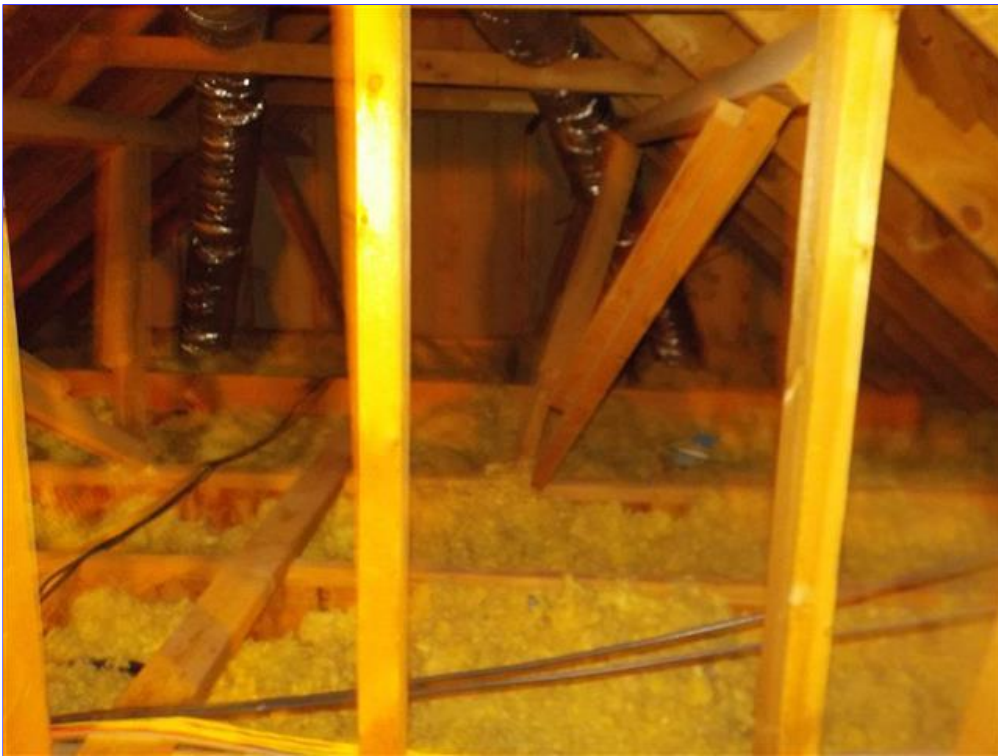
C. Item 22(Picture) Fiberglass blown in insulation has voids

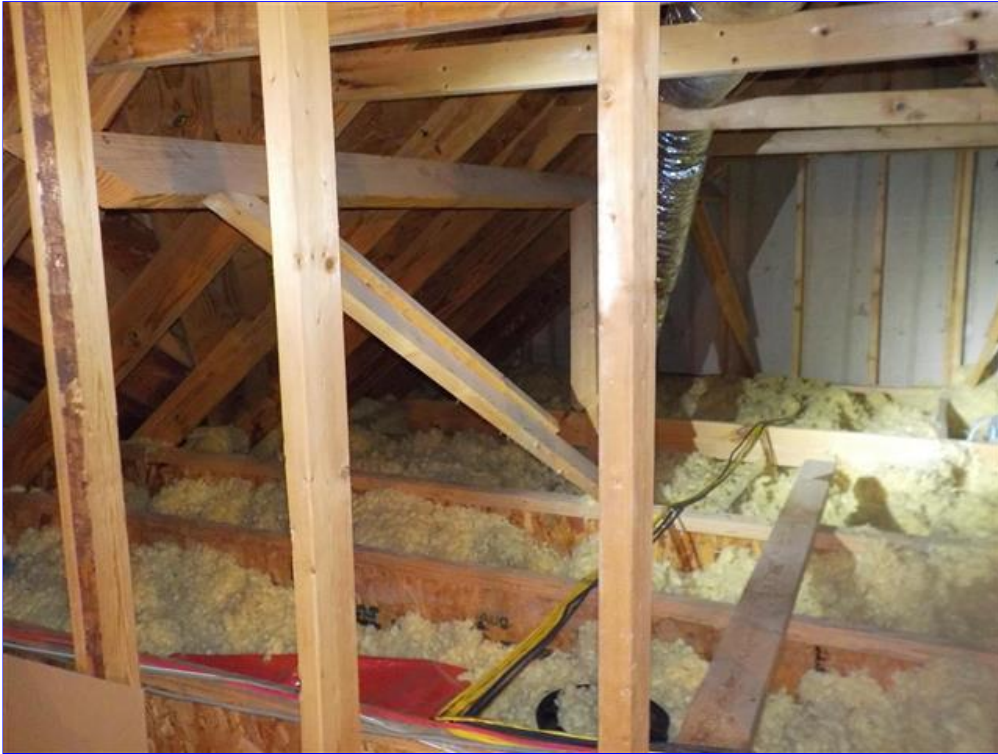
C. Item 23(Picture) Missing baffles

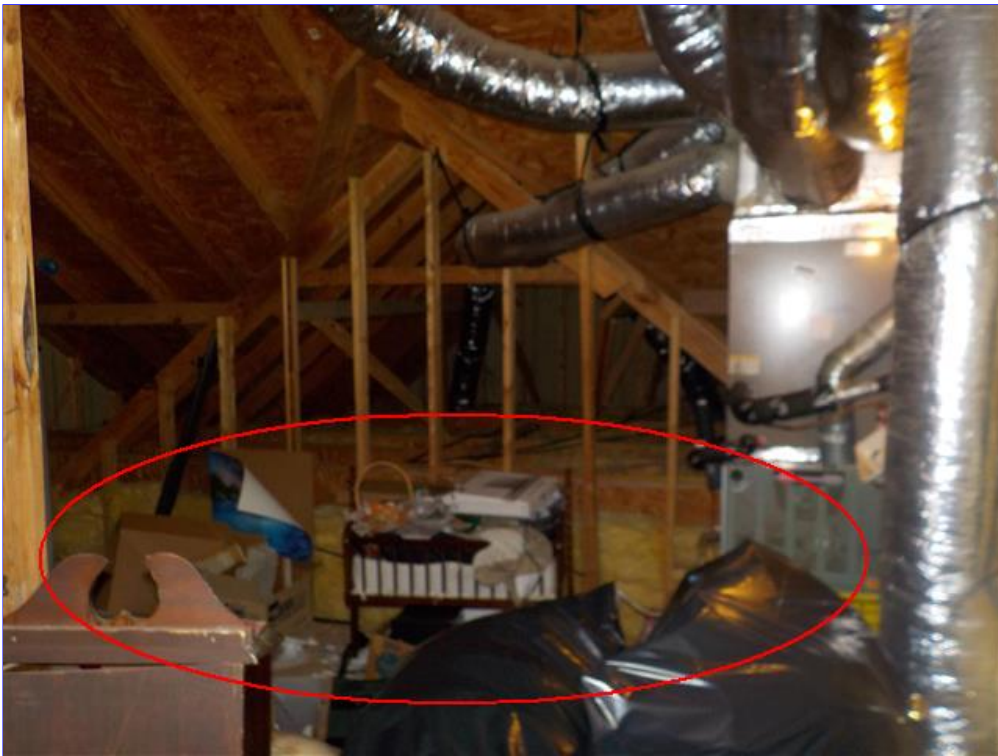
C. Item 24(Picture) Attic full of debris

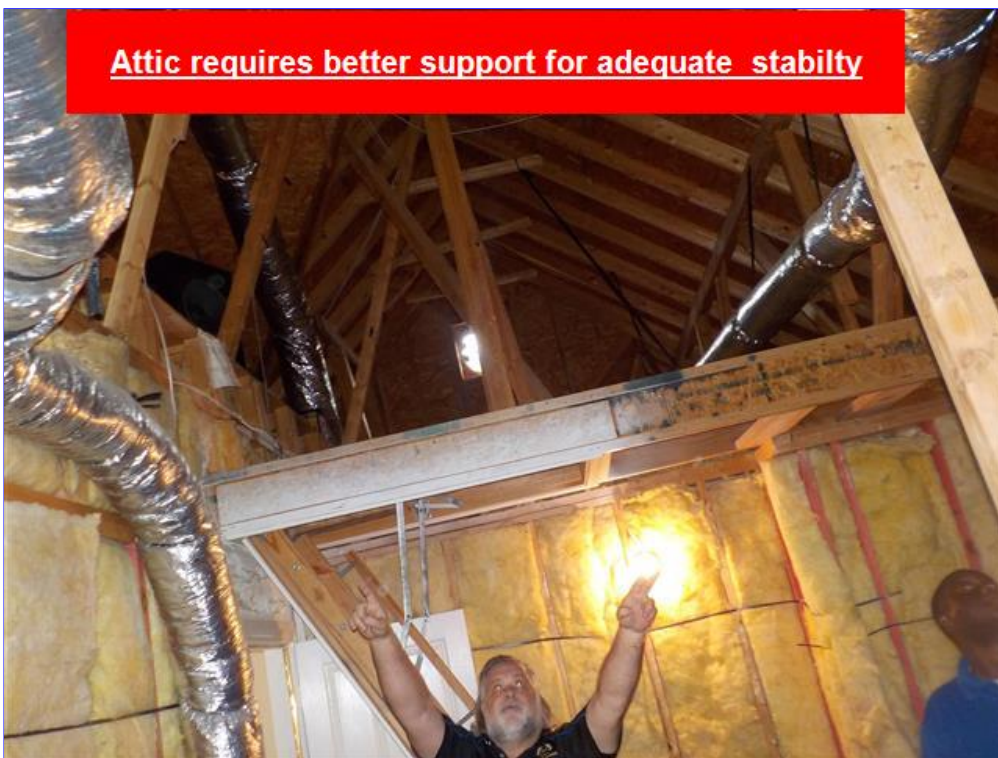
C. Item 26(Picture) Be sure the structure is fully supported.

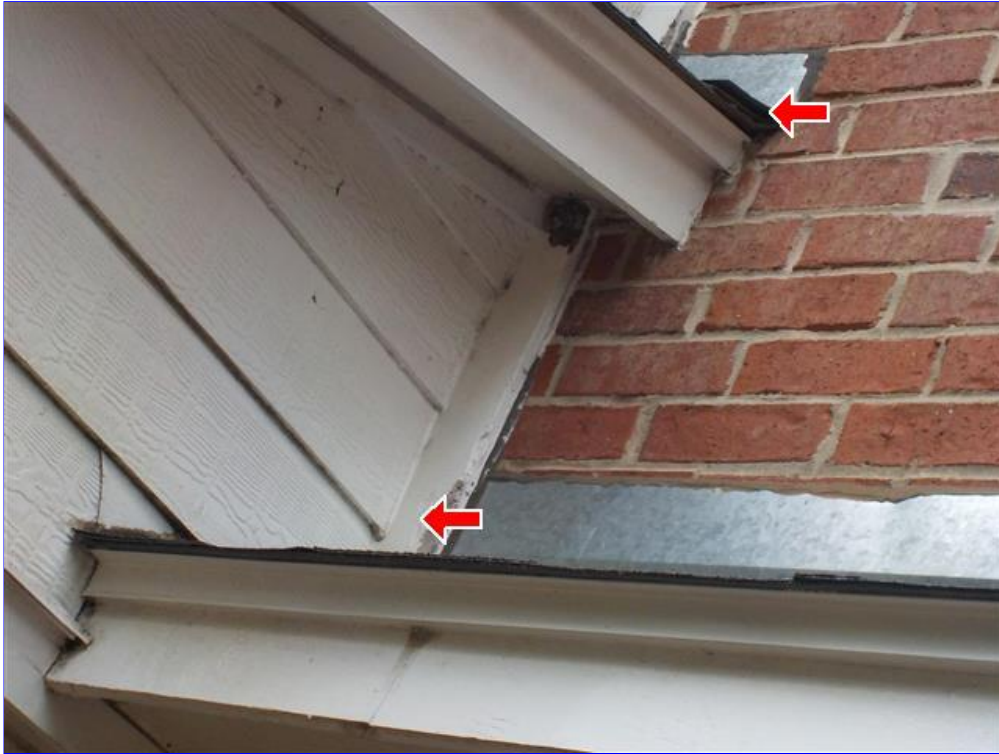
D. Item 1(Picture) Flashing should be completed

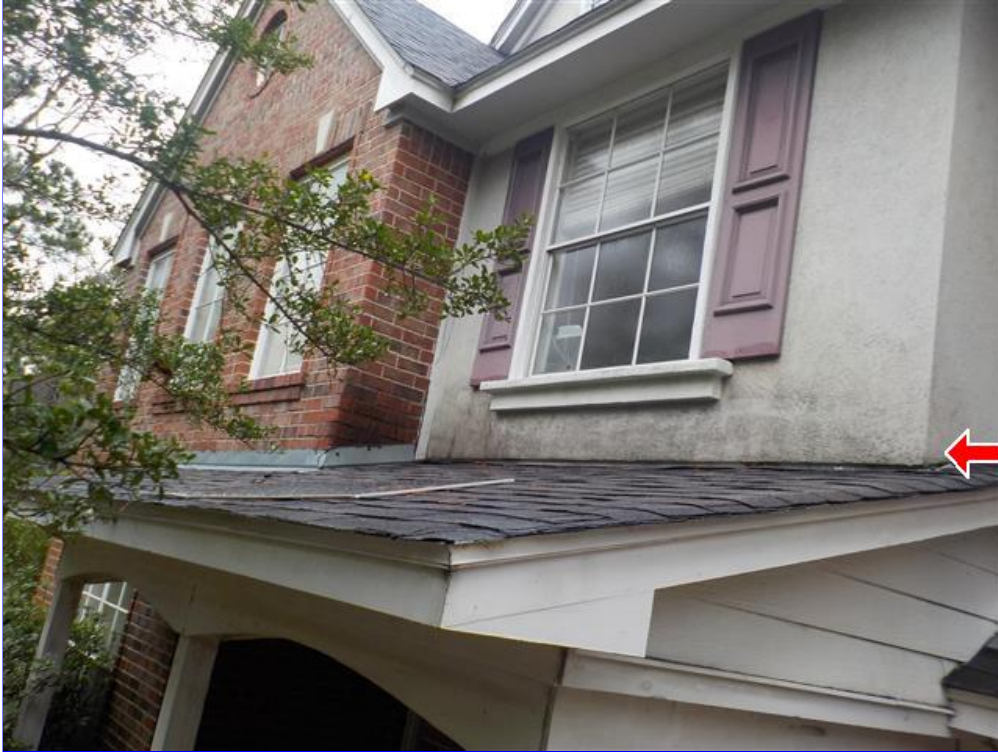
D. Item 3(Picture) Needs ro be flashed also noted the wicking water discoloration

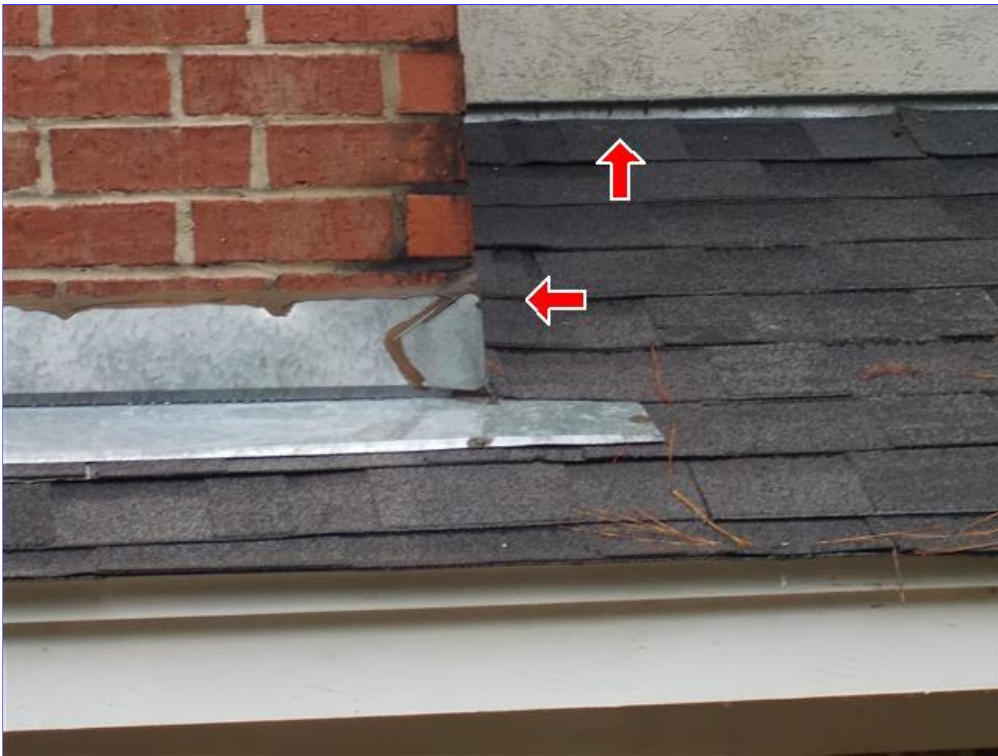
D. Item 4(Picture) Should be properly flashed

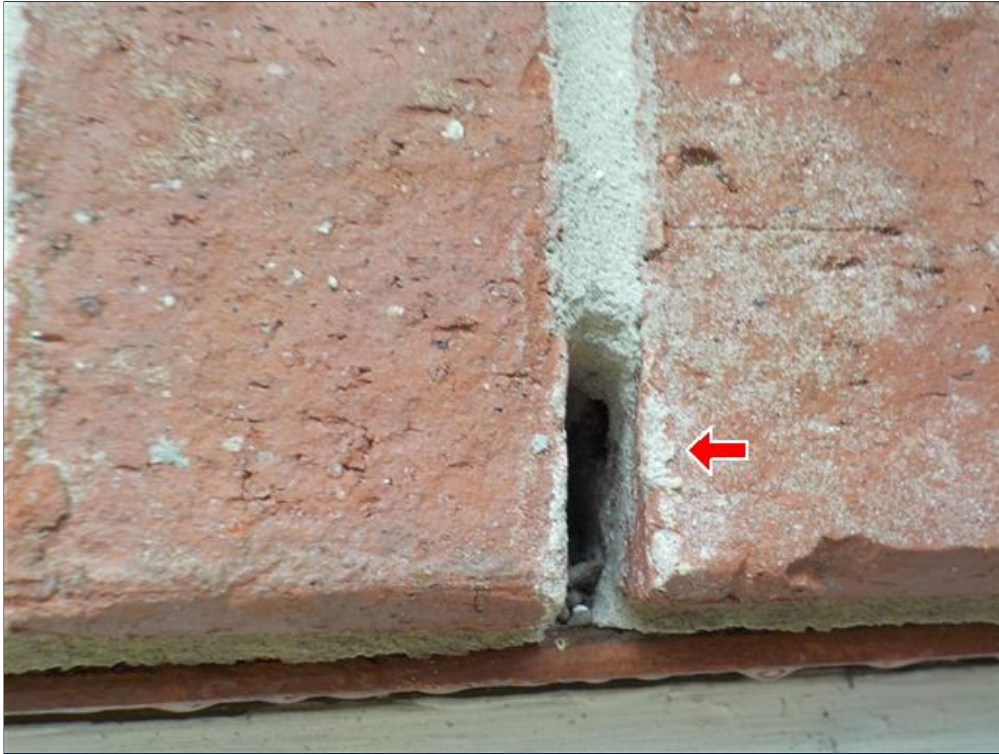
D. Item 7(Picture) Recommend weephole protectors

Weep holes should be every 33" apart: Also weep holes should be above bricked doors and windows. Recommend weep hole protectors to keep larger bugs and debris and rodents out of wall cavity.

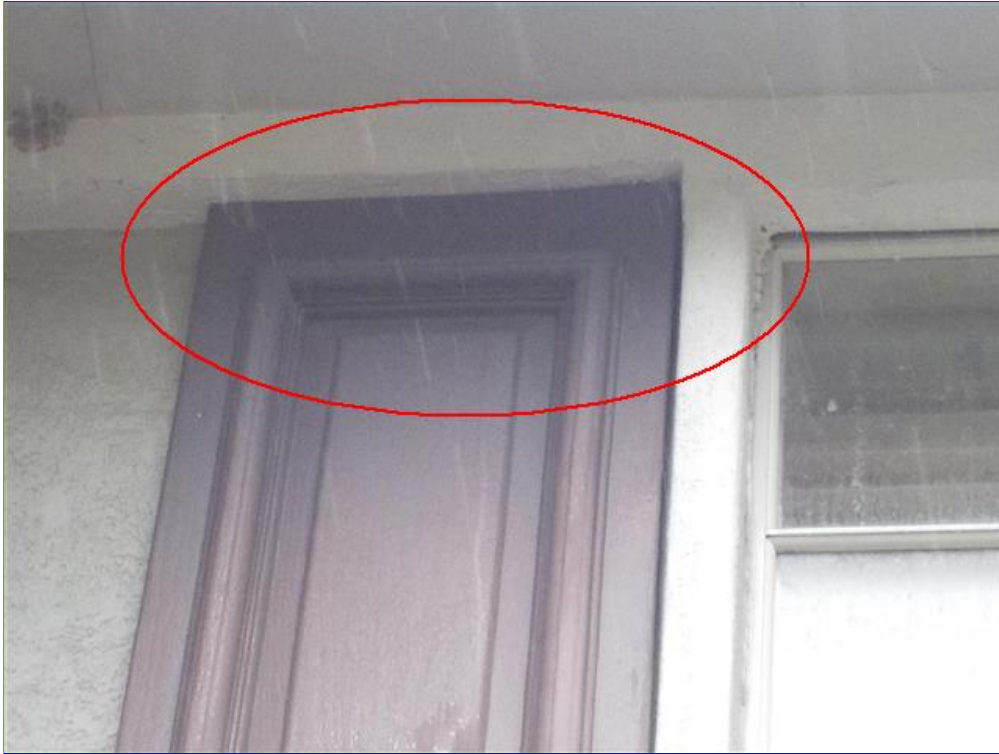
D. Item 9(Picture) Its not good that these blinds are flat against the wall

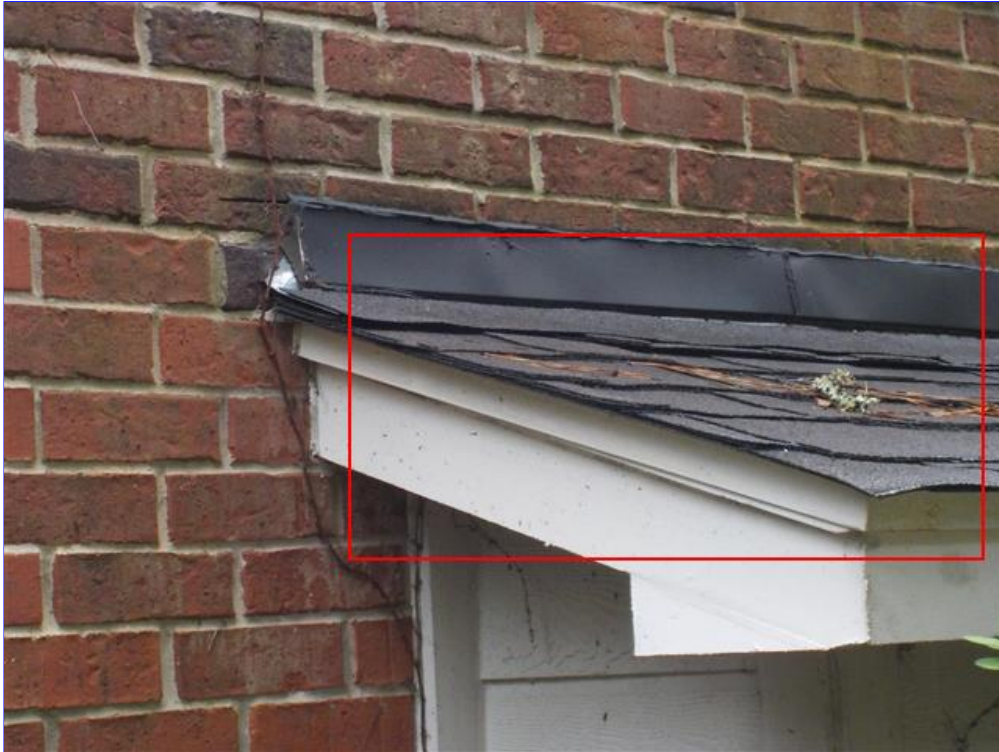
D. Item 13(Picture) Not secured

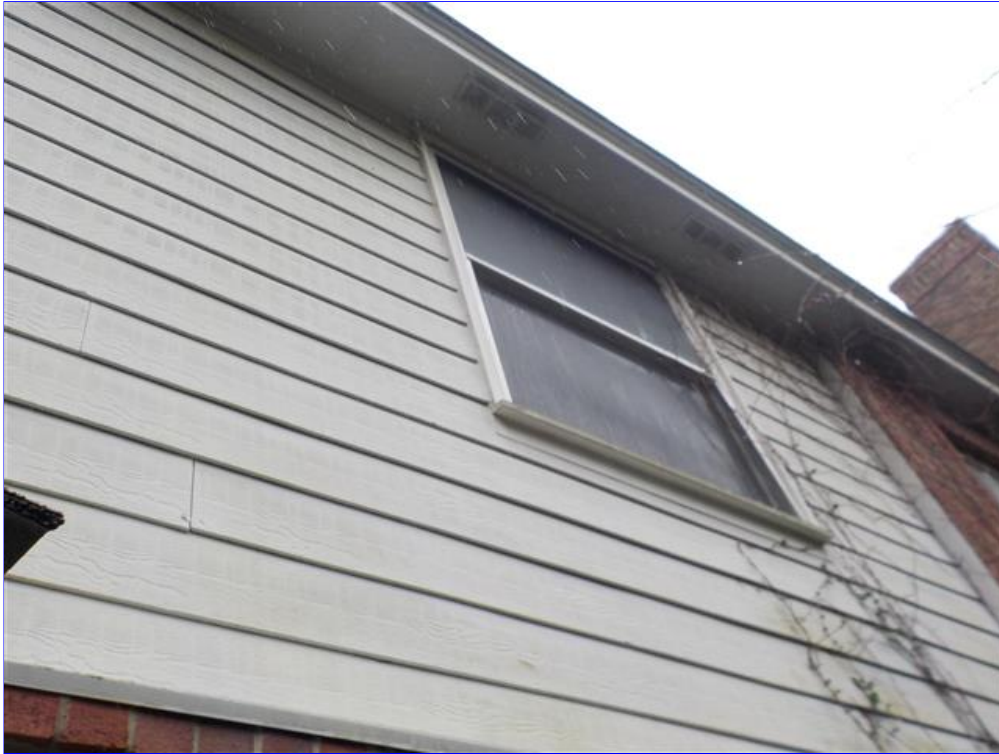
D. Item 15(Picture) caulk siding gaps weep holes should be cleaned out and above windows and doors

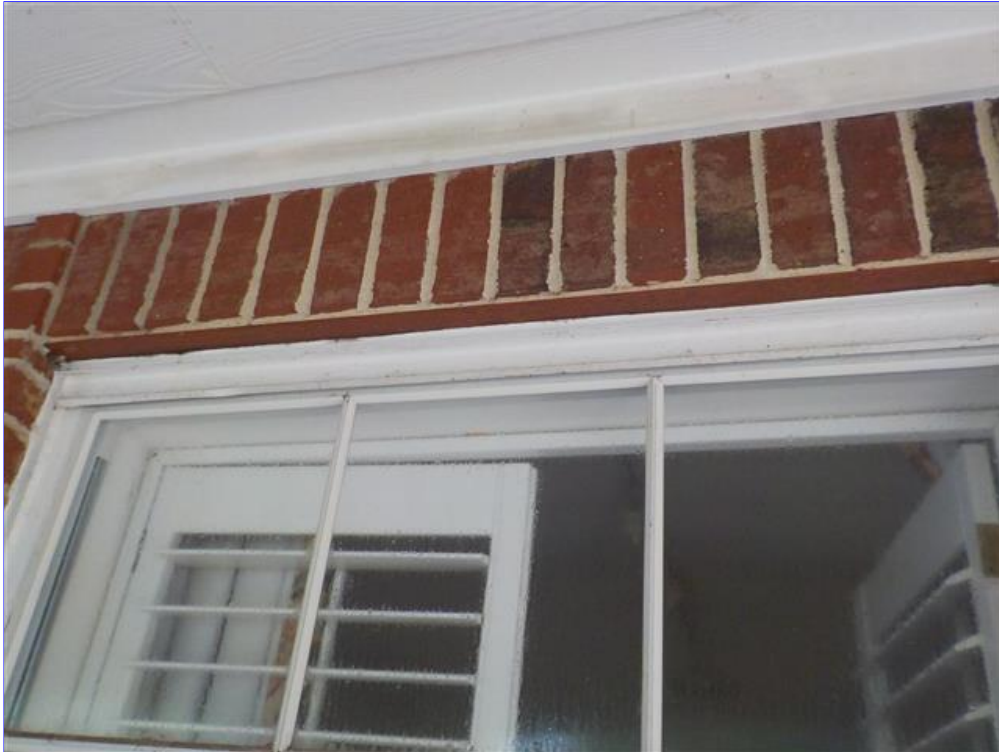
D. Item 16(Picture) Be sure lintels are in good condition

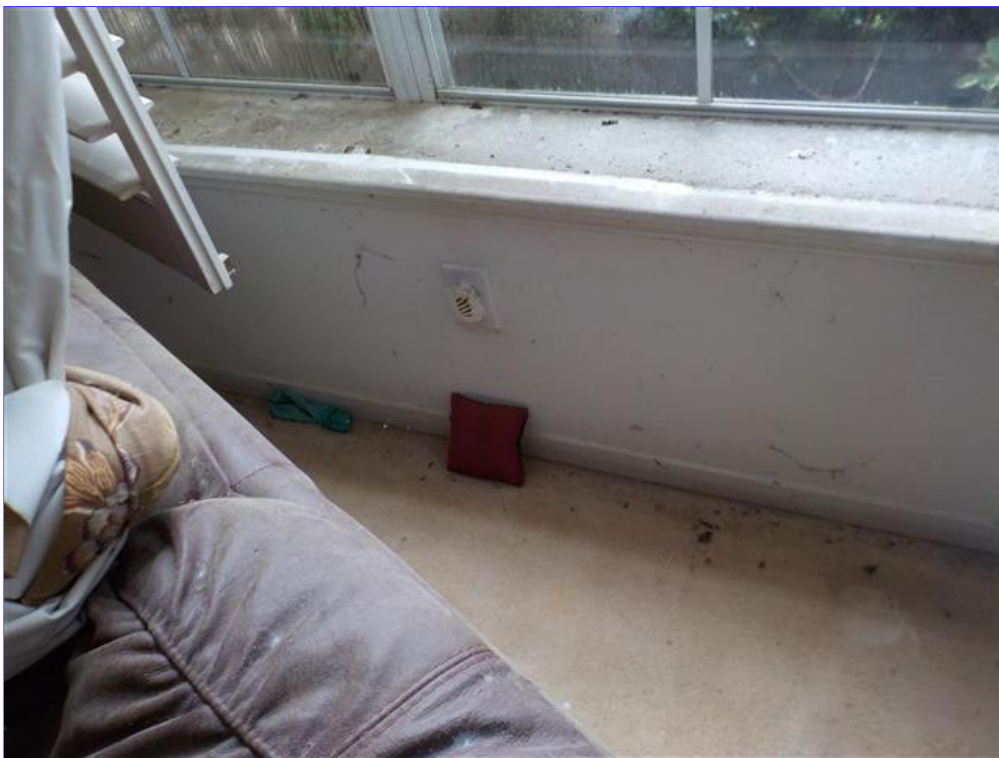
D. Item 20(Picture) Debris in and around walls and flooring
