Inspection Report

Property Address:
26 South Bethany Bend
Woodlands Texas 77382

PROPERTY INSPECTION REPORT

Concerning: 26 South Bethany Bend, Woodlands, Texas 77382

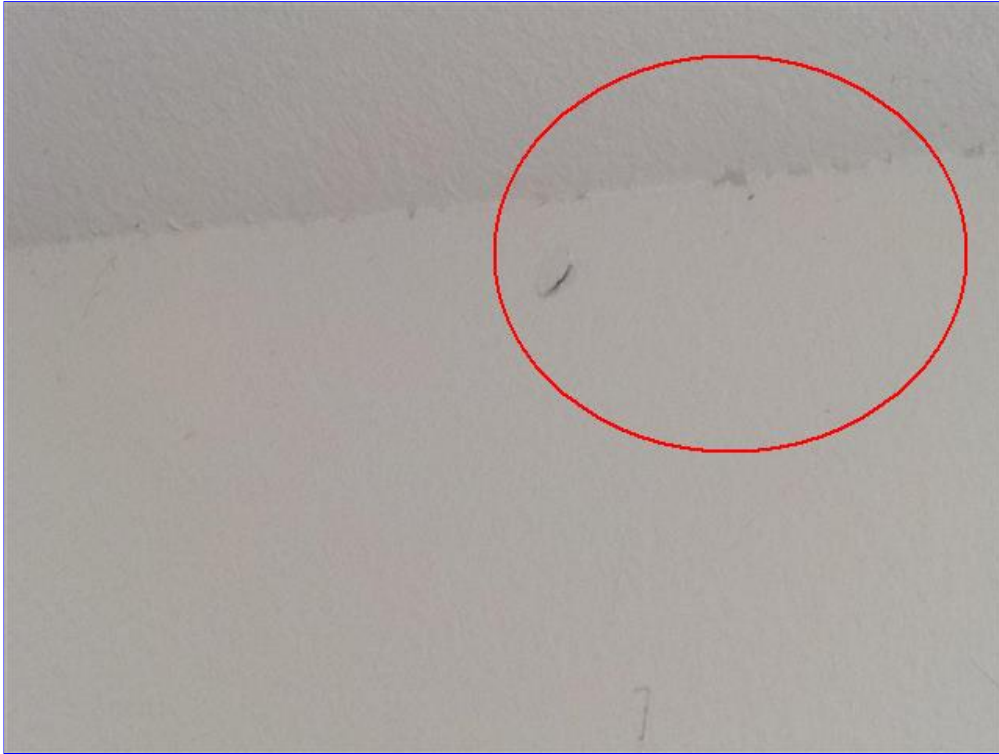
D. Item 25(Picture) Cosmetic damage can be rom the moisture

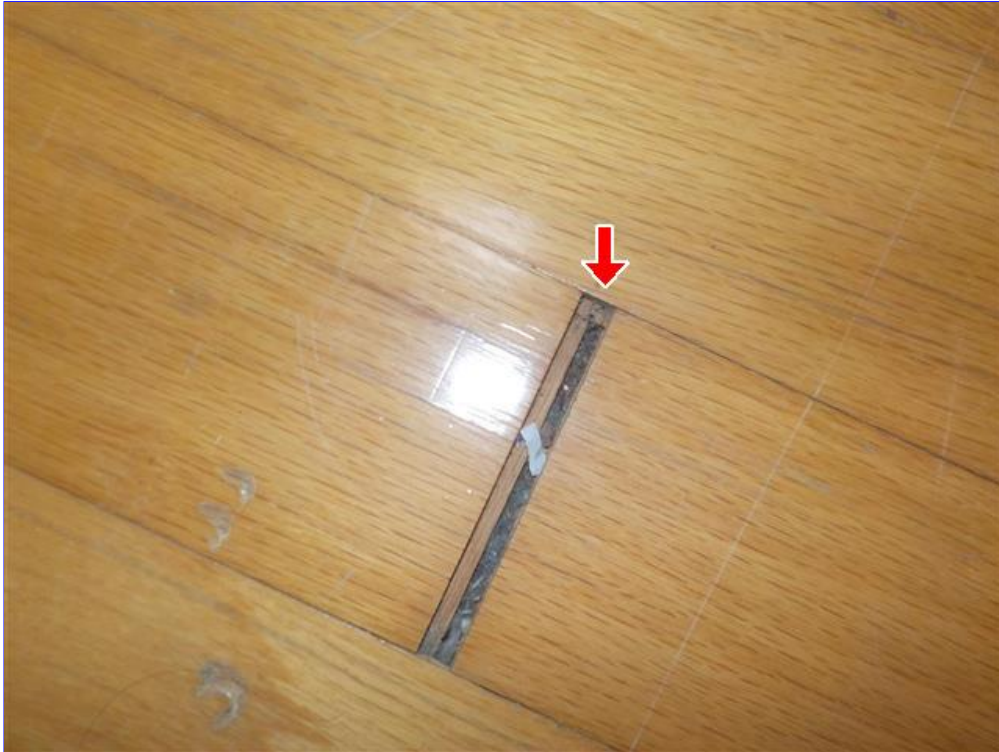
E. Item 1(Picture) Floors are not properly connected

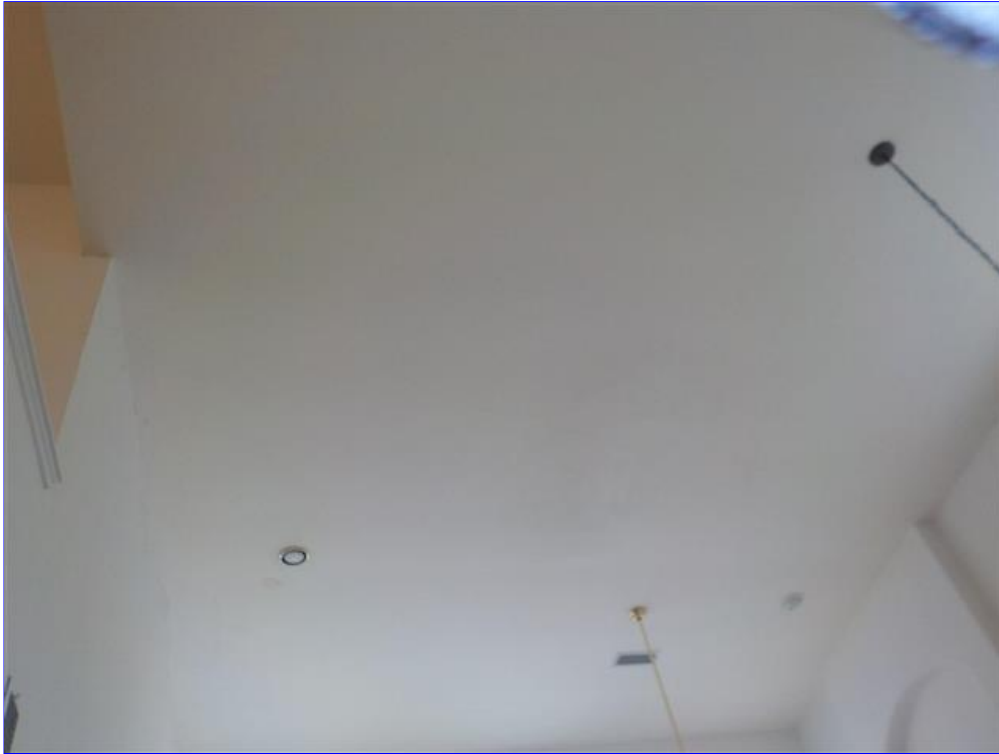
E. Item 3(Picture) Ceiling has ripples and stains

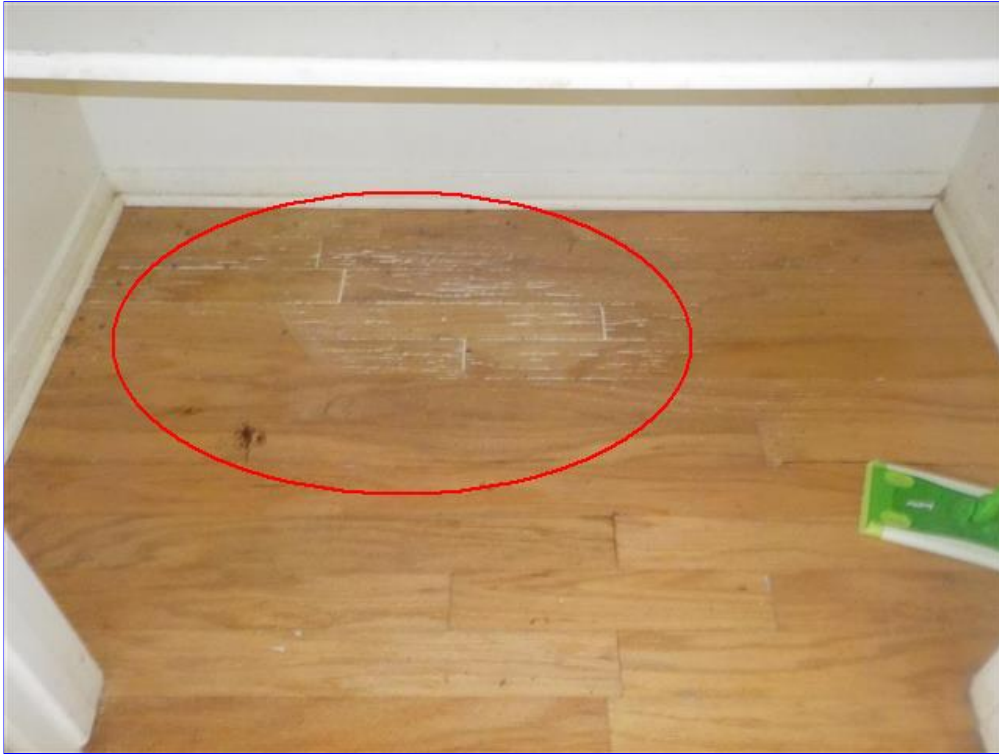
E. Item 7(Picture) Moisture damage

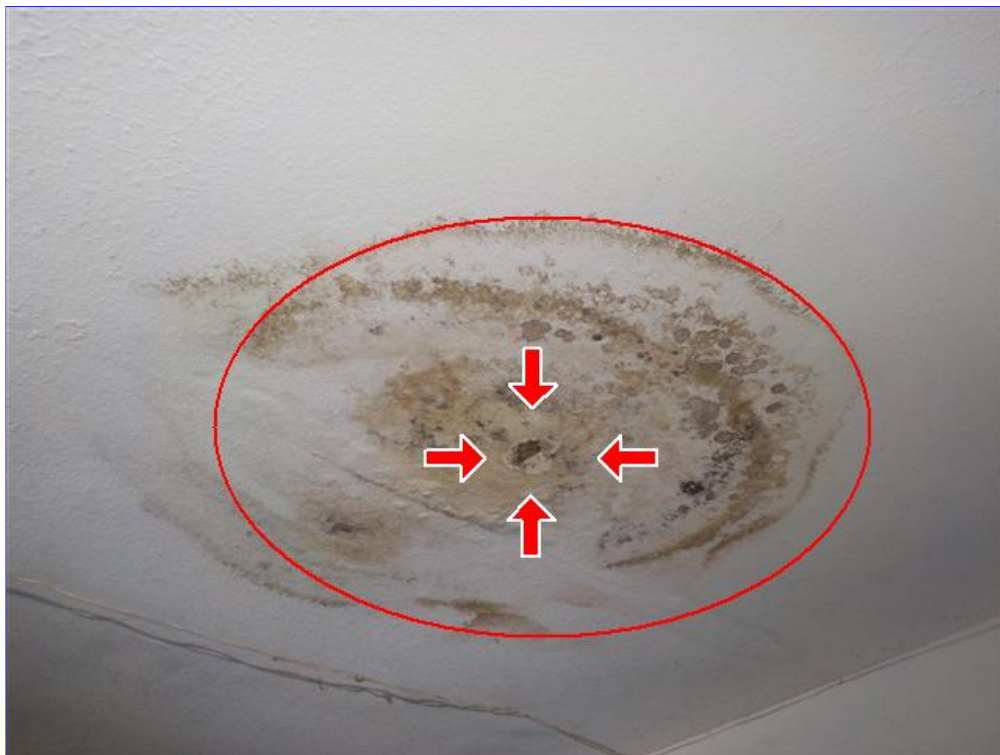
E. Item 9(Picture) Moisture issues can be severe

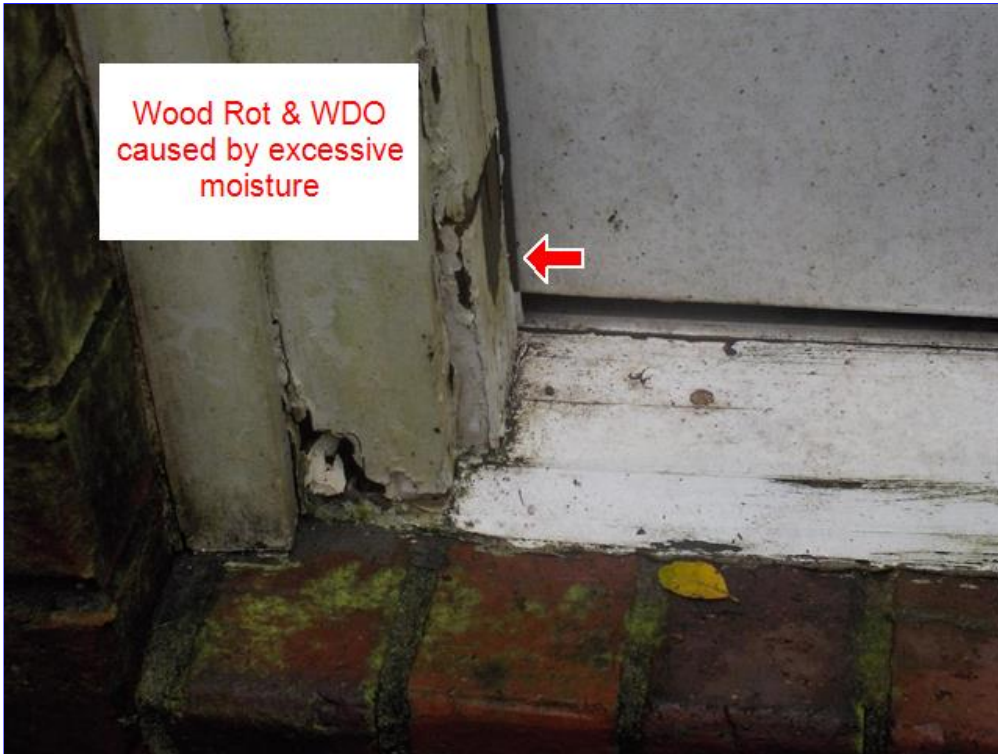
F. Item 1(Picture) Wood Rotting

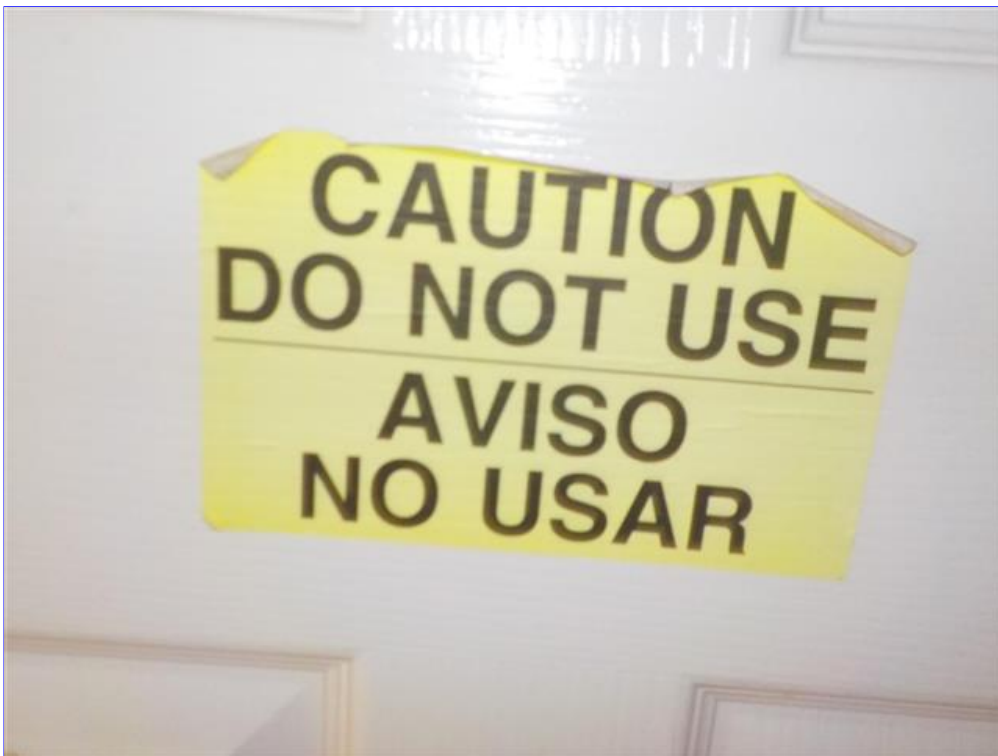
F. Item 2(Picture) Door stops not all in good condition

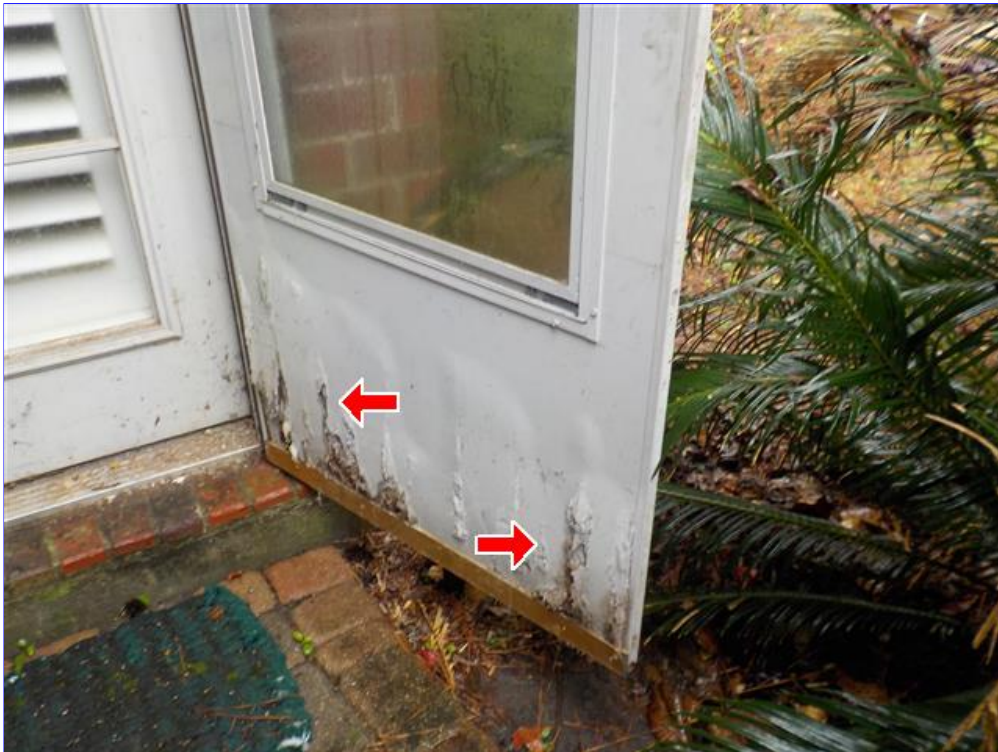
F. Item 3(Picture) Moisture damage possible wdi and wdo wood destroying insects and wood destroying organisms

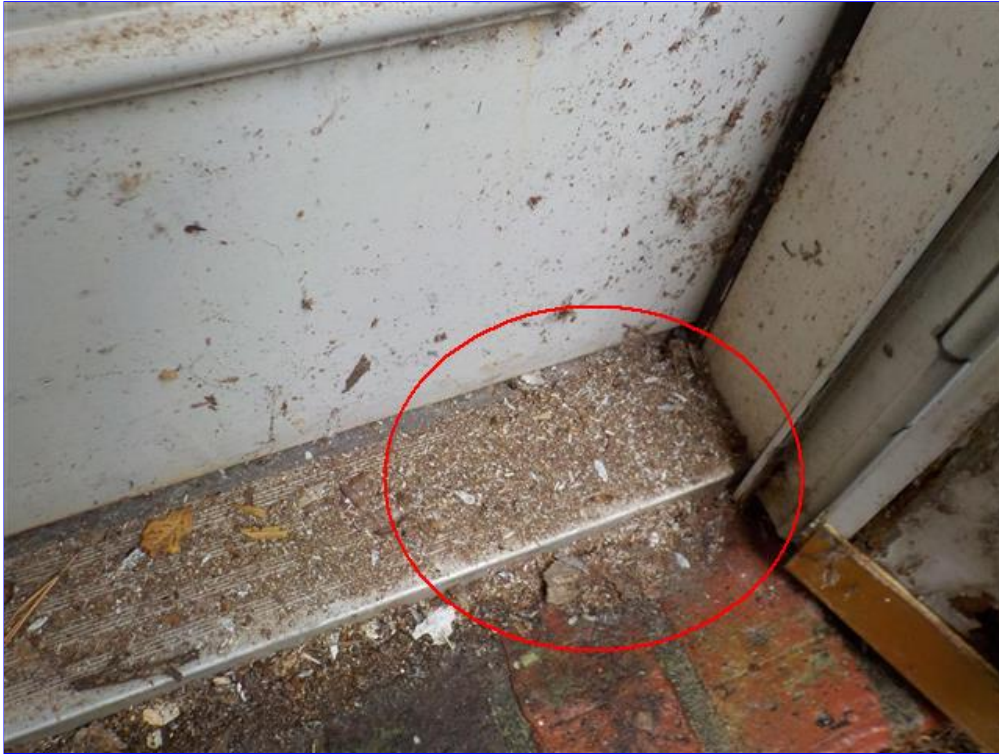
F. Item 5(Picture) Wood debris from deteriorated wood

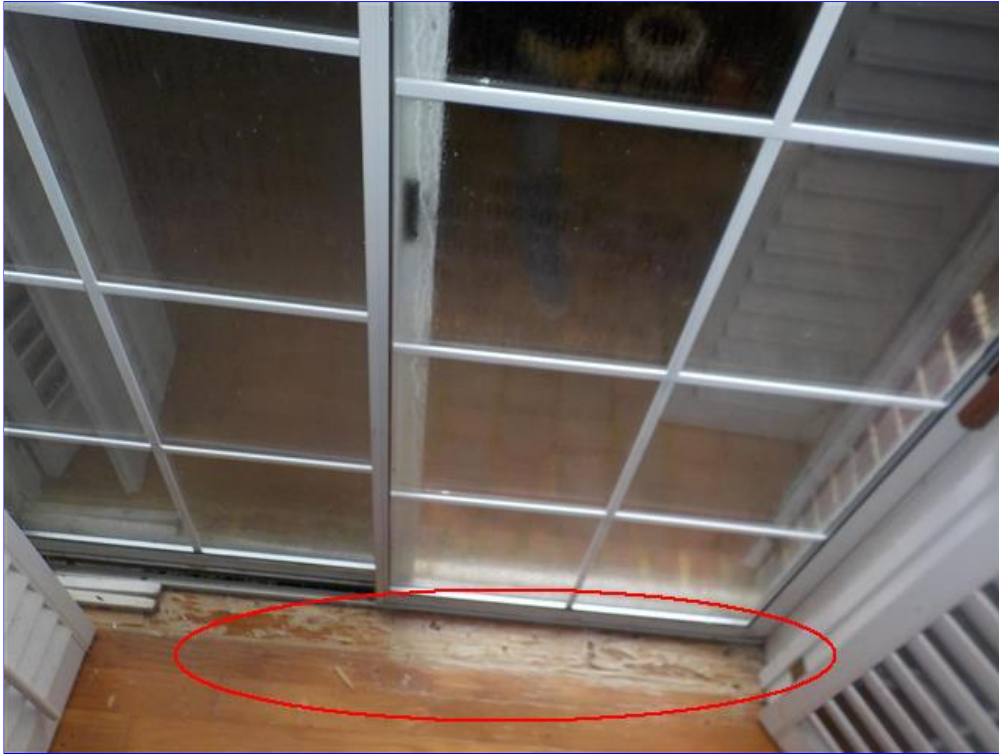
F. Item 7(Picture) Damage from wicking

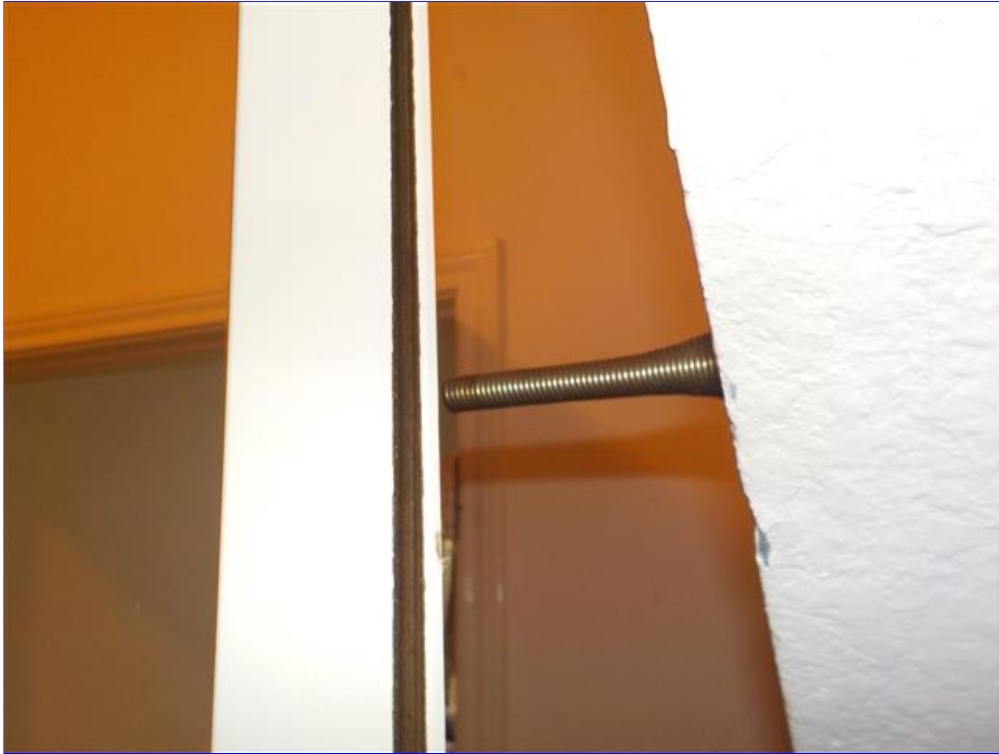
F. Item 9(Picture) Doorstop bumper not in place

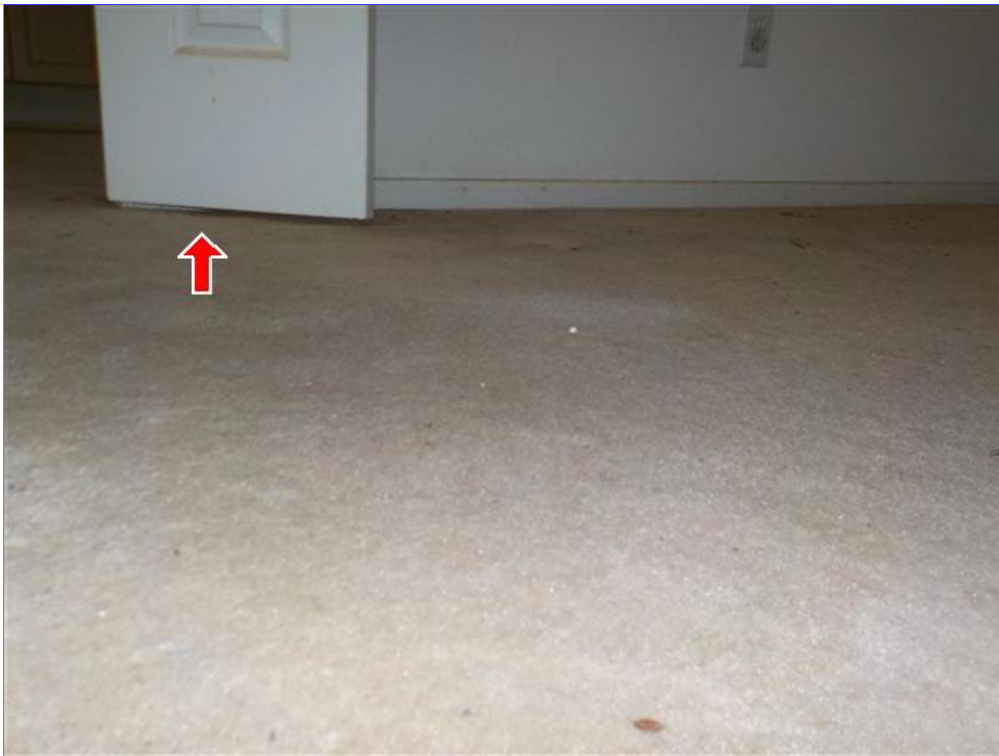
F. Item 10(Picture) Should be an air gap for the door

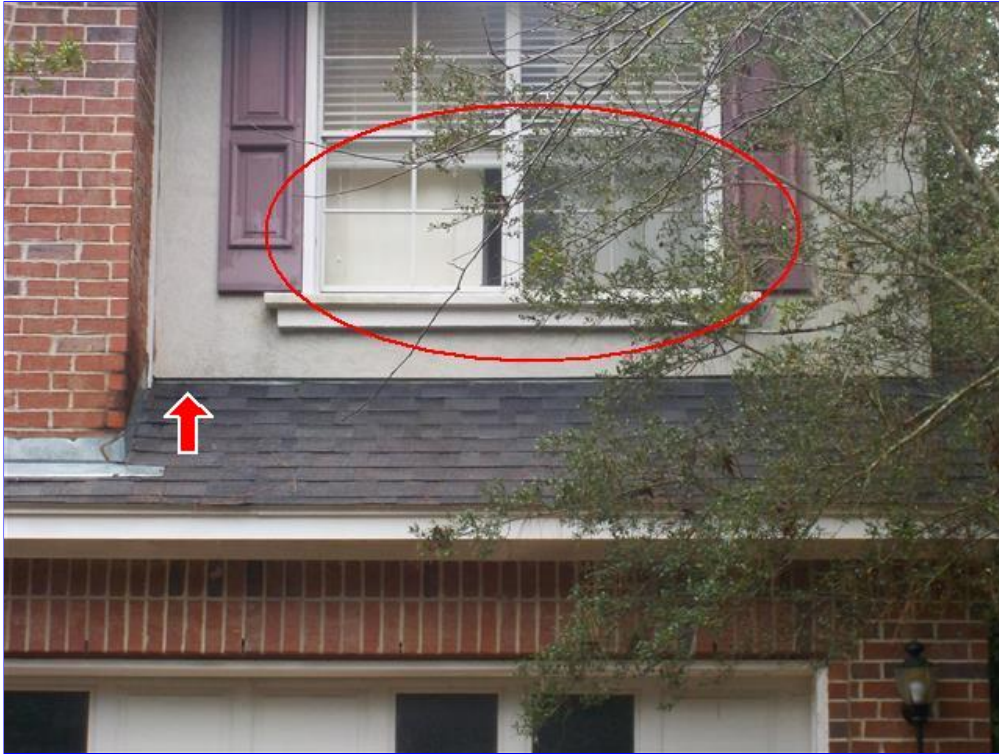
G. Item 1(Picture) Should be flashing

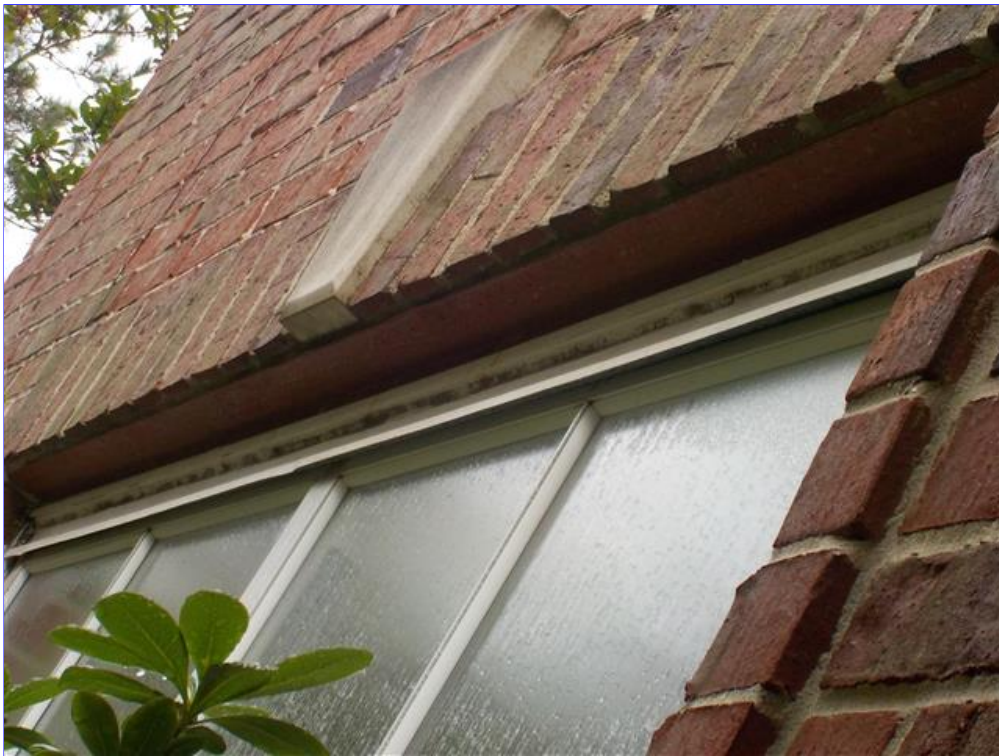
G. Item 2(Picture) Window lentil experiencing moisture damage

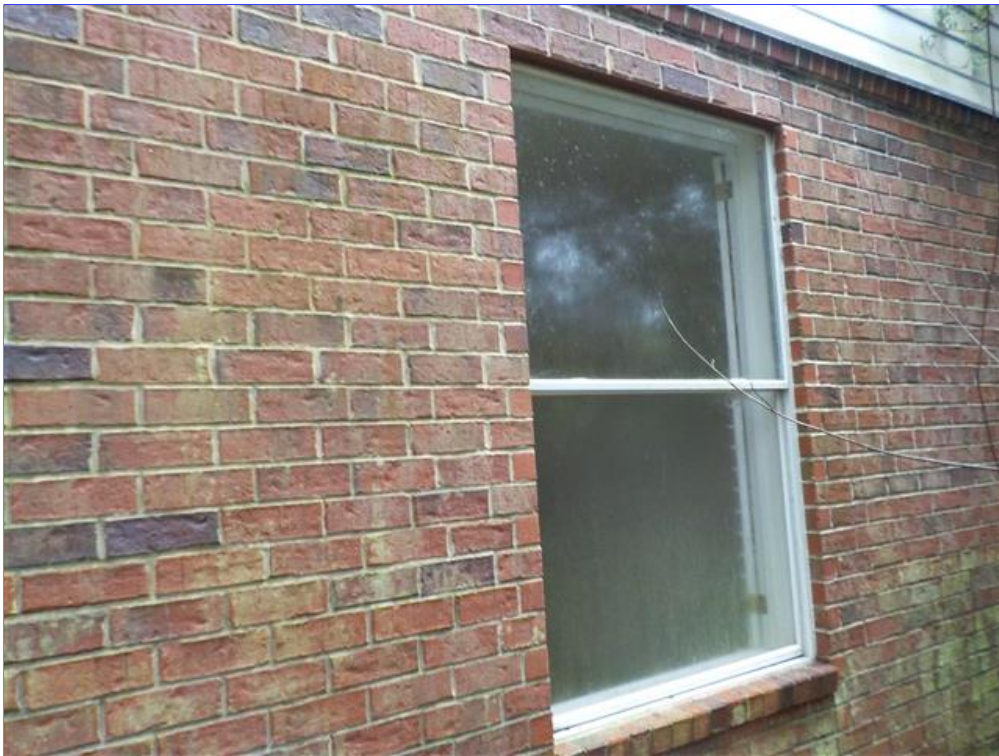
G. Item 4(Picture) screens missing

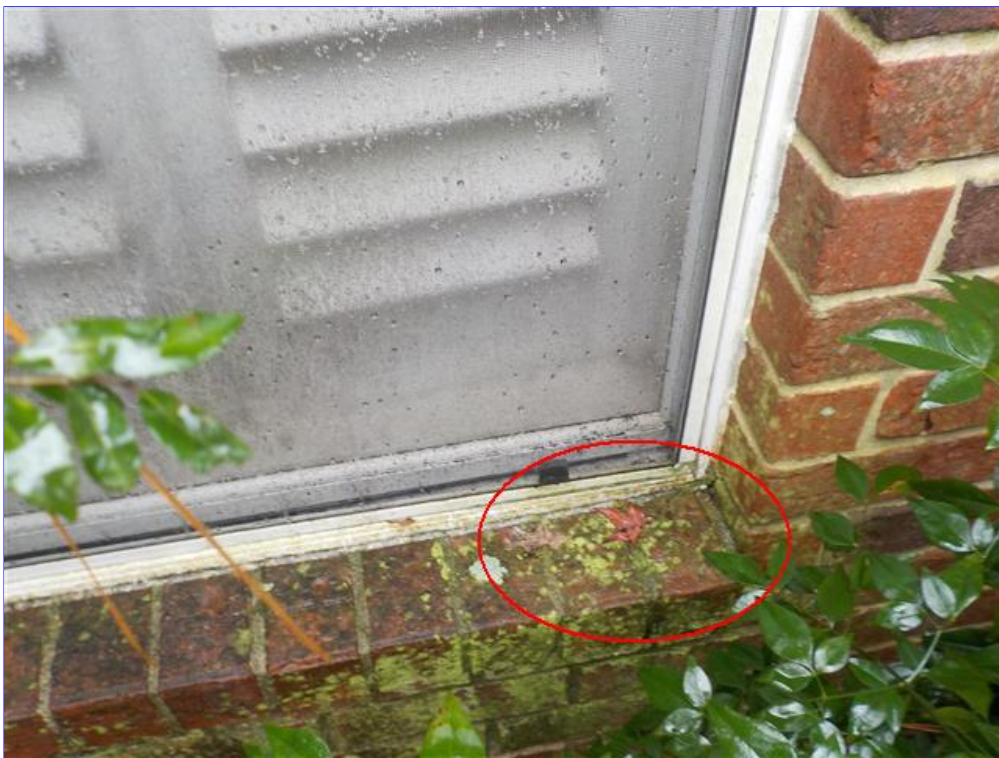
G. Item 8(Picture) Very moist in and around structure

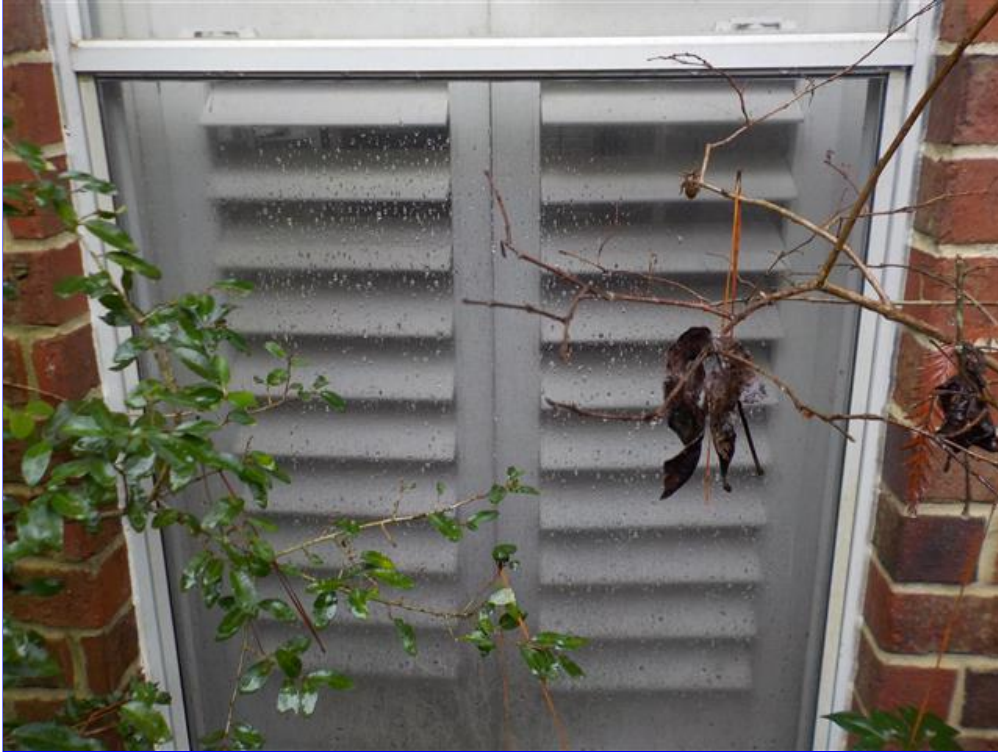
G. Item 9(Picture) Foliage brushing against the home

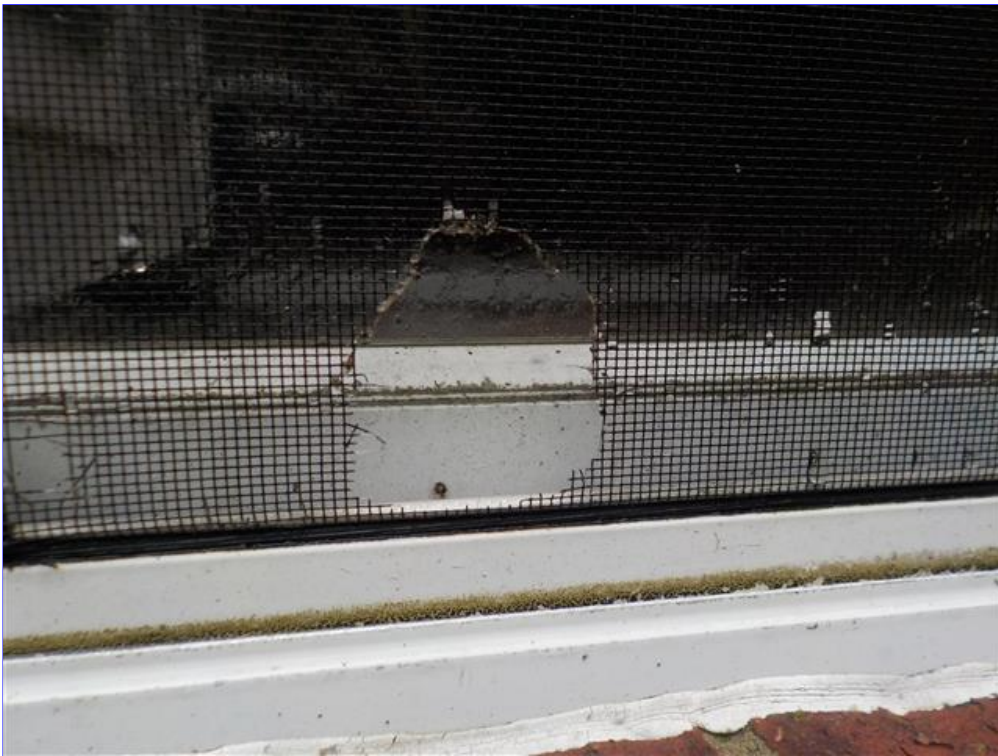
G. Item 10(Picture) The screen is ripped

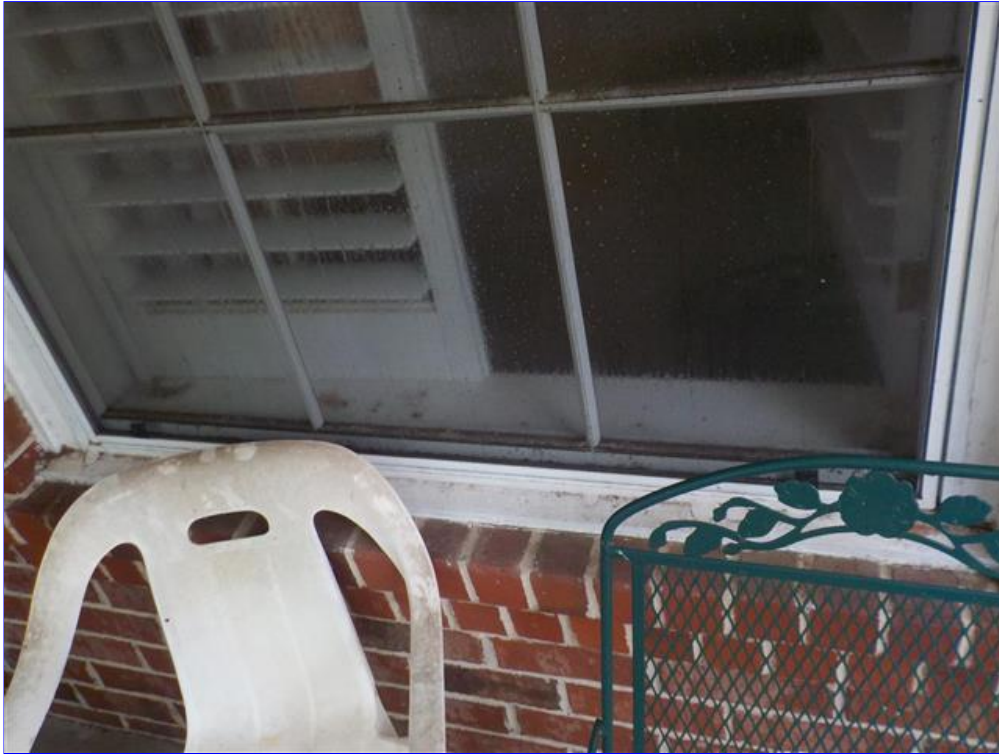
G. Item 11(Picture) Debris around structure

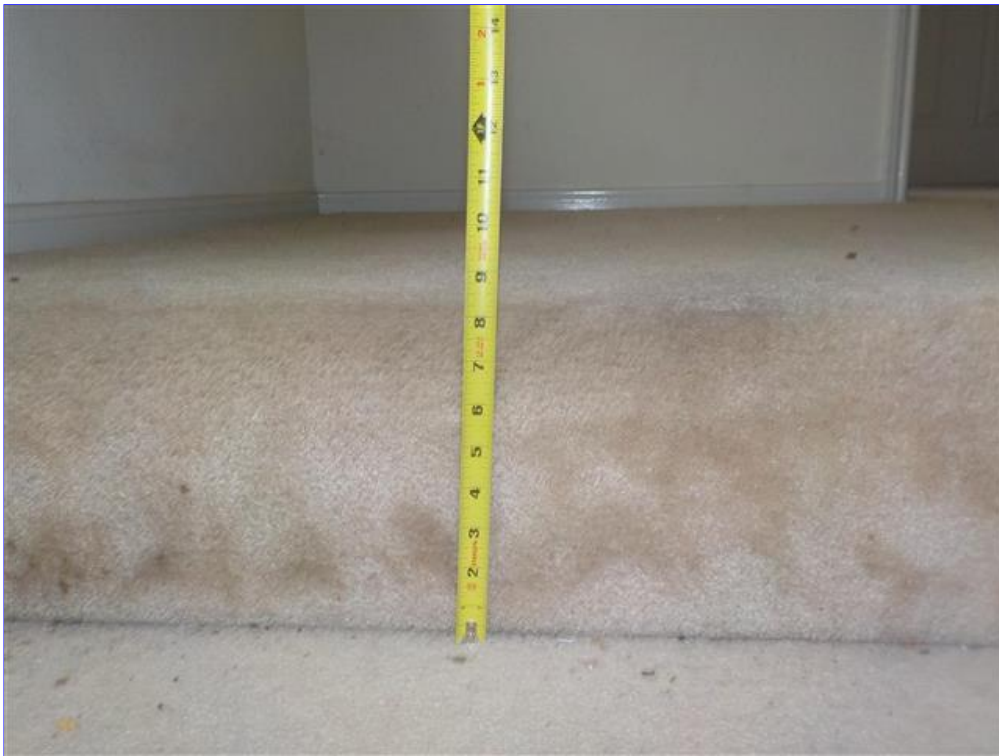
H. Item 2(Picture) The stairs should be corrected.

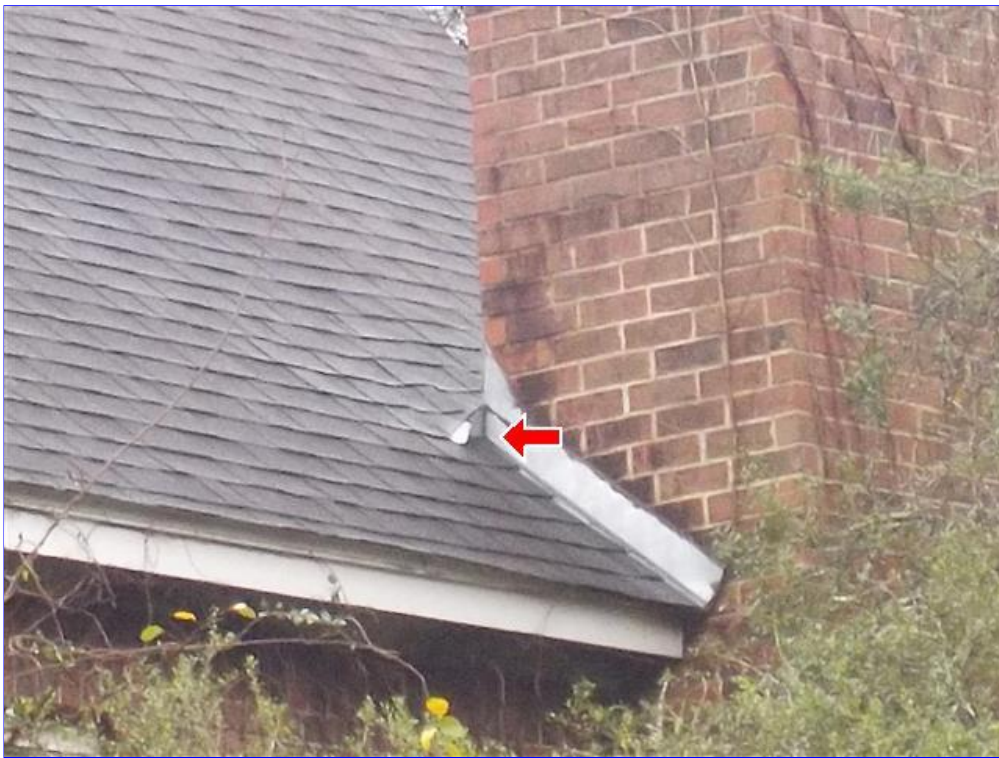
The chimney does not appear to have been recently maintained as evidenced by soot accumulation. Black soot is expected and should be cleaned from inner walls of liner in order to properly inspected for breakers or loose section. Recommended a licensed chimney sweep clean and inspected for safety.

I. Item 1(Picture) soot on outside of chimney or growth should be cleaned off and fireplace cleaned inside and out

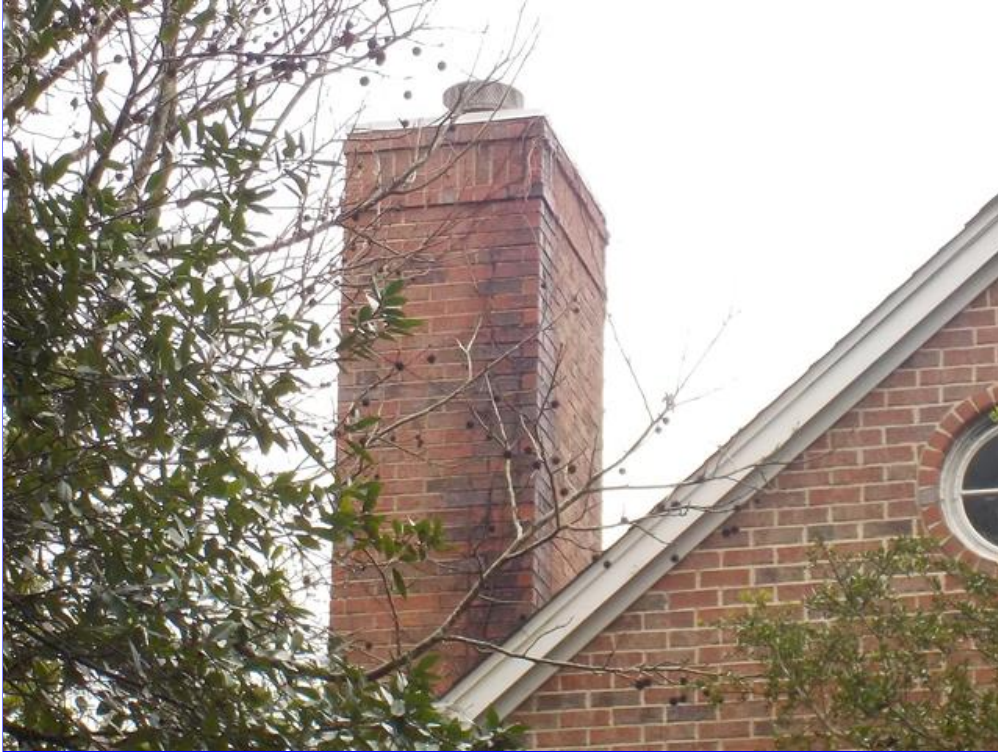
I. Item 3(Picture) check for leaks and clean and seal

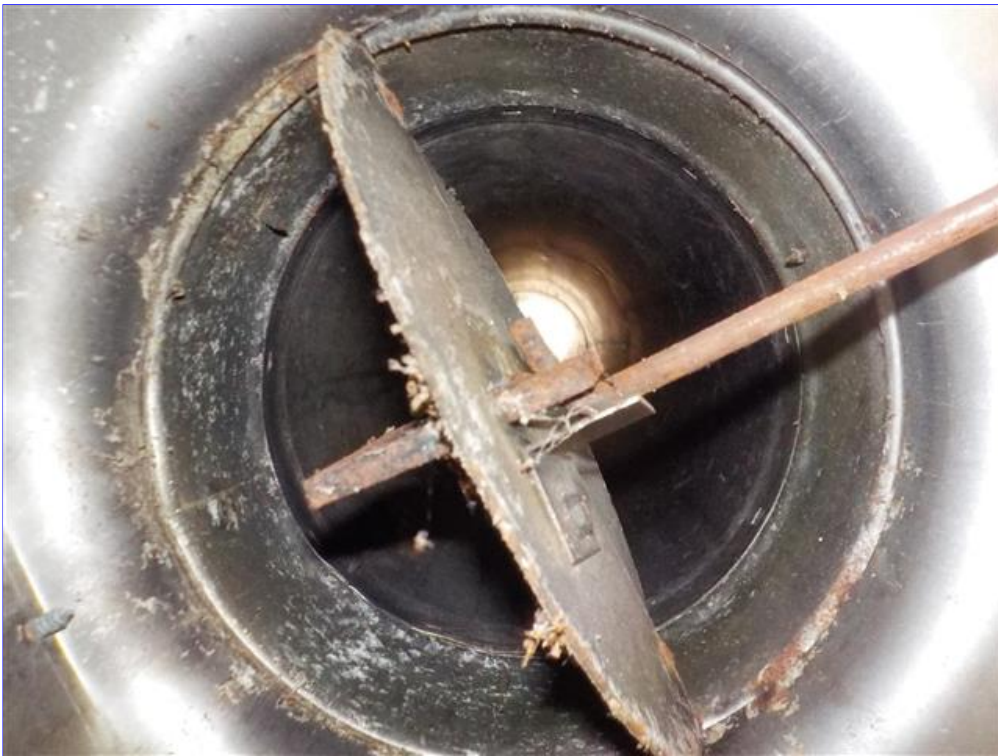
I. Item 4(Picture) Chimney Flue dirty make sure to clean

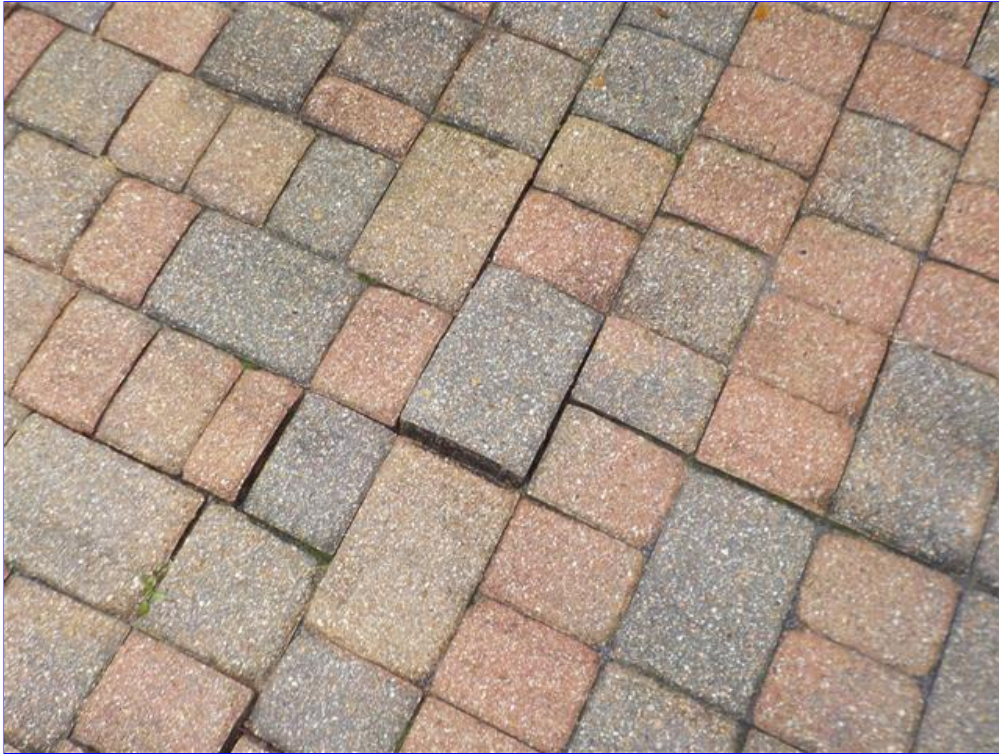
J. Item 1(Picture) Tiles Bricks can be a trip hazard

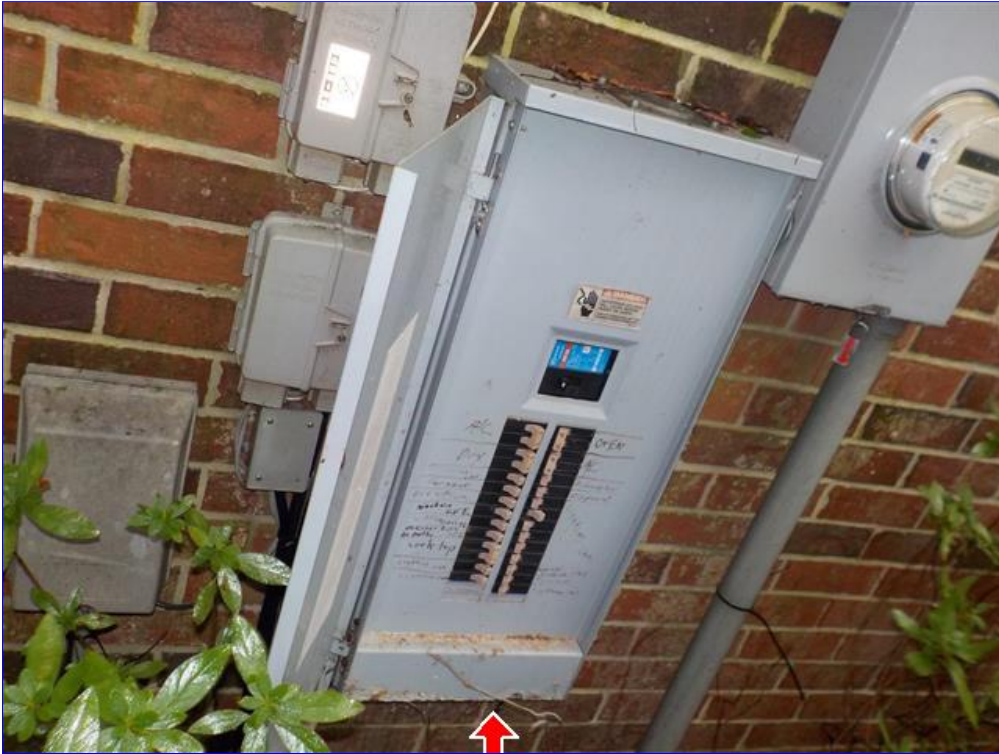
A. Item 1(Picture) 150amp rusting panel make sure to take off dead front cover and check wiring so that no exposed wires are showing

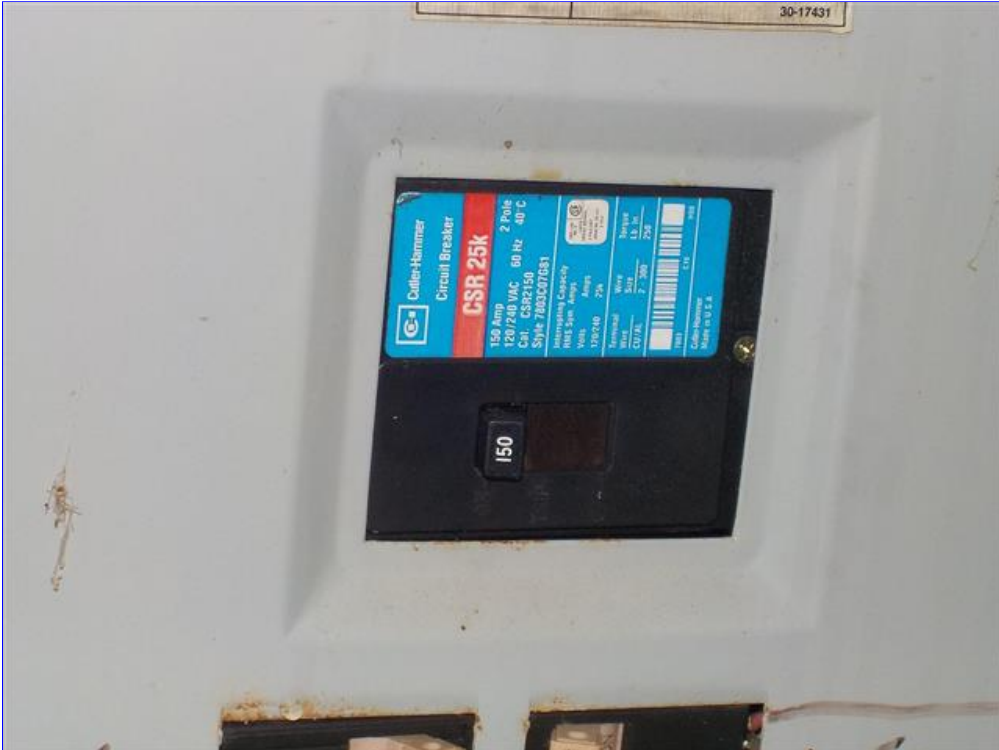
A. Item 2(Picture) Due to moist conditions and inclement weather could not open the dead front cover

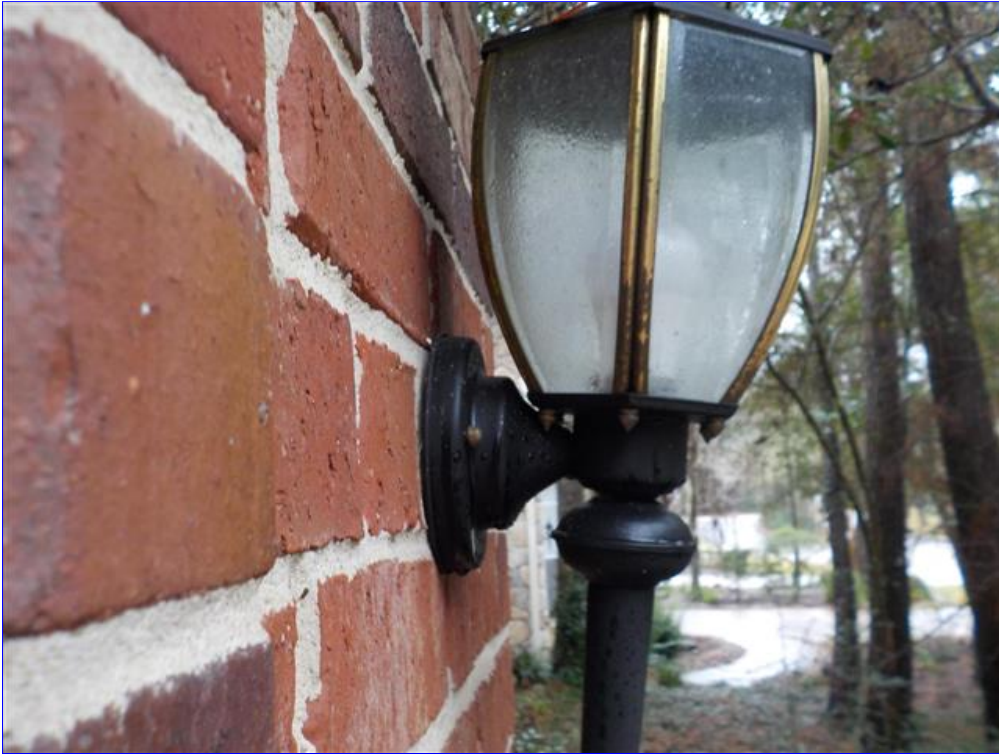
B. Item 1(Picture) Should be caulked to prevent moisture intrusion

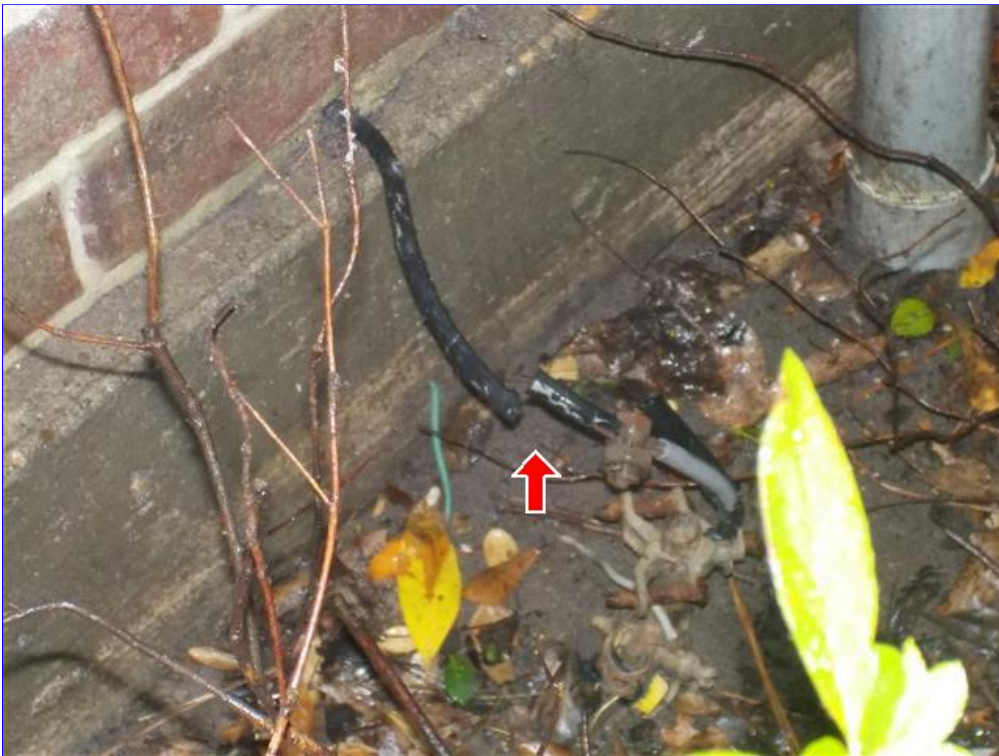
B. Item 2(Picture) Grounding wire broken

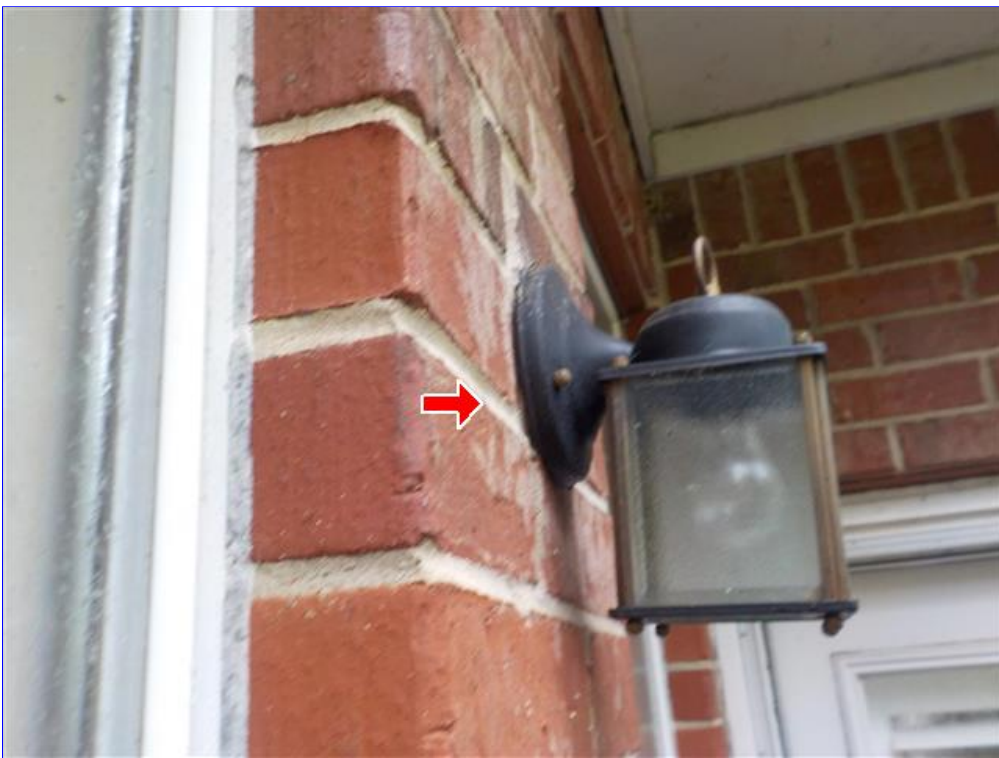
B. Item 6(Picture) Really recommend weather proofing

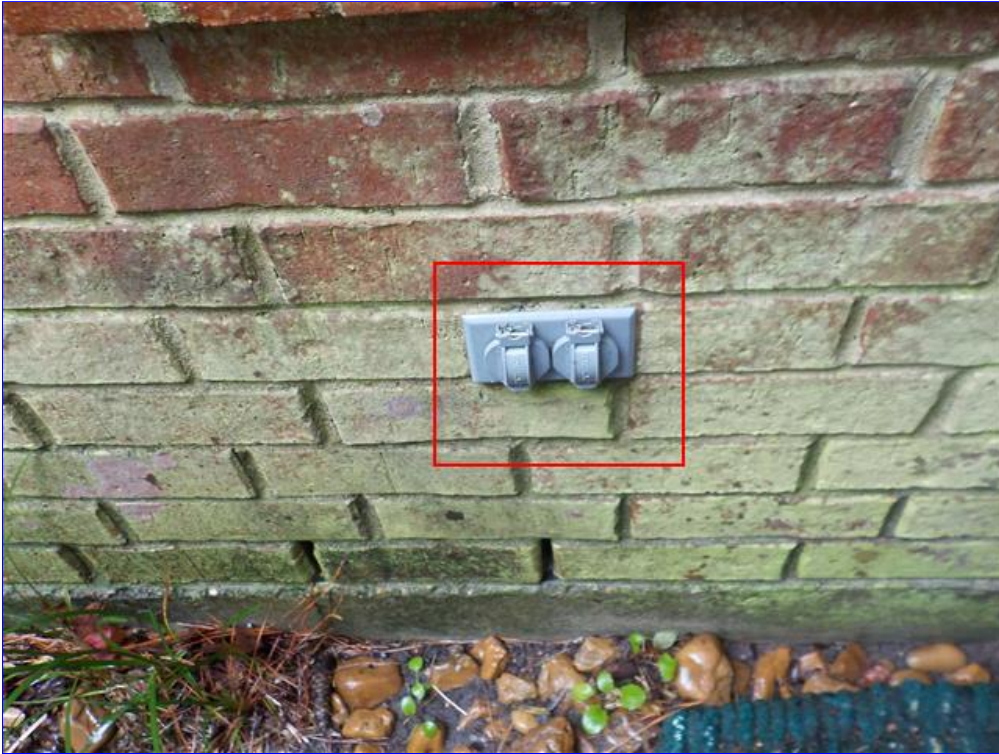
B. Item 7(Picture) Recommend water proof cover
