Inspection Report

Property Address:
26 South Bethany Bend
Woodlands Texas 77382

PROPERTY INSPECTION REPORT

Concerning: 26 South Bethany Bend, Woodlands, Texas 77382

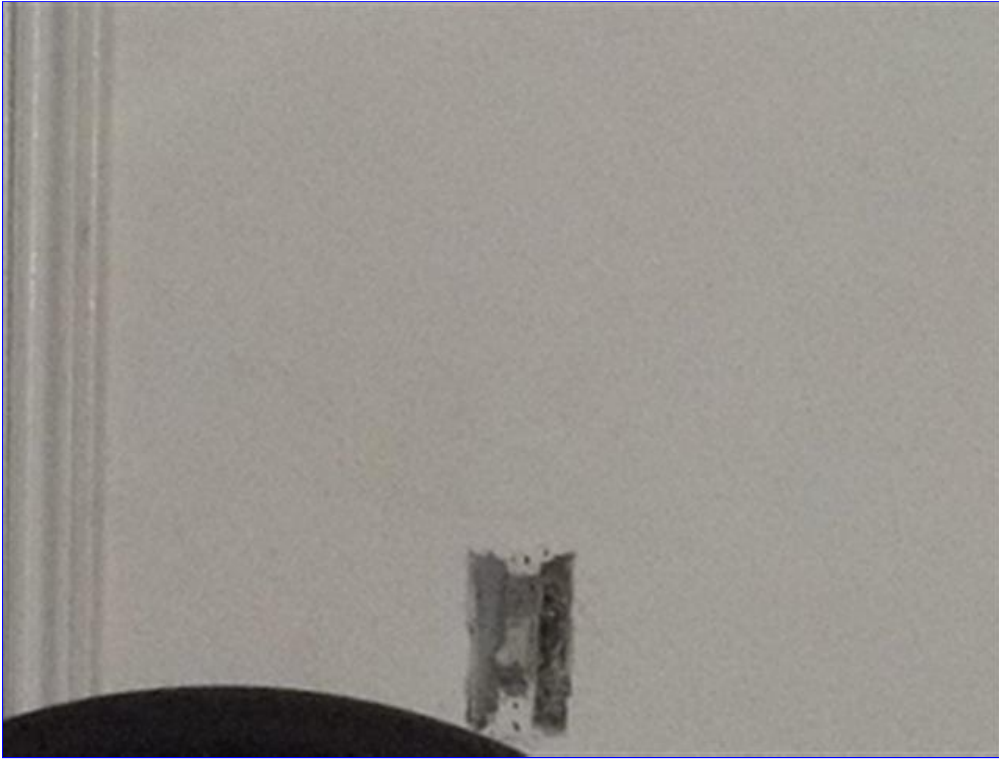
B. Item 9(Picture) All switches need front panels

Damaged/Missing Covers There are damaged/missing receptacle/switch cover plates. These plates should be replaced for safety reasons.

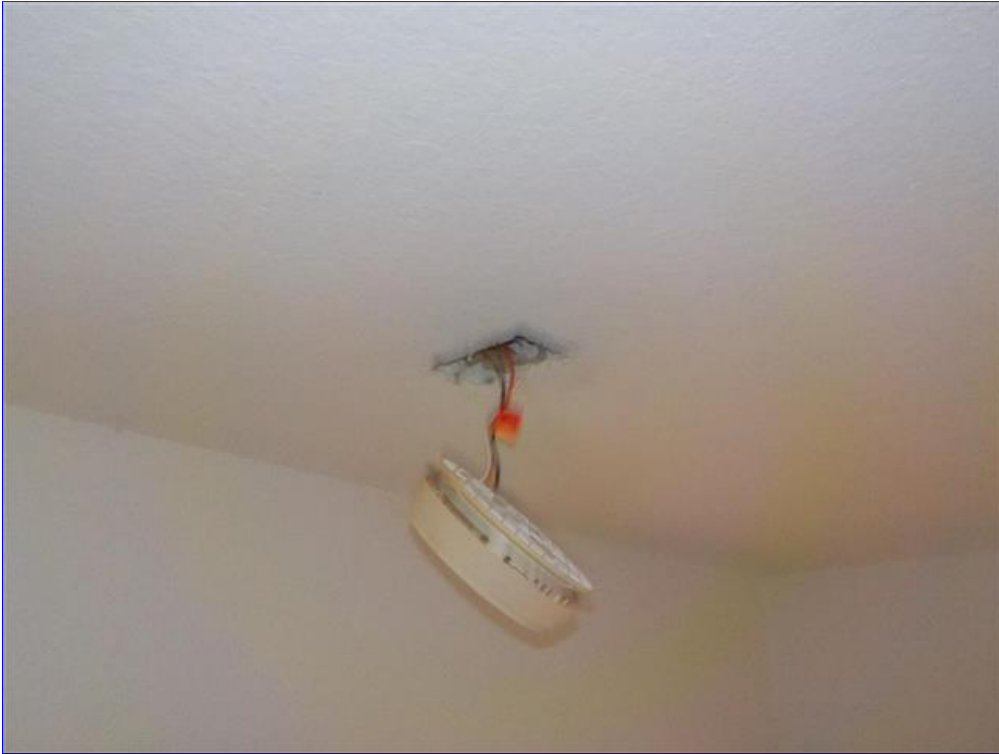
B. Item 14(Picture) Smoke Alarms should be corrected

Smoke detectors are present at required locations, but appear to be aged. I recommend replacement of existing units, manufacturers recommend replacement every ten (10) years, for personal safety reasons.

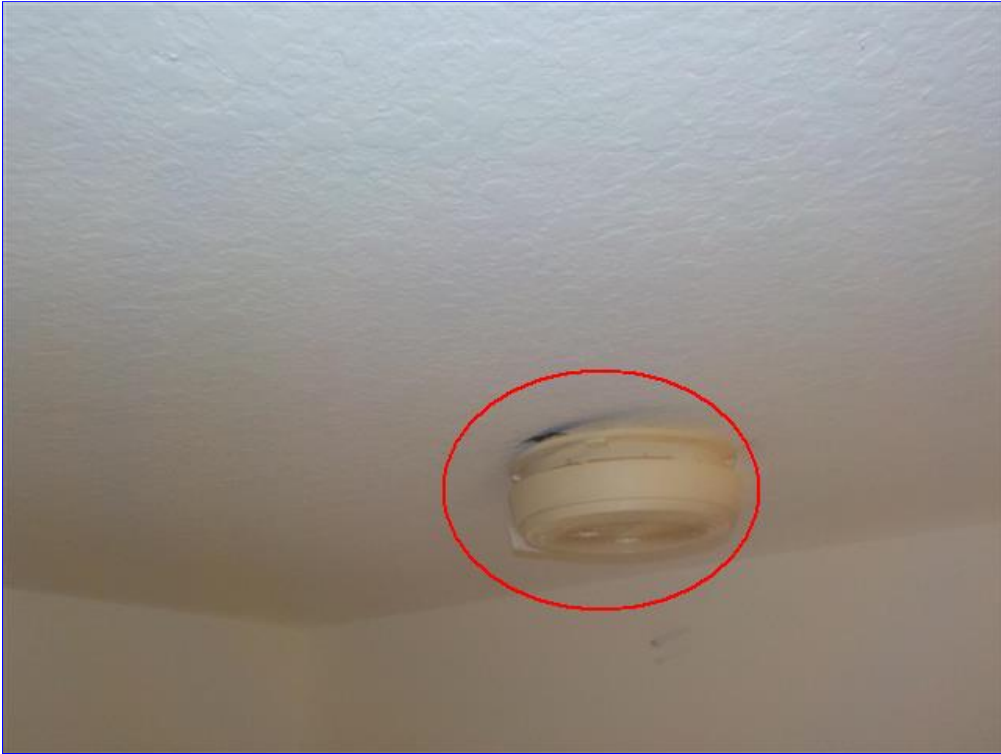
B. Item 16(Picture) Smoke Alarm old aged

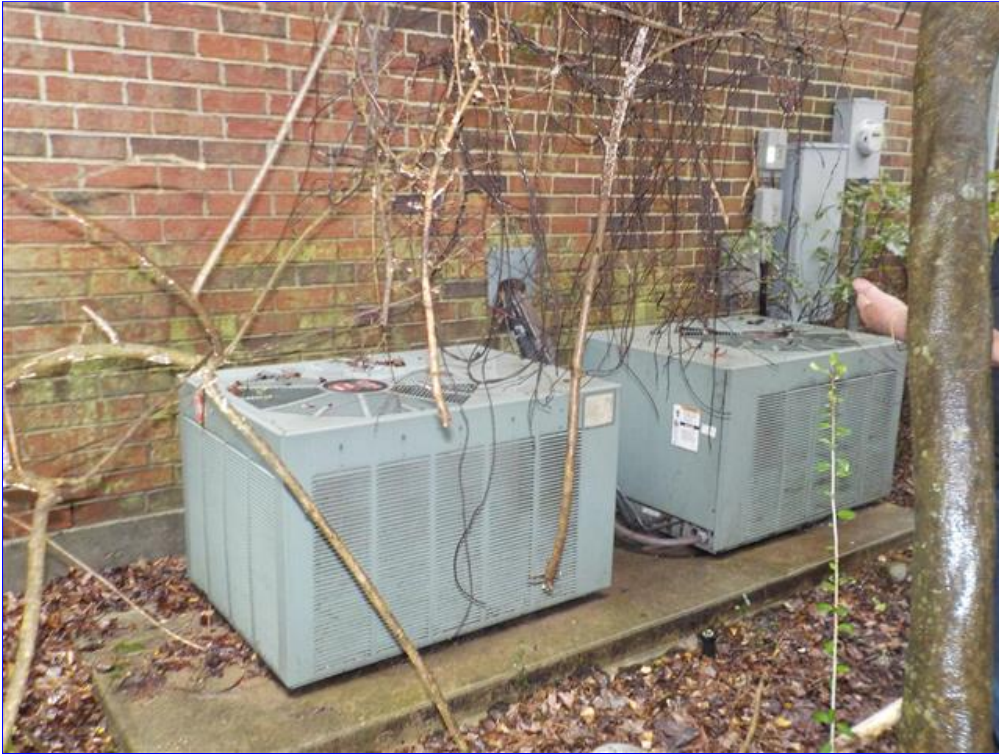
The condenser outside (AC unit) is very old and may last a few years more, but maybe not. I have seen units fail shortly after a home inspection during the seasonal change from mild to hot weather. I cannot determine how long your AC will last before a replacement is necessary.

The compressor (outside AC unit) appears to be the original unit installed when the house was built. With proper annual maintenance, modern compressor units can last 15+ years. I cannot determine how long your AC will last before a replacement is necessary.

A. Item 1(Picture) Old condensers recommend service

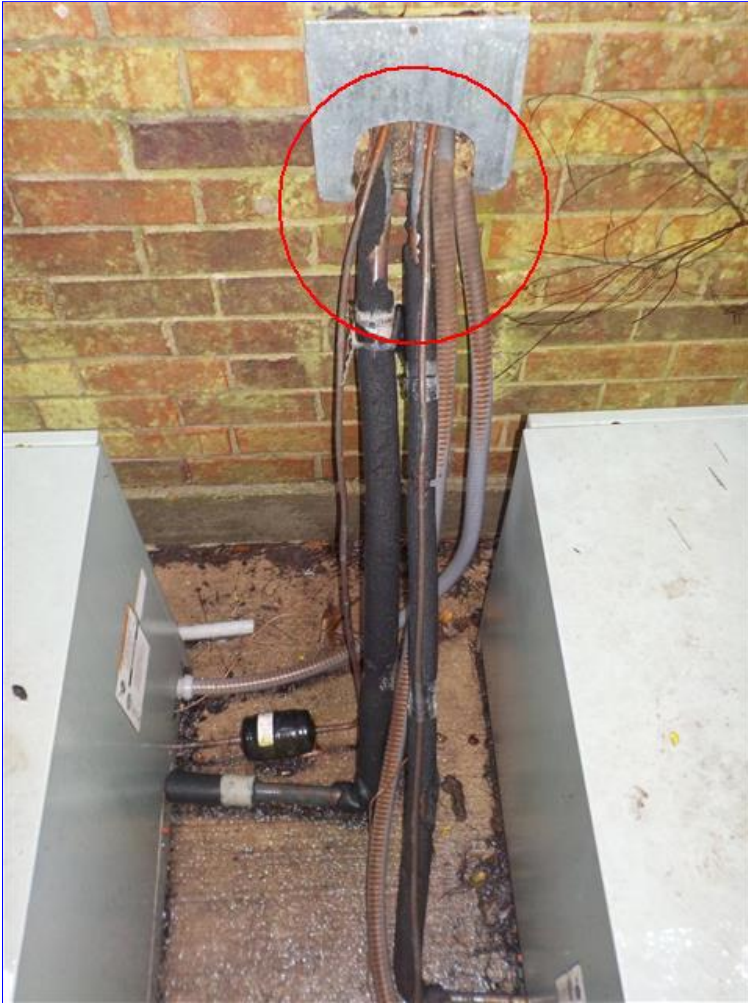
A. Item 3(Picture) Blocked well

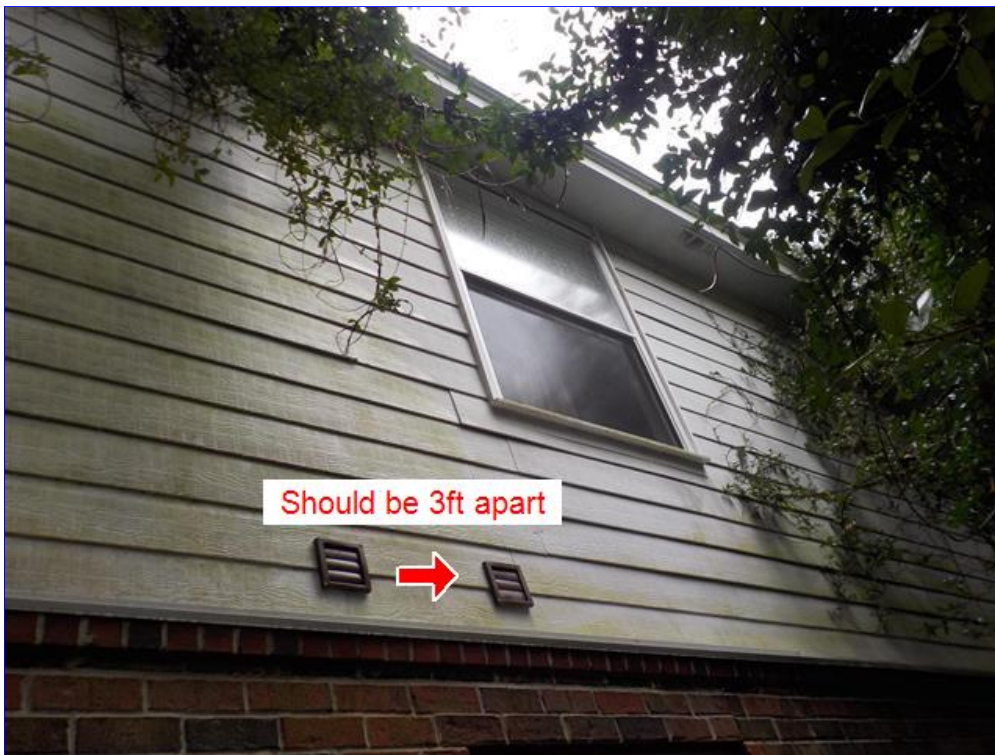
C. Item 1(Picture) Vents should be 3ft apart

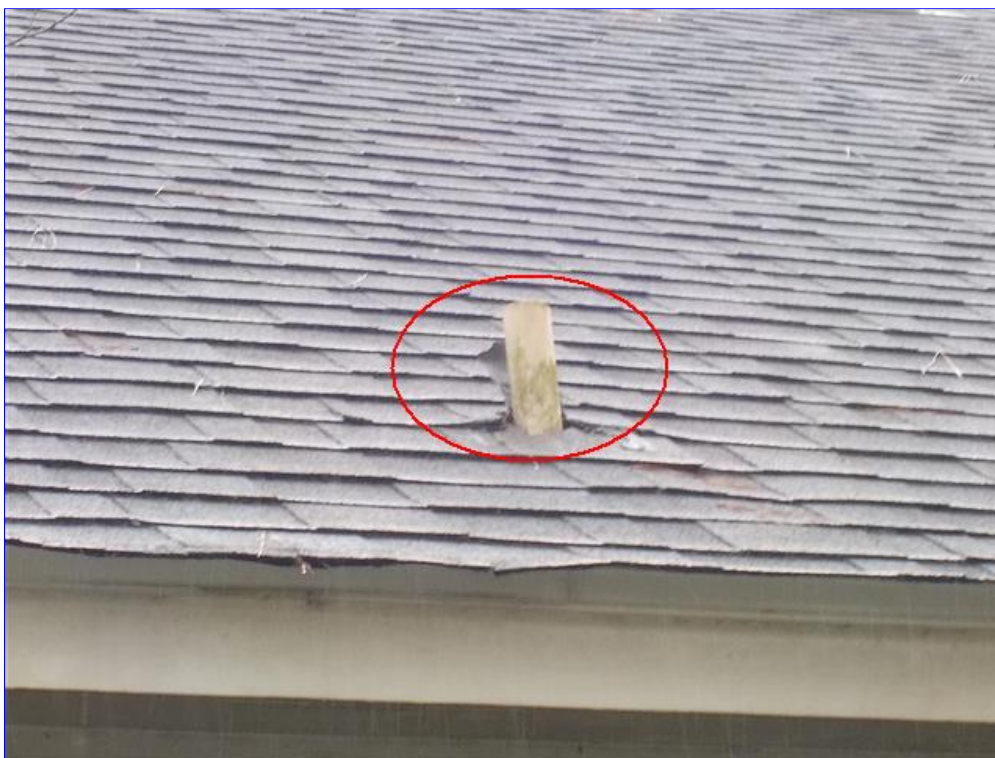
C. Item 2(Picture) Should be properly sheathed and PVC should not be used in this format

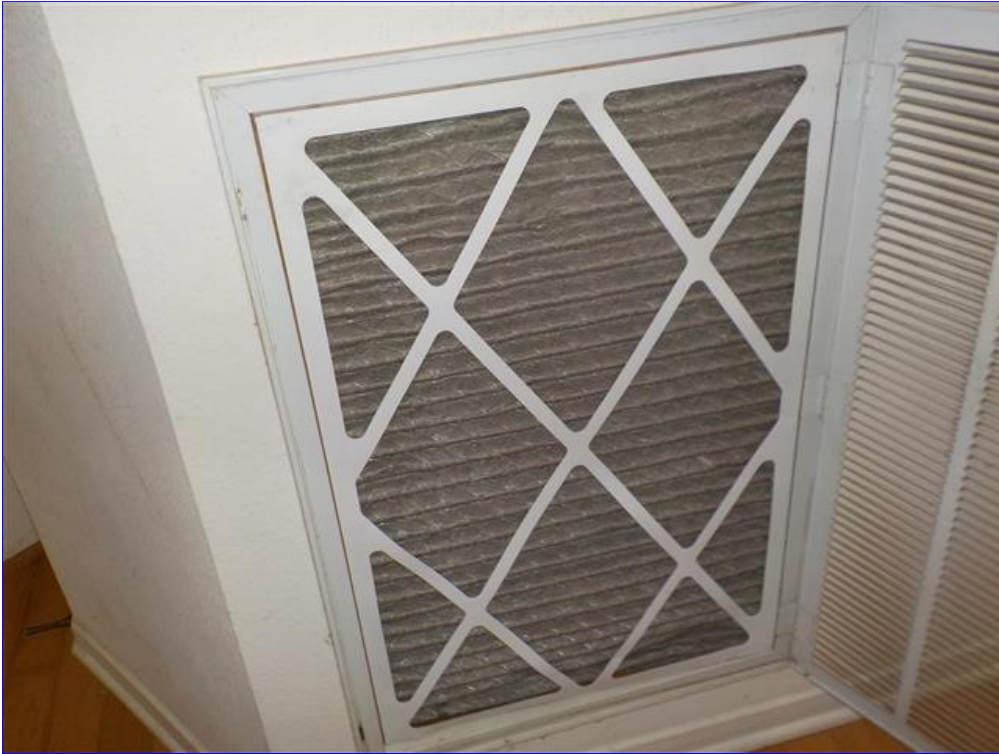
C. Item 5(Picture) Dirty filtration recommend HVAC specialist come repair

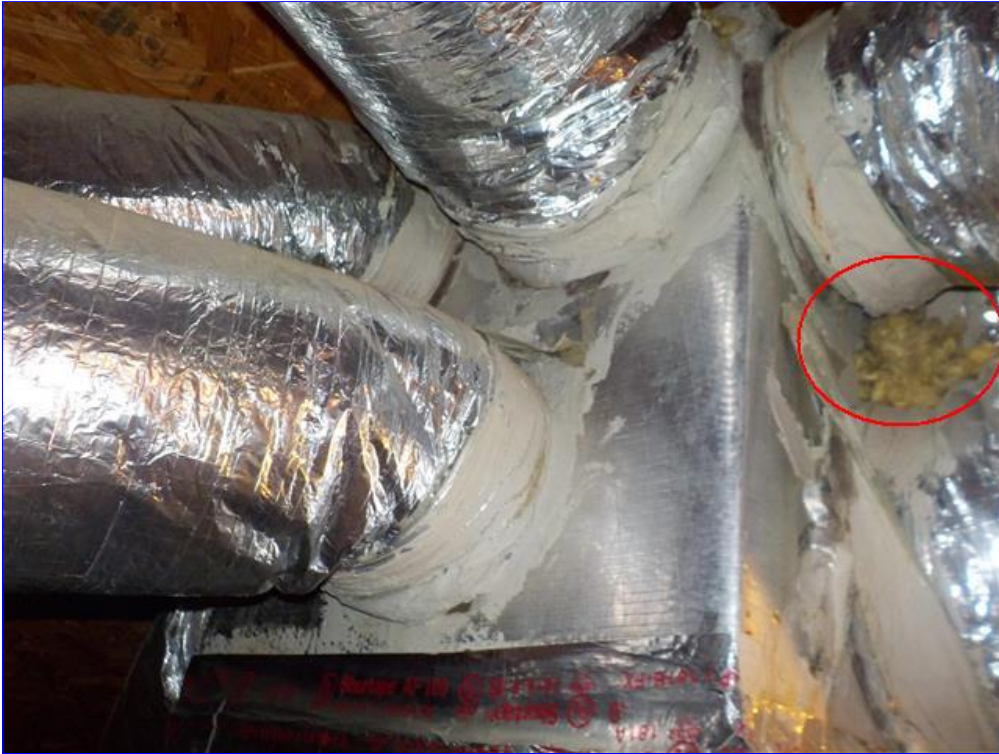
C. Item 9(Picture) Mastic should be properly applied

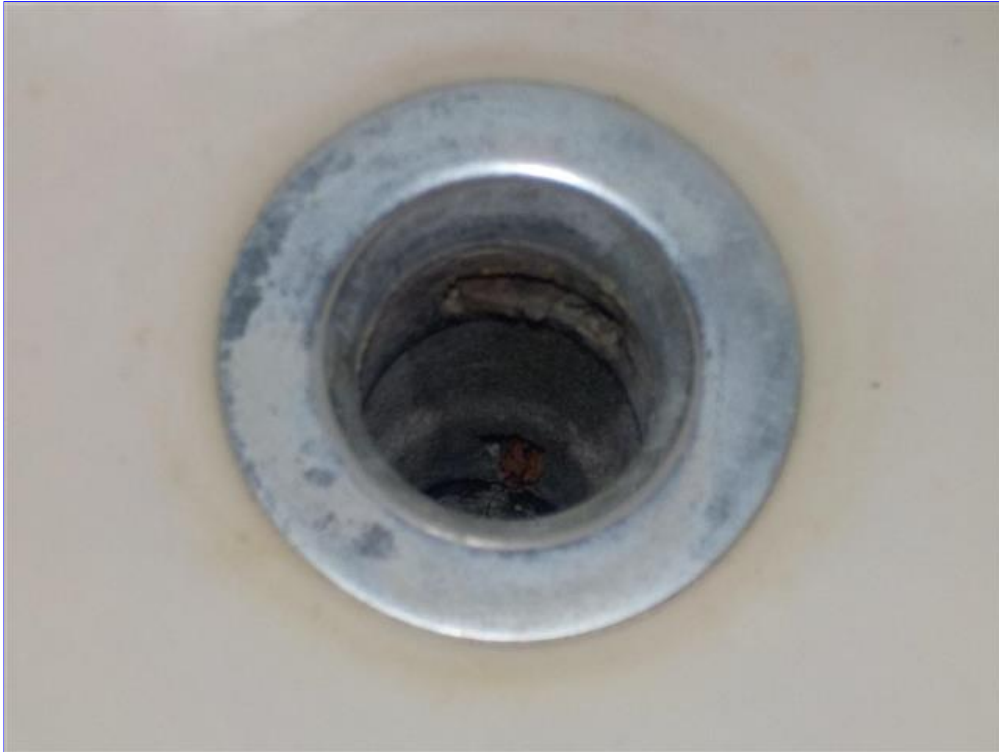
A. Item 3(Picture) Need to install stoppers in multiple drains

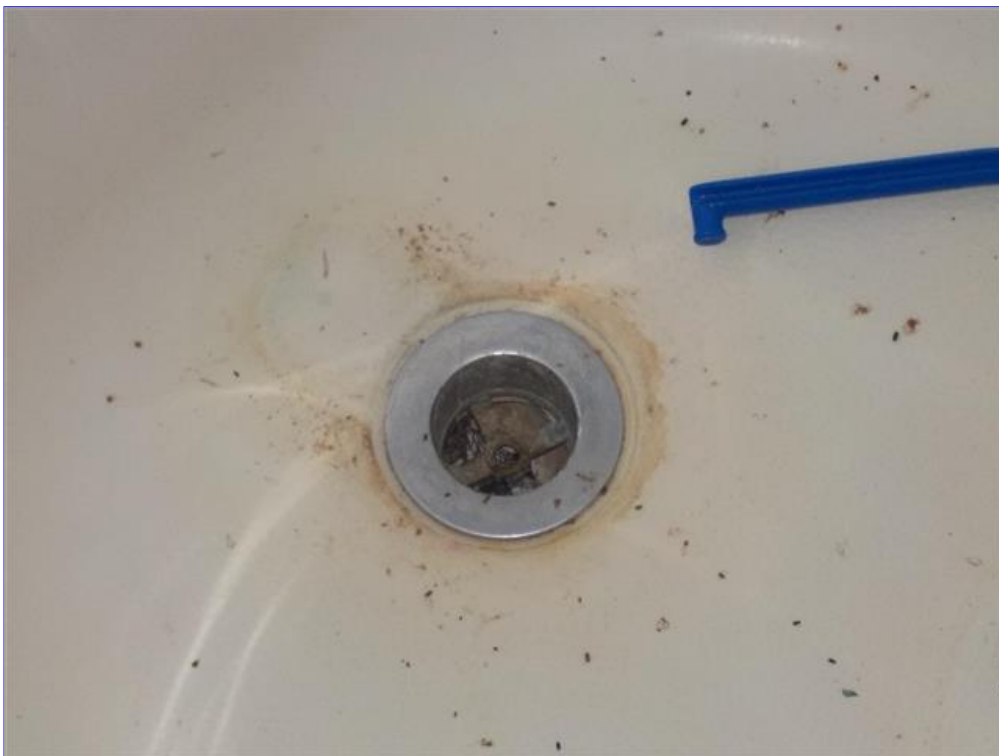
A. Item 4(Picture) Insects and critters can easily invade a home from these entry points

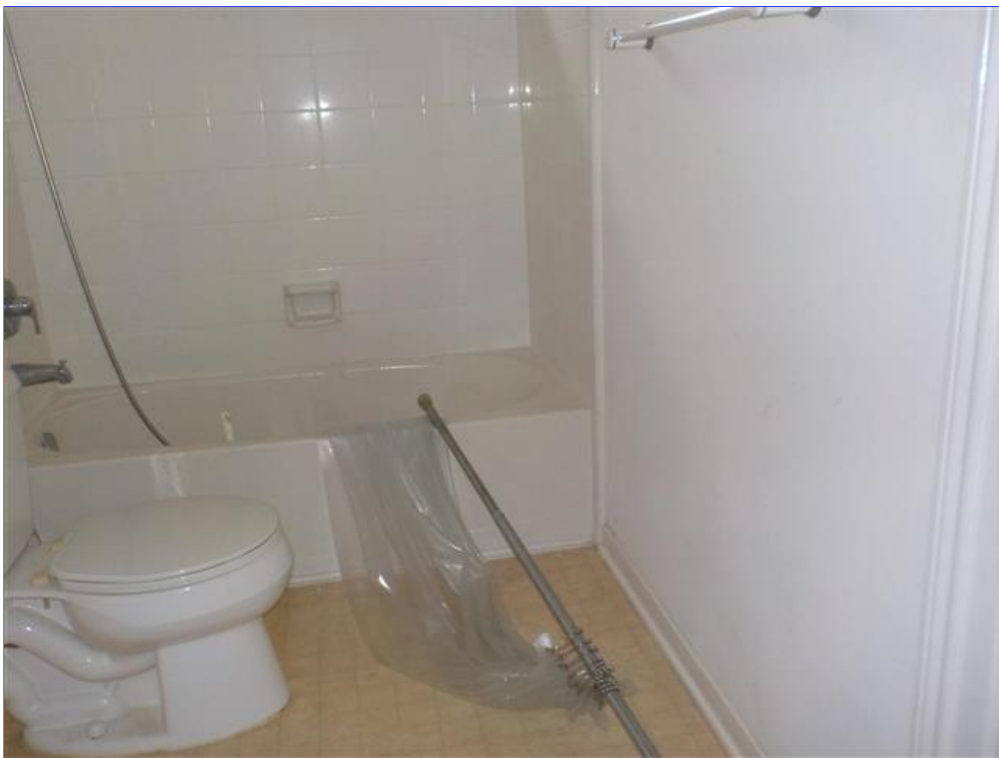
A. Item 8(Picture) Shower curtain should be rebraced into place

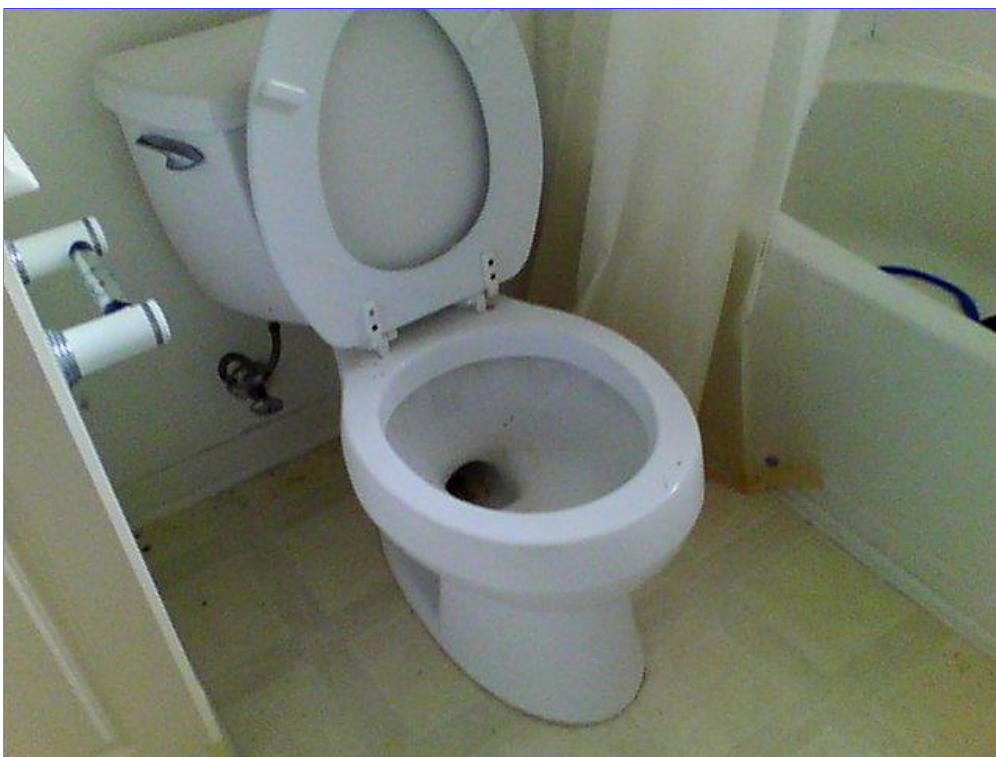
A. Item 10(Picture) Tight fit should be 18in clearance

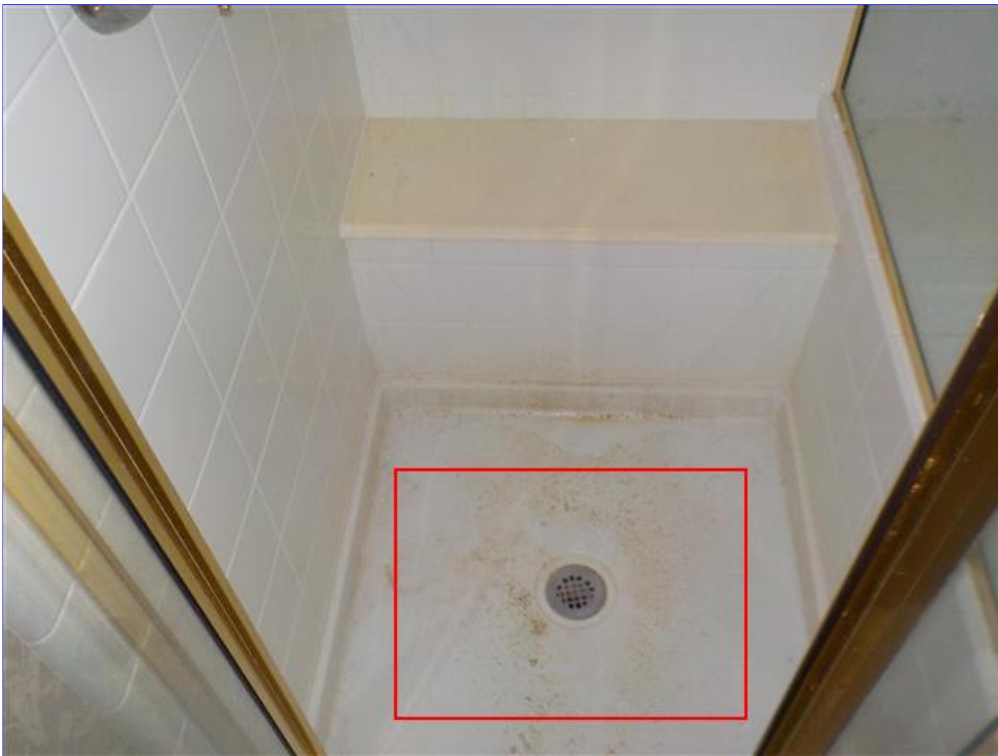
The master bathroom shower has built up tile. I cannot determine if a shower pan or liner has been installed under the tile (not visible). The shower does not appear to be currently leaking.

B. Item 2(Picture) Cannot see if liner properly installed due to fascia

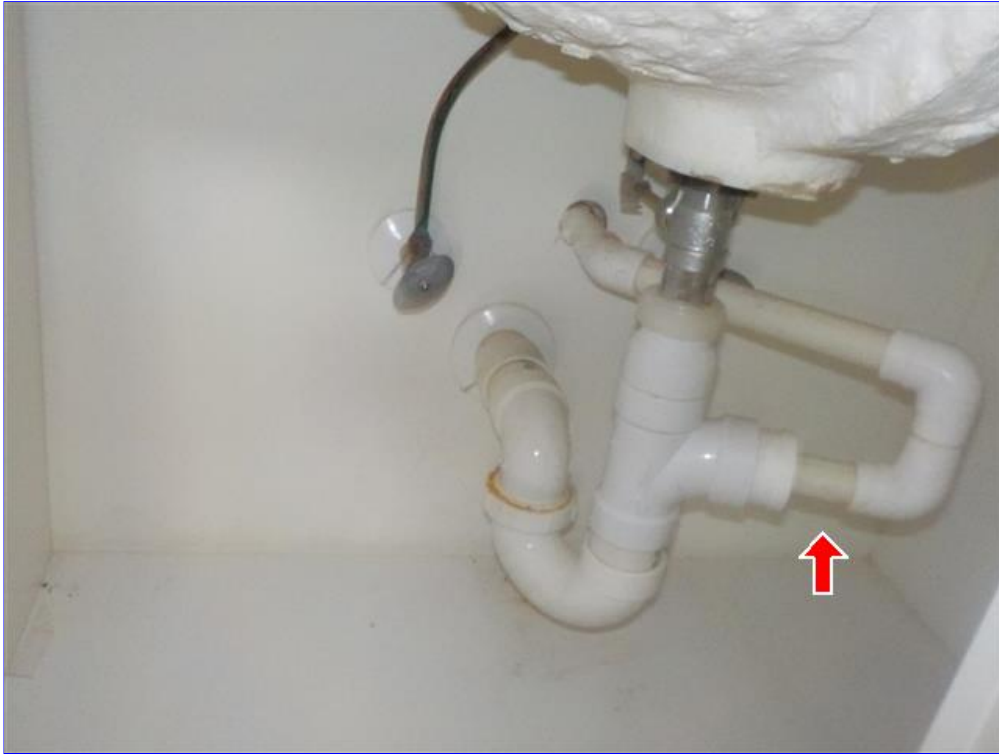
Black hose is the **primary drain** for the AC units one per unit and is found under the bathroom sinks see photos:

B. Item 3(Picture) Primary A/C drain (1/2)

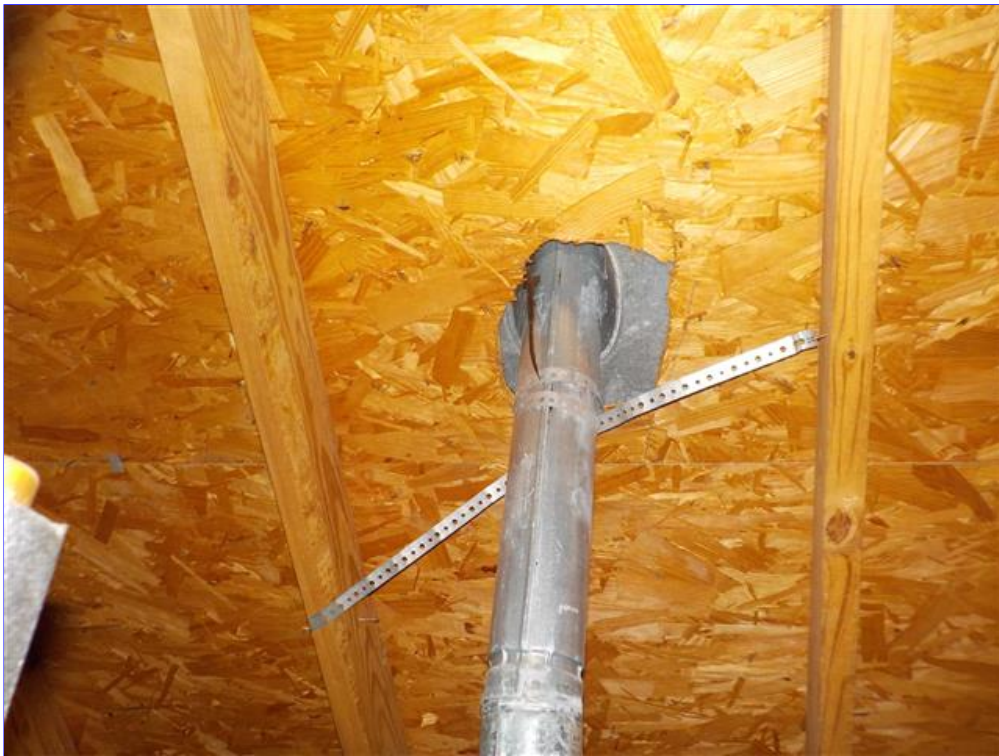
B. Item 4(Picture) Water heater ventilation has enough clearance but not installed correctly

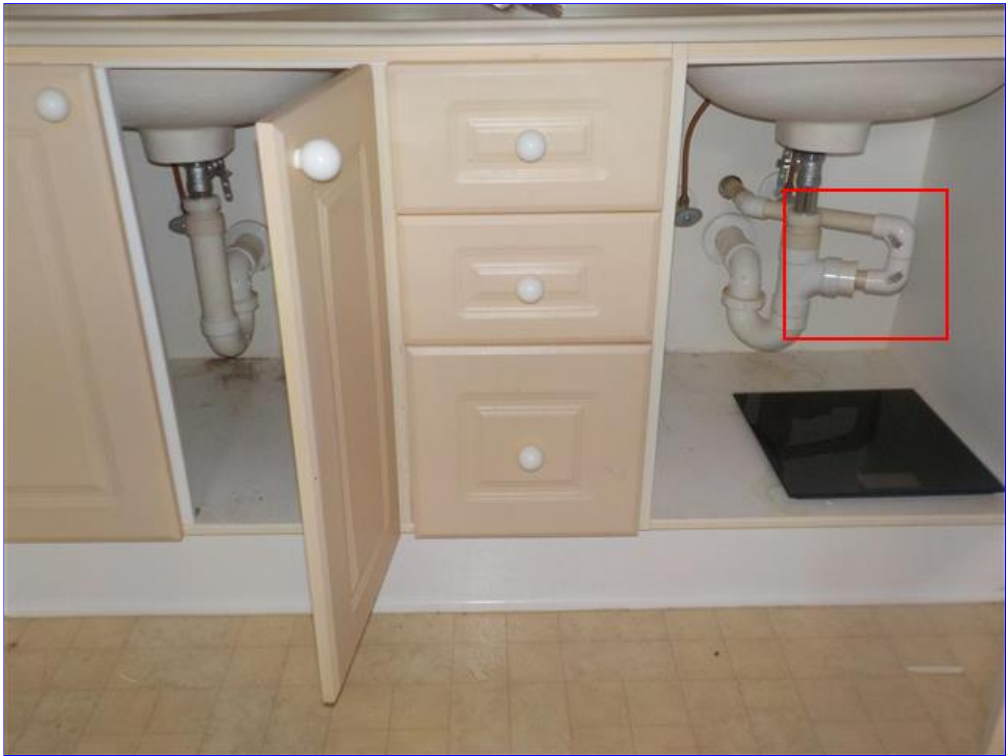
B. Item 5(Picture) Primary A/C drain (2/2)

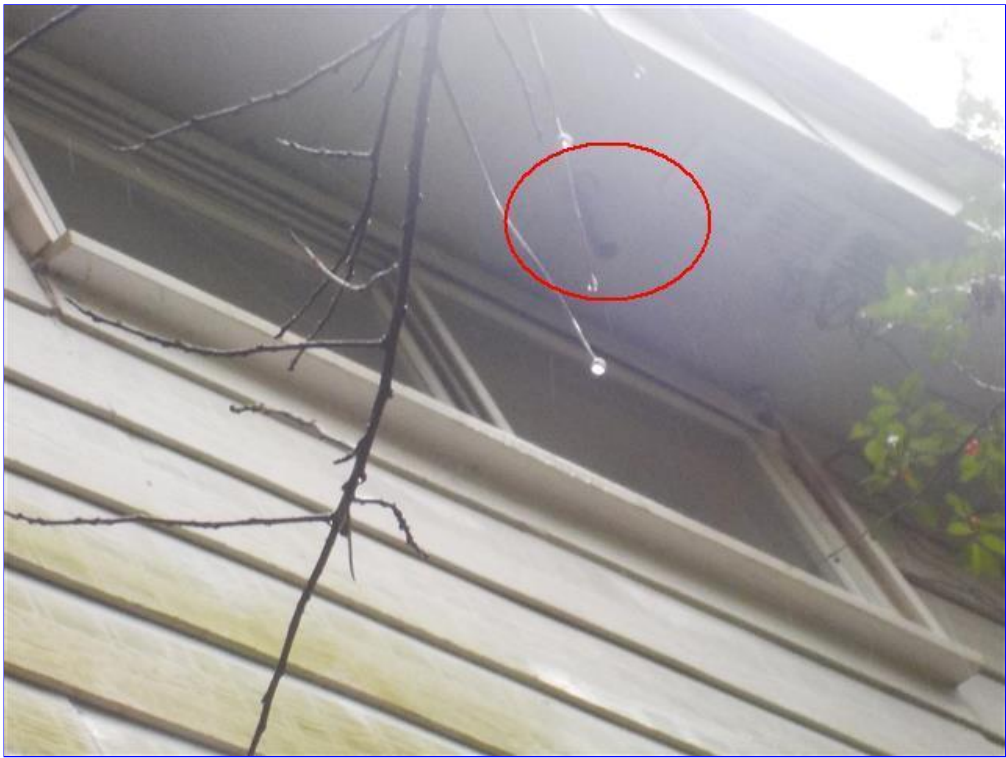
B. Item 6(Picture) Secondary A/C drain

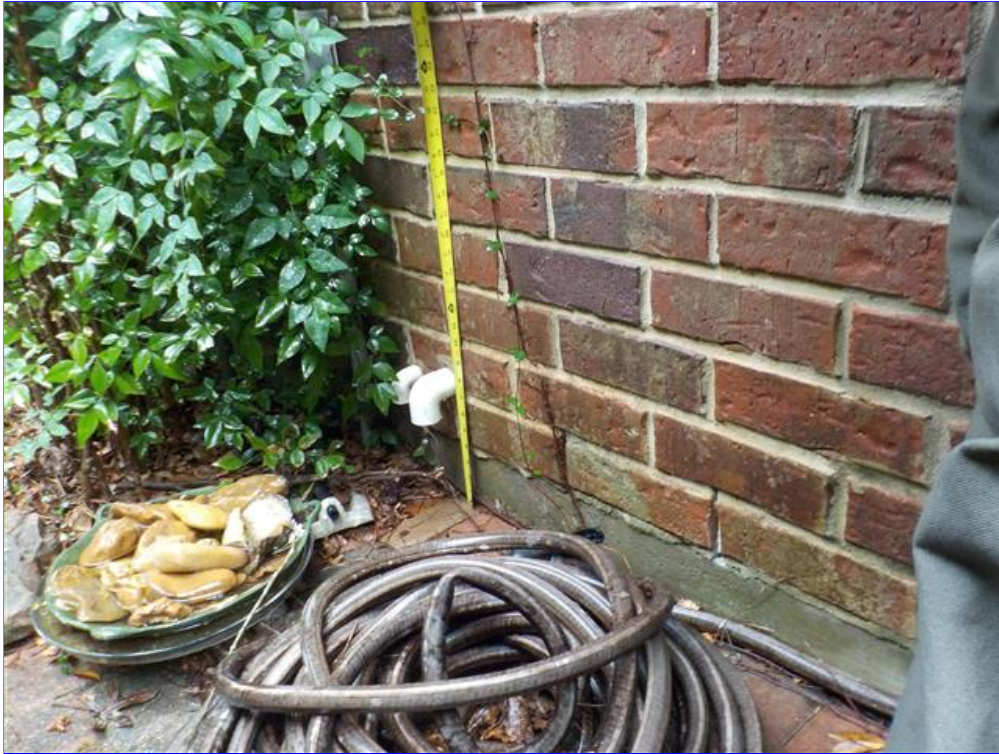
C. Item 1(Picture) Drains for the water heater

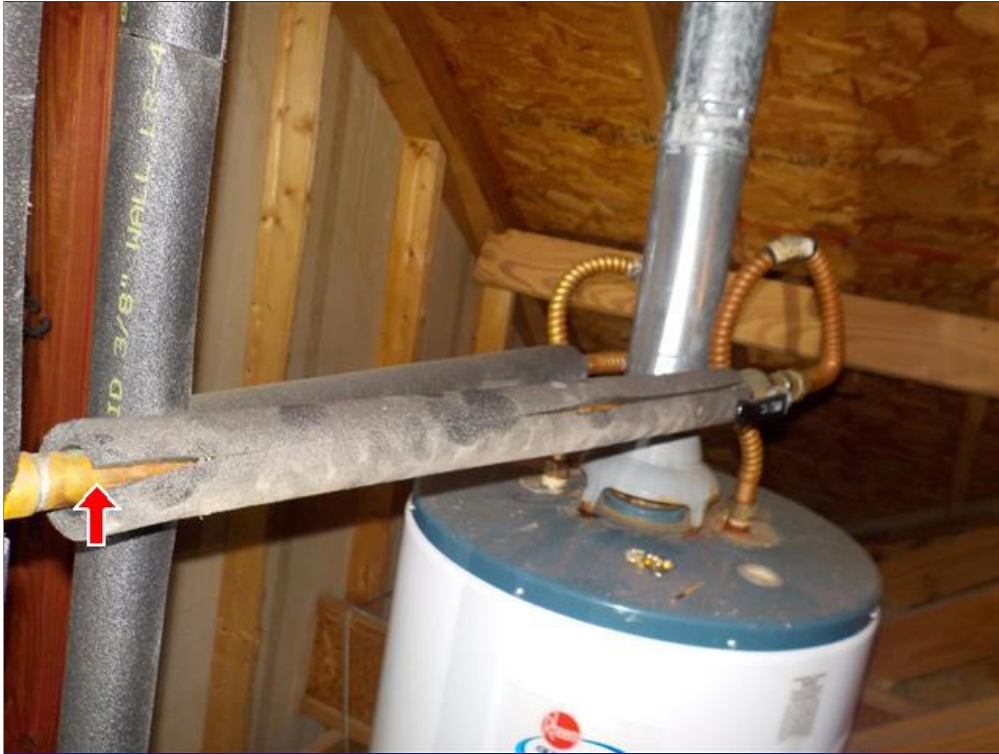
C. Item 3(Picture) copper pipe

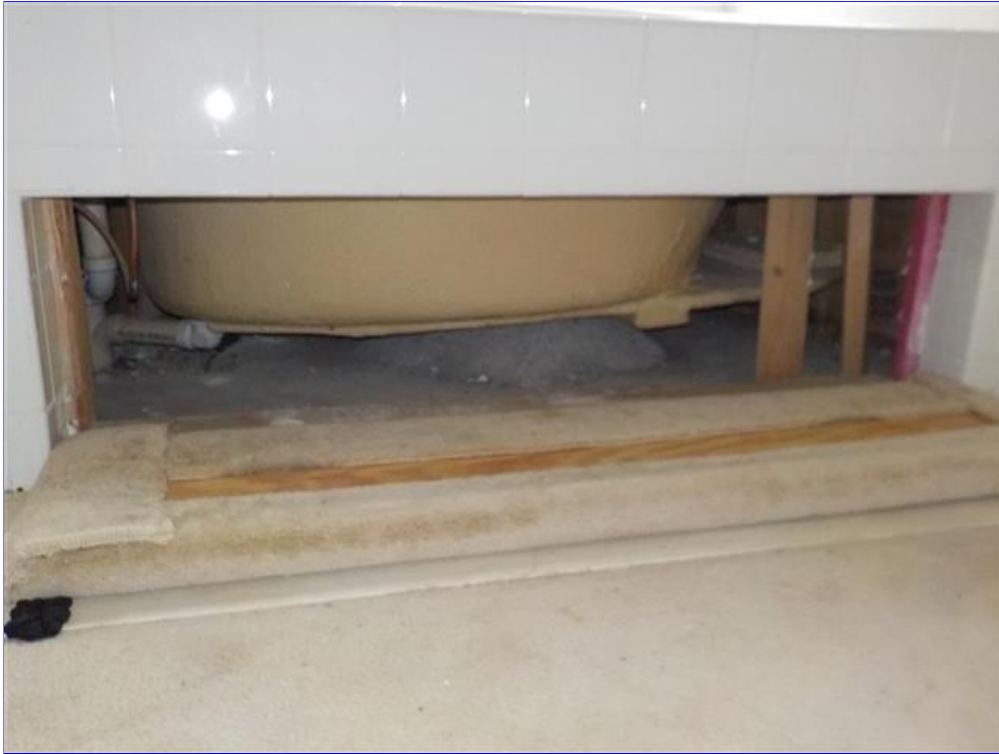
All tubs should have a minimum size access panel of 12" x 12" to review plumbing, slip joints and conditions under tubs as well as inspection for wood destroying insects or like vermin access or rodents and insect, termite or WDI and inspector access .

D. Item 1(Picture) Tub service panel removed

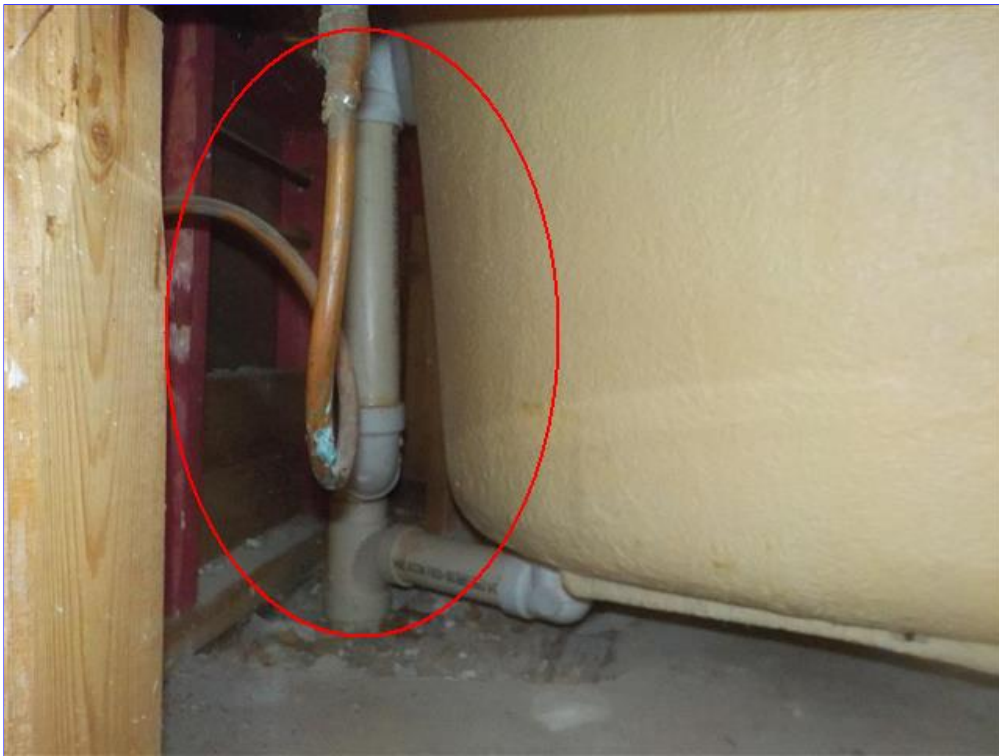
D. Item 2(Picture) Piping for the tub

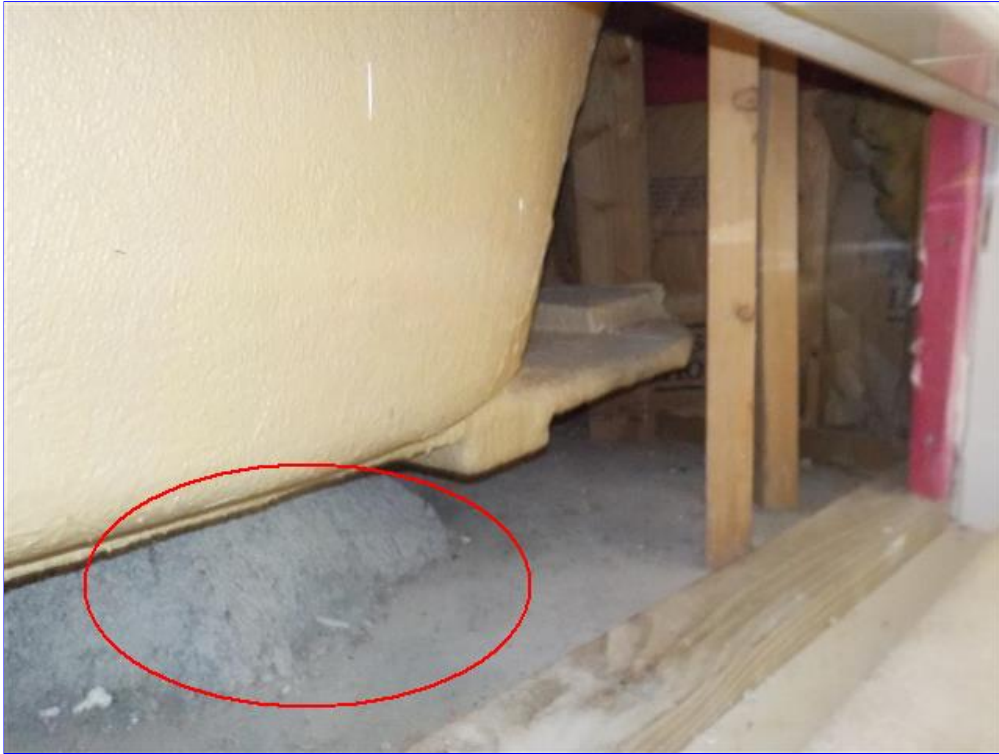
D. Item 3(Picture) Support for the Tub

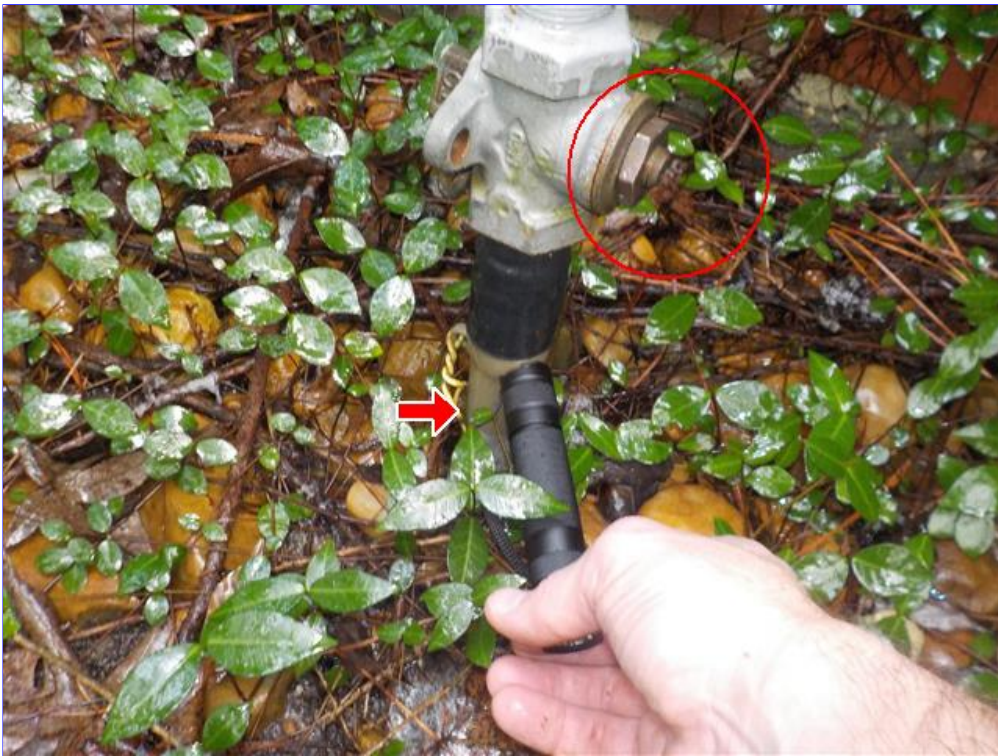
G. Item 2(Picture) Gas supply

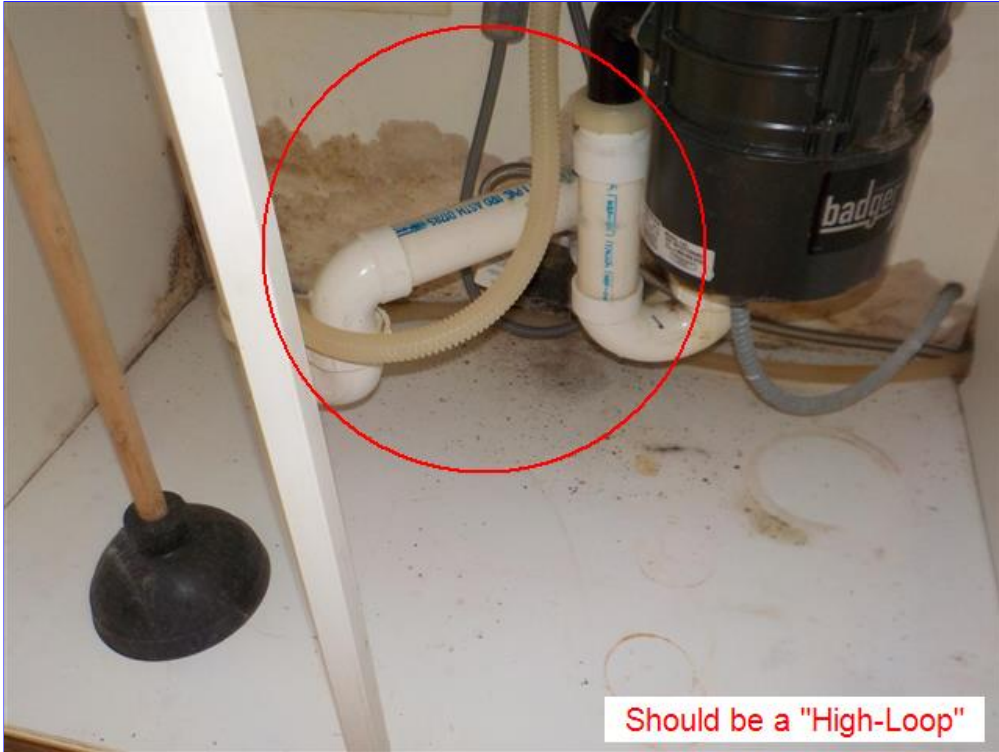
The drain line should be in a **HIGH LOOP** and also have a **HIGH LOOP** bracket connection and or a anti back flow device on counter to keep water from dishwasher and disposal from draining into potable water. Deficient when disposal is missing and not properly looped and attached.

B. Item 1(Picture) Not properly installed

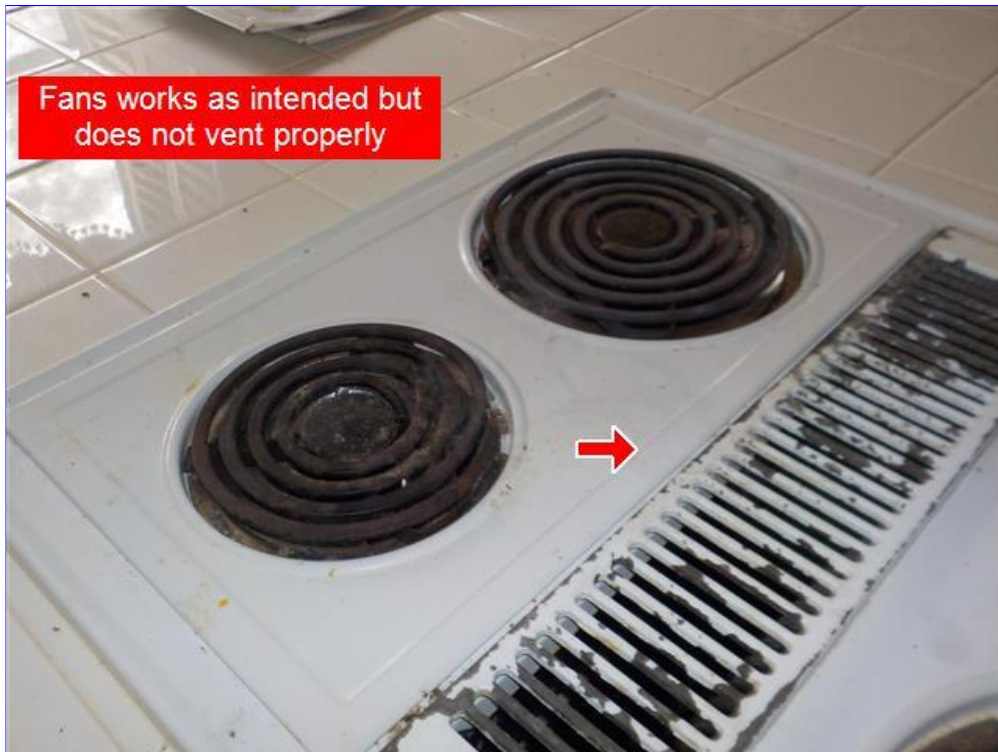
The unit vents directly into the kitchen, should vent to the exterior.

C. Item 1(Picture) Vent is on the range and is operational.

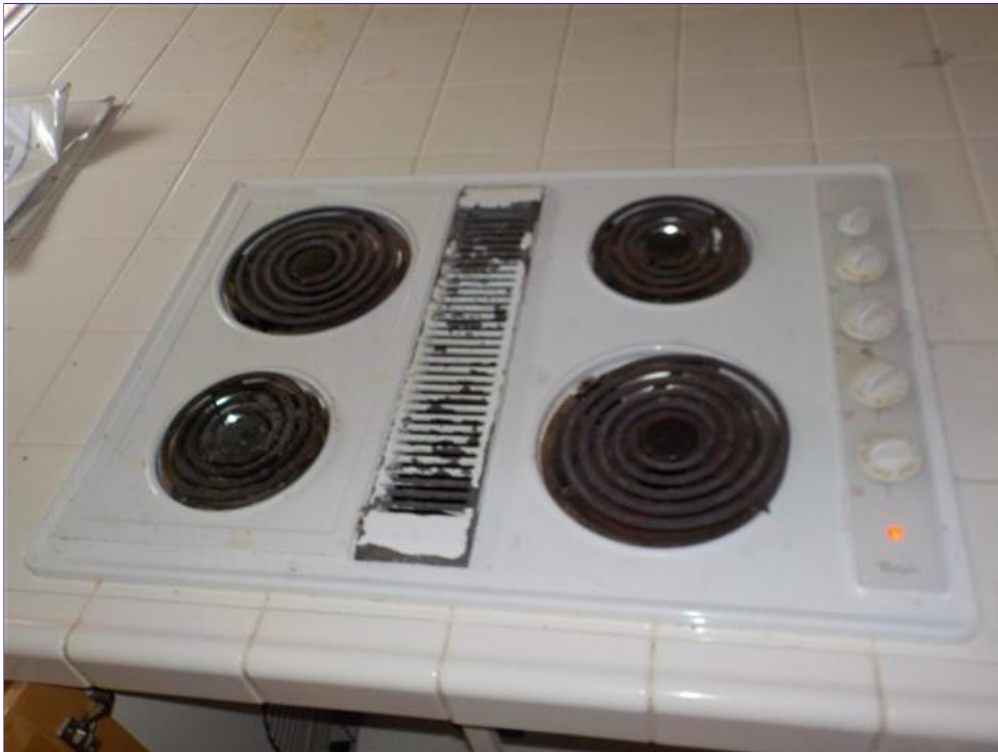
Burners should not cause smoke, this can result in a fire.

D. Item 1(Picture) Recommend replacing burners due to them smoking when ignited

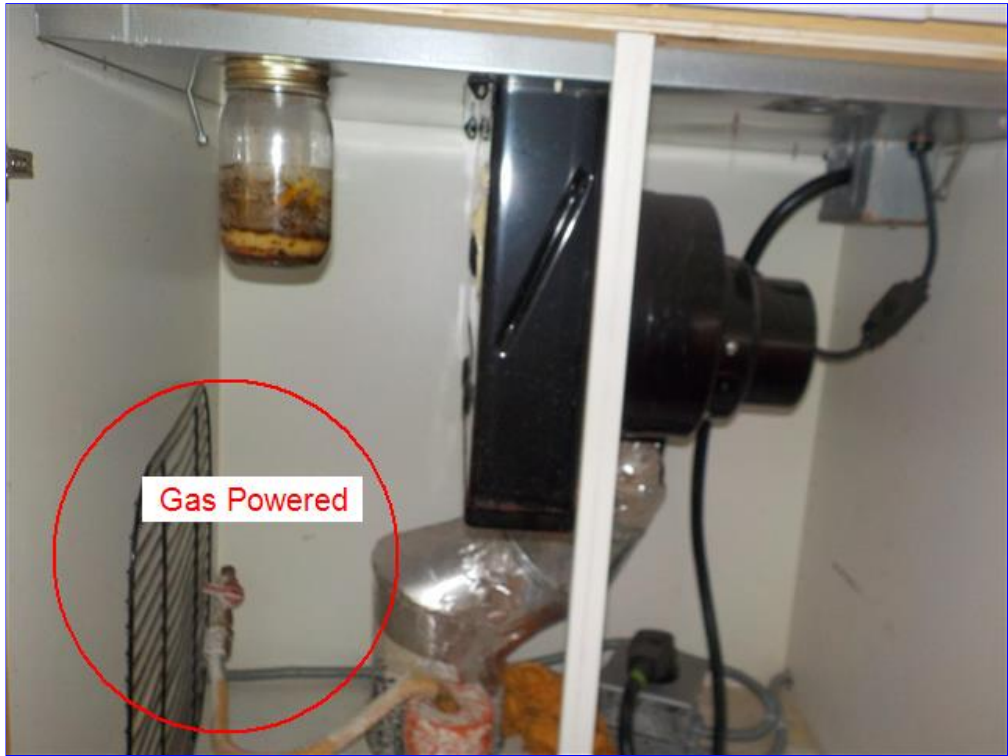
D. Item 3(Picture) Vents to kitchen

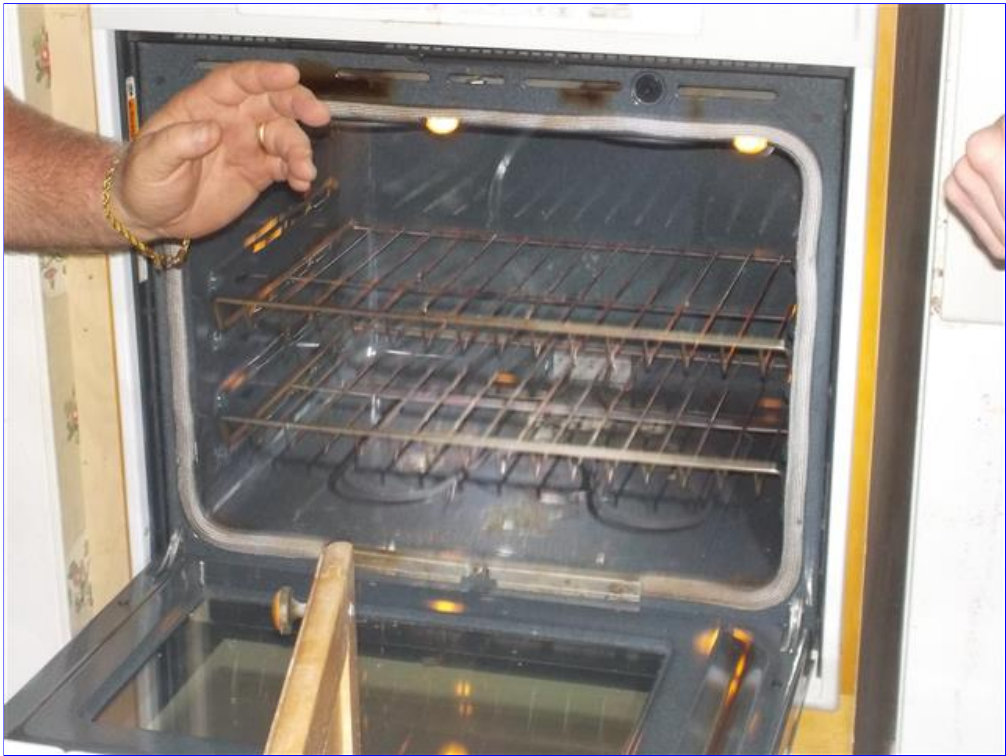
E. Item 1(Picture) Oven was inspected for functionality
