Inspection Report

Property Address:
26 South Bethany Bend
Woodlands Texas 77382

PROPERTY INSPECTION REPORT

Concerning: 26 South Bethany Bend, Woodlands, Texas 77382

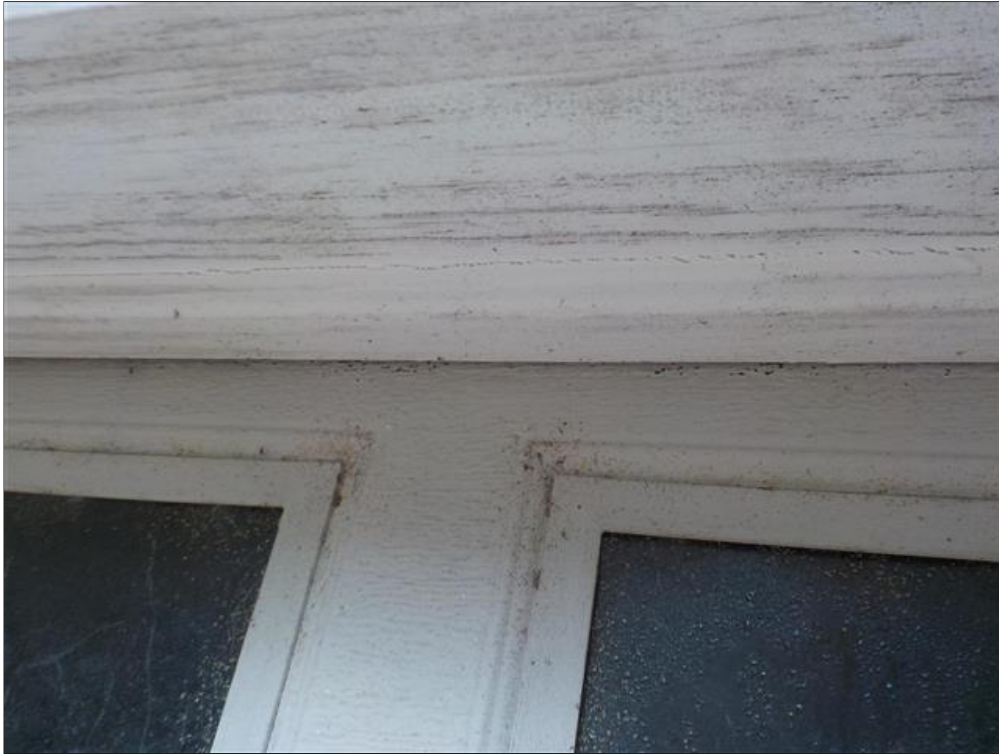
H. Item 1(Picture) Rotting is evident on areas of the structure

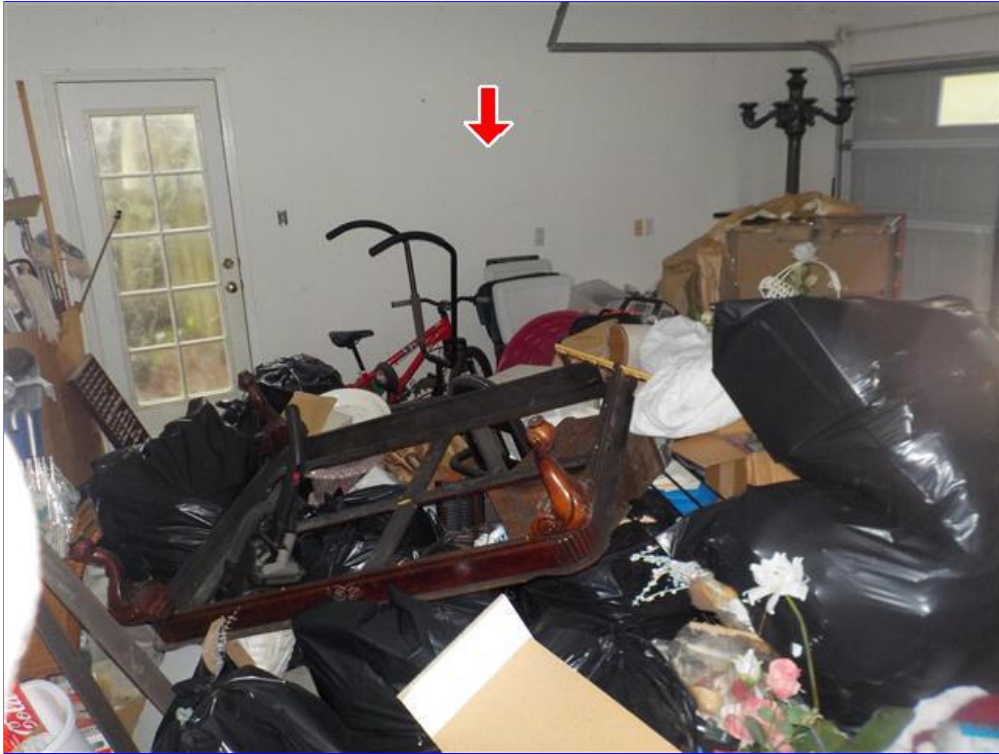
H. Item 3(Picture) Debris made it difficult for us to completely evaluate the garage floor

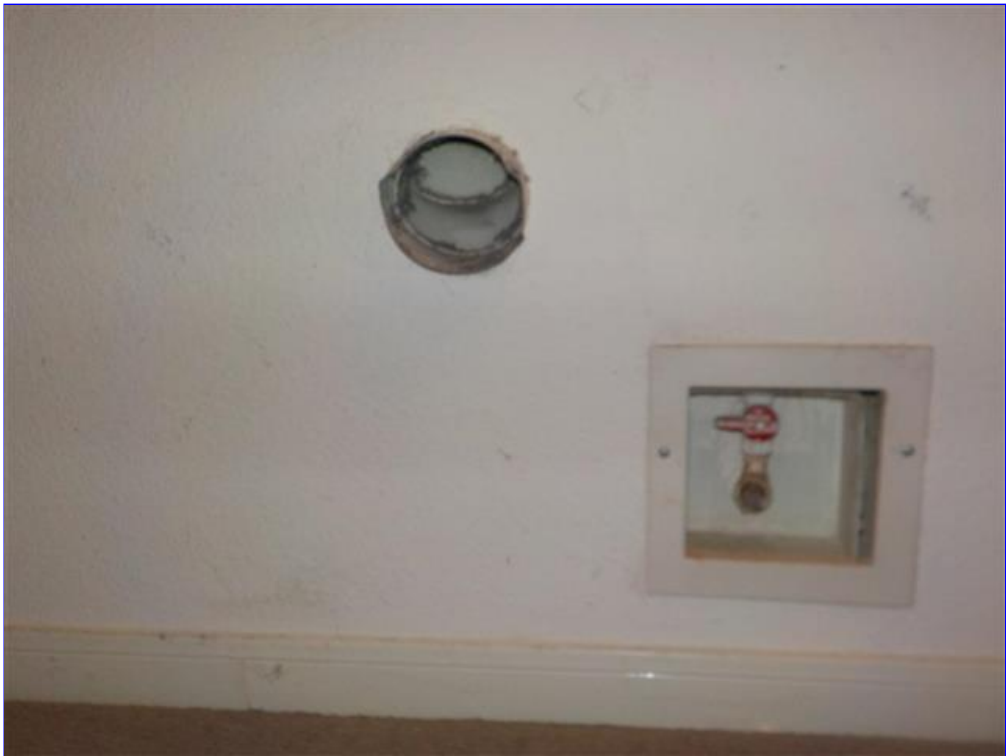
I. Item 1(Picture) Dryer exhaust pipe

Make sure a dryer vent does not have any screws in pipe and that it vents at least 3 feet away from any window or doors and never into attic area.

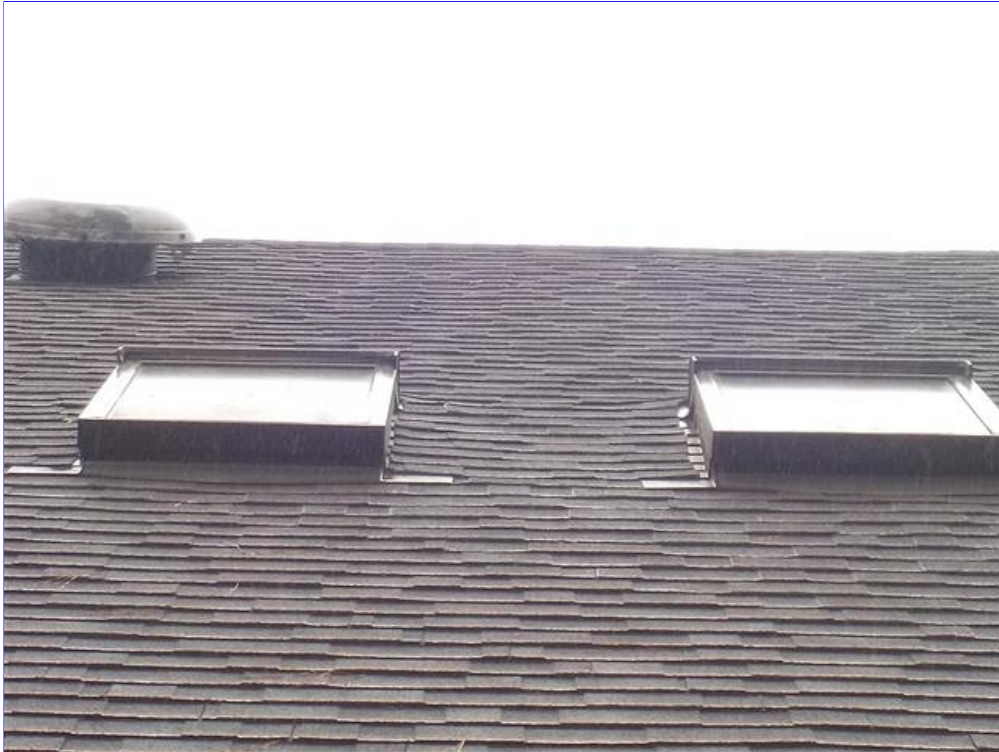
J. Item 1(Picture) Dirty skylights recommend replacing the glass or possibly cleaning
