McCoy & McCoy Home Inspections PLLC

PROPERTY INSPECTION REPORT

Concerning: 6702 & 6704 W. Fuqua St, Houston, TX
(Address or Other Identification of Inspected Property)

By: Thomas A McCoy, Lic #21821 09/14/2019
(Name and License Number of Inspector) (Date)

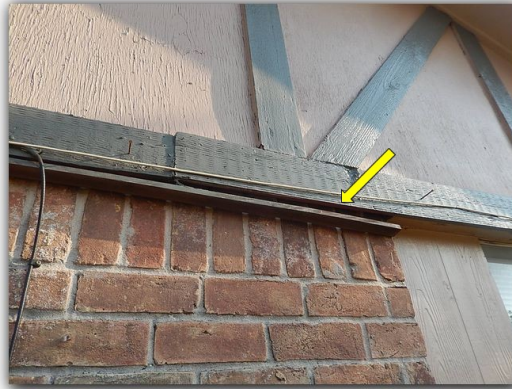
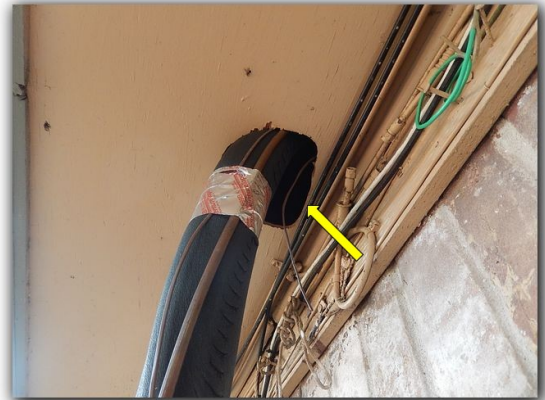
All exterior wall penetrations and exposed openings should be sealed to help prevent water or pests from entering the wall cavity.

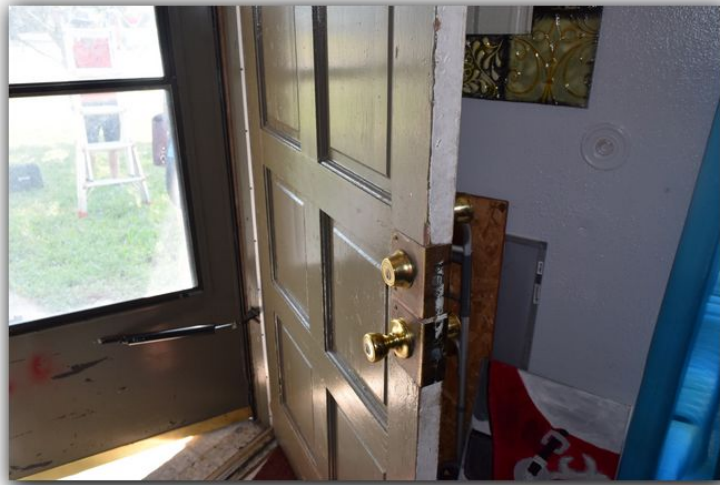
Multiple doors in both unit 6702 & 6704 were out of square or binding consistent with structural movement.

Front door of unit 6704 difficult to latch.

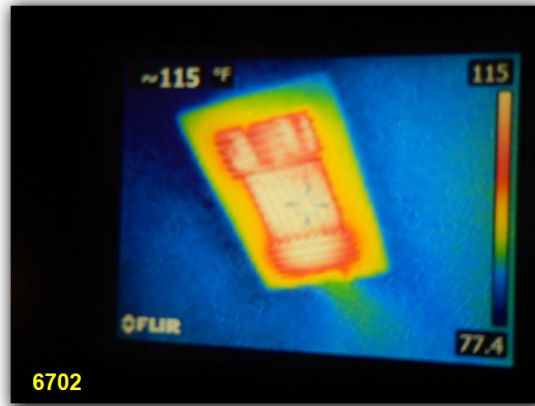
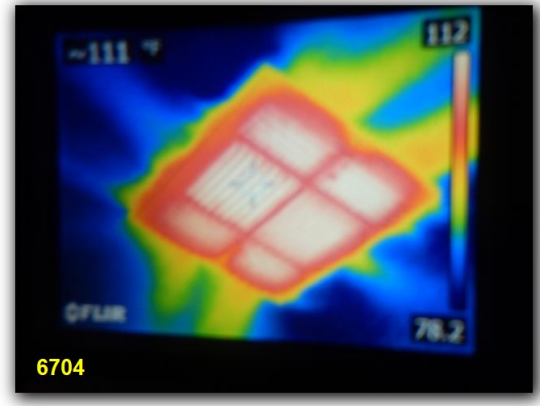
Recommend the heating and cooling systems be serviced by a licensed HVAC technicians prior to each heating and cooling season. The inspector has limited visual access to the HVAC system only a licensed HVAC technician is permitted to review the interior parts of the HVAC system for a complete inspection.

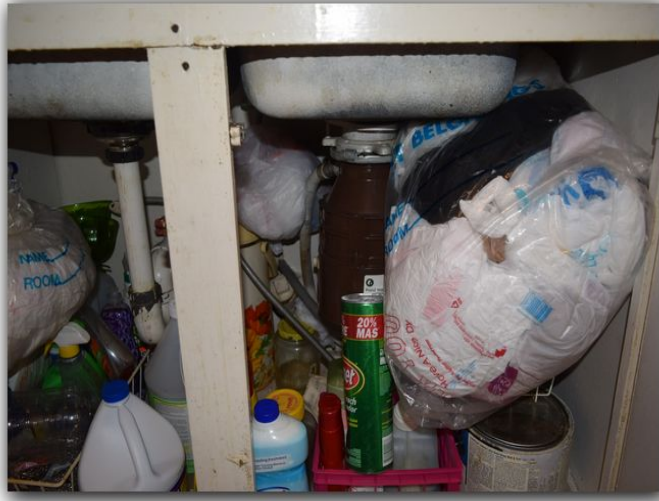
Units 6704: Food waste disposal unit would not operate at the time of the inspection.
