PROPERTY INSPECTION REPORT

Concerning: 6734 and 6736 W Fuqua Drive, Houston, Texas 77489

By: Harold K. Randle License # 10237

September 28, 2019

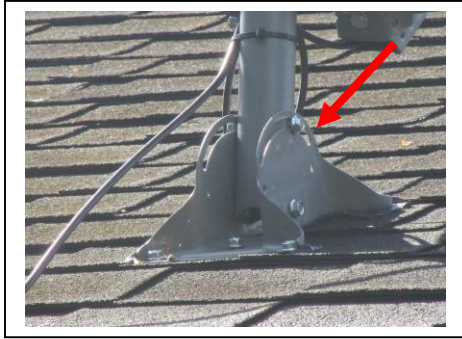
Satellite Dish Installed On Roof

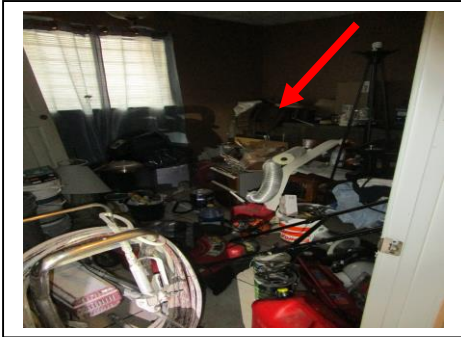
Stored Items At Bedroom

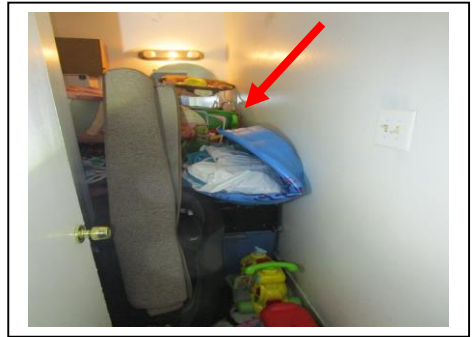
Stored Items At Bathroom

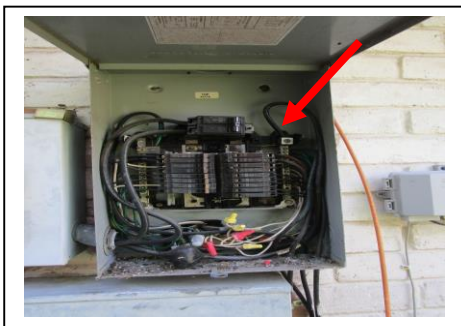
Electrical Service Panel

7. Wires inside panel are connected with wire nuts. Wires entering panel should connect directly to breakers or bus bar when possible.

Recommend having licensed electrician further evaluate any item listed above and make appropriate repairs.

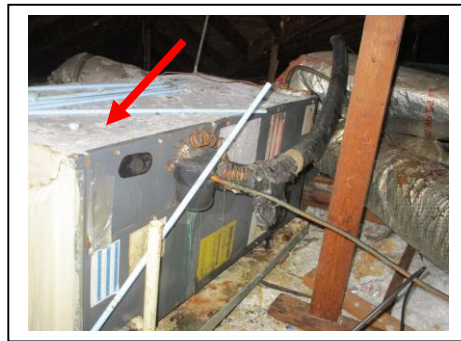
Furnace

1. Unit 6734 furnace operated as intended.
2. Unit 6736 attic was not accessible and furnace was not inspected.
3. Unit 6736 furnace did not provide adequate heat at time of inspection.

Recommend having licensed heating and air conditioning specialist further evaluate heating and air conditioning system.

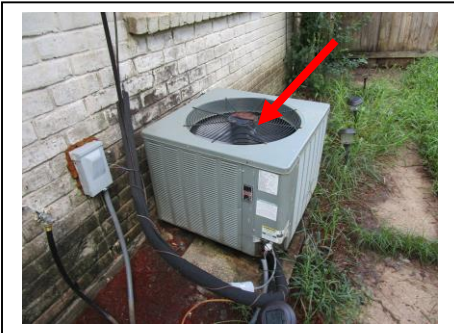
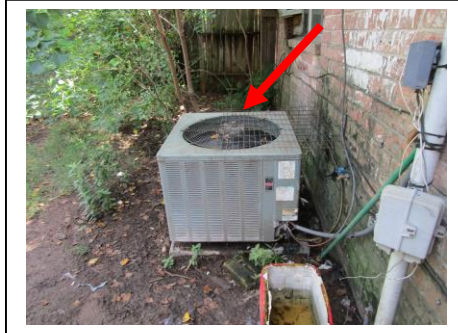
Exterior Condensing Unit

- 1. Ambient air test was performed by using laser thermometer readings to determine if the difference in temperatures of the supply and return air are between 14°F and 22°F which would indicate that the unit is cooling as intended.
The temperature on the system(s) read:
Unit 6734: Supply (66°F); Return (75°F); Difference = 9°F
Unit 6736: Supply (67°F); Return (79°F); Difference = 12°F
The above difference indicates system is **not** cooling as intended.**
- 2. Exterior refrigerant piping is not insulated properly.**
- 3. Refrigerant piping should be sealed properly where it enters property through exterior wall to prevent rodents and/or pests from entering property.**

Recommend having licensed heating and air conditioning specialist further evaluate air conditioning system.
