***BE Inspected LLC***  
**Property Inspection Report**

1122c W 22nd St, Houston, TX 77008  
Inspection prepared for: Fernando Blanco  
Date of Inspection: 9/10/2019 Time: 9:00  
Age of Home: 2018  
Weather: Hot and Clear

New Construction. Directional statements are from the perspective of standing at the front door looking in.

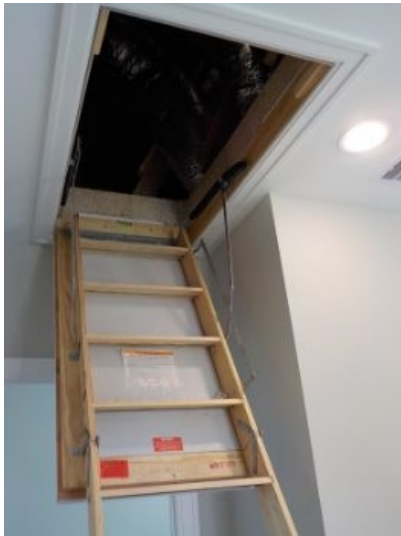
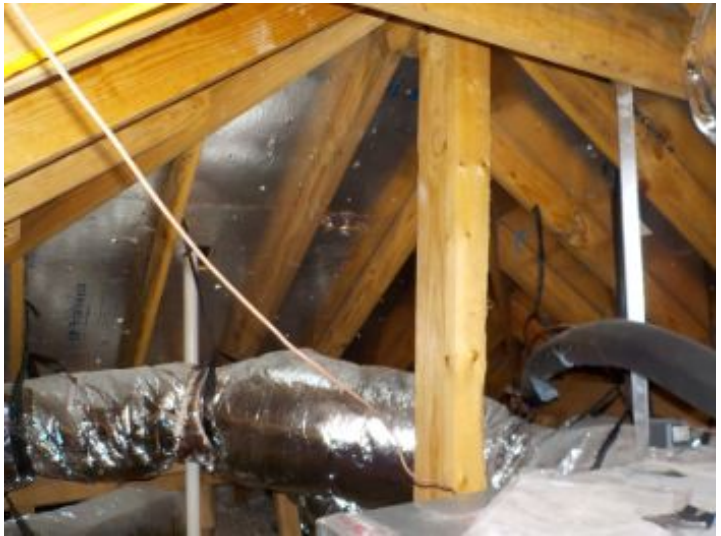
• Access door was not seating properly in the closed position.

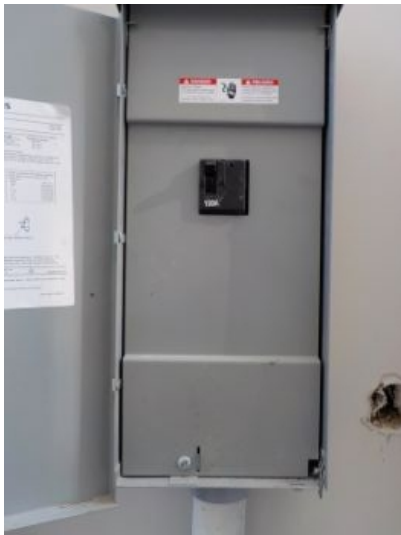
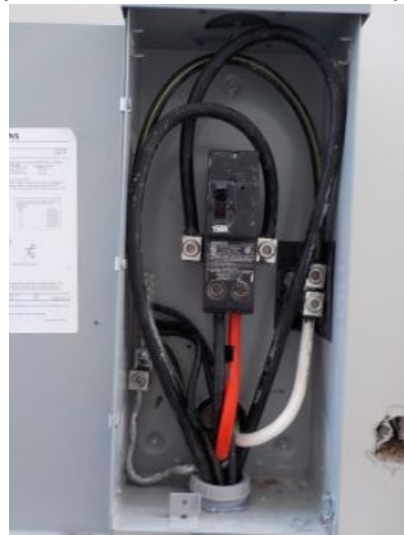
AFCI breakers may not have been completely installed. There was a 20 amp breaker labeled for small appliances that was not AFCI protected.

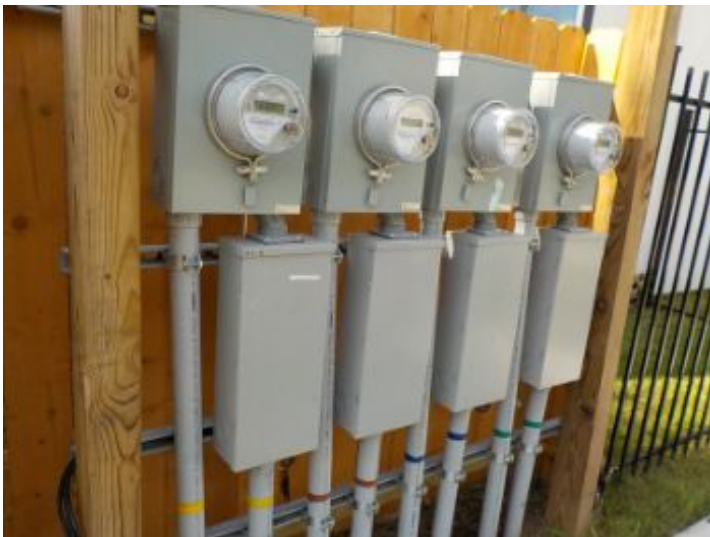
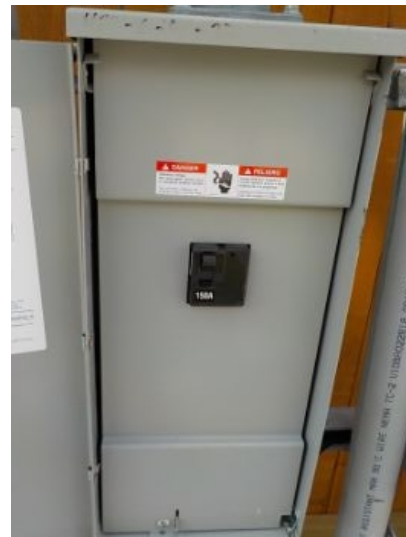
The dead front cover was not properly flushed with the panel enclosure. The panel enclosure appeared to be recessed well behind the drywall creating a gap between the enclosure and dead front cover.

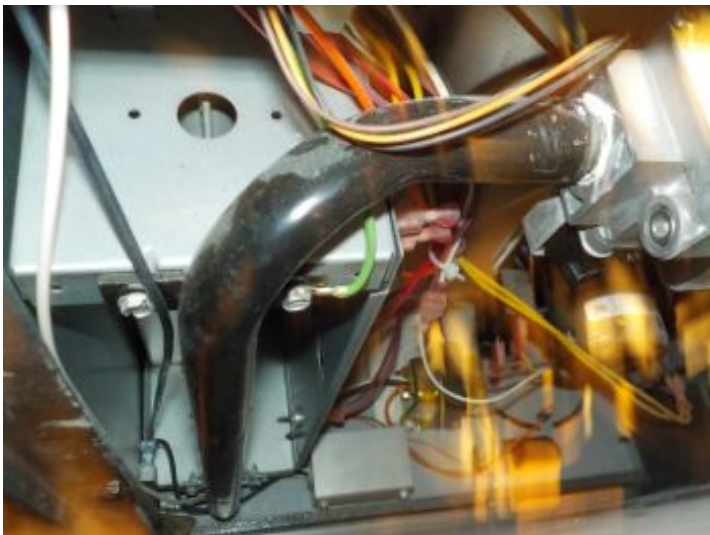
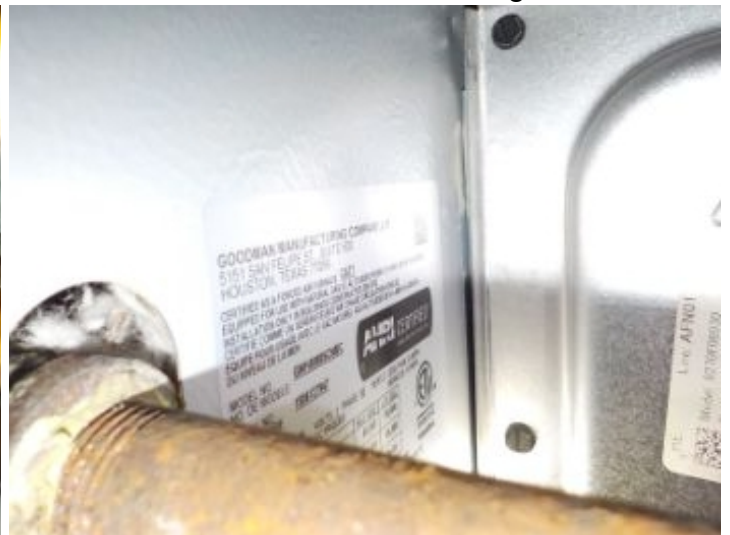
Furnace access door was missing a fastener.
