NationSpec Home Inspection

7027 Brockington Dr, Katy, TX 77494

PROPERTY INSPECTION REPORT

Concerning: 7027 Brockington Dr, Katy TX, 77494
 (Address or Other Identification of Inspected Property)

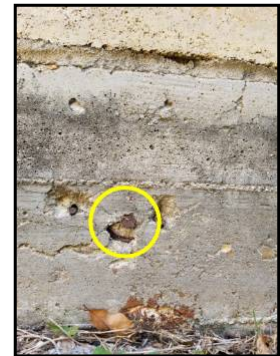
Left side, exposed cable end should be sealed

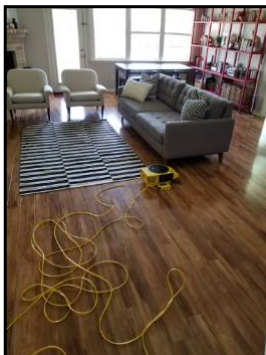
Zip level placed approximately center of house

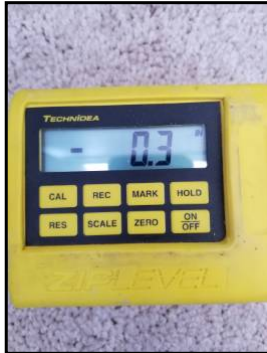
South wall (Lt middle bedroom window), -0.3

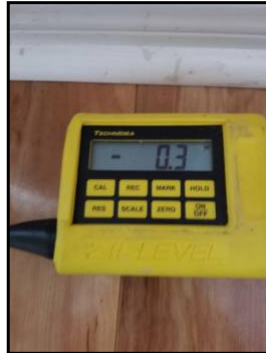
West wall (rear door), -0.3

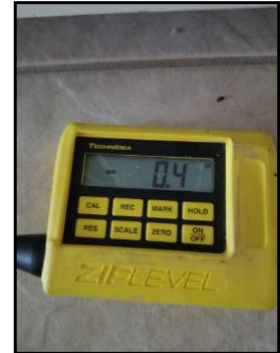
North wall (between master bathroom sinks), -0.4

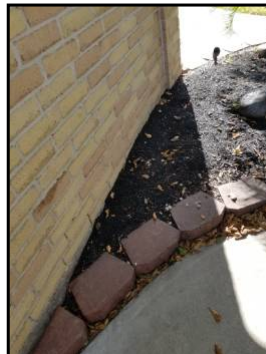
Front, grading is too high/partially covering weep holes

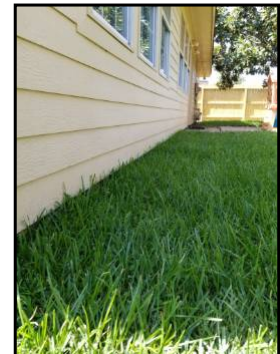
Rear, grading is too high

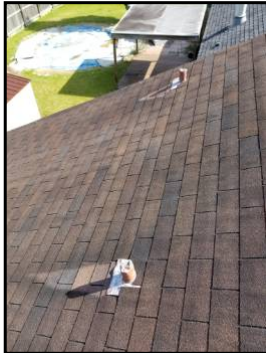
Vents should be painted, vent stacks are less than 6"

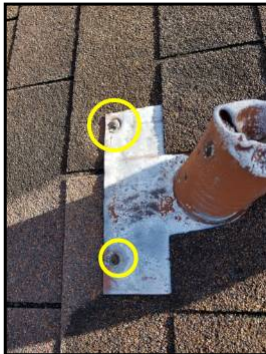
Rear, exposed nails needs sealant

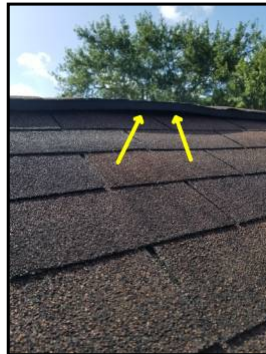
Top ridge vent is lifting and should be re-secured

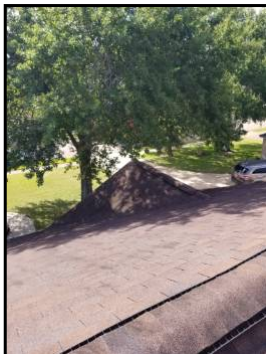
Front, tree branches should be cut far back from roofing material

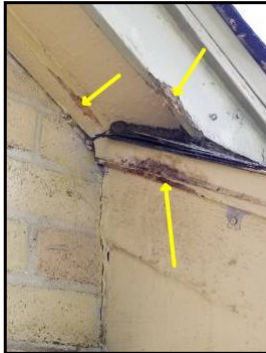
Front, soffit/fascia boards are slightly deteriorated

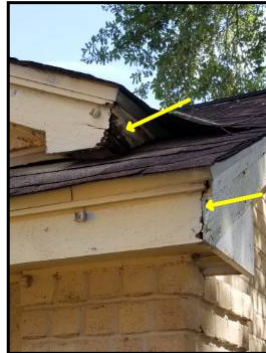
Left side, fascia board deterioration needs repair

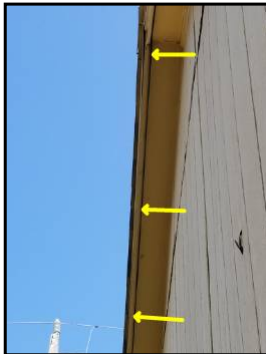
Left side, gap between fascia board and soffit, needs to be re-secured and/or sealed

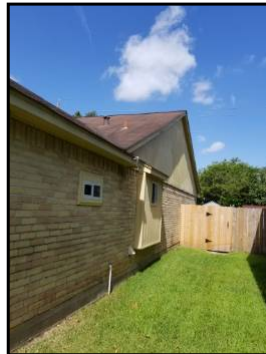
No soffit(except rear) and/or gable vents observed around structure

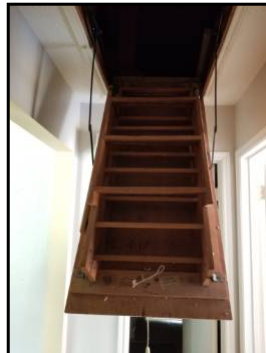
Attic ladder is not insulated and/or weatherstripped

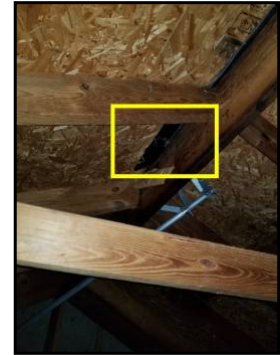
Hole in roof decking shingled over

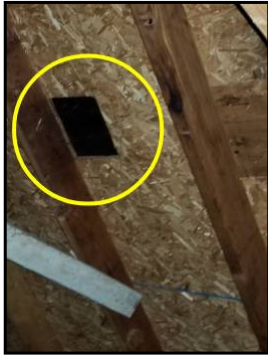
Hole in roof decking, shingled over

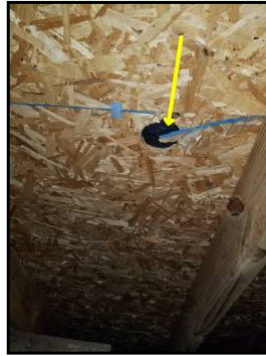
Hole in roof decking, shingled over

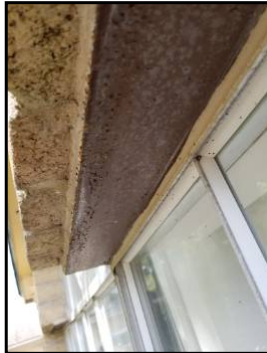
Front, recommend painting lintels

E.4. The steel lintels above the exterior doors and windows should be painted to prohibit corrosion

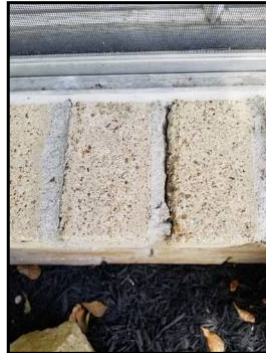
Front, window sill needs mortar pointing

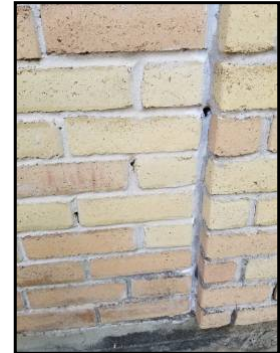
Left side, needs mortar pointing

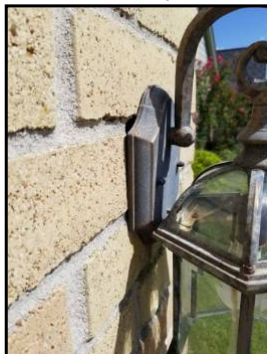
Front, light fixtures should be caulked

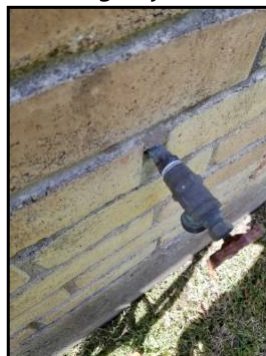
Right side, needs caulk

E.1. Elastomeric caulking improvements are recommended between the exterior veneer and the window frames. See photos.

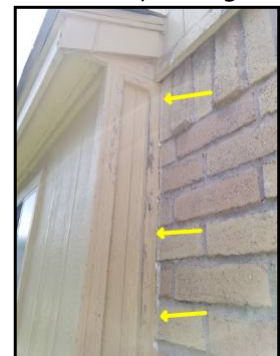
Right side, needs caulk improvements

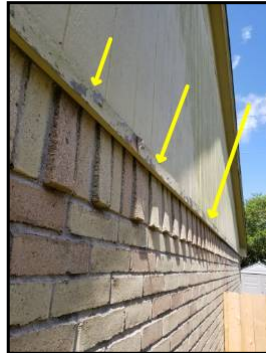
Right side, bottom trim board paint peeling

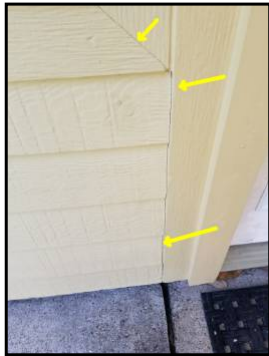
Rear, needs caulk

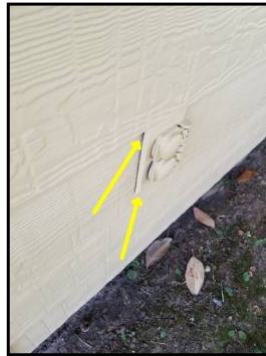
Rear, needs caulk

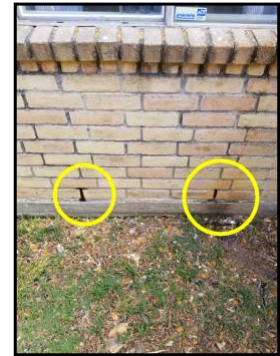
E.5. There were no weepholes observed in the lower course of the masonry veneer in one or more areas of the structure. Under current building standards; there should be open weepholes not less than {3/16"} in diameter on the lower course of the masonry wall and spaced no more than {33"} apart to drain excess water from the interior of the wall voids.

Left side, weep holes are sealed

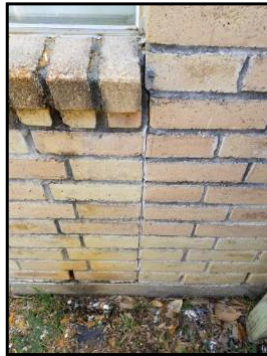
Left side, expansion joint needs caulking improvements

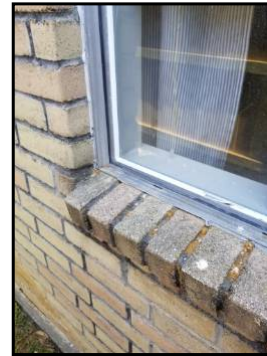
Left side, window needs caulking improvements

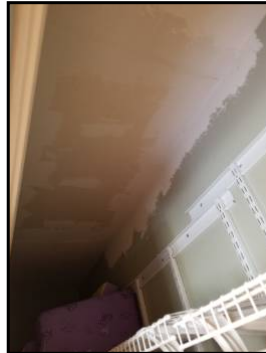
Left side middle bedroom closet, previous ceiling repairs observed

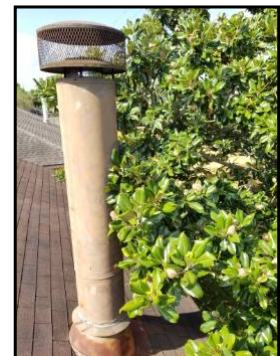
J.1. It was noted that excessive tree branches are in close proximity of the chimney and need to be trimmed to a minimum of {10'} from the chimney opening

Tree branches need to be cut back

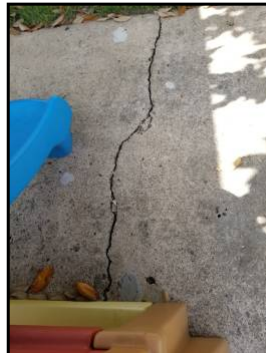
K.3. Cracks were visible in the driveway and rear patio that appear larger than normal settlement cracking and should be monitored

Rear patio, crack

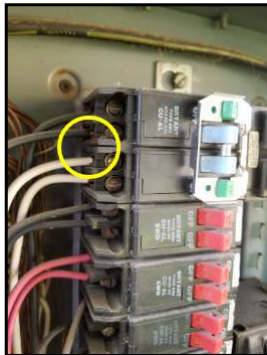
A.9. Undersized wiring for the circuit is considered a Safety Hazard and should be repaired by a licensed electrician

Undersized conductors for a 50 amp breaker. 10AWG

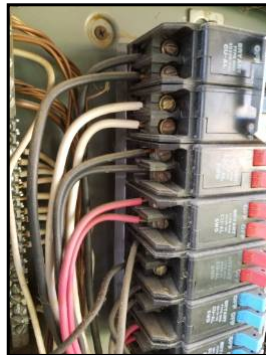
White conductors not marked as hot

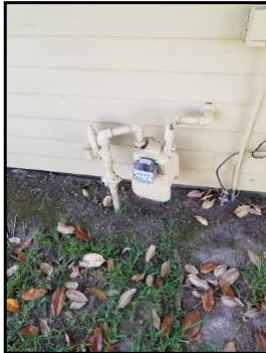
- B.6. Gas meter was not observed to be bonded and/or grounded. Recommend further review by a licensed electrician.
 250.104 Bonding of Piping Systems and Exposed Structural Steel.

Rear, gas meter does not appear to be bonded and/or grounded

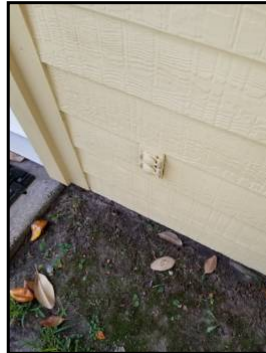
Rear, no bubble cover, receptacle has no power/non-operational

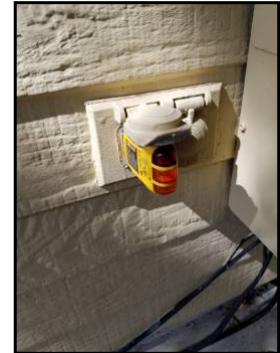
- B.7. This may be an as built condition but is required as of 2004 per the NEC. GFCI protection is required on 15A/20A circuits providing power to kitchens, bathrooms, garages, laundry rooms, exterior receptacles, pools, spas and whirlpool tubs.

Front, no GFCI protection

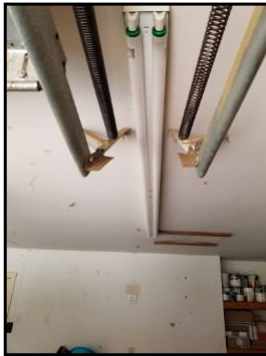
Garage, light is non-operational

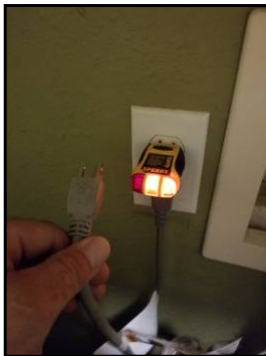
Laundry, no GFCI protection

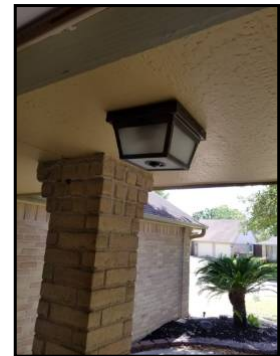
Front door, light is non-operational

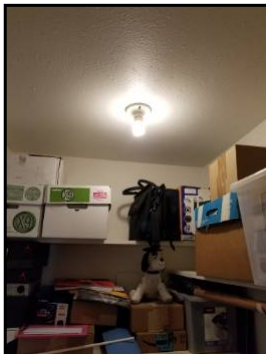
- B.8. Light fixture covers were observed to be missing in one or more locations. Light fixture covers missing in a closet is considered to be a safety/fire hazard. Recommend installing light fixture covers

Front bedroom, closet no cover on light fixture

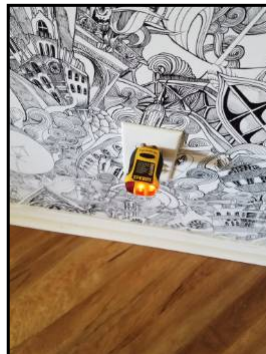
- B.9. Receptacles were observed to be loose in multiple locations. Receptacles should be repaired/re-secured
- B.10. One or more locations were observed to have unknown switch functions. See photos

Living room, loose receptacle

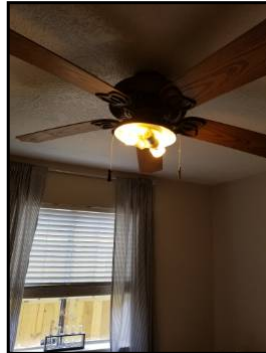
Left middle bedroom, missing light cover

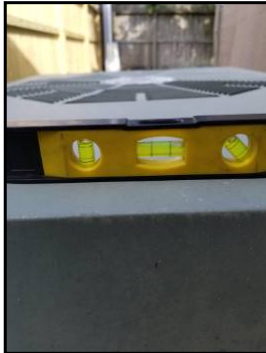
B.1. The outside condenser unit was noted as out-of-level and should be corrected

Condenser is not level

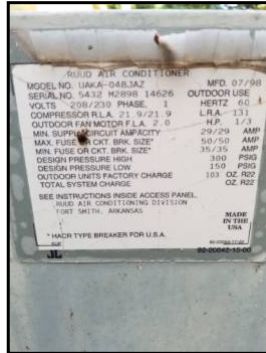
B.8. The system also uses the older style R-22 refrigerant as opposed to the newer R-410A. R-22 refrigerant will not be available after 1/1/2020.

Data plate, manufactured 1998, 4 ton, max 50 amp breaker, R22 refrigerant

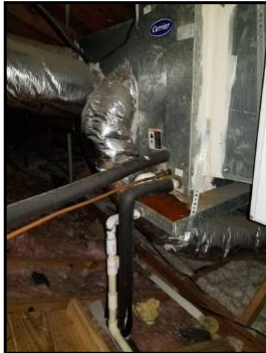
Primary drain, no p-trap, secondary drain from unit, pan(rusted an full of water), secondary drain from pan.

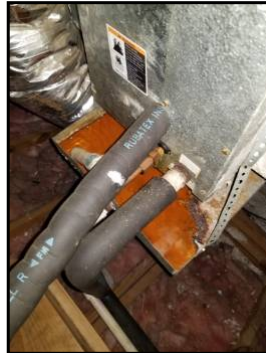
B.4. Rust and/or corrosion was noted in the condensate drip pan

Detail of rusted pan and water observed in pan

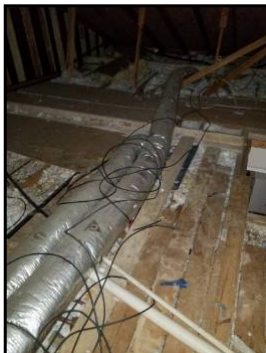
C.1. HVAC ductwork is in contact with each other. Provide air space on all sides of ducts when they run through unconditioned spaces such as attics. Avoid fully or partially covering ducts with insulation or abutting against other ducts. This is more important in humid climates. Moisture can condense on ducts that do not have adequate air flow on all sides. This moisture can damage surrounding material and contribute to fungal growth.

C.2. HVAC ducts need to be lifted off floor in attics on both sides of home at least 4" as per IRC 1601.4.7

Ducts touching and laying on attic floor

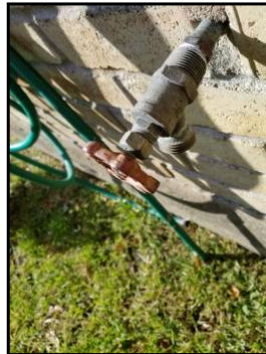
Right side, no backflow preventer

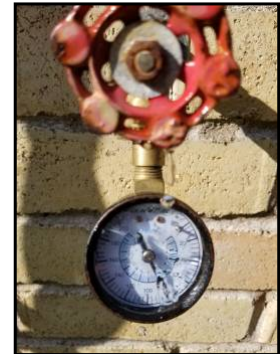
A.2. 82PSI. The anti static water pressure readings are typically at {40-80 psi} in the normal operating range. Pressure exceeding these limits or higher than {80 psi} is likely to put excessive pressure on the household water system. It is recommended that a licensed plumber and/or the city water department further evaluate in the event a pressure reducing valve is required for safety concerns.

Static water pressure, 82PSI

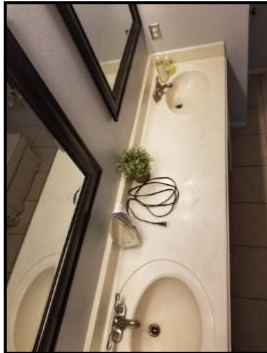
Master bathroom sinks, stoppers are missing and/or non-operational

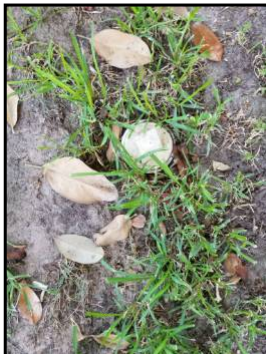
B.1. The exterior main cleanout was located at the rear of the structure

Rear, main waste cleanout

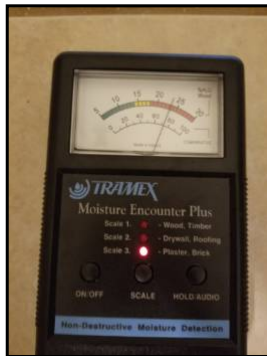
Hallway bathroom control, 23%

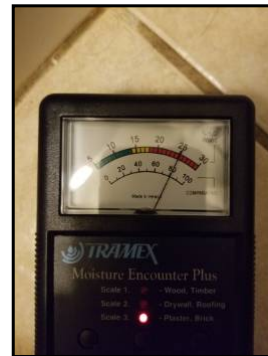
B.2. Subsurface moisture readings were observed to be high in the hall bath and master bathroom as the bathtub was draining. This could potentially be caused by a variety of influences including but not limited to high retained mc at the material, over watering of the grounds or possibly a subsurface leak. Recommend further review by a licensed plumber.

Hallway bathroom tub, 25%

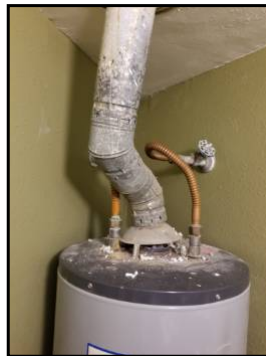
Cold water valve, supply lines, vent hood, exhaust vent

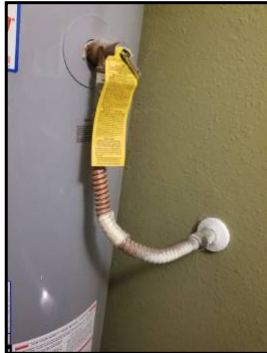
TPR valve and drain line

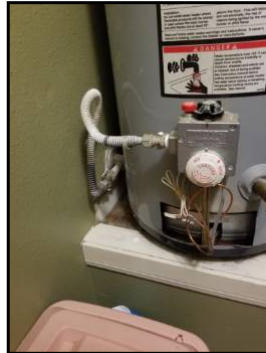
C.1. It was noted that the water heater was not equipped with a corrosion resistant drain pan to discharge on the exterior

C.3. Missing sediment trap. IRC G2419.4 (408.4) Sediment trap. Where a sediment trap is not incorporated as part of the appliance, a sediment trap shall be installed downstream of the appliance shutoff valve as close to the inlet of the appliance as practical. The sediment trap shall be either a tee fitting having a capped nipple of any length other device approved as an effective sediment trap.

C.4. Missing lower cover at the time of inspection

Gas valve, no sediment trap, heat control, missing lower cover, no pan and drain line to the exterior

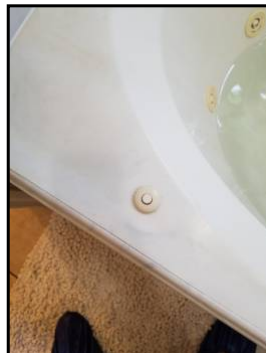
D.3. The on/off button was not functioning properly

On/off button not functioning properly, have to hold button down to operate

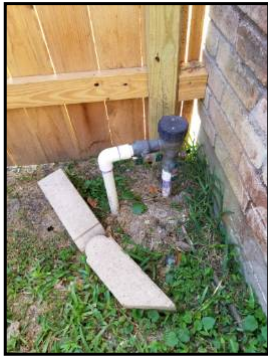
Right side, high loop and main irrigation valves

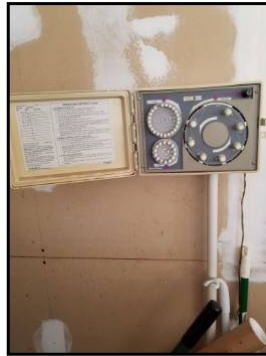
Garage, Rain-bird old style dial controller

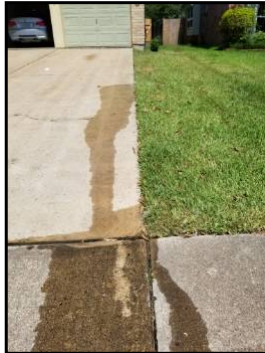
A.1. One or more of the sprinkler heads were either damaged, missing, and/or PVC pipes were damaged/leaking

Zone 5, broken sprinkler heads

A.3. The sprinkler system requires further evaluation by a licensed irrigation contractor

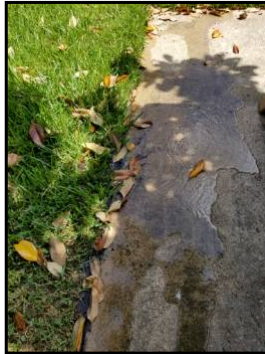
Zone 6, broken sprinkler head and/or underground pipe
