PROPERTY INSPECTION REPORT

Prepared For: DENNIS & CATHY ORLANDO
(Name of Client)

Concerning: 15018 RIVERLET CT., CYPRESS, TX 77429
(Address or Other Identification of Inspected Property)

By: Stephen Perry, Lic #7854 05/12/2017
(Name and License Number of Inspector) (Date)

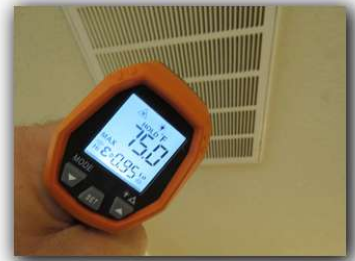
Unit #1:
 Supply Air Temp: 57 °F Return Air Temp: 75 °F Temp. Differential: 18 °F

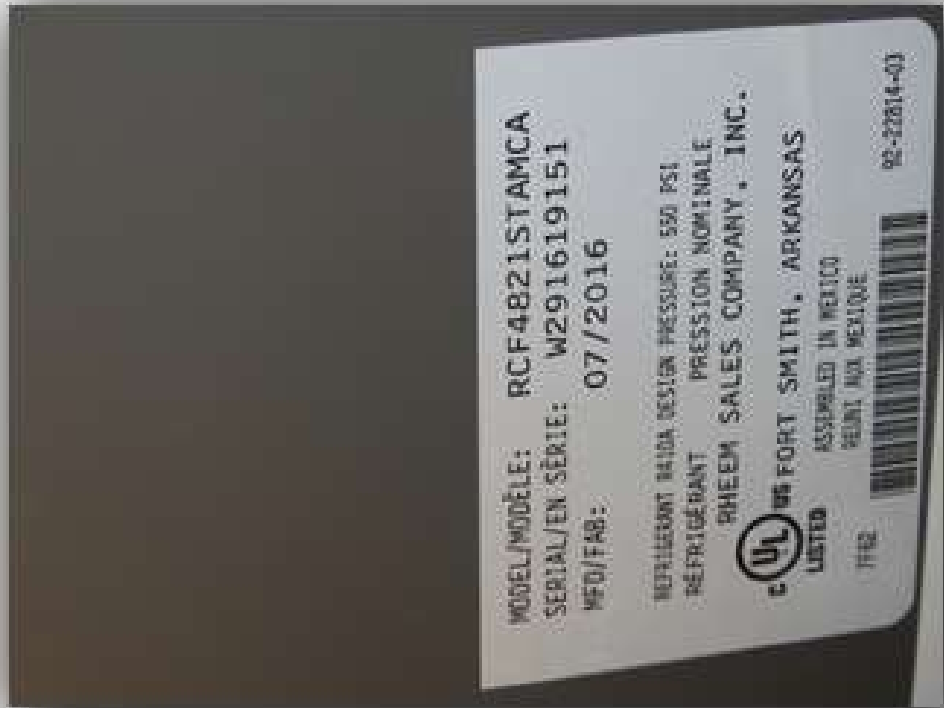
THE AIR CONDENSER IS A "RHEEM" 2 1/2-TON FOR THE UPSTAIRS AND 4-TON UNIT FOR THE DOWNSTAIRS; MANUFACTURED IN 2016. (1 YEARS OLD).
