PROPERTY INSPECTION REPORT

Concerning: 19103 Putting Green Dr, humble, TX 77346
(Address or Other Identification of Inspected Property)

By: James Lee, Lic #23485 05/24/2019
(Name and License Number of Inspector) (Date)

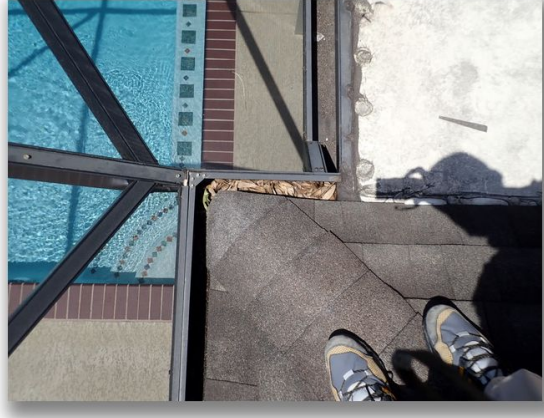
Gutter & Downspout System

- The gutters require cleaning.

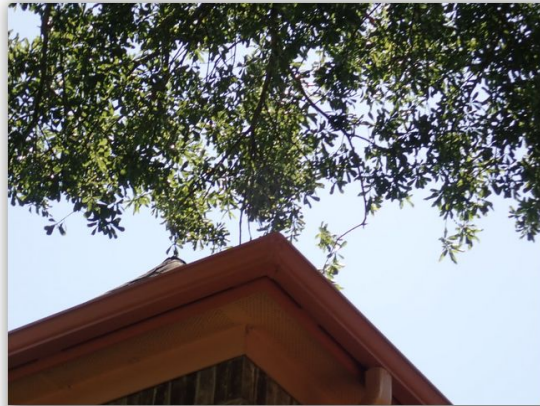
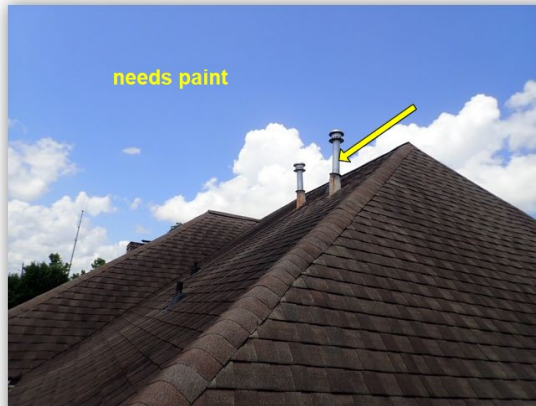
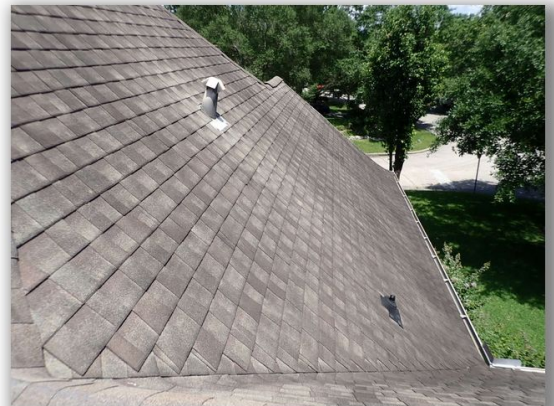
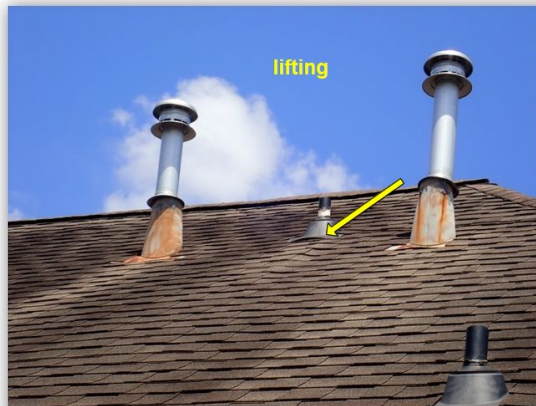
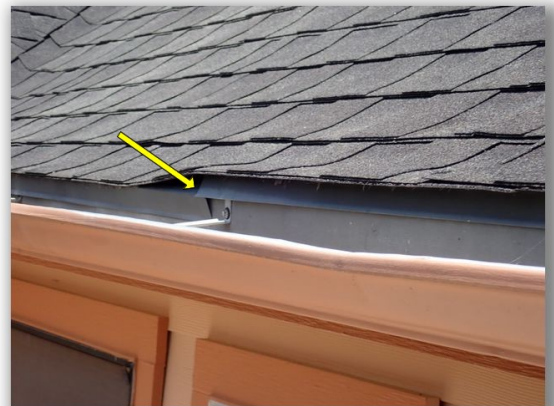
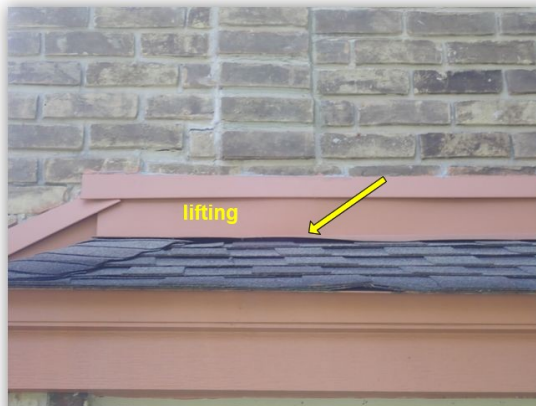
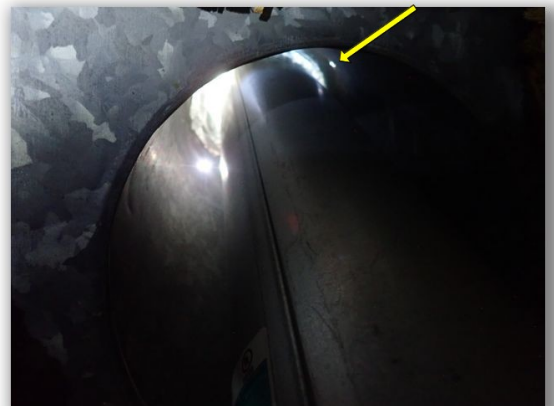
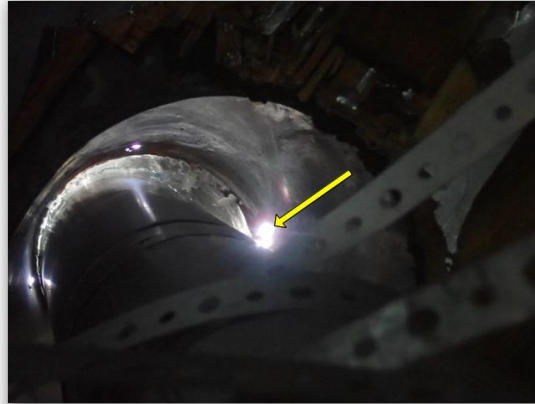
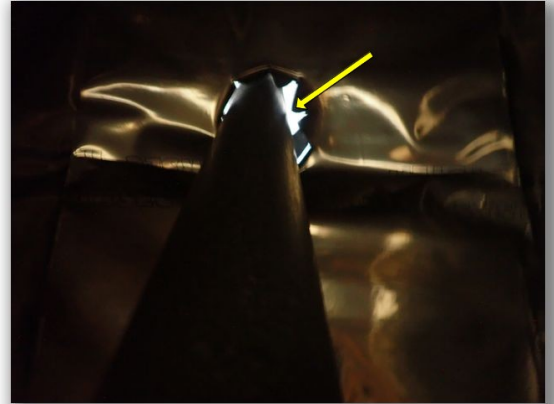
Flashing Details

The flashing details needs to be checked, reset or repaired as necessary. The observations made to support the rendering of this opinion are listed but may not be limited to:

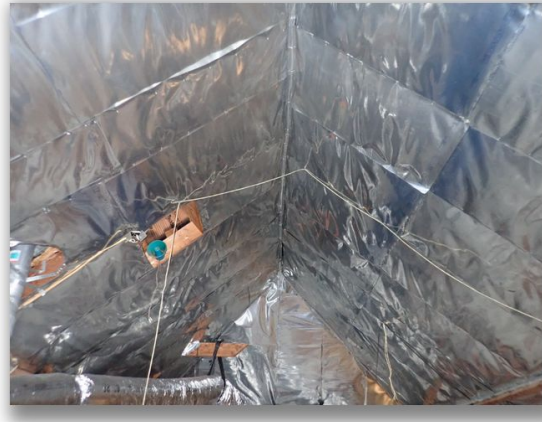
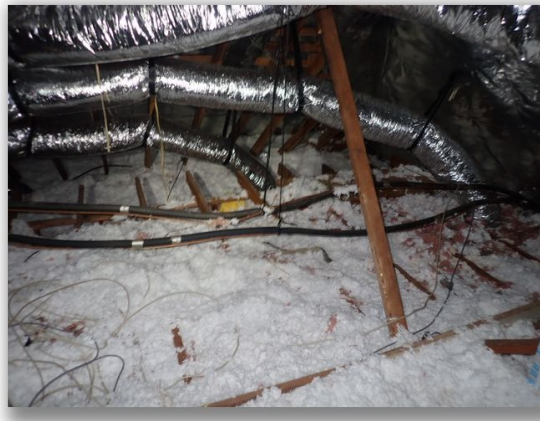
Attic Ventilation

All components were found to be performing and in satisfactory condition on the day of the inspection.

Attic Insulation

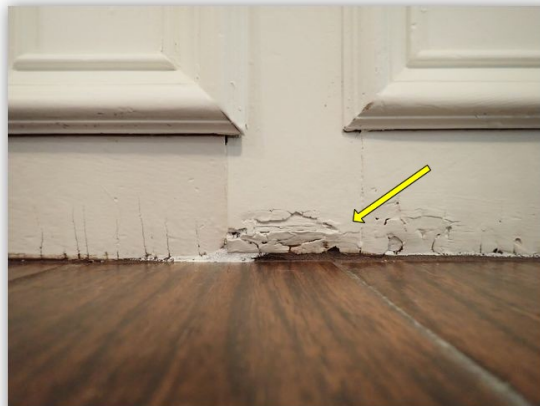
Interior Walls & Surfaces

- Wall surface damage was observed in the kitchen, breakfast area.
- Interior wall joint cracks were observed in the master bedroom.

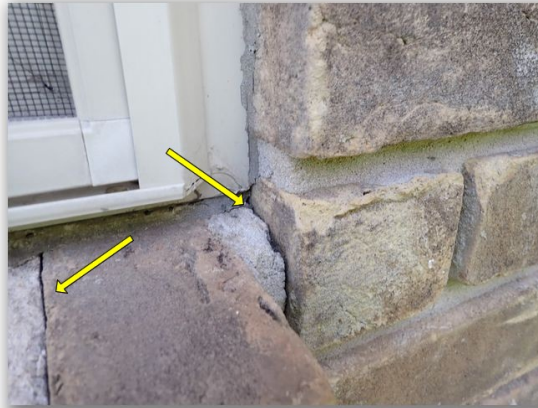
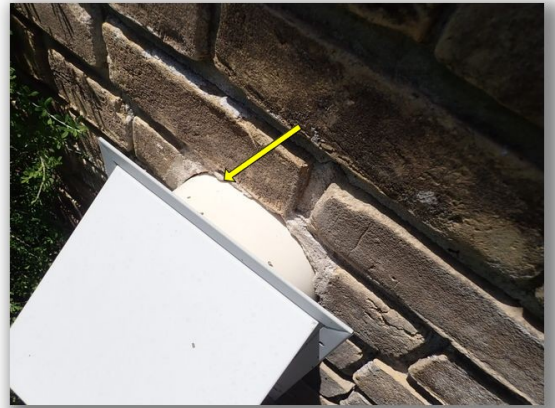
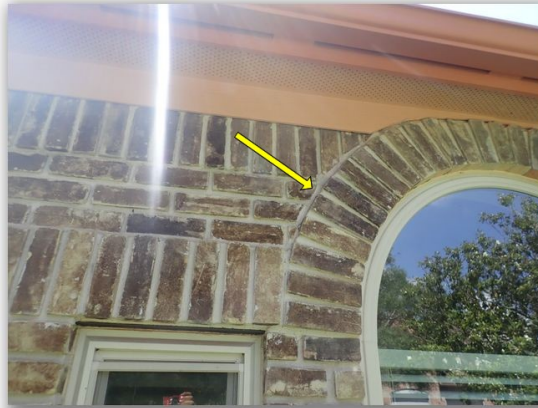
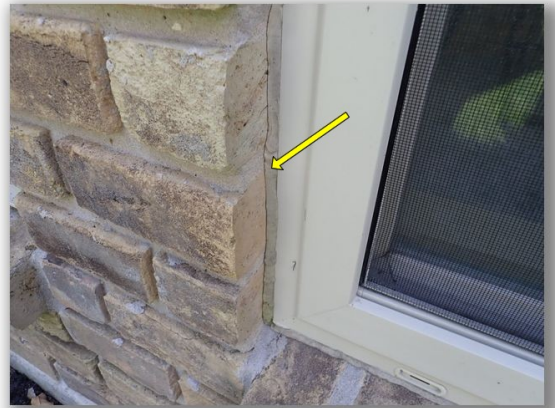
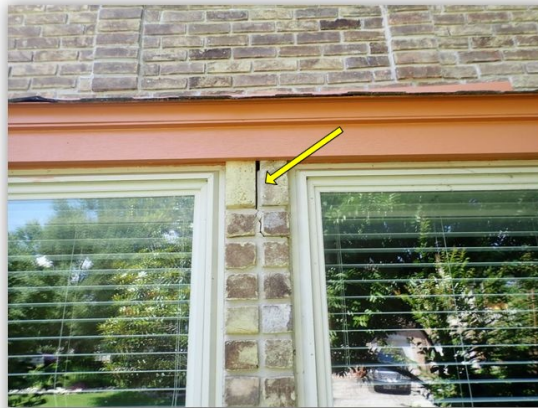
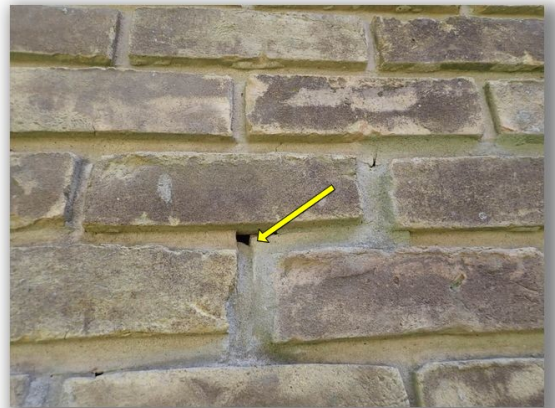
Note: Minor mortar and/or brick cracks were observed in the exterior veneer on the south side, east side of the structure.

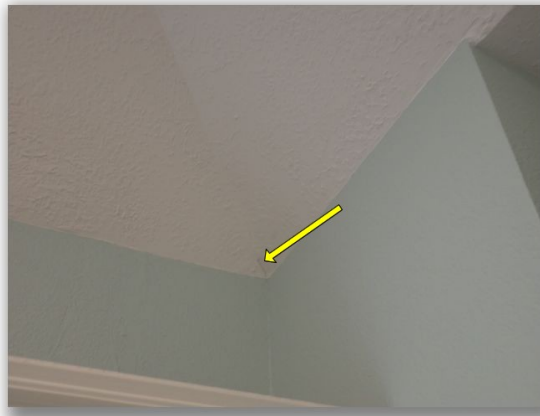
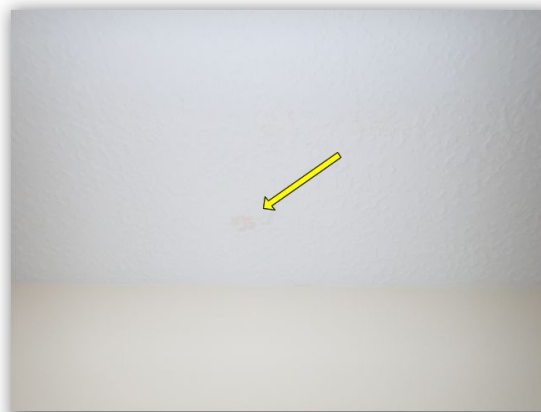
Ceilings

- Ceiling joint cracks were observed in the kitchen.
- Water stains and water damage was observed on the ceiling finishes in the upstairs rear middle bedroom. The cause and remedy should be further evaluated and corrected as necessary.

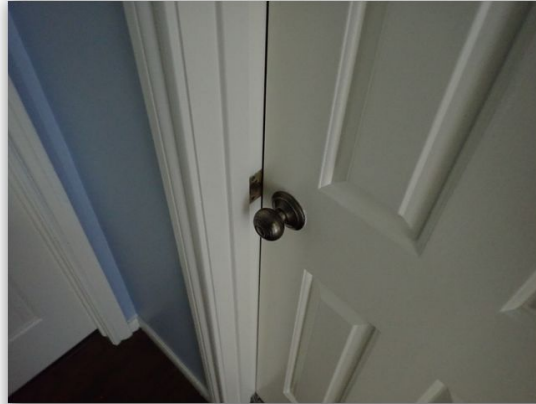
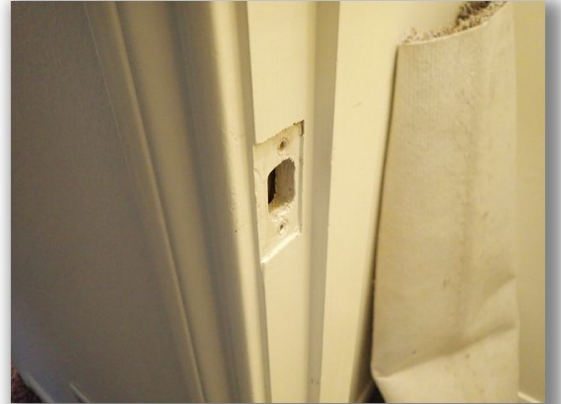
Interior Doors

- The door is not latching properly to the laundry room, upstairs rear corner bedroom closet, Jack and Jill bathroom.
- The door frame has some damage to the laundry room.
- The door has some surface damage to the upstairs rear corner bedroom closet.
- The door hardware is missing to the upstairs rear middle bedroom closet.

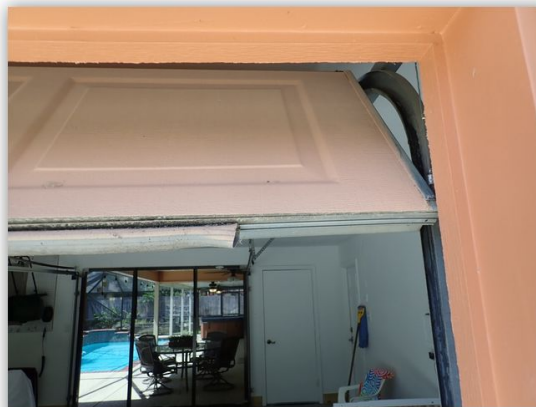
Overhead Garage Door

- The weather-stripping at the bottom of the overhead garage door is damaged and repairs or replacement may be necessary.
- The overhead garage door panel(s) and/or panel trim has some deterioration and/or damage.

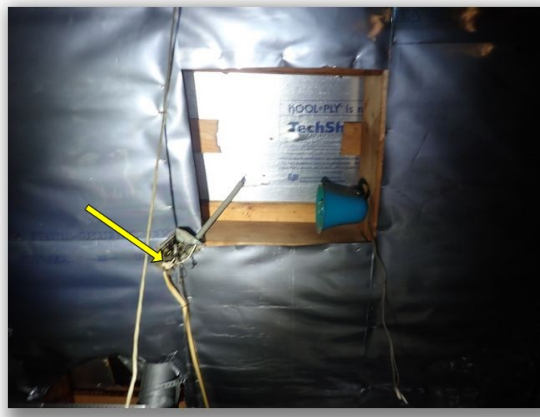
Distribution Wiring

- Open end wires were observed in the attic.

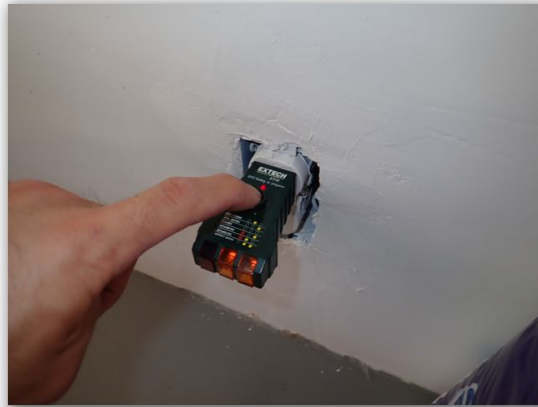
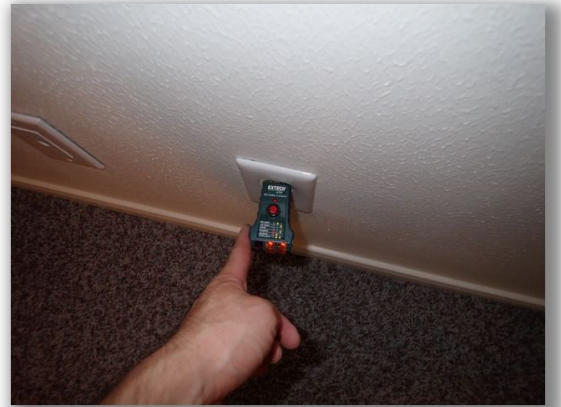
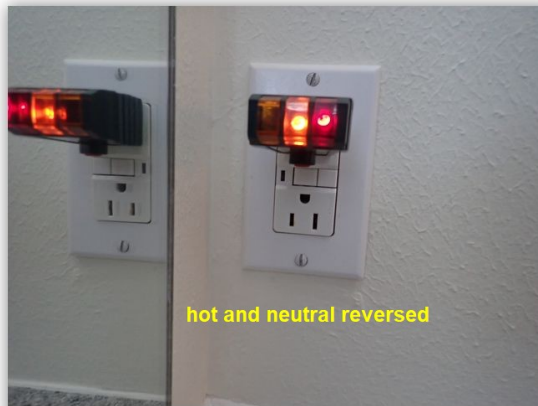
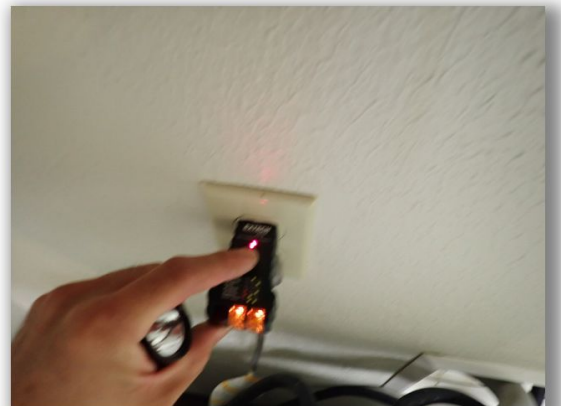
- One or more of the receptacles is missing its cover plate in the garage.
- One or more of the receptacles were observed to be loose at the wall mount in various locations throughout the house.

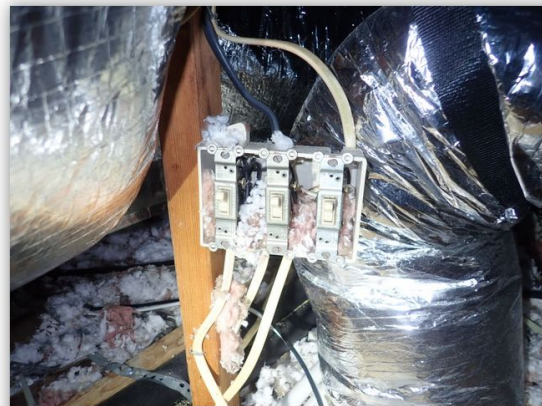
Switches

- The switch is missing its cover plate in the attic.

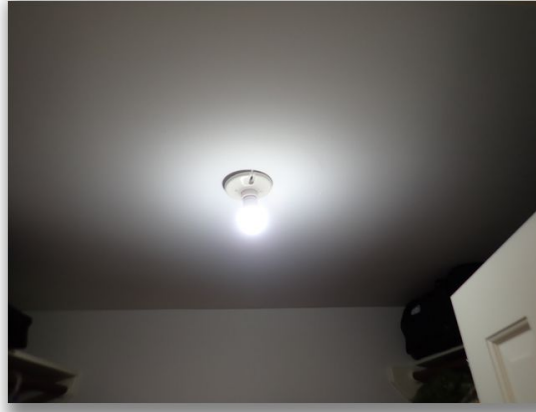
Fixtures

- One or more of the closet light fixtures appear to be installed without globes and/or covers. Safety precautions should be taken around these light fixtures.
- The ceiling fan was observed to be noisy when operated in the upstairs front middle bedroom.

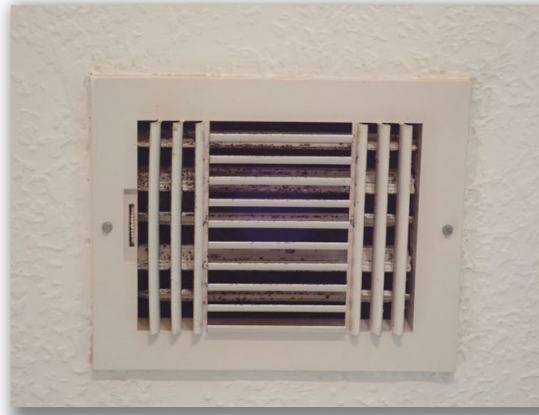
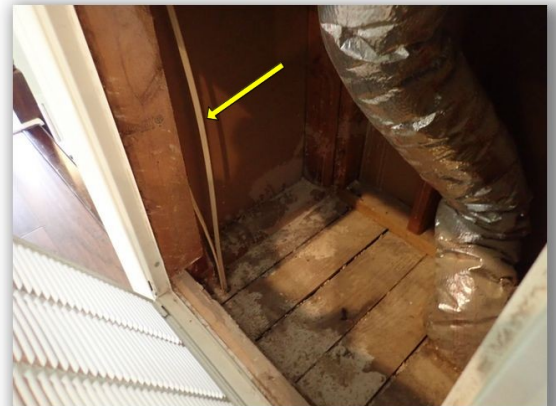
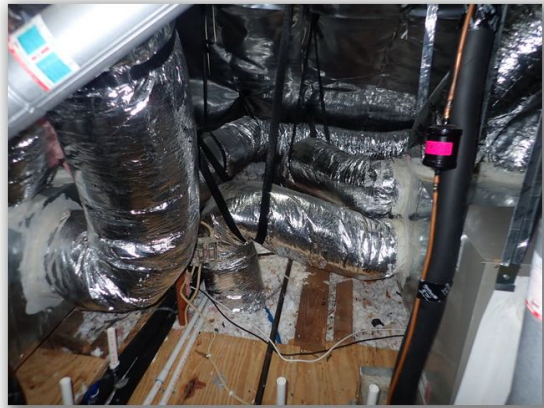
- There is visible dust and/or mildew on the air registers in the kitchen. The cause and remedy should be further evaluated. It is recommended to have the air registers and duct system cleaned for air quality purposes.
- There are electrical romex wires observed in the air return chase. Under current building standards, this is no longer an accepted practice.

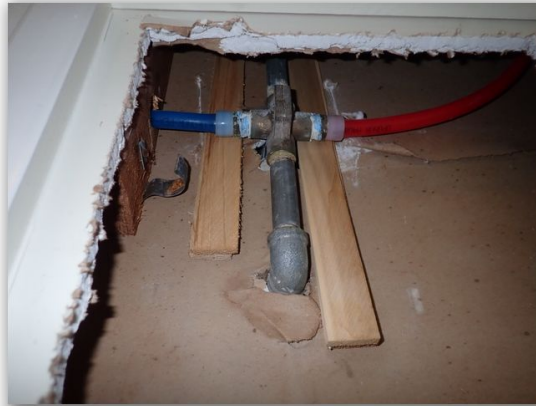
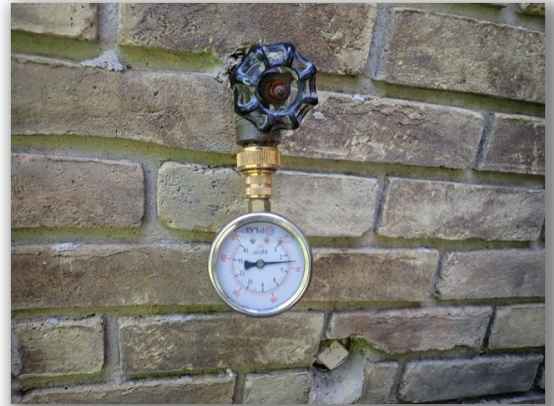
Water Supply System

- There are galvanized water lines in use at the time of this inspection. This is an older obsolete water supply system that is prone to water leaks. Full evaluation of all of the galvanized water line components and the integrity of those components are beyond the scope of this inspection. You are strongly encouraged to have the integrity of all of the galvanized water line components further evaluated by a qualified plumber prior to the expiration of any time limitations such as option or warranty periods. All plumber recommended repairs should be made. It would be wise to budget for replacement of all the older galvanized water supply system and to make a conversion over to a newer type of water supply system as soon as it is financially feasible.

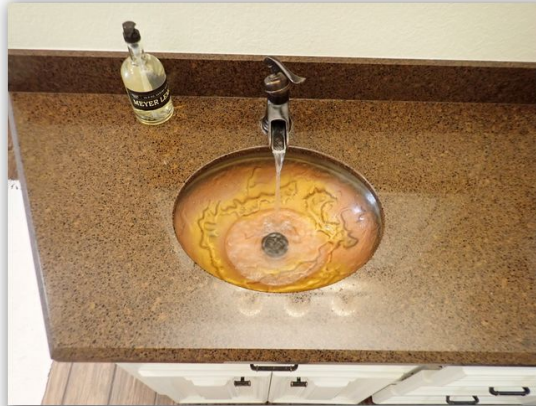
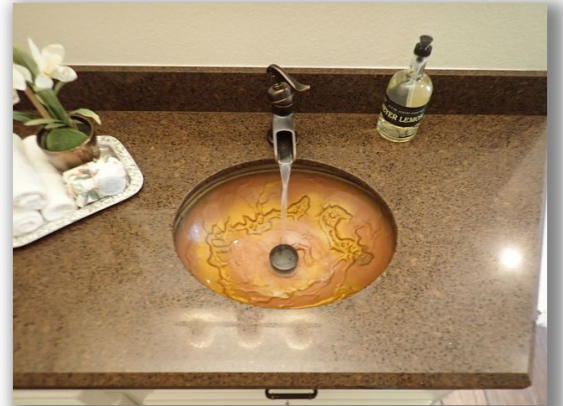
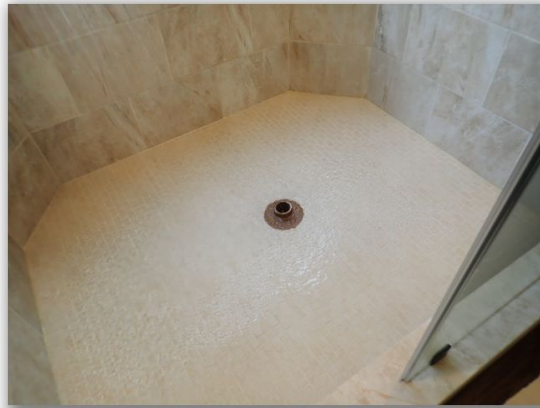
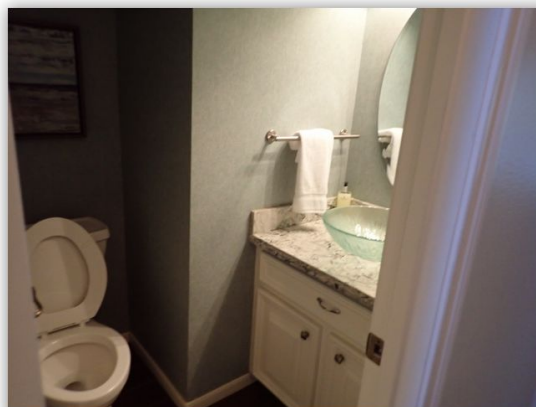
Half Bath

- The stopper does not appear to be functioning properly.
- The sink was observed to drain slowly, suggesting that an obstruction may exist.
- The faucets hot/cold water orientation is reversed.

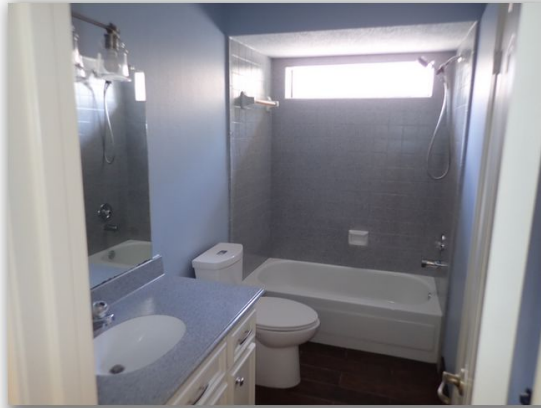
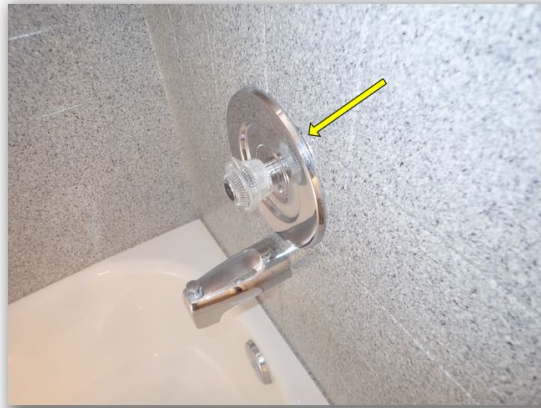
Bathtub

- The faucet assembly is not sealed at the wall. This condition has the potential to allow water to leak back into the wall cavity.
- The tub spout is not sealed at the wall. This condition has the potential to allow water to leak back into the wall cavity.
- The shower spout is leaking at the neck connection.

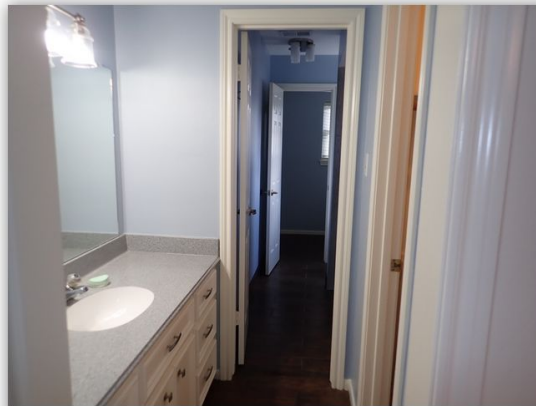
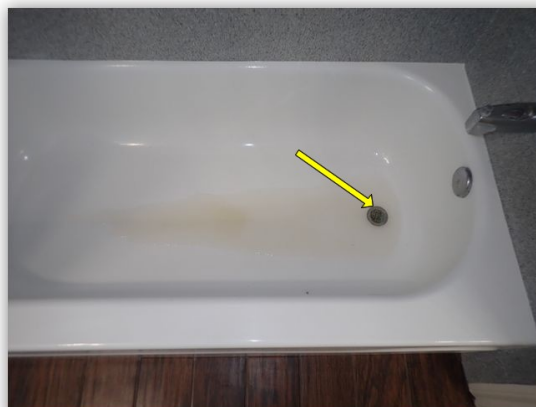
Bath Between Rooms – “Jack & Jill Bath”

- The faucet assembly is not sealed at the wall. This condition has the potential to allow water to leak back into the wall cavity.
- The faucet leaks at the handle when on.
- The stopper has some surface damage.

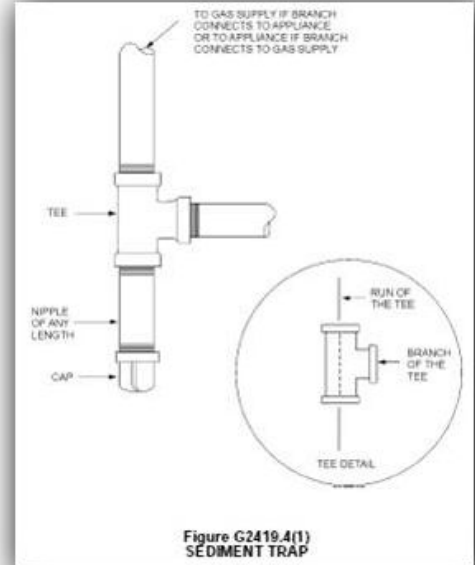
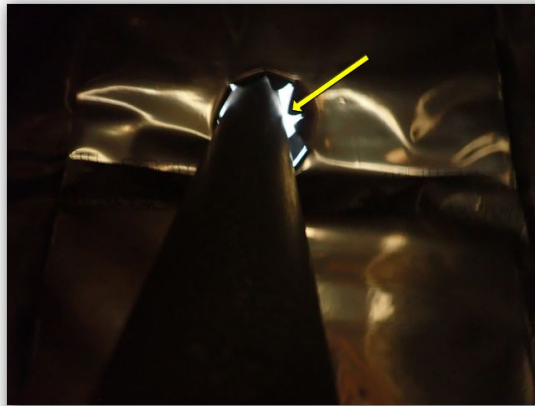
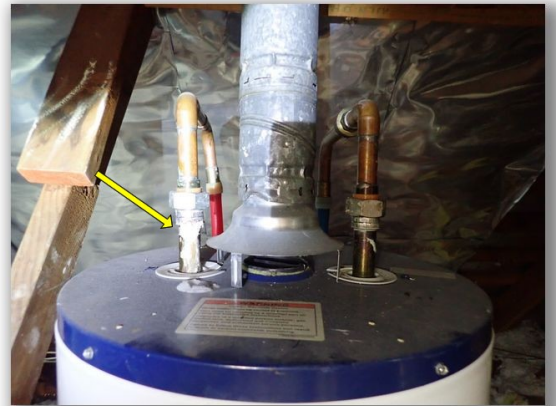
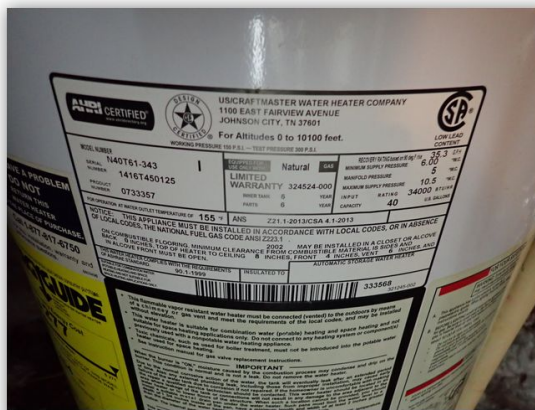
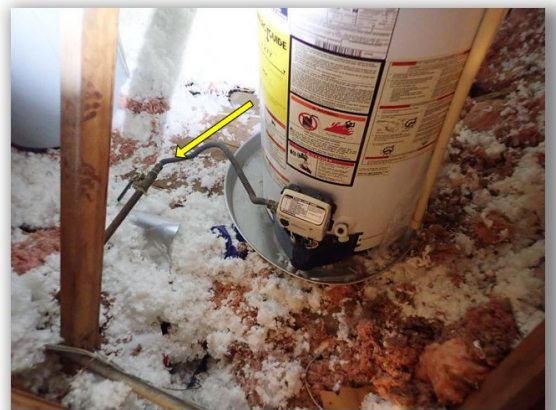
- Some corrosion was observed at the water supply connections at the top of the water heater.
- The fittings at the top of the water heater are made of dissimilar metals (galvanized steel connected to copper and/or brass). It is recommended to replace the galvanized steel fittings with brass or copper fittings or install a dielectric union between the two dissimilar metals to prevent electrolysis from occurring.
- The roof level flue storm collar needs to be properly sealed to help prevent water intrusion into the structure.
- The water heater gas supply line is not equipped with a sediment trap just before the gas appliance connector. This condition does not meet current installation requirements and should be corrected.

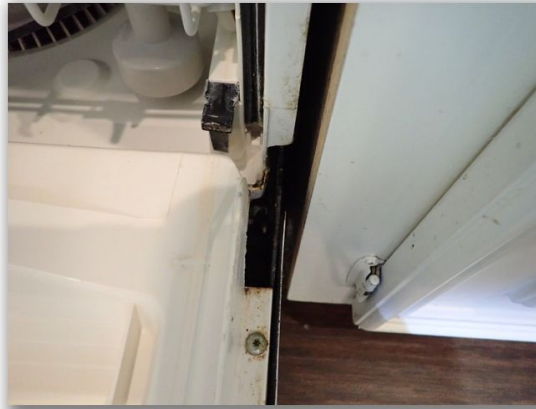
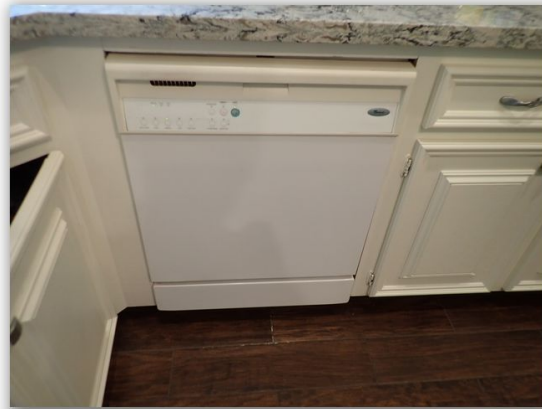
Brand Name: Whirlpool

- Some rusting of the dishwasher interior components was observed.
- Some damage to the dishwasher controls and/or control panel was observed.

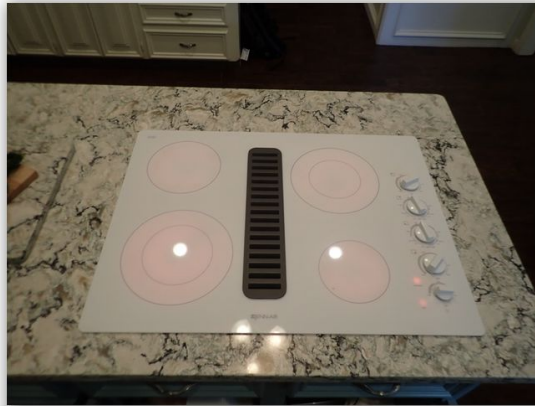
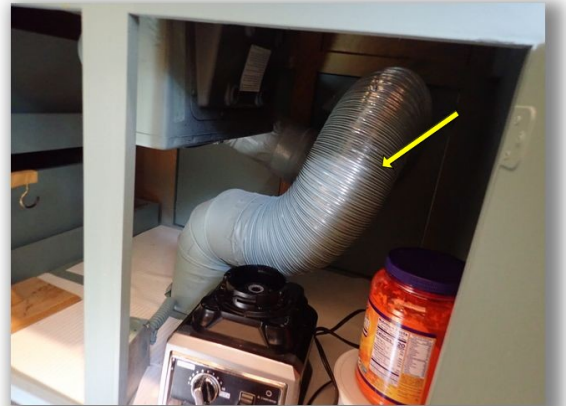
C. Range Hood and Exhaust Systems

- There is aluminum ductwork in place for the range hood vent. Under current installation standards, aluminum flex ducting should not be used for the range exhaust vent connection.

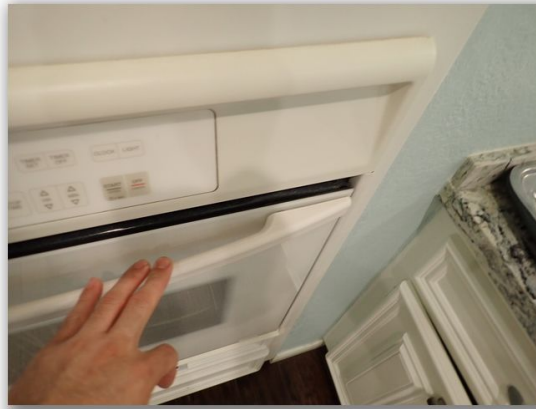
Built-in Oven Brand Name: Whirlpool

- The door handle is loose at the time of inspection.

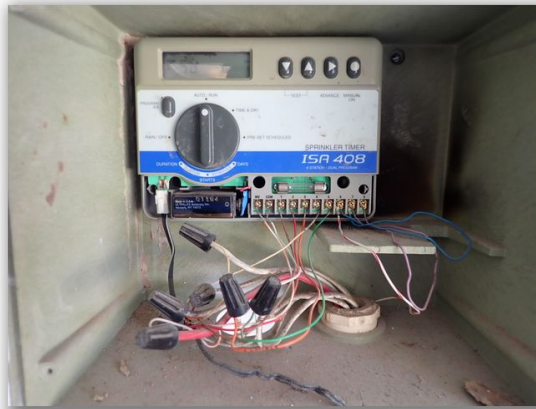
Sprinkler System and Associated Components

The sprinkler system did not respond to the controls when tested in the manual setting. The cause and remedy should be further evaluated and corrected as necessary.

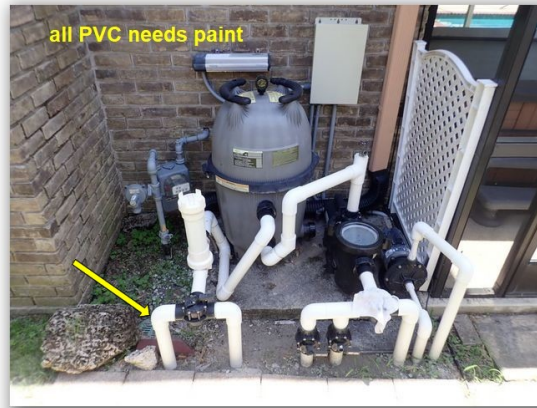
Some of the pool components appear to have deficiencies that are beyond normal. The buyer should have this condition further evaluated by a pool technician familiar with pool structures and associated pool components for remedial cost estimates. The observations made to support the rendering of this opinion are listed but may not be limited to the following:

- There appears to be a water leak at the above ground plumbing lines at and around the equipment. The cause and remedy should be further evaluated and corrected as necessary.
- It is recommended to paint all exposed PVC pipes to prevent UV break down.
- There is a visible water leak at and around the filter housing.
- Some cracking of the deck was observed.

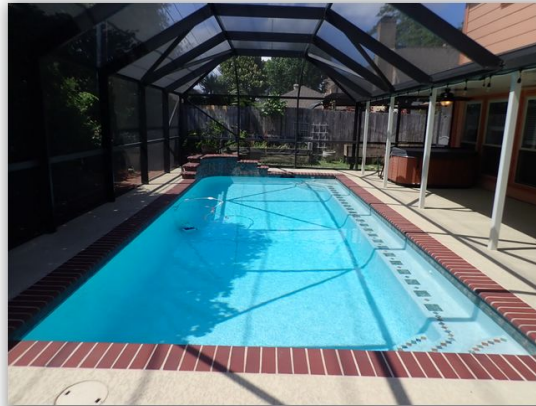
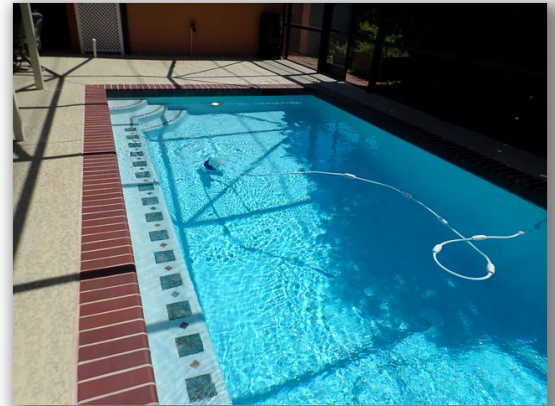
Barriers

- Under current standards, all of the homes entry doors that give access to the pool area should be equipped with an audible alarm that can be heard throughout the house, sound continuously for 30-seconds, and be mounted at least 54-inches from the doors threshold. A self-closing and self-latch door device can be used in lieu of the audible alarm system as long as the protection is not less than the audible alarm.

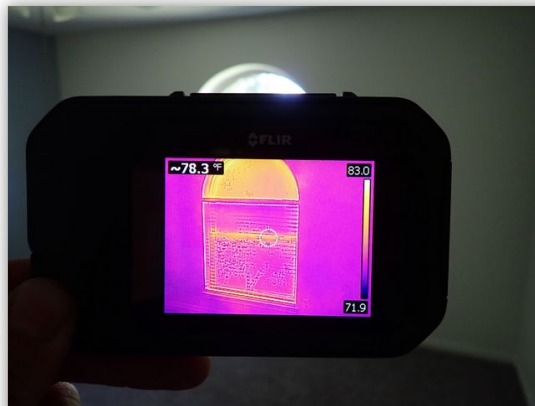
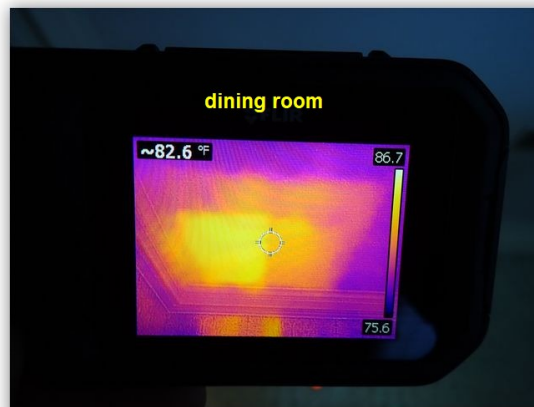
Thermal Imaging / Infrared

- Missing insulation was observed within the wall cavity in the dining room, upstairs living room.
