**MAIN GATE REAL ESTATE INSPECTION**

# Property Inspection Report

**Property Address:** 10510 Autumn Meadow Ln, Houston, TX 77064-5033

**Date of Inspection:** 07/18/2019

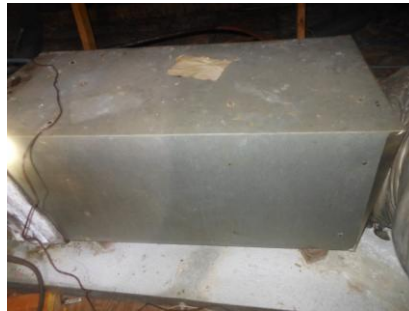
**Observation:** Central forced air gas heating system- 94 Goodman electric heater. The heating system is in serviceable condition

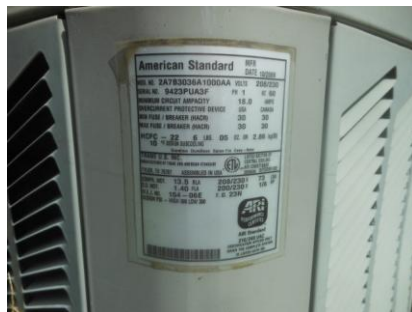
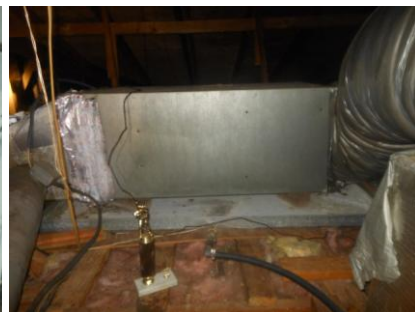
**Observation:** Central forced air electric cooling system. 3-ton AC system with 2009 Trane condensing unit/outdoor unit and 94 Goodman evaporative coil/indoor unit

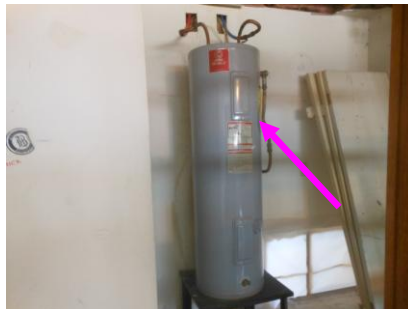
**Observation:** 20110 State Select 40-gallon electric water heater locates in garage  
**Comments:**

**Note:** T&P valve(s) was not tested during the inspection because it could cause personal / property damages. The valve(s) should be replaced per manufacturer's instruction. Manufacturing has suggested draining and flushing the equipment annually, this maintenance can reduce calcium settlements, deposits, and noise and it also extends the life of the appliance
