Inspection Report

Property Address:
119 White Oak Drive
Lake Jackson TX

PROPERTY INSPECTION REPORT

By: Brad Summers TREC #22343 / SumTex Inspections 11/5/2019

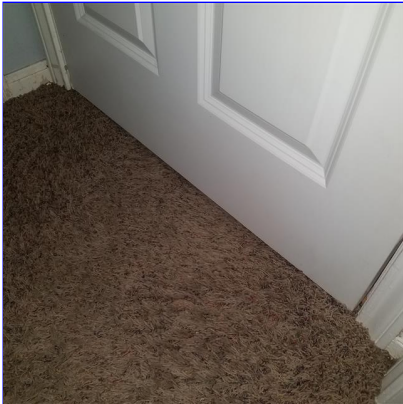
G. Item 2(Picture) master bedroom

(2) Some interior doors in this bedroom rubbed on the carpet and needed to have the bottoms cut. Cutting the bottom of the bedroom doors insures adequate air flow for the HVAC systems to work properly.

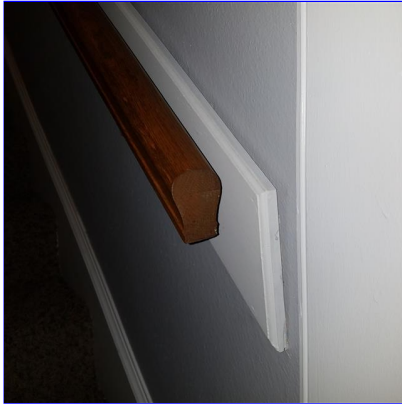
I. Item 1(Picture)

A handrail at this staircase did not terminate at a wall or newel post as is required by generally-accepted current safety standards.

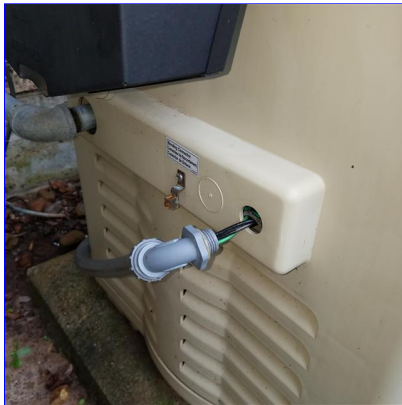
B. Item 1(Picture)

(1) The conduit is not secure for the pool heater at the time of the inspection.

This will be remedied before this weekend SWR

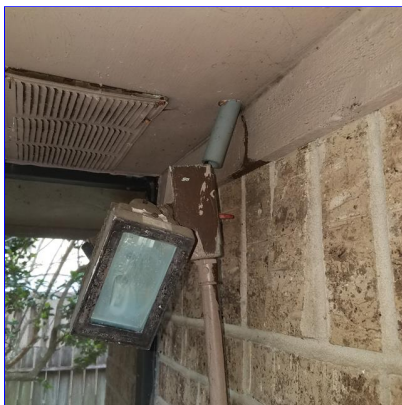
B. Item 2(Picture)

(2) Unsecured electrical conduit at the back right of the home.

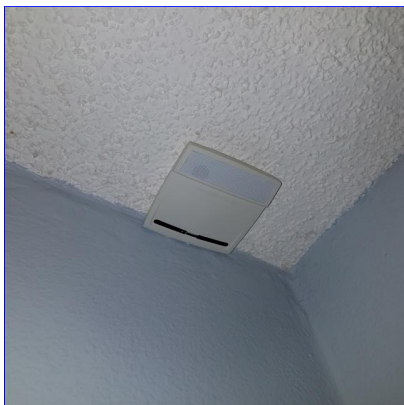
B. Item 10(Picture) master bedroom

(6) Smoke alarms mounted on the wall must be located no closer than 4" from the ceiling and no further away than 12" from the ceiling. Not all occurrences were photographed.

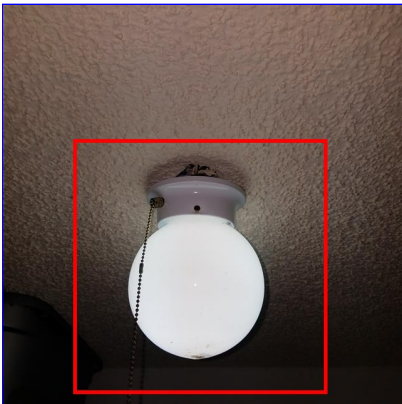
B. Item 15(Picture)

(10) Light fixture is not secure in the upstairs back left back bedroom closet.

This will be remedied before this weekend SWR
