Total Home Inspection

Property Inspection Report

16122 Wimbledon Forest Dr, Spring, TX 77379
Inspection prepared for: Claud During
Real Estate Agent: Kathy Hinds - Abby Realty

Date of Inspection: 10/2/2019 Time: 1:00 PM
Age of Home: 1995 Size: 5300
Weather: Partly Cloudy

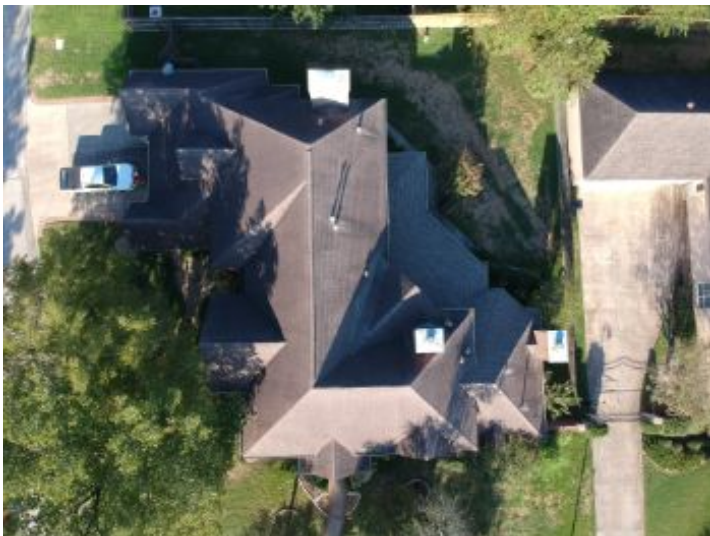
Structural Systems Roof Covering Materials

- Shingle surface showed normal degree of deterioration in areas and is functioning as intended. Regular maintenance is required on areas of the roof.
- Shingles were loose/falling in front of backside chimney.
- Rusting was observed on some B-Type vents. They should be readjusted, resealed, a rust inhibitor paint may be applied.
- Trees were contacting the roof surface. Tree limbs and vegetation may prematurely wear or damage shingles.
- Exposed screws in satellite dish bracket should be sealed.
- Some areas of the roof surface appeared to be uneven.

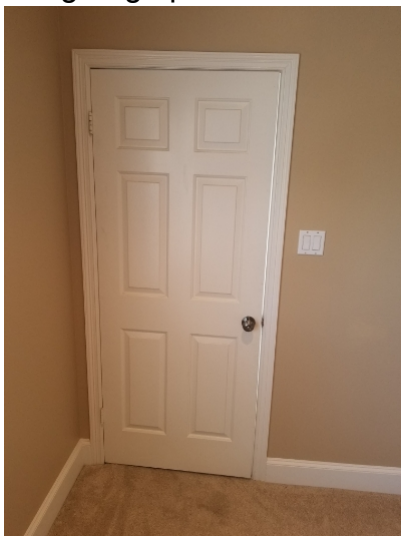
The 2nd level back bedroom door was not square and contacting the frame and may require adjustment.

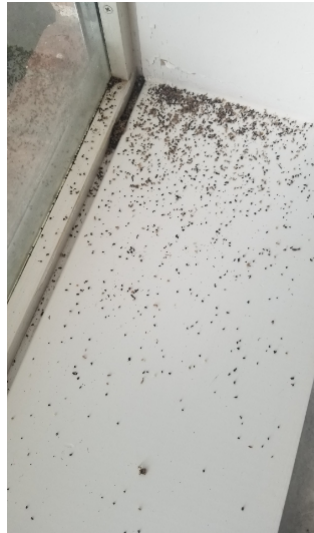
Evidence of insect activity at left foyer/stairwell window.

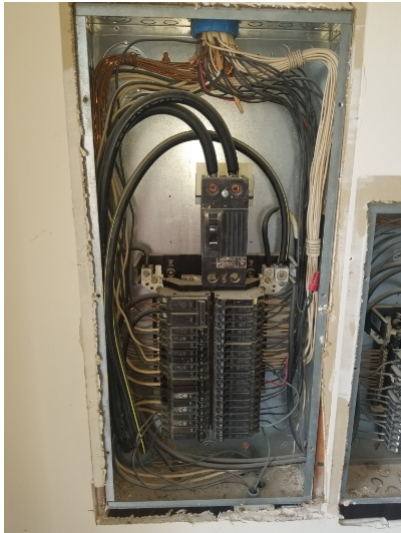
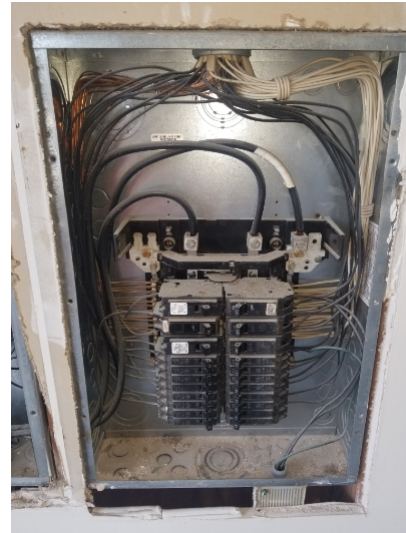
Electrical Systems Service Entrance and Panels

Sub panel was observed and fed with 3 wire plus ground from a amp breaker in the main panel.

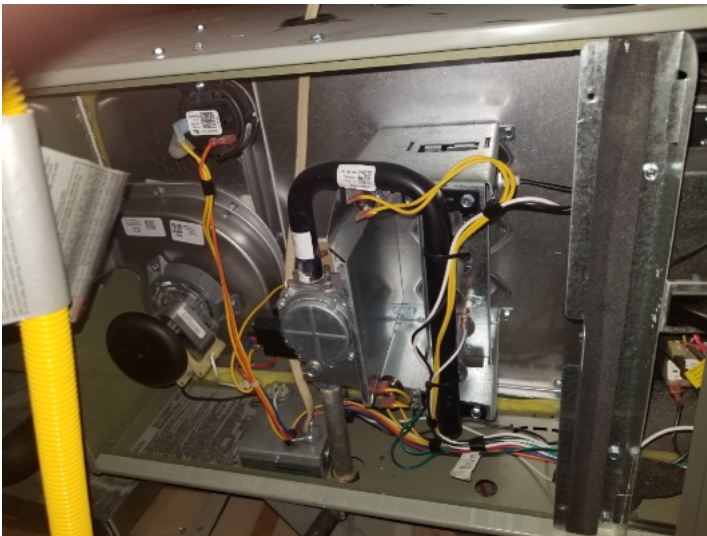
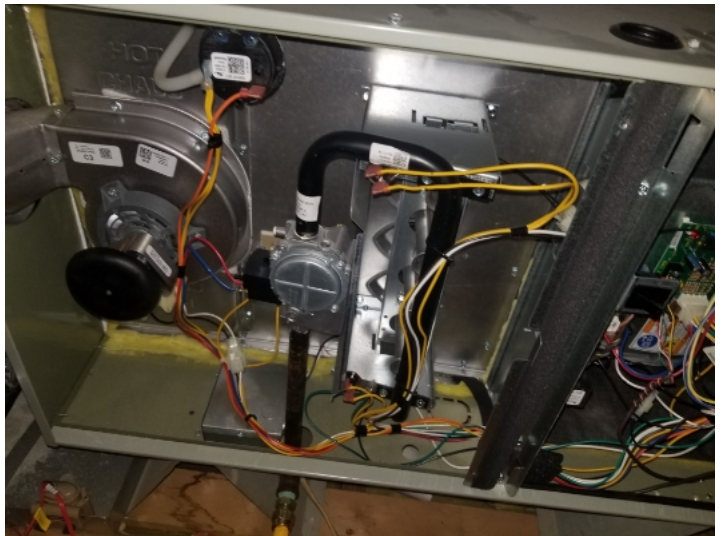
Heating, Ventilation and Air Conditioning Systems Heating Equipment

A natural gas fired, standard efficiency furnace was manufactured by Trane in 2017. Furnace serviced the 1st level with 100k btu's. Furnace was operated, covers were remove and interiors observed. Unit appeared to be functioning as intended.

A natural gas fired, standard efficiency furnace was manufactured by Trane in 2017. Furnace serviced the 2nd level with 80k btu's. Furnace was operated, covers were remove and interiors observed. Unit appeared to be functioning as intended.

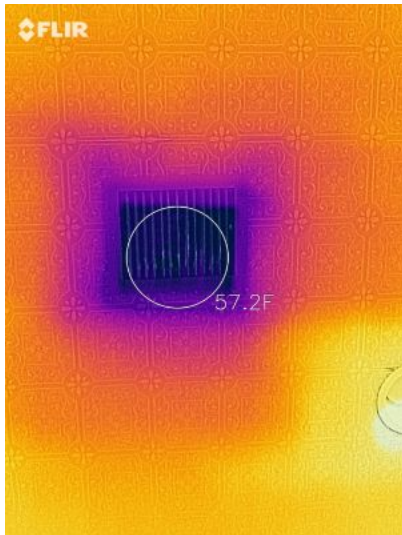
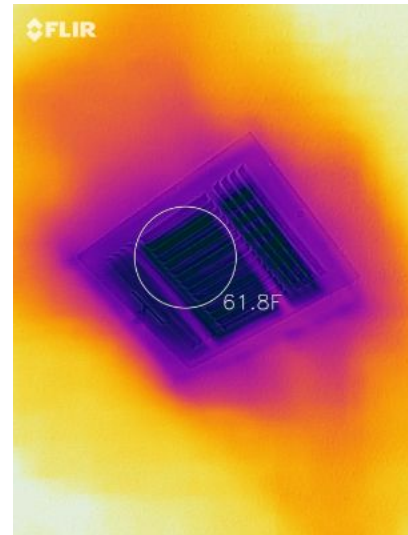
AC appeared to be cooling properly. Temperature differential measured (77-58=19 1st level; 73-57=16 master suite; 78-61=17 2nd level) between air supply and registers. Typical range should be 15 to 20 degrees.

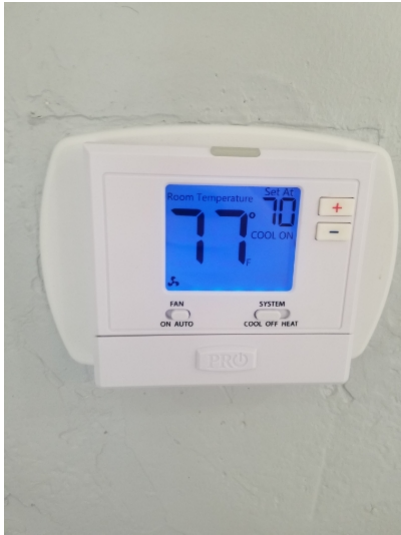
Thermostats were Pro1, digital programmable types.

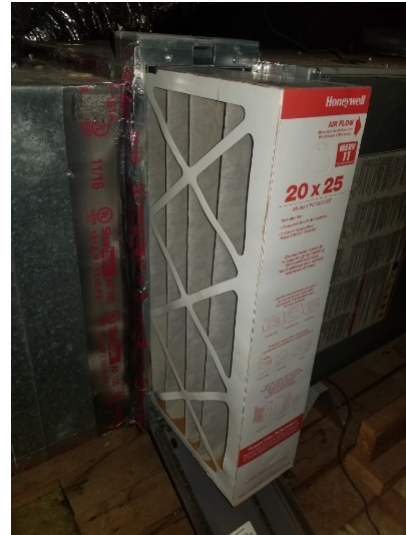
Media filters were observed at the air handlers.

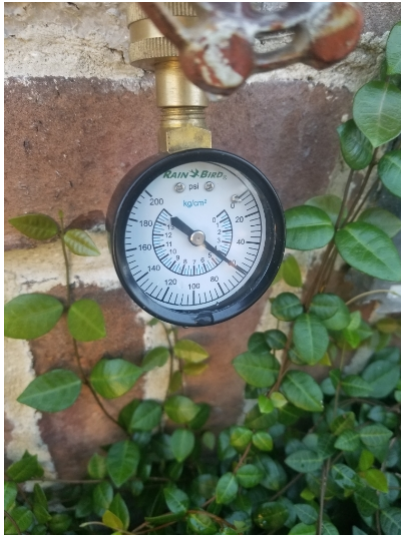
Static water pressure was observed to be: 60 psi. The acceptable range for residential water pressure is 40 to 80 psi.

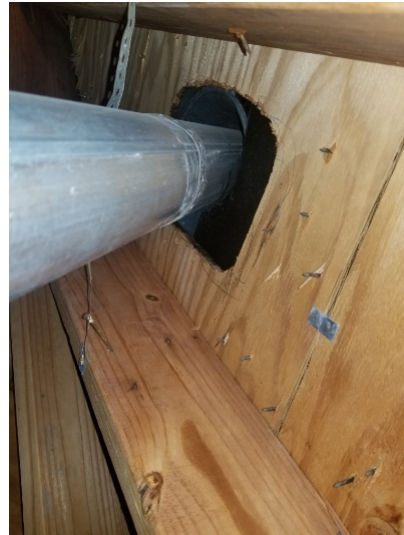
Water heater flue was not proper distance from combustibles in attic and should be at least 1 inch from wood or other combustible material.

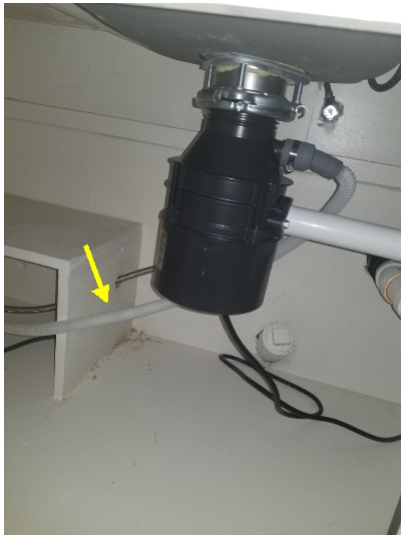
There was no anti-siphon device or high loop on the dishwasher drain. The dishwasher drain hose may be attached to the bottom of the counter top under the sink. This would prevent water flowing back to the dishwasher in the event the sink backed up.
