Inspection Reveal, LLC

Property Inspection Report

1477 River Oaks Dr.. Huntsville , TX 77340

Date of Inspection: 9/11/2019 Time: 7:30 am to 2:00pm
Age of Home: 1986

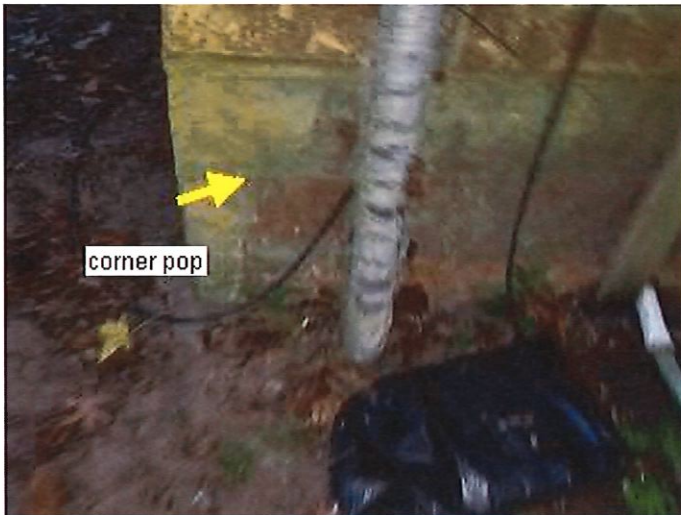
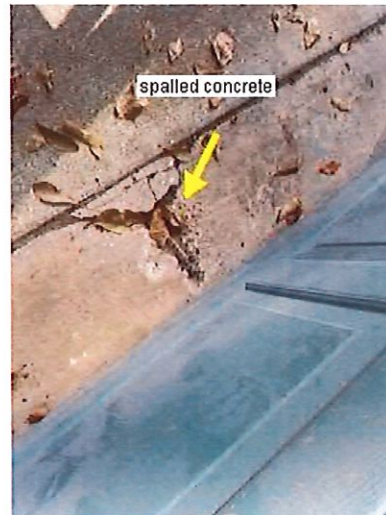
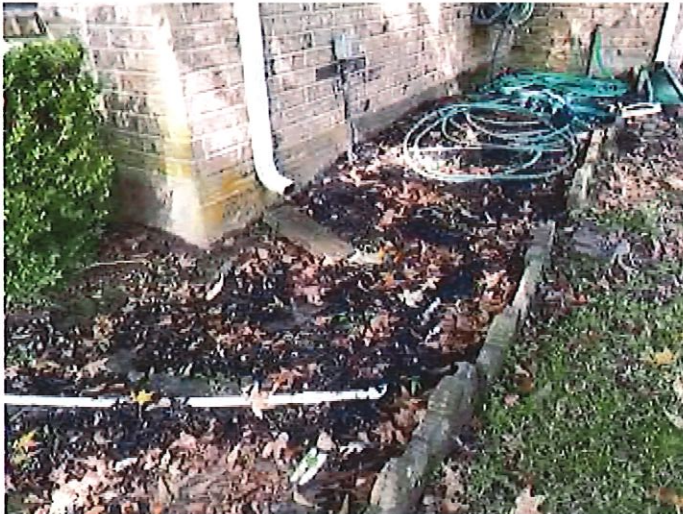
- All components were found to be performing and in satisfactory condition at the time of the inspection.
- Slab not visible due to floor coverings.
- Corner pop noted on rear of foundation. Does not appear to be effecting performance of foundation.
- Spalled concrete noted at front of garage area. Does not appear to be effecting performance of foundation. Consideration should be given to patching area when time and budget permits.
- Small cracks in garage floor appear to be normal shrinkage / settlement cracks.

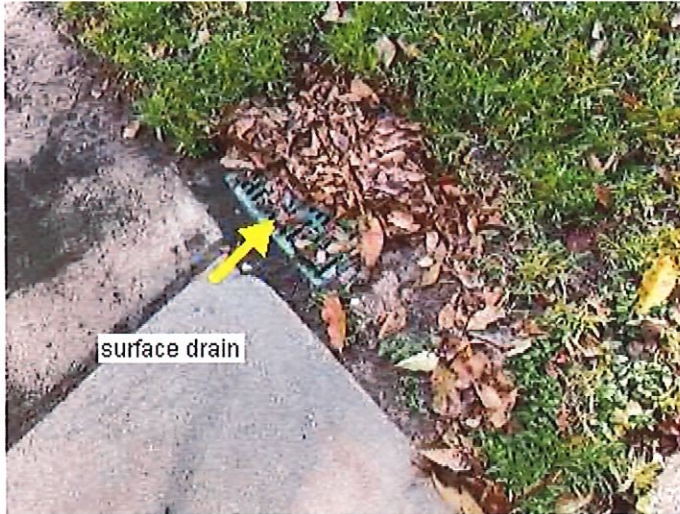
- Trees too close to structure. Tree roots could possibly cause damage to foundation and sidewalks. Future evaluation is recommended.
- Surface and french drains observed and not tested at the time of inspection. Recommend keeping all drains clear of debris.
- **High soil observed promoting earth to wood contact. Recommend lowering soil to expose 4 inches of foundation.**
- **The gutter system was partially blocked with debris and one or more downspouts or splash blocks were missing. Recommend keeping gutters clean and replacing splash blocks to prevent erosion of soil.**

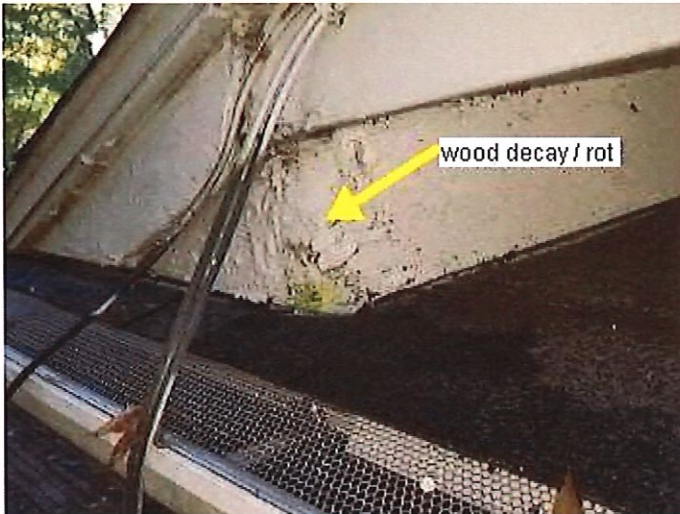
- The pulldown attic ladder is not insulated or weather stripped at this time. This is an "As Built" condition that does not meet current energy standards. It is recommended to insulate the hatch door after taking ownership of the property.
- The fascia board has some deterioration in one or more locations. Recommend repairs / replacing when time and budget permit.

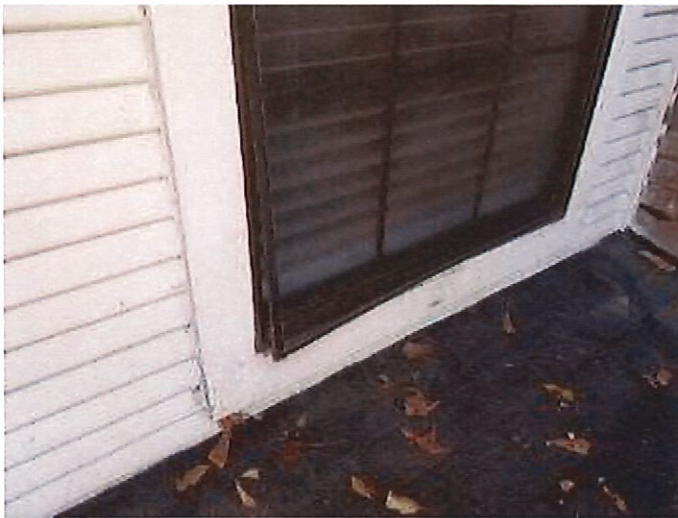
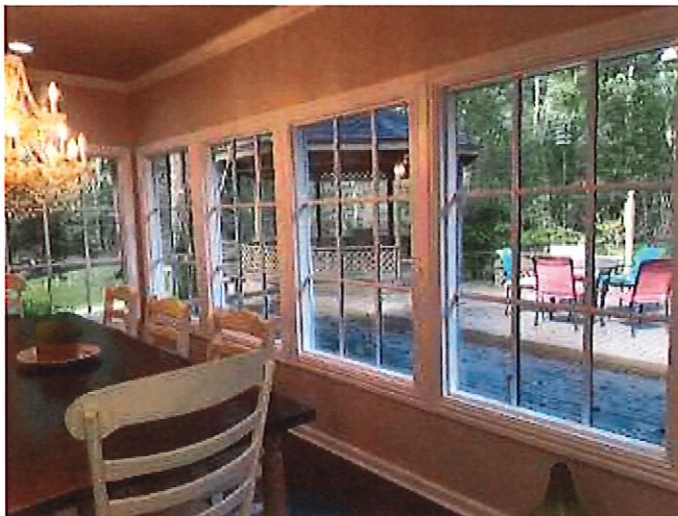
- One or more of the thermal pane windows were observed to have lost their seals. This has resulted in condensation or a fog like film to develop between the panes of glass. The thermal pane windows are no longer functional as designed when the seal is lost and replacement may be necessary.

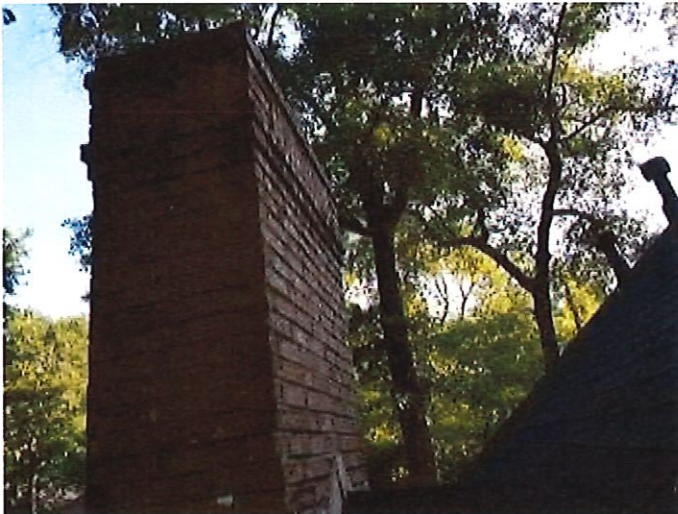
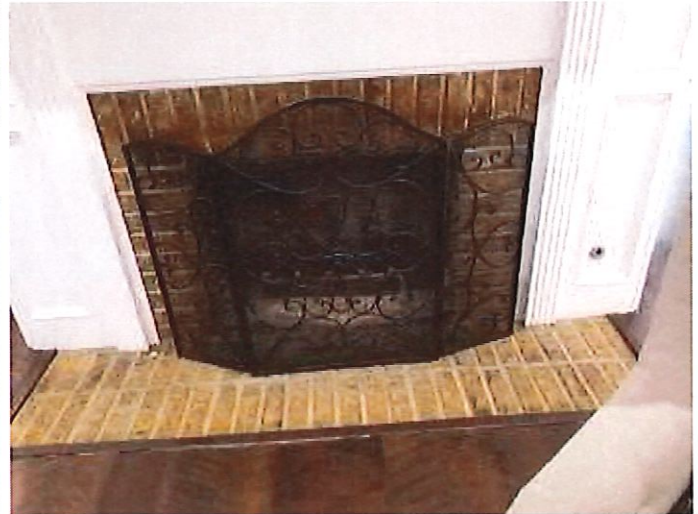
- Visual inspection of the fireplace, hearth, hearth extension, firebox and damper.
- Unable to view chimney cap and spark arrestor due to location.

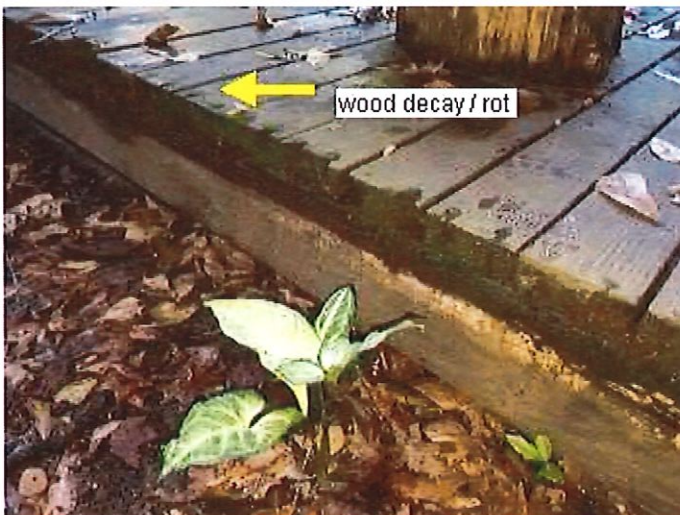
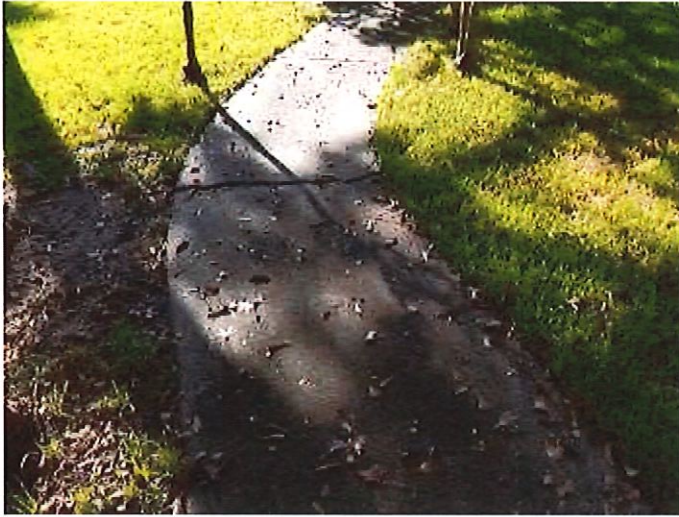
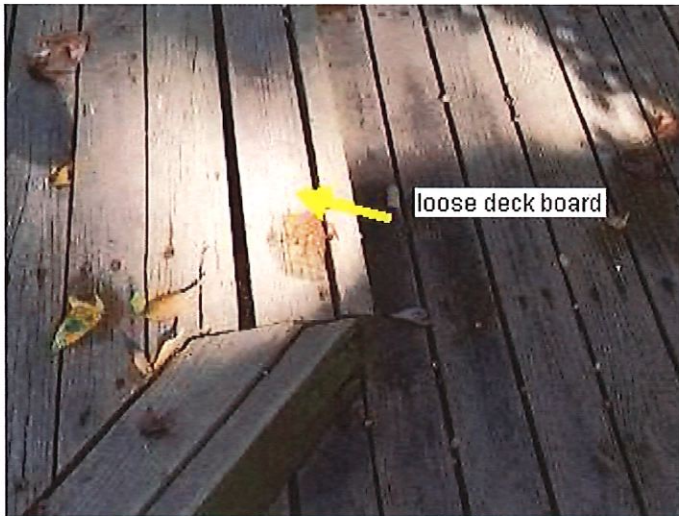
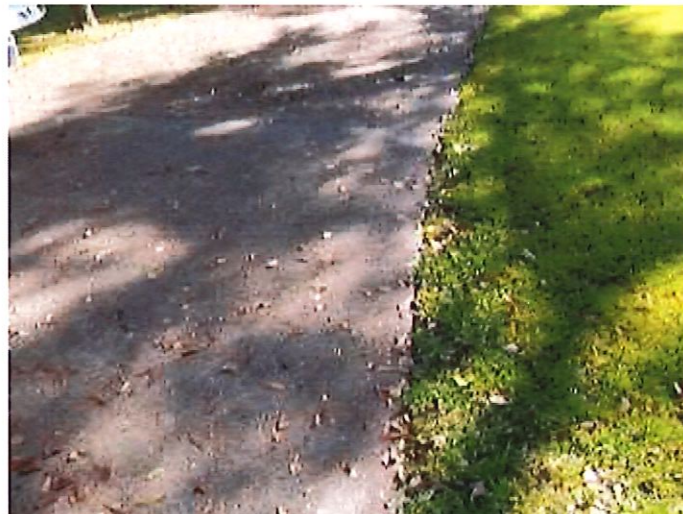
- Concrete driveway was noted.
- Concrete sidewalks were noted. Cracks noted in sidewalks do not appear to be effecting performance.
- **The deck structure was observed to have either dry rotted, water damaged and/or insect damaged areas and further evaluation is recommended.**
- **Loose deck board noted in one or more areas. Recommend repair by qualified contractor.**

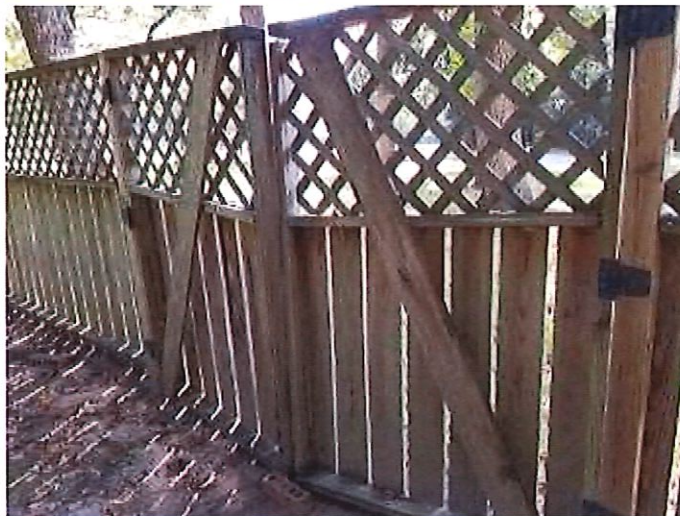
- One or more gates did not appear to swing freely. Recommend repairs when time and budget permit.
- The horizontal top rail was not connected in one or more areas.

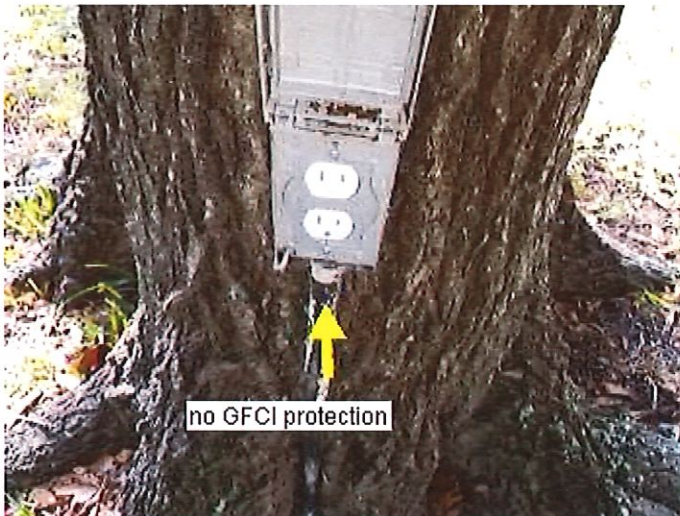
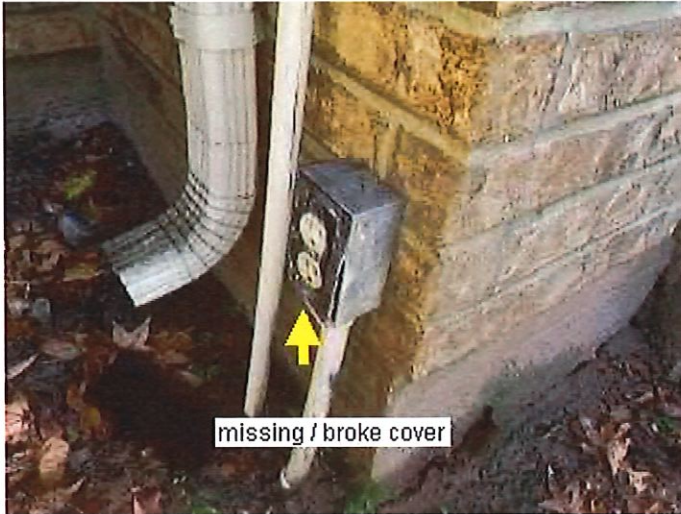
- Inadequate smoke alarm coverage was observed and it is recommended that additional smoke detectors and CO2 detectors be installed in accordance with current building standards. The NFPA {National Fire and Protection Agency} recommends one smoke alarm on each level, every bedroom and adjoining hallway, above stairwells and a CO2 detector in the garage and outside each bedroom with fuel fired appliances. A primary fire extinguisher is recommended on each level with a UL rating of 2-B:C.

- Damaged and/or missing outlet and/or switch covers were observed. This situation creates a Safety Hazard and should be corrected.

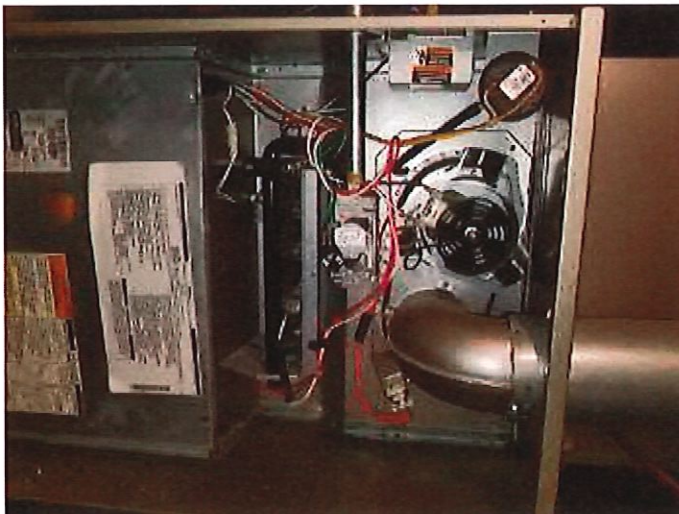
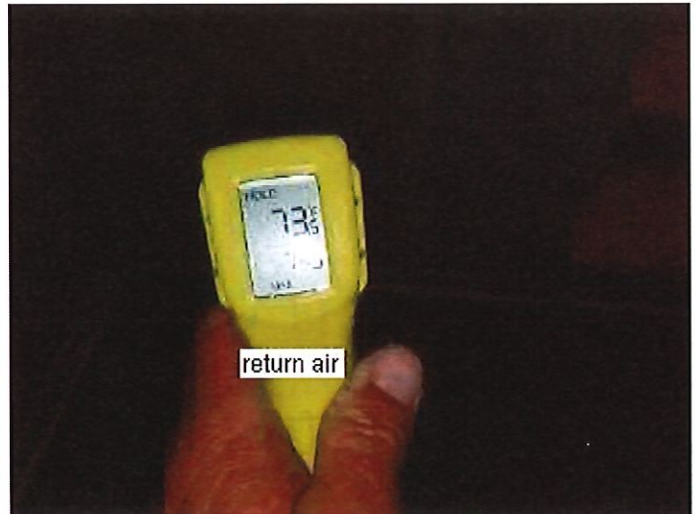
- The unit appeared to be functioning as intended at the time of the inspection.

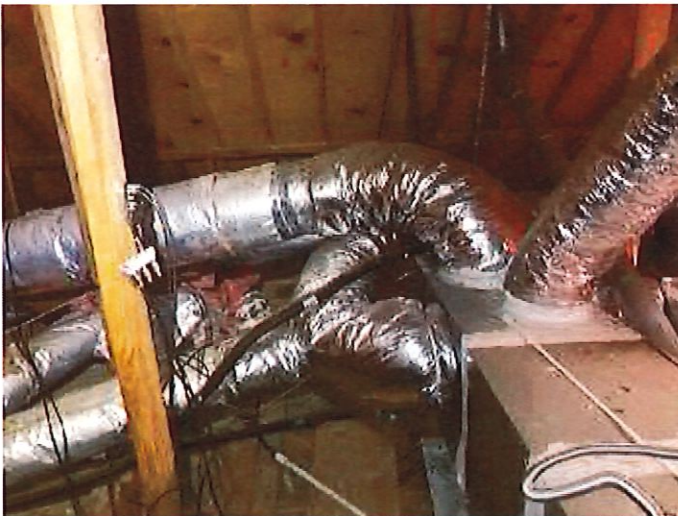
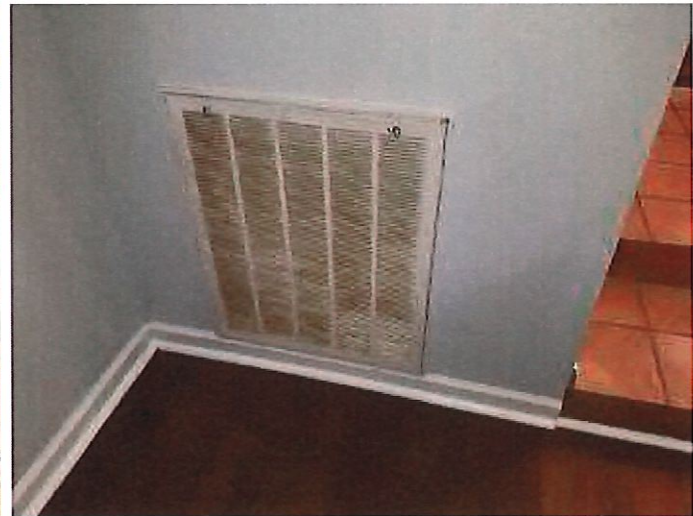
C. Duct Systems, Chases, and Vents

Comments:
• Ducts and vents appeared to be performing as intended.

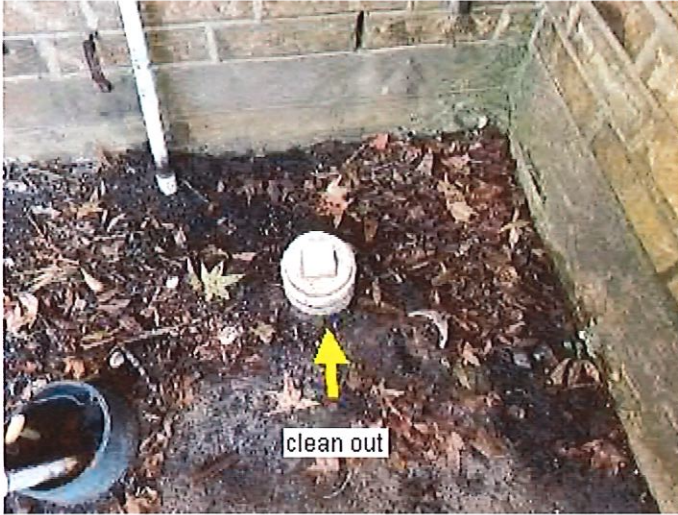
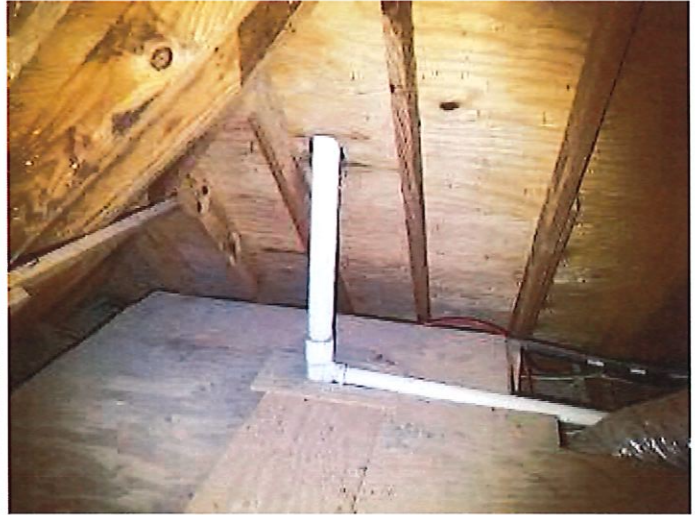
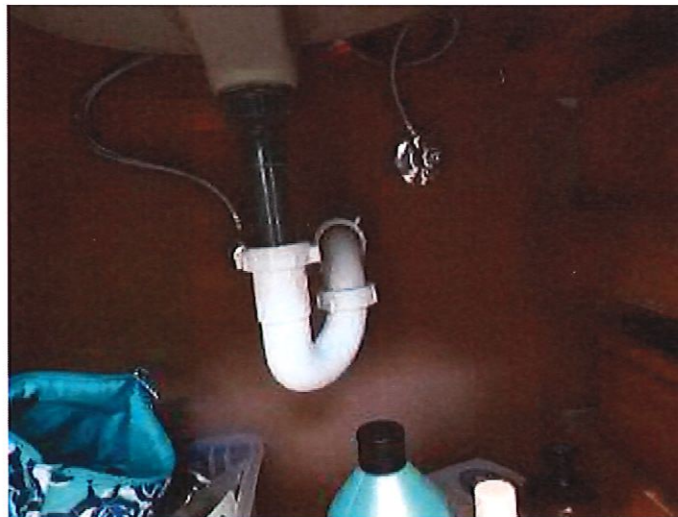
- The exterior main cleanout was located at the front of the structure.
- Vent pipes are noted as PVC

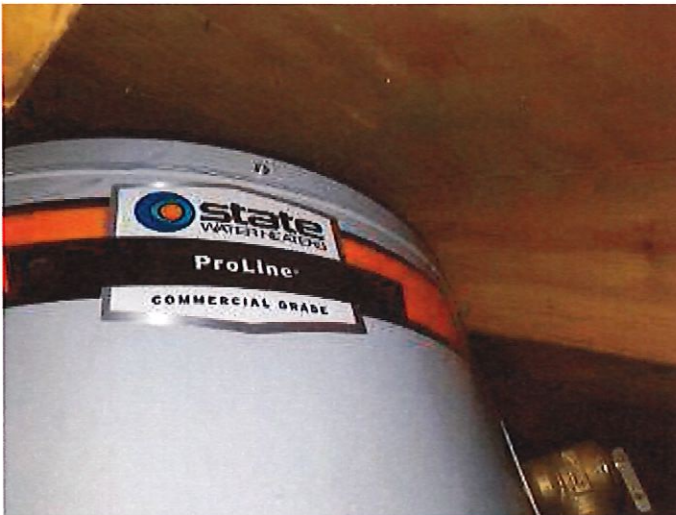
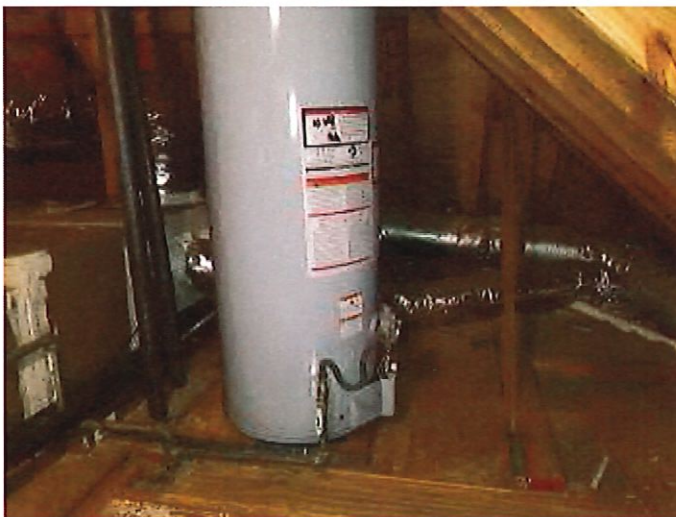
- The water heater and its components were found to be performing and in satisfactory condition at the time of the inspection.
- Water markings noted on top of GE water heater. Appeared to be previous leak above water heater (possibly roof jack / vent). Recommend future monitoring to ensure leak is repaired.

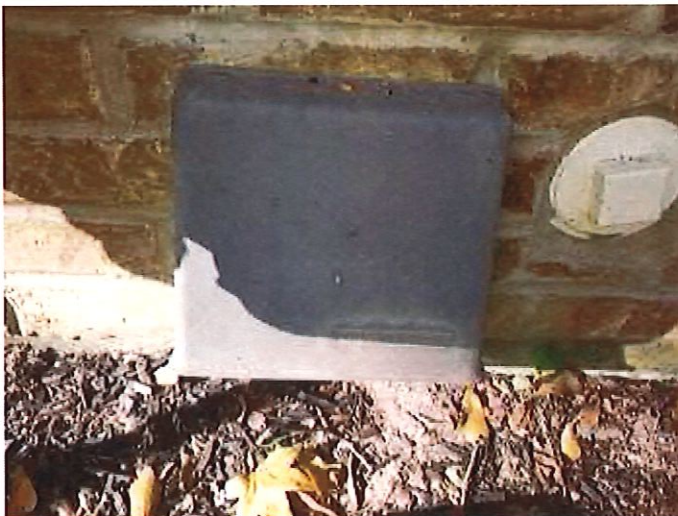
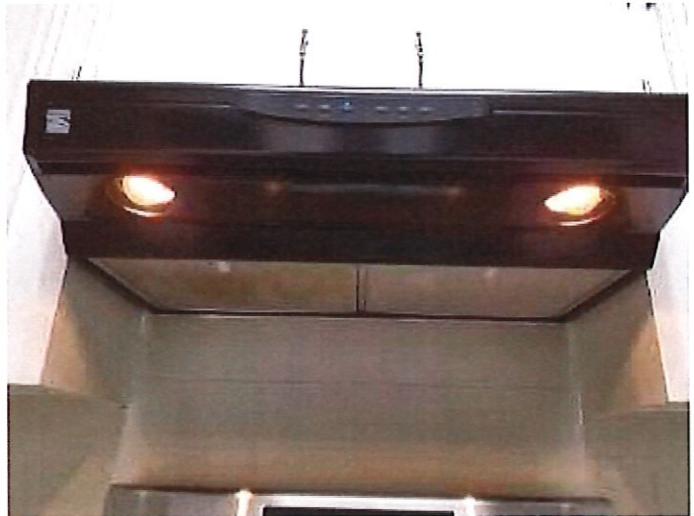
C. Range Hood and Exhaust Systems

- The range hood was functional at the time of the inspection.

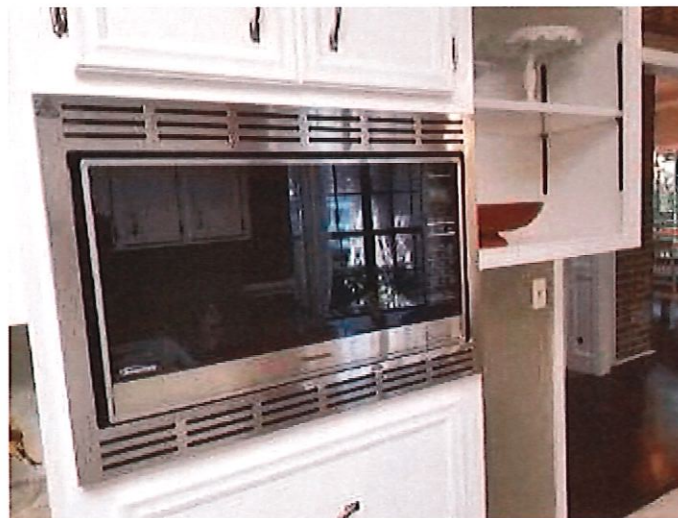
E. Microwave Ovens

- Built-in microwave ovens are tested using normal operating controls. Unit was tested and appeared to be serviceable at time of inspection. Leak and/or efficiency testing is beyond the scope of this inspection. If concerned, client should seek further review by qualified technician prior to closing.

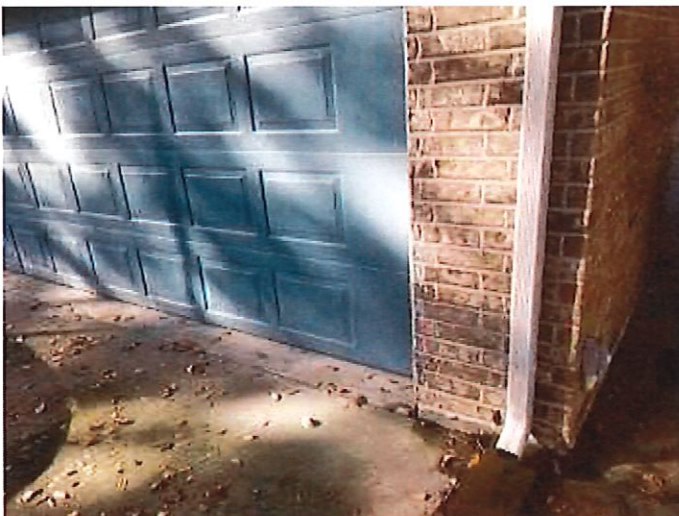
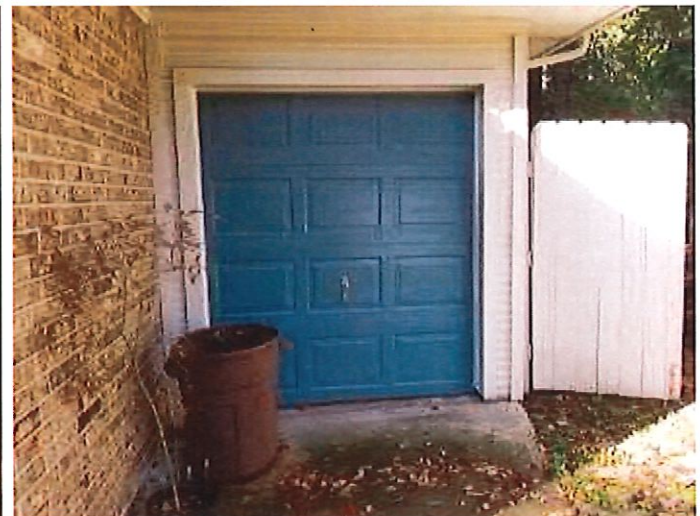
G. Garage Door Operators

- The garage door was not accessible for testing and/or inspection due to personal belongings.

• **The manual lock should be removed when an automatic garage door opener is in use.**

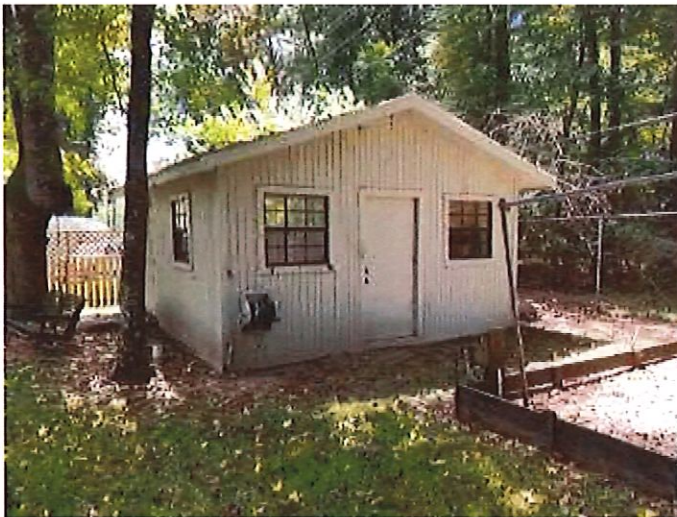
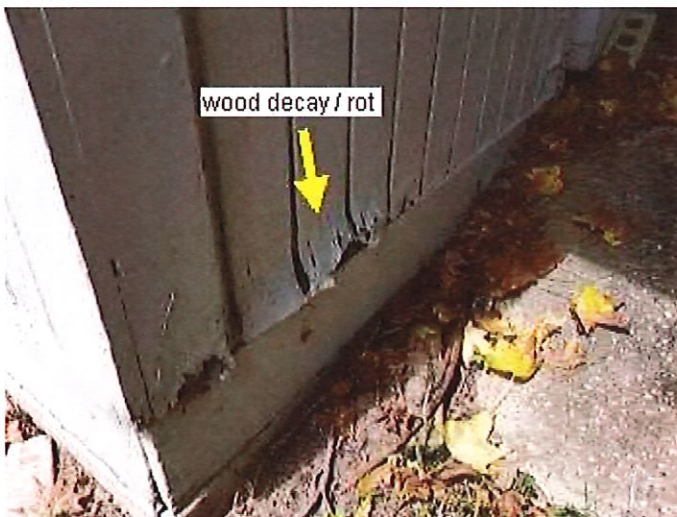
- The shed was observed to have wood rot and/or damage and should be further evaluated.
- Sub panel in building did not appear to have a ground. This is a safety hazard and should be corrected by licensed electrician. Sub panel was not tested to see if it was live at time of inspection. Recommend having licensed electrician evaluate panel and repair as needed to meet current standards.

Page 40 Item: C	Outbuildings	<ul style="list-style-type: none">• The shed was observed to have wood rot and/or damage and should be further evaluated.• Sub panel in building did not appear to have a ground. This is a safety hazard and should be corrected by licensed electrician. Sub panel was not tested to see if it was live at time of inspection. Recommend having licensed electrician evaluate panel and repair as needed to meet current standards.
-----------------	--------------	--
