## RESIDENTIAL INSPECTION REPORT

2132 Emerald Cove Drive  
League City TX 77573

Melody Hermes  
OCTOBER 31, 2019

# PROPERTY INSPECTION REPORT

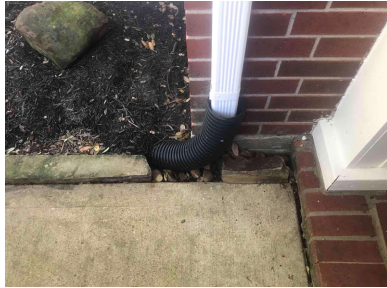
**1: Grading & Drainage: Negative Grading**

Grading was sloping towards the home in some areas. This can lead to water intrusion and foundation issues. Regrading by a qualified landscaping contractor or foundation contractor so that water flows away from the home is recommended.

Recommendation: Contact a qualified landscaping contractor

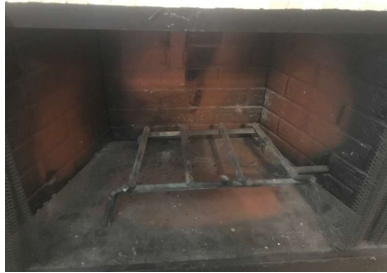
*Gas Line Capped:*

The gas line was capped and the fireplace could not be fully tested.

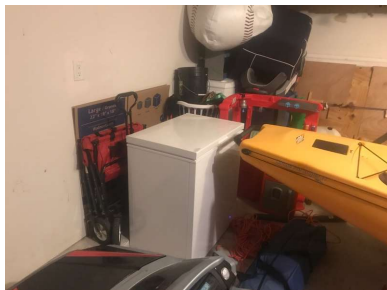
*Freezer in Garage - GFCI Not Tested:*

A refrigerator/freezer is in use inside garage. The GFCI outlets were not tested due to risk of power loss to the appliance.

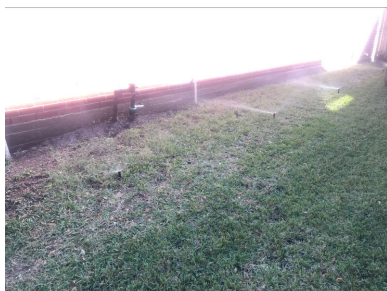
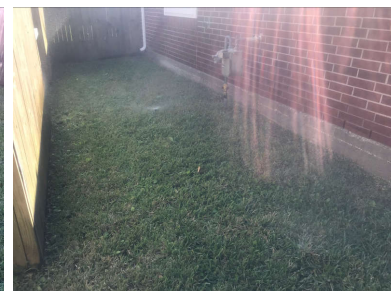
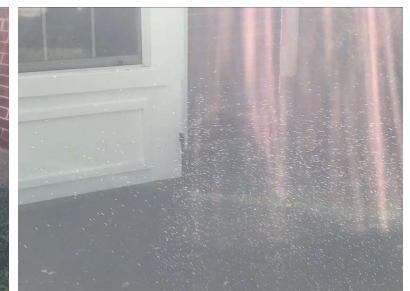
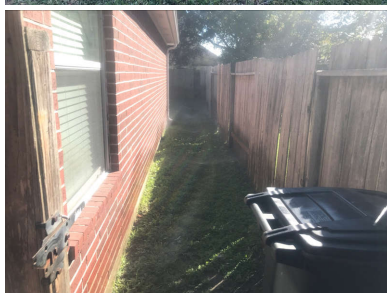
Sprinkler heads were spraying the structure. Sprinkler heads should be adjusted to spray away from the structure(s). Remedy as needed.

Recommendation: Contact a qualified professional.
