PROPERTY INSPECTION REPORT

Concerning: **10217 Teneha Street, Houston, Texas 77033**

By: **Scott Gillis # 22819**

April 25, 2019

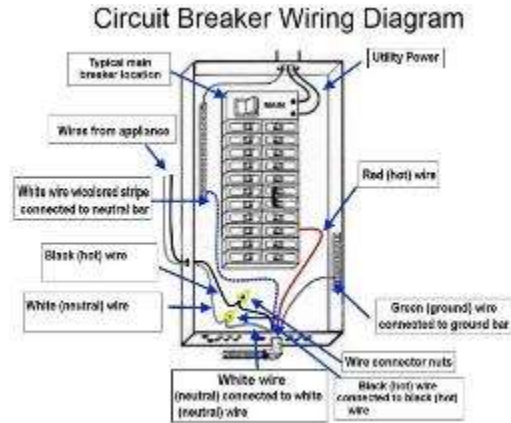
Breaker Panel

Arc Fault Circuit Interrupters (AFCI) were not installed for the houses at the time of the inspection. An AFCI device is intended to shut off the power to a 120-volt circuit should an electrical arc be detected in the circuit. It is pointed out, from 2002-2008 it was mandatory for houses to be equipped with AFCI breakers for the 120-volt circuits in the bedroom areas. Currently for construction built after January 1, 2009, most 120-volt circuits should be protected by AFCI breakers (with few exceptions). It is noted that this houses' current condition regarding AFCI protection is considered an "as built" condition by the local building authorities.

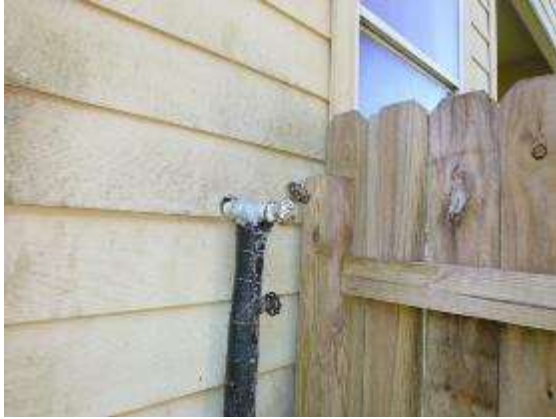
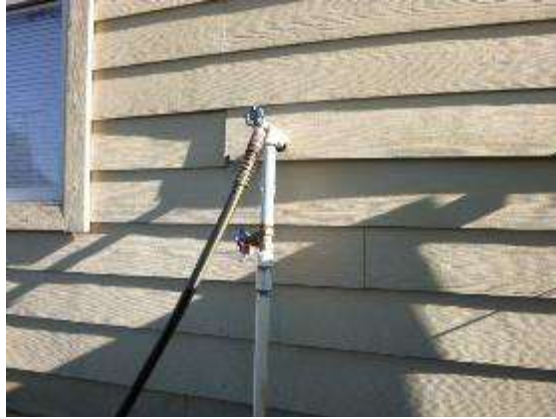
Supply Piping

Vacuum breakers were not installed at one or more of the hose bibs around the building. Vacuum breakers are intended to prevent backflow of water from a source outside of the houses potable water system. It is recommended that you contact a contractor to provide a cost estimate for any needed repairs.

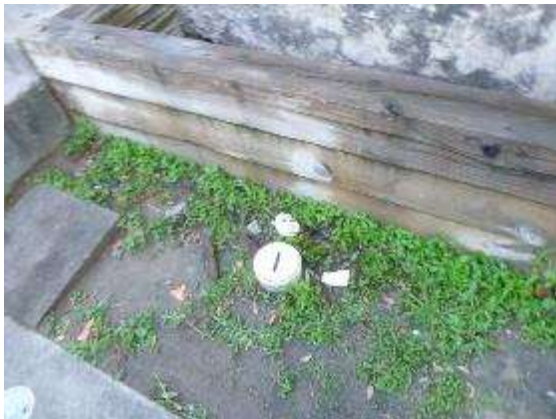
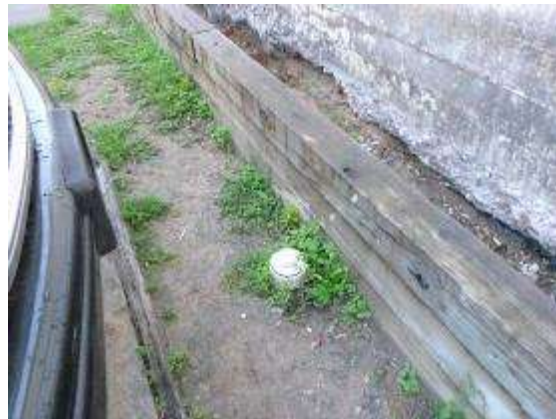
The sewer PVC clean out(s) were located at the front of each Unit. The clean out is needed in the event of a stoppage in the main sewer drain line, and the clean out is where a sewer snake would be installed to remove the clog in the drain line.

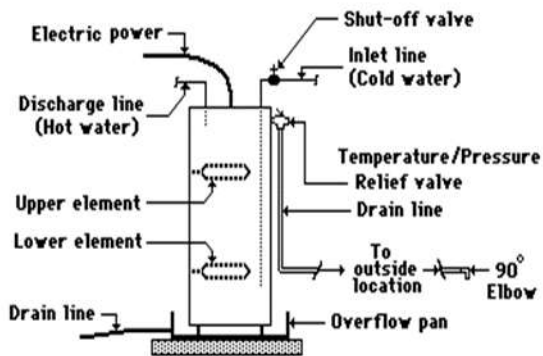
ELECTRIC WATER HEATER

The electric water heaters were equipped with disconnecting means for the power supply, so that the power could be shut off while the unit was serviced or replaced.

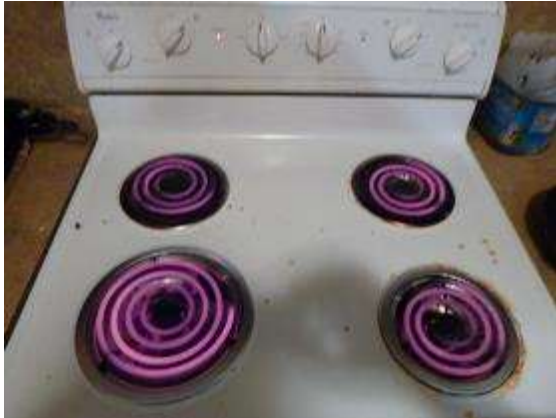
No items requiring repair were visible for the operation of the Unit A electric cooktop. All of the elements and controls were operating properly at the time of the inspection.

The Unit A oven thermostat was checked, and was not properly calibrated. The thermostat was set at 350 degrees, and the oven did not heat to within the allowable ± 25 degrees. The oven was checked with an oven thermometer, and found to heat to 390 degrees. Have a service company make the necessary adjustments to the thermostat.
