HEDDERMAN ENGINEERING, INC.

REF: CONDITION OF PROPERTY SURVEY

At your request, a visual survey of the house located at 10217 Teneha Drive, Houston, Texas, was made by Mr. Ruben Martinez and Mr. Scott Gillis.

10217 Tenaha Drive

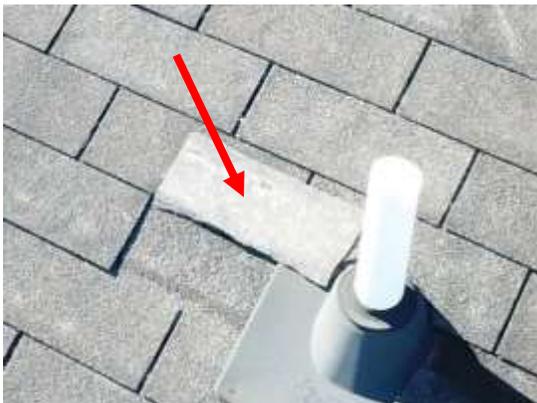
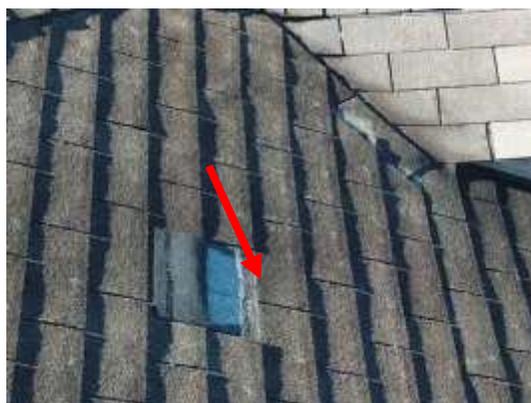
We observed shingles that were loose or missing, and need to be replaced.

Obtain Cost Estimate

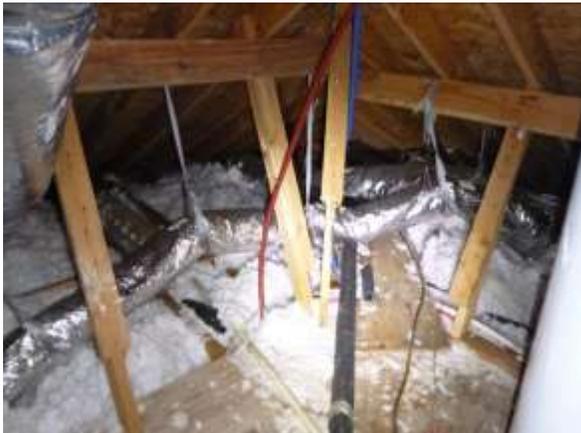
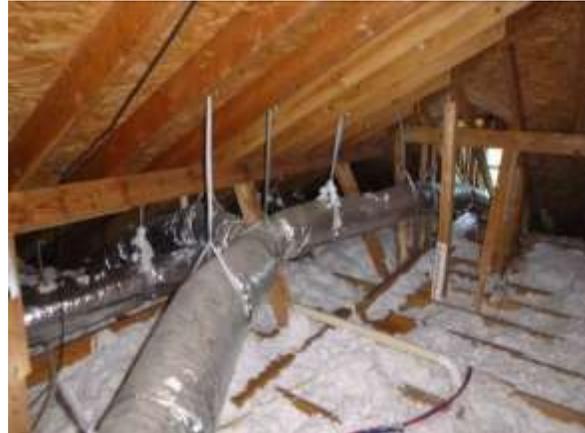
Wind uplift or hurricane clips and/or straps were observed to be installed over the ridge beam to rafters on both sides of the ridge beam, and also at the hip rafters. This provides a stronger structure and will be more resistant to wind uplift from hurricane and tornadoes. Due to the insulation installed at the eaves of the attic, we were not able to view the metal clips attaching the rafters to the top of the wall framing.

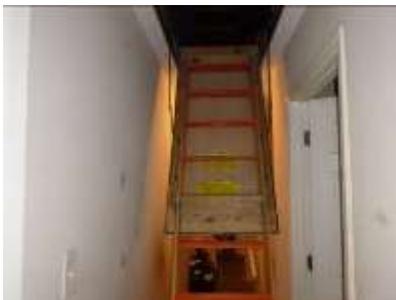
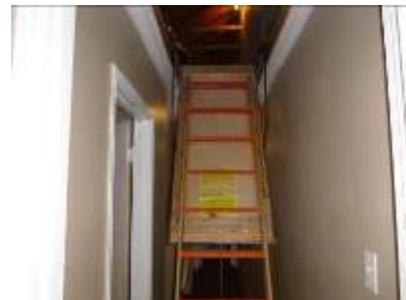
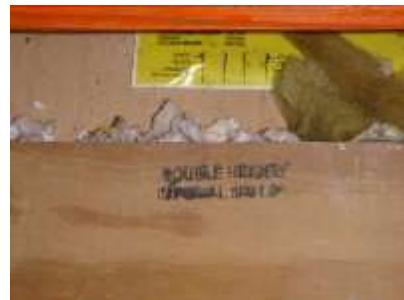
The attics had adequate service decking to the equipment, with a walkway that was a minimum of 24 inches wide. In addition, the attics had adequate platform decking at the equipment, with a working platform that was a minimum of 30 inches wide.

The access ladders were observed to be rated at 350 pound capacity.

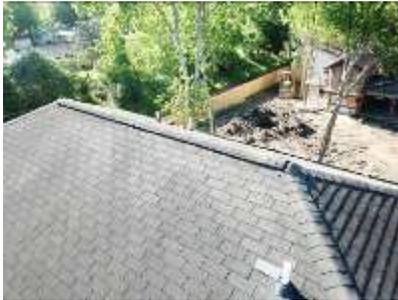
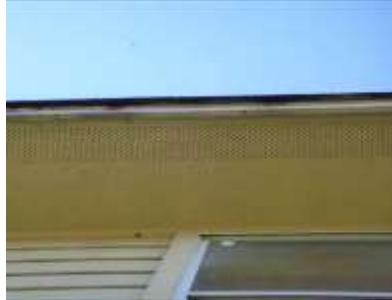
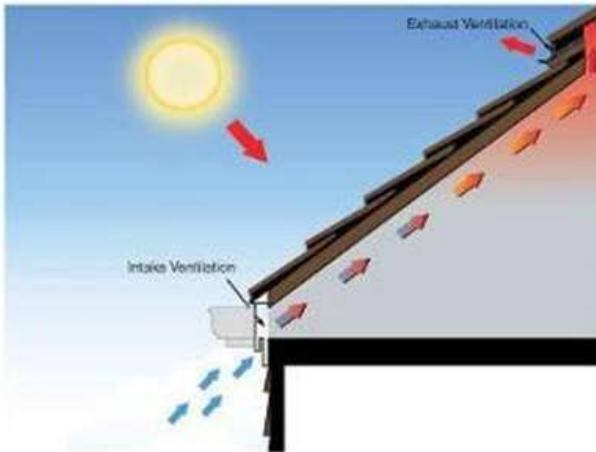
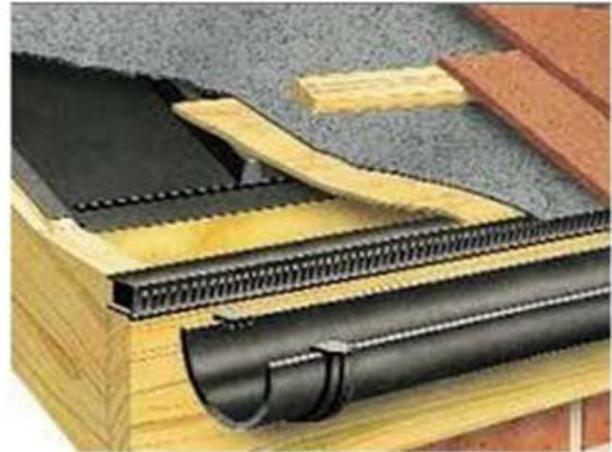
The ventilation for the attic included continuous ridge vents and continuous soffit vents.

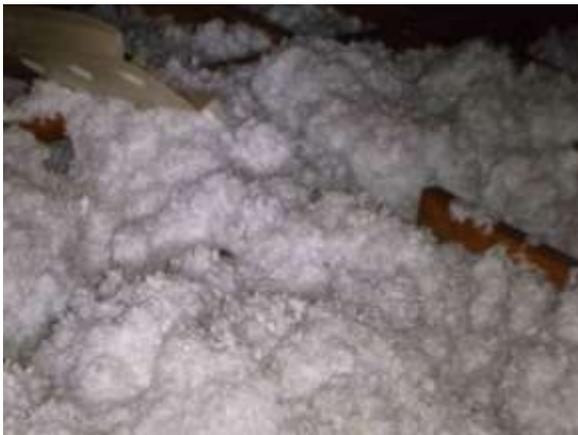
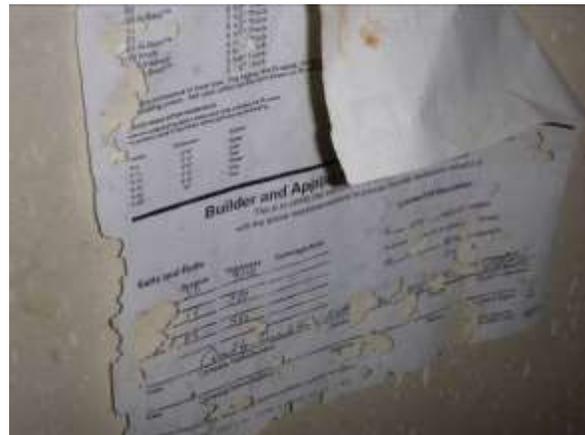
The insulation in the attics were average by today's standards. The normal amount of insulation for attics in this area is an R30 energy rating. The company who installed the insulation left a tag in the attic stating that the insulation was an R30 rating.

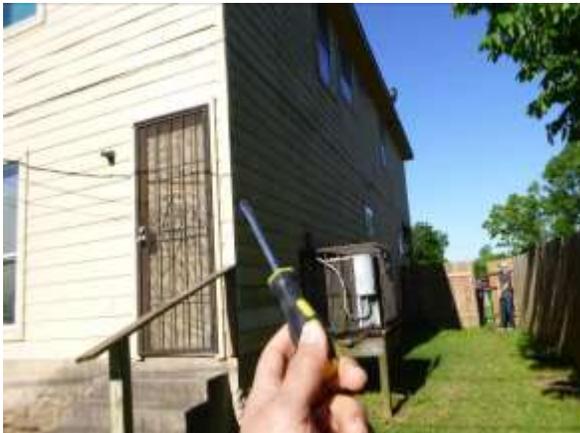
The siding around the house was damaged/broken and needs to be repaired.

Obtain Cost Estimate

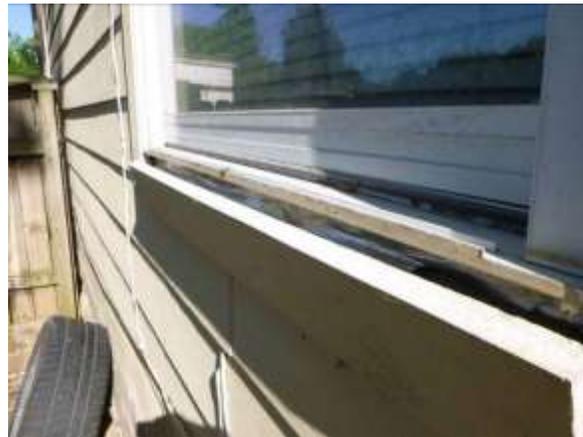
The siding around the house was loose/warped and need to be resecured.
Obtain Cost Estimate

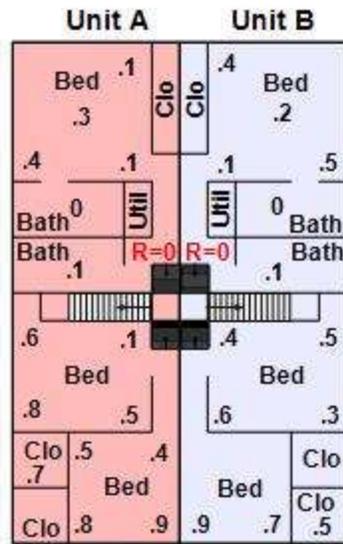
2nd Floor

The floors were checked with an electronic level, and were observed to be acceptably level throughout the house. The difference in elevation between the high point and low point was 1.1 inches at the 1st floor and 0.9 inch at the 2nd floor. The unlevelness takes place over a horizontal distance of approximately 35-40 feet.
