HouseCheck
Property Inspection Report

210 Birchwood Dr, Spring, TX 77386
Inspection prepared for: Chris Shannon
Real Estate Agent: Travis Foote - INETO Real Estate Services

Date of Inspection: 6/3/2019 Time: 1:00 PM
Age of Home: 1975 Size: 2609
Order ID: 619

PROPERTY INSPECTION REPORT

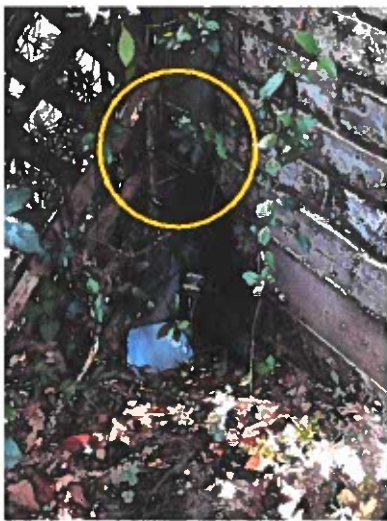
Left rear downspout

• The lower turn spouts on the downspouts were missing in the folloing location(s) front, back sides of the residence and should be replaced to direct water runoff away from structure.

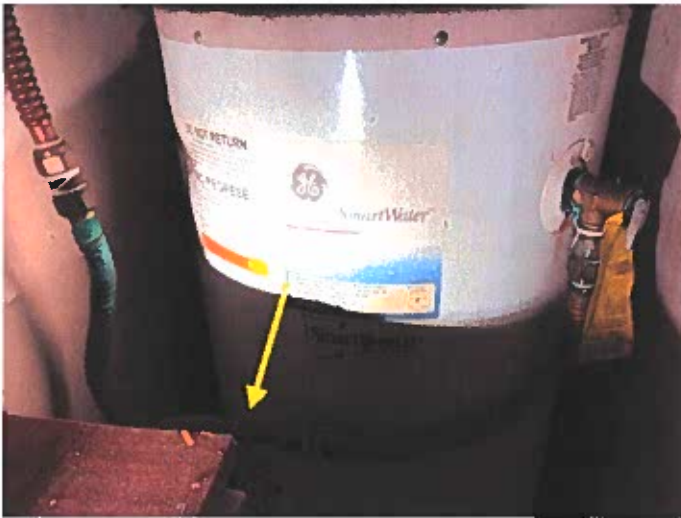
- The water heater(s) is/are 2007 model manufactured by GE
- Limitation: Gas service was not active at the residence during the time of the inspection. Unable to test water heating equipment functionality.
- Missing drip pan and drain line to the exterior underneath the water heater.
- Missing drip leg (sediment trap) for the gas line to the water heater.
- Temperature/pressure relief line slopes uphill this is a potential safety hazard. The drain for a TPR valve is to slope continuously downhill to prevent water being trapped in the line. This condition should be further evaluated by a licensed plumber.
- Water heater vent pipe incorrectly installed. This type of vent should be installed vertically.
- TPR valve discharge line constructed from multiple flexible connectors. This is an improper material. Line should be constructed from CPVC.

TPR drain line
