Property Inspection Report

Concerning:
526 Magnolia Bend St,
League City, TX 77573

By:
Cory Alan Haddox, P.E.
Professional Real Estate Inspector
License No.: 20464
2635 North Spring
Spring, TX 77373

Issued: 18 May 2019
Revision: 0

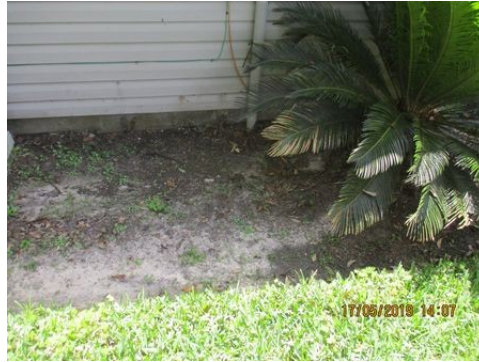
Photo 3

1. The yard and landscaping were found to be sloped to drain towards the foundation in a few places. See Photos 2 and 3.
2. The gutter downspout at the back left of the house was noted to be filled with debris. See Photo 4.

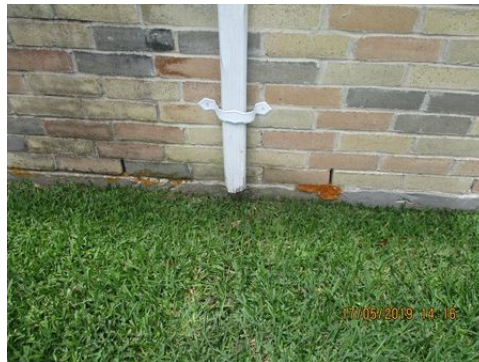
Photo 5

3. The gutter downspout on the right side of the house was observed to be missing the bottom piece and therefore was positioned to discharge water adjacent to the foundation. See Photo 5. It is recommended that water be discharged three to six feet away from the house.

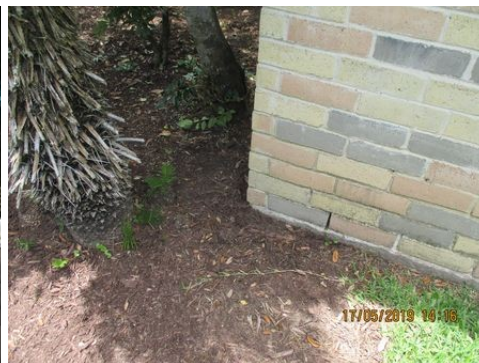
Photo 7

4. Some of the gutters were found to not be secured to the trim board properly. See Photo 6.
5. The landscaping at the front of the house was observed to have been recently pulled back from the foundation in some places, but was still noted to be built up above the brick line in others. See Photos 7 through 10.

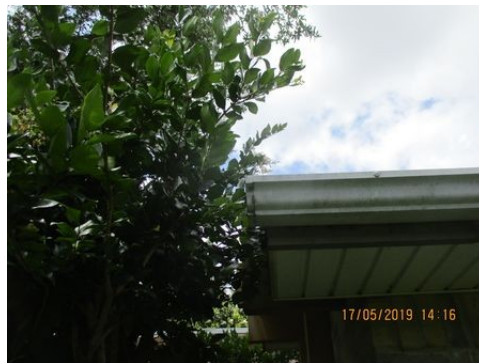
1. An uncovered and deteriorated piece of the roof decking was noted on the right side of the house. See Photo 11.
2. Tree limbs were found to be touching the roof surface at the front right corner of the house. See Photo 12
3. The flashing at the top edges of the roof was noted to be unpainted. See Photos 13 through 18. It is expected that flashing would be painted in order to avoid ultra-violet degradation.
4. As well, some exposed and rusted nails and unsealed seams were observed in several places on the flashing. See Photos 13 and 17 through 20.
5. Some damaged shingles were found. See Photo 21.
6. The small section of roof at the front of the house was noted to be without the sidewall flashing. See Photo 22.

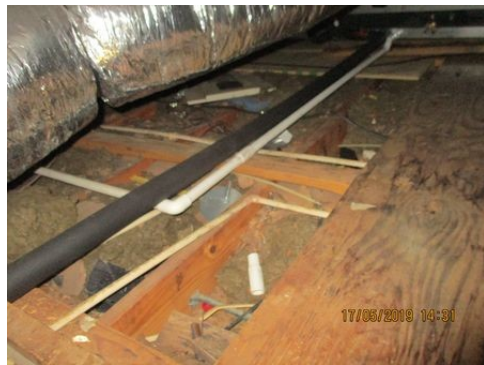
Approximate Average Depth of Insulation: 2-4 inches, see Photo 23

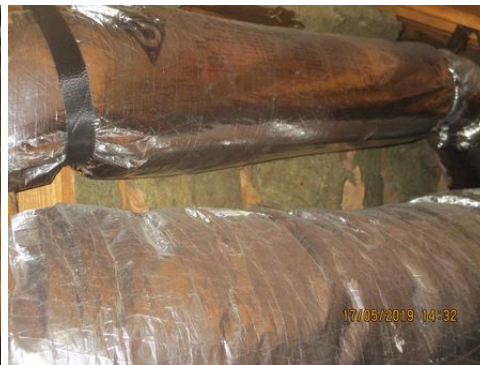
Approximate Average Thickness of Vertical Insulation: 4 inches, see Photo 24

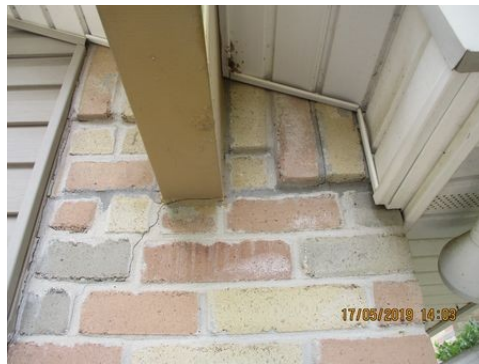
Photo 28

1. Several brick and mortar separations were noted on the exterior walls. See Photos 27 through 35.
2. The caulk in the exterior brick wall expansion joints was found to be deteriorated and separated. See Photos 36 and 37.
3. The caulk on the trim and siding was observed to be deteriorated and separated in several places. See Photos 38 through 50.
4. Openings were noted above the beams at the front of the garage. See Photos 51 and 52.
5. The trim and siding were found to be damaged in a several places. See Photos 53 through 65.
6. The tile was observed to be cracked near the shower head in the master bathroom shower. See Photo 66.

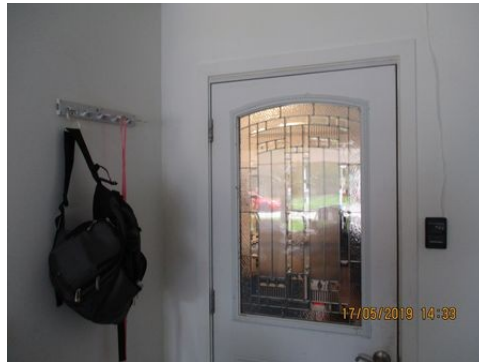
Photo 68

1. The front and back doors were found to have a piece of unpainted wood underneath. See Photo 67.
2. A garage entry door is expected to be 1-3/8 inches thick and to be self-closing. This garage entry door was noted to be less than the expected thickness and to not be self-closing. See Photo 68.
3. As well, the door handle for this door was observed to be loose. See Photo 69.
4. The closet by the front door was found to rub the frame.
5. The back right bedroom closet door was noted to not latch.
6. The master bedroom shower door was observed to have a loose handle.
7. The laundry doors were found to be misaligned and rub together when they were shut. See Photo 70.

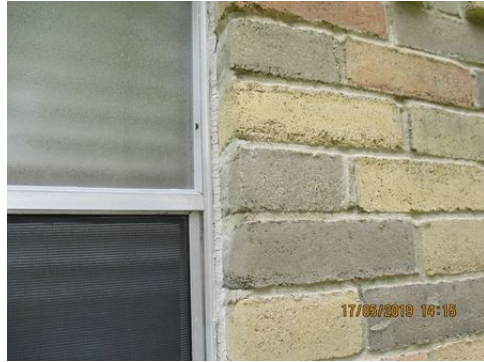
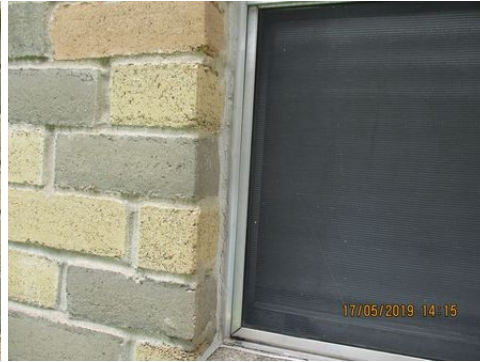
1. Some of the windows were noted to have deteriorated window seals. See Photos 71 through 74.
2. The caulk around some of the windows was observed to be deteriorated. See Photos 75 and 76.
3. Some of the windows were found to be without window screens.
4. The window screens at the back left window were noted to have bent frames. See Photos 77 and 78.
5. Windows that are less than 18 inches off of the floor are expected to be made of safety glass. Some of the windows in the house were noted to be less than 18 inches off of the floor but to not be made of safety glass or labeled as such.

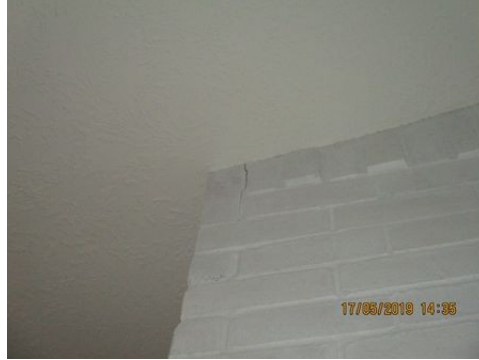
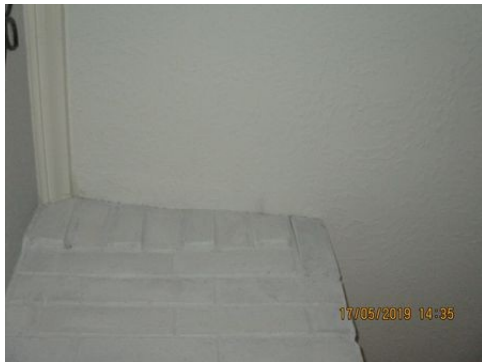
1. The chimney flashing was noted to be rusted. See Photos 79 and 80.
2. The chimney screen was found to be damaged. See Photo 81.
3. Brick and mortar separations were observed above the fireplace. See Photos 82 and 83.
4. The fireplace front cover was noted to not be secured in place properly.
5. It is recommended to have the fireplace cleaned and serviced before use.

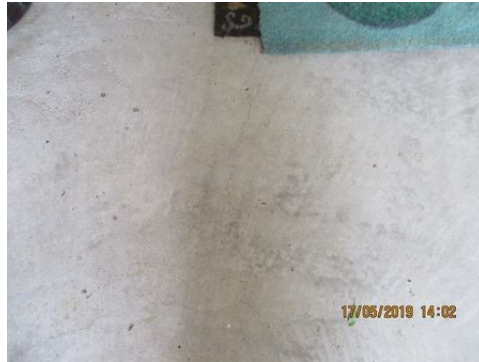
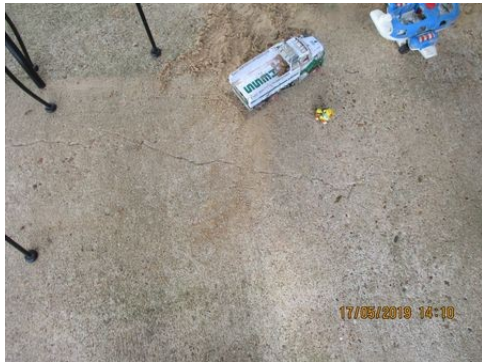
1. The front and back patios were noted to have cracks in the concrete. See Photos 85 through 88.
2. The back patio cover was found to move when pushed. It is recommended to have the cover further evaluated for the possible addition of bracing.

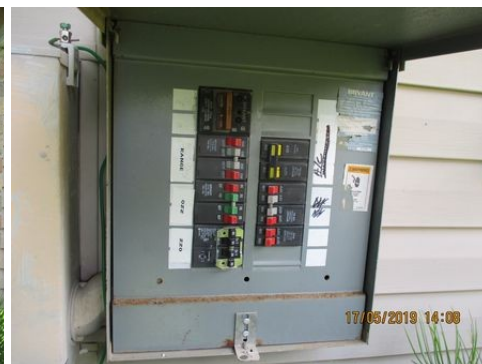
Photo 90

1. The 150 amp panel was observed to be Brand Bryant and was found to be located at the back left of the house. See Photo 89.
2. The panel was noted to not be labeled completely. See Photo 90.
3. Some replacement breakers of a different brand than the panel were observed in the panel. This could be a safety hazard.
4. Due to the age, it is recommended to have the panel further evaluated for replacement.

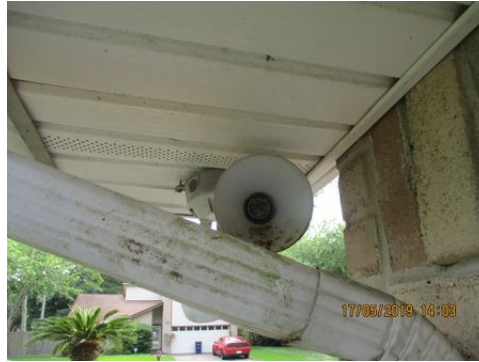
Photo 92

1. The exterior light fixture at the front right of the garage was found to not be secured to the eave properly. See Photo 91.
2. As well, pests were noted to have a nest built in one of the fixtures. See Photo 92.

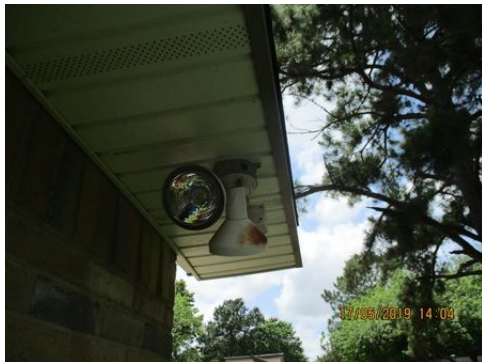
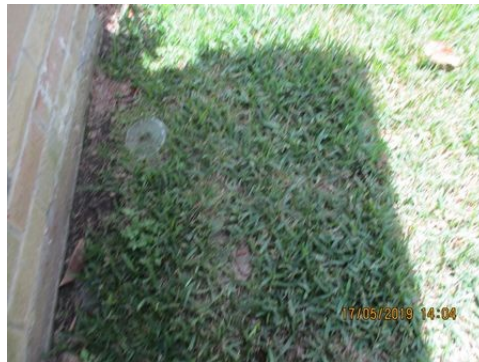
3. The exterior light fixture at the front left of the garage was observed to have a cover that had fallen off. See Photos 93 and 94.
4. Ground Fault Circuit Interrupter (GFCI) receptacles were noted to be missing or not labeled in several locations. GFCI receptacles should be in all wet and exterior locations. See Photos 95 through 98.

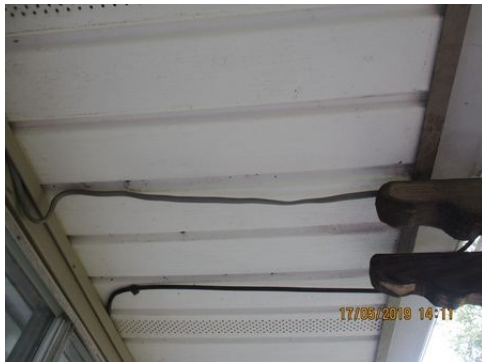
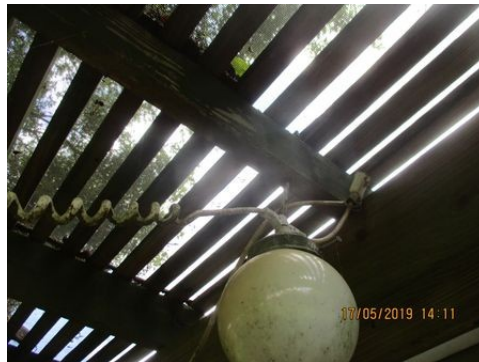
5. As well, the receptacle at the front of the house was found to not be secured to the wall properly. See Photo 96.
6. The wiring at the back patio cover was observed to be run outside of a conduit. See Photos 99 through 101.

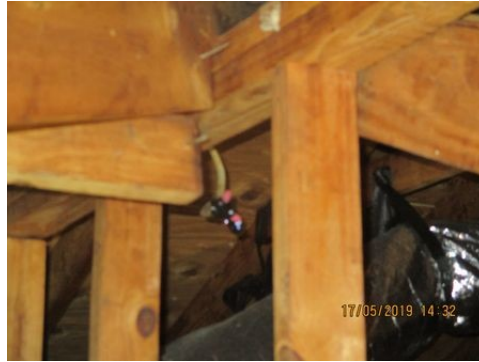
Photo 104

9. A light fixture at the back of the garage was observed to not be secured to the ceiling properly. See Photo 103.
10. A wire termination outside of a junction box was noted in the attic. See Photo 104.

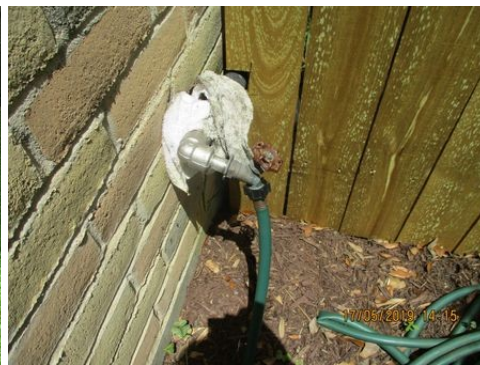
Photo 108

1. The exterior hose spigots were noted to be without back flow prevention devices.
2. The exterior hose spigot pipe on the right side of the house was found to not be secured to the wall properly. See Photo 108.
3. Signs of water supply plumbing repairs were observed in the attic.
4. The shower valve for the guest bathroom shower was noted to not be functioning properly at the time of the inspection.
5. A few of the supply valves were found to be corroded. See Photos 109 and 110.
6. The sink sprayer hose was observed to not return on its own. See Photo 111.

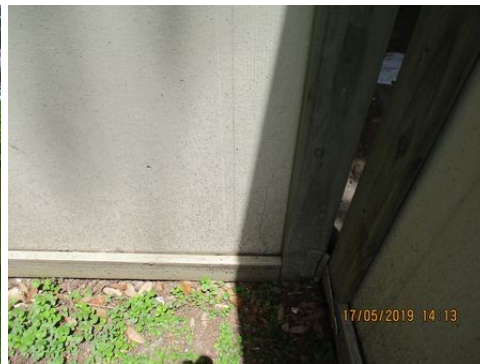
Photo 116

1. The trim and siding were found to be damaged and separated. See Photos 116 through 118.
2. The door was noted to be damaged. See Photo 119.
3. The hole for the light fixture above the door was observed to not be sealed properly. See Photo 120.
4. Ground Fault Circuit Interrupter (GFCI) receptacles were noted to be missing or not labeled in the shed. GFCI receptacles should be in all wet and exterior locations.
5. The receptacle on the outside of the shed was found to be missing the cover. See Photo 121.
