Total Home Inspection

Property Inspection Report

141 Clear Water W, Montgomery, TX 77356
Inspection prepared for: David Wisdom
Real Estate Agent: Kathy Hinds - Abby Realty

Date of Inspection: 11/11/2019 Time: 9:00 AM
Age of Home: 1996 Size: 1987
Weather: Cloudy - 70s

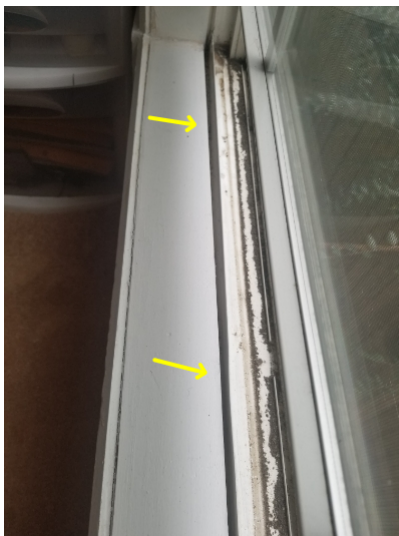
Some windows were not square and were contacting the frame.

Some windows had gaps in the caulk seal around the framing/drywall junction and require a caulking upgrade.

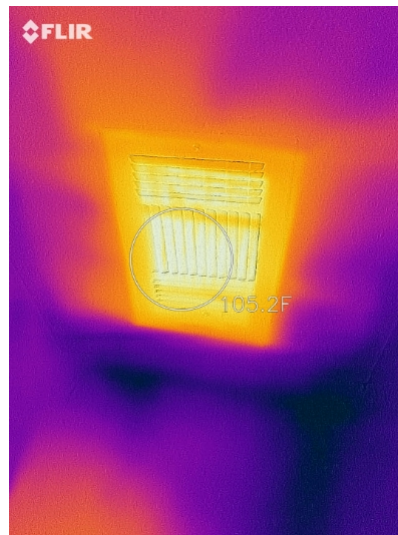
• An electric powered furnace was manufactured by Alumacoil in 2018. Furnace serviced the home with approximately 10 kw. Furnace was operated. Unit appeared to be functioning as intended.

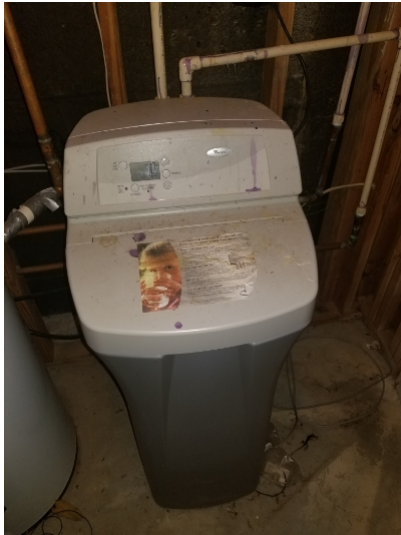
Water softening system was observed. Integrity of these systems was not tested. Manufacturer and service information was located on these units and seller may be consulted for operations.
