Addendum to Seller's Disclosure Notice relating to the real property and improvements located at 4315 Dorothy Street, Bellaire, Texas 77401

HEDDERMAN ENGINEERING, INC.

REF: CONDITION OF PROPERTY SURVEY

4315 Dorothy

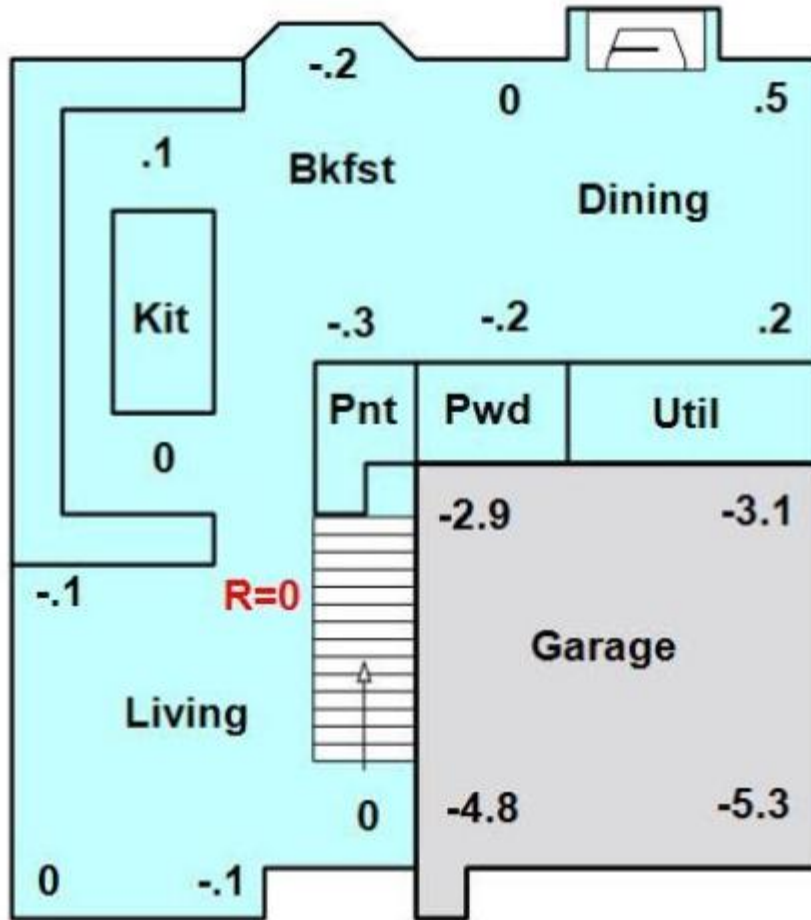
**Elevation Readings
4315 Dorothy**

The floors were checked with an electronic level, and were observed to be acceptably level throughout the house. The difference in elevation between the high point and low point was 0.8 inches. The high point was located at the southwest corner of the dining room, and the low point was located at the breakfast/kitchen area. The unlevelness takes place over a horizontal distance of approximately 25-30 feet.
