Morúa Real Estate Inspections, Inc.

PROPERTY INSPECTION REPORT

22711 Merrymount Dr., Katy, TX 77450

Juan Carlos Morúa License #5903 2/18/2020

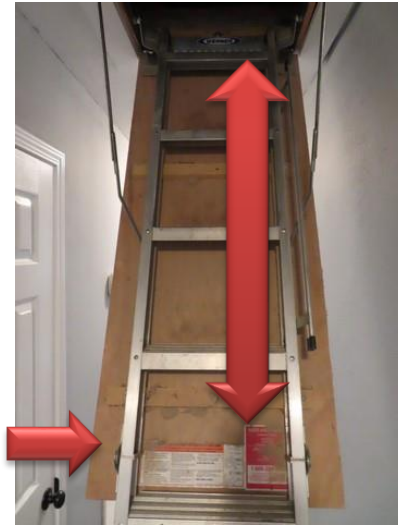
**Improper fasteners:**

Pull down attic stairs are installed with improper fasteners. Improper fasteners may have reduced shear strength and may not support pull-down ladders weight rating, thus causing a possible hazardous condition. Approved fasteners for attic pull-down stairs are 16d penny nails or ¼" x 3" lag screws.

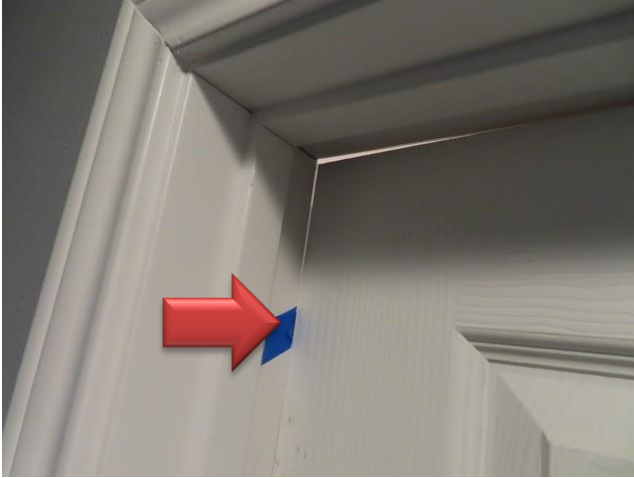
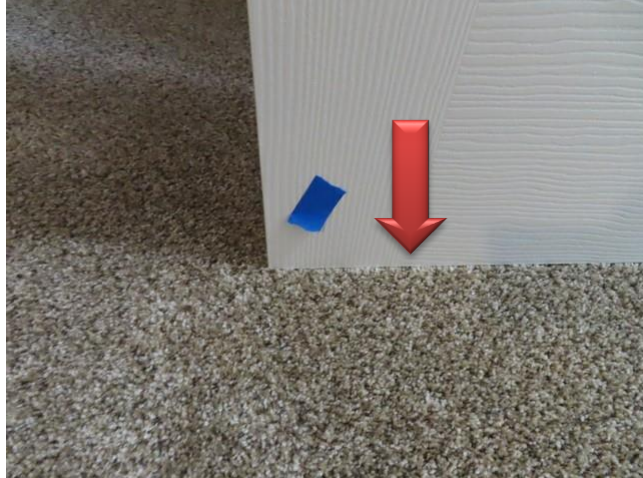
Door appeared to be out of square at bathroom. Door is making contact with frame
At several locations, doors are making contact with carpet.

Recommendation: Employ the services of a reputable carpenter to re-align door to close properly

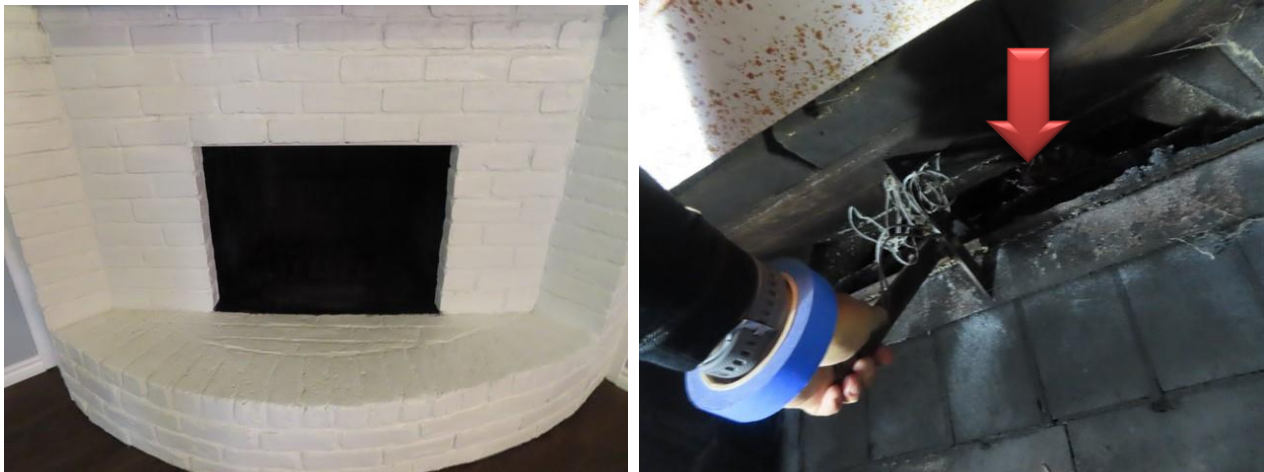
Comments: Type: Brick/stone - wood burning
 Damper does not remain open.

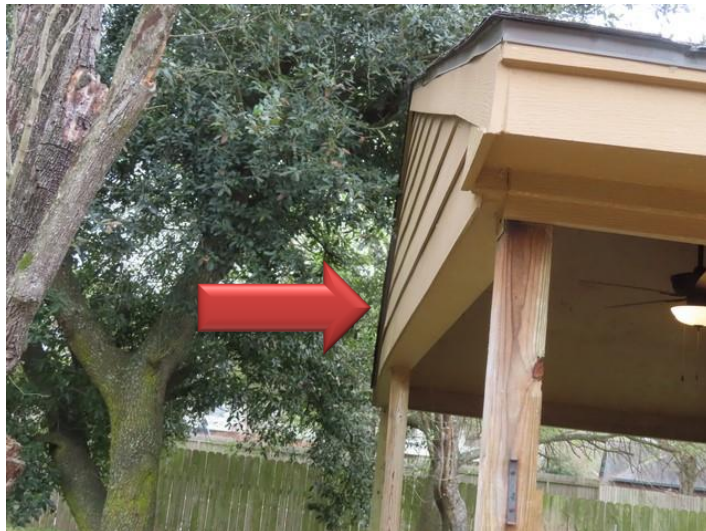
At rear porch, wall appears to be bowed and supports do not appear to be grounded at flooring.

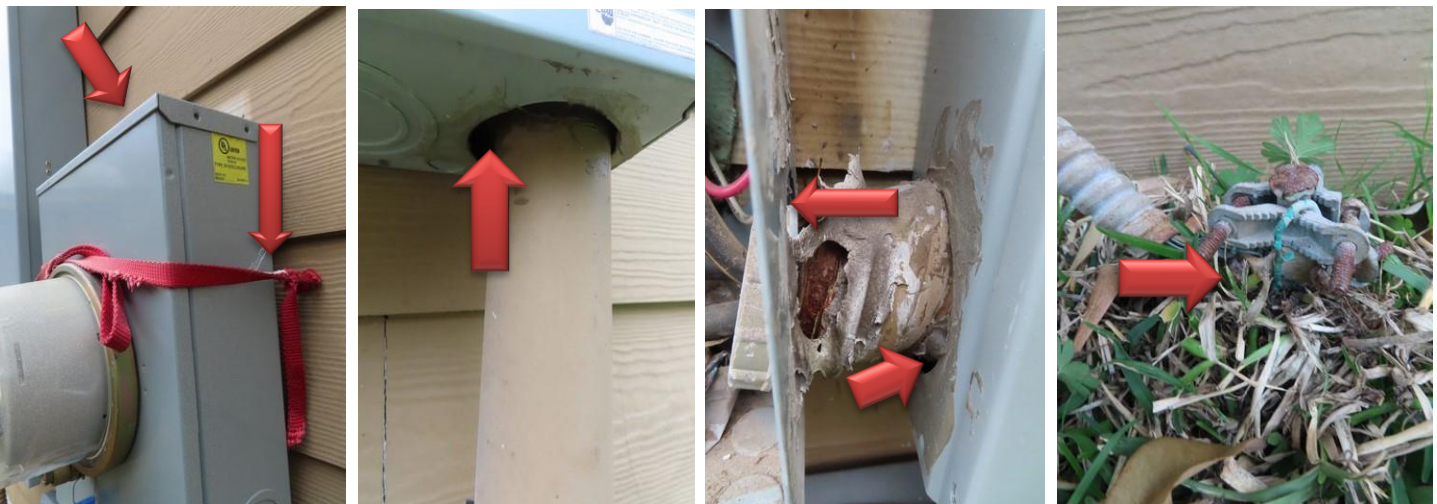
Service supply liquid tight conduit does not fully encase power supply line. Box junction conduit is not sealed. Openings create shock hazard.

Clamp is not properly secured to rod.

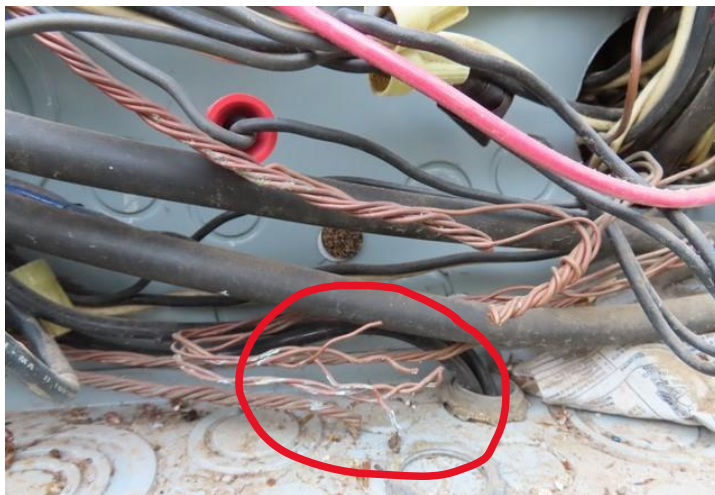
Grounding

Wiring at bottom of box are not connected.

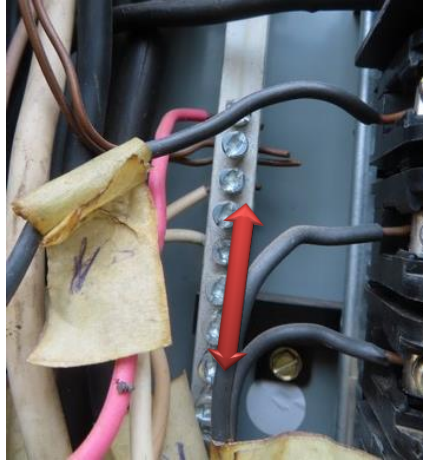
Wires on same bus:

The ground & neutral wires are installed on the same connecting bar. They should be kept separate bars.

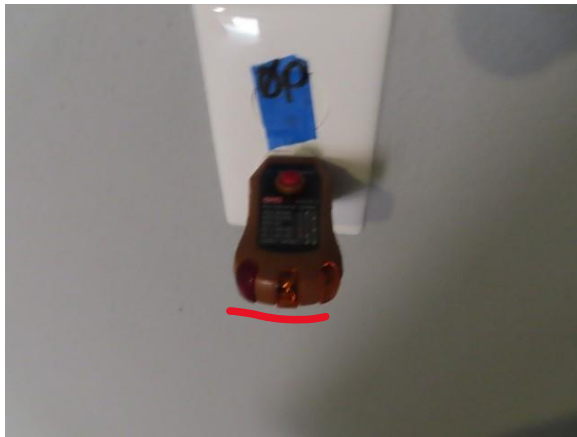
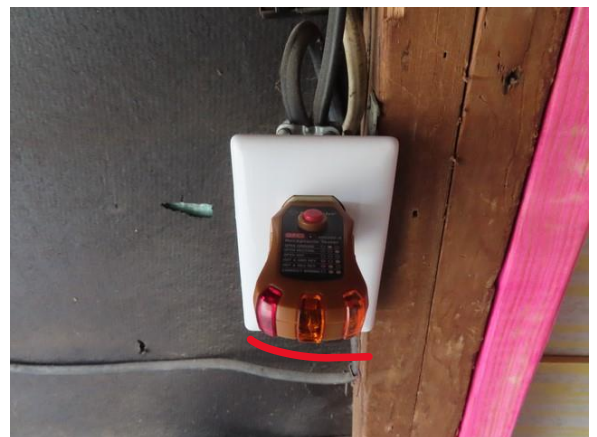
Outlets and switches:

At several locations, receptacles do not have power.

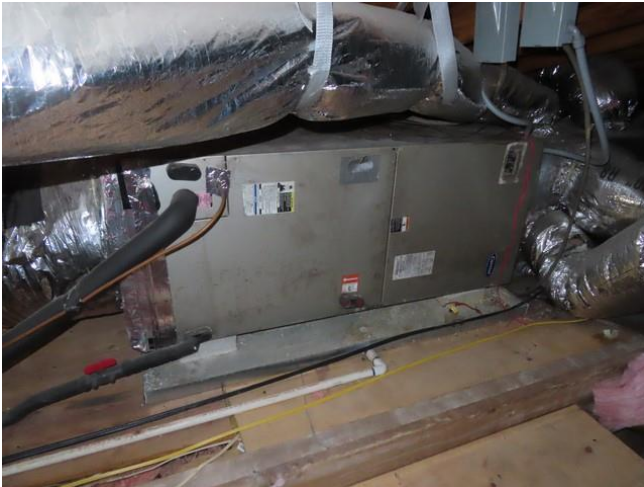
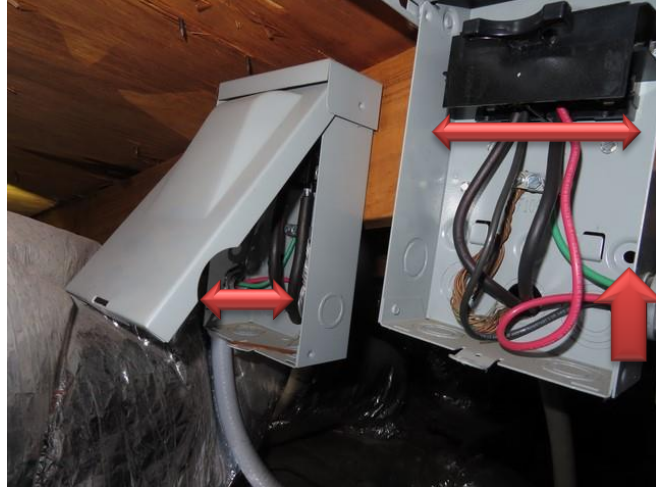
Working disconnects lack inner safety covers. Opening pose shock hazard.

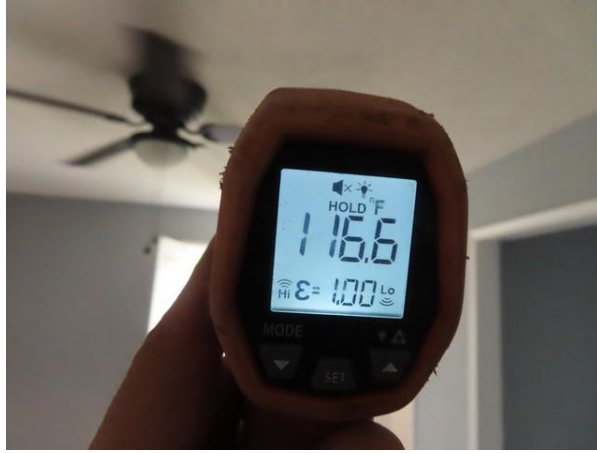
Hot Air Reading

Hot air reading throughout the house averaged about 116 degrees F. The acceptable minimum temperature is 107 degree reading from air supply vents throughout the house.

Recommendation: Access to the heat exchanger portion of a gas fired furnace requires disassembly and cannot be adequately checked during an external visual inspection. Inspection of the heat exchanger is typically part of a routine seasonal cleaning/inspection of the HVAC system available from HVAC professionals at a nominal cost. It is recommended units receive yearly service to optimize efficiency. Installation of a CO (carbon monoxide) detector is also recommended in homes heated by a natural gas furnace.

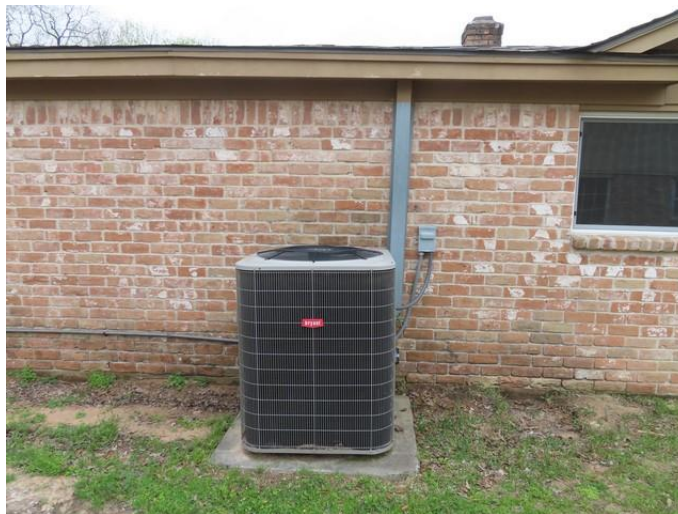
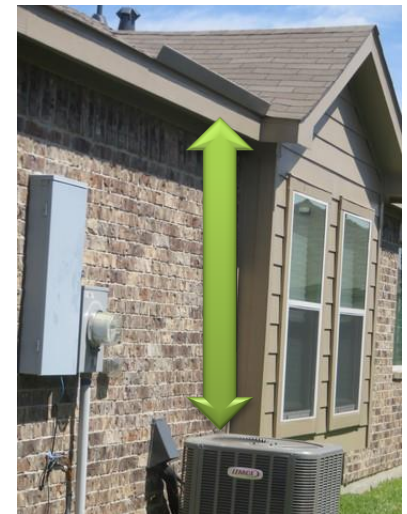
On roof of house, client ought to consider adding a water diverter to keep water from landing and causing water damage to unit.

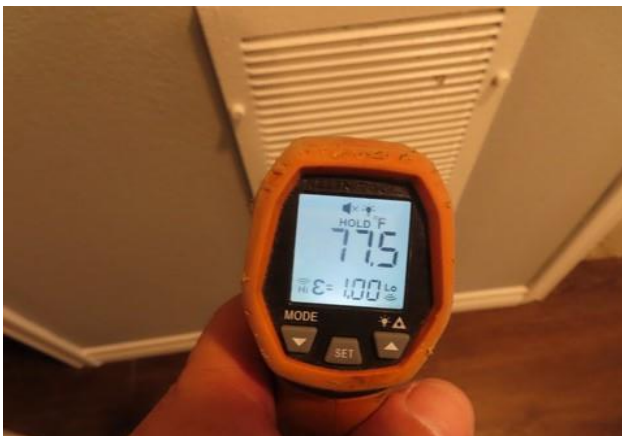
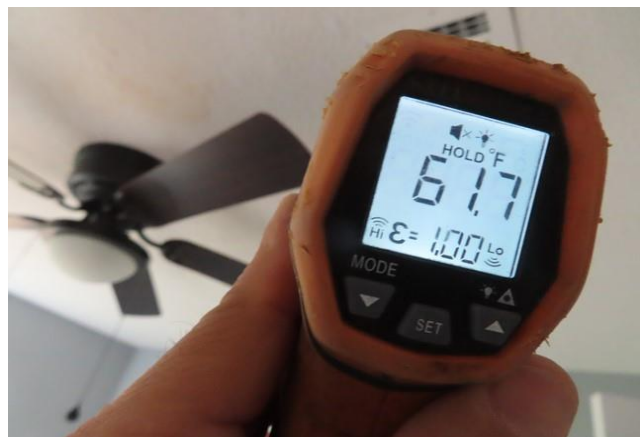
Differential temperature is 16 degrees F.

The acceptable differential temperature (temperature at the return minus temperature at the register) **range of the house should be between 14° to 20°F**. When the temperature drop is not within the tolerance levels, it usually indicates that servicing is needed.

Access to the condenser requires disassembly and cannot be adequately checked during an external visual inspection. Inspection of the condenser is typically part of a routine seasonal cleaning/inspection of the HVAC system available from HVAC professionals at a nominal cost. It is recommended units receive yearly service to optimize efficiency.

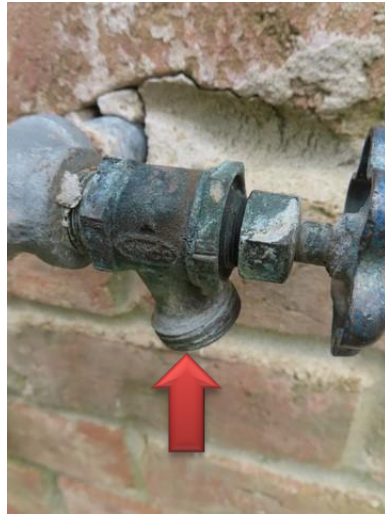
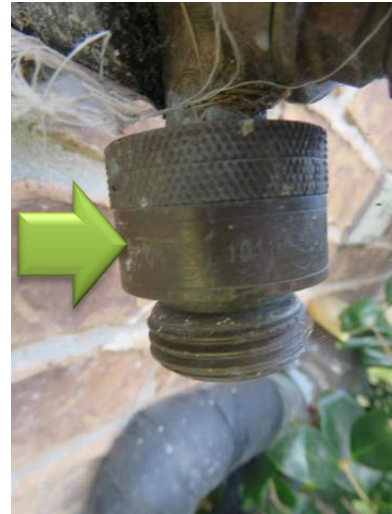
Exterior hose bibs do not have back flow prevention device.

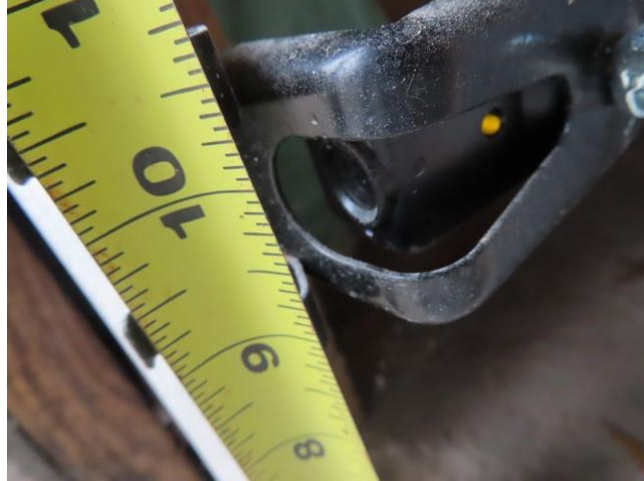
Garage door electronic eye sensors have been placed at an improper height at each side of the garage door. The acceptable height for garage door electronic eye sensors is 6 inches from ground level.

Recommendation: Correct issue as applicable per manufacturer's specifications.
