Moisture Assessment Report

Edwards McReynolds

1616 Castle Ct

7/18/2019

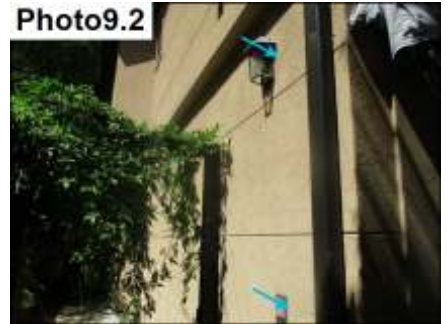
Photo9.2

Penetration Sealants/ Maintain

Grid Location	Item Description	Moisture Readings	Substrate Condition	Observations
Blue Arrows	Penetration Sealants			The penetration sealants are present in this location. The inspector states that this is a positive detail and suggests to maintain all sealants in an effort to prevent moisture intrusion. Please refer to photos #9.2, #9.3, #9.4 and #9.5 for more detail.

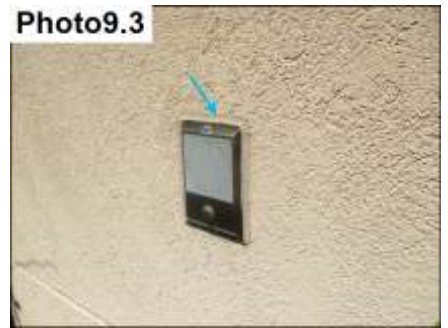
Photo9.3

Penetration Sealants/ Maintain

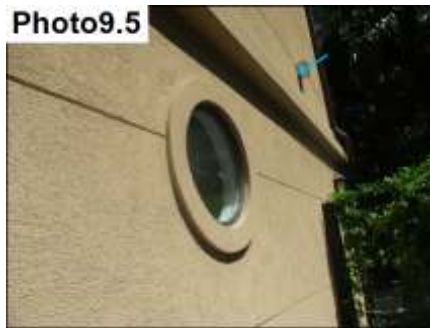
Photo9.5

Penetration Sealants/ Maintain

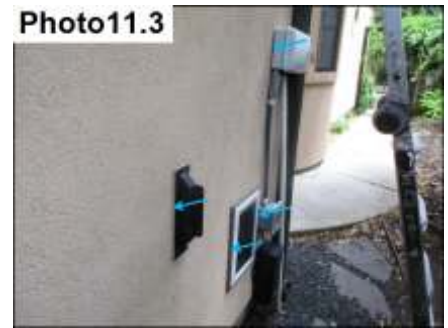
Photo11.3

Penetration Sealants/ Maintain

Grid Location	Item Description	Moisture Readings	Substrate Condition	Observations
Orange Arrow	Sprinklers			Sprinklers have been noted on this home. The inspector suggests to always redirect sprinkler heads away from the system and windows as needed in an effort to prevent moisture intrusion. Please refer to photo #11.2 for more detail.
Blue Arrows	Penetration Sealants			The penetration sealants are present in this location. The inspector states that this is a positive detail and suggests to maintain all sealants in an effort to prevent moisture intrusion. Please refer to photos #11.3, #11.4 and #11.5 for more detail.

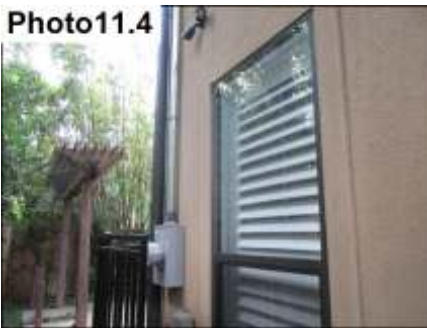
Photo11.4

Penetration Sealants/ Maintain

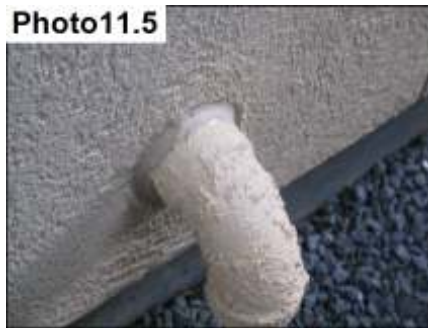
Photo11.5

Penetration Sealants/ Maintain

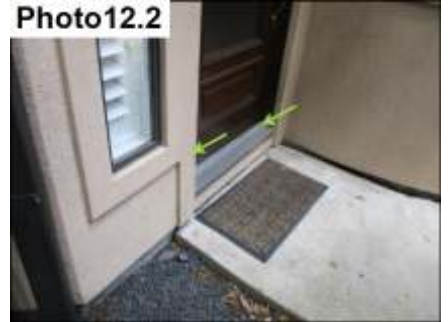
Photo12.2

- The door trim and miter sealants are present in this location. The inspector states that this is a positive detail and suggests to maintain all sealants in an effort to prevent moisture intrusion. Please refer to photos #12.2 #12.3, #20.2 and #20.3 for more detail.

Door Trim And Miter Sealants/
Maintain

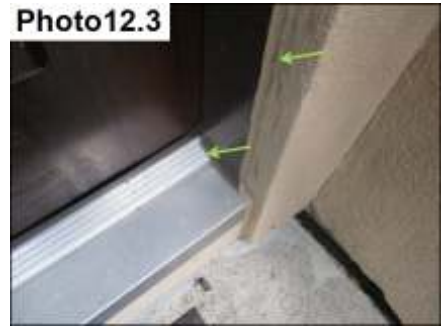
Photo12.3

Door Trim And Miter Sealants/
Maintain

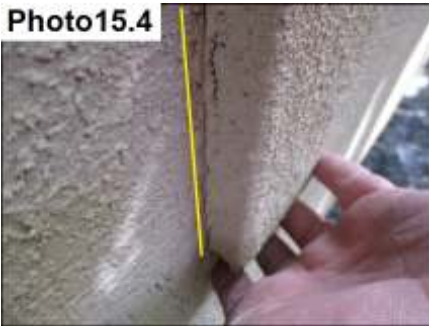
Photo15.4

- The window trim/stucco termination sealants are deteriorating. The inspector suggests to have a qualified stucco waterproofing contractor seal this area with NP1 or low modulus sealant in an effort to prevent moisture intrusion. These types of sealants are of high quality and compatible with stucco and other termination points. Please refer to photos #15.2, #15.3, #15.4, #15.5 and #15.6 for more detail.

Window Trim/Stucco Termination Sealants/ Seal

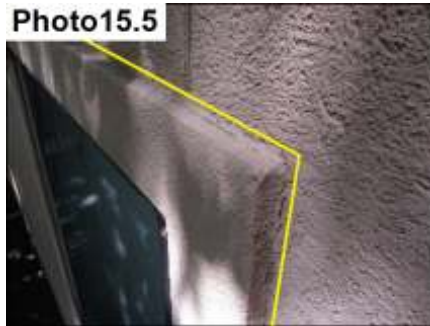
Photo15.5

Window Trim/Stucco Termination Sealants/ Seal

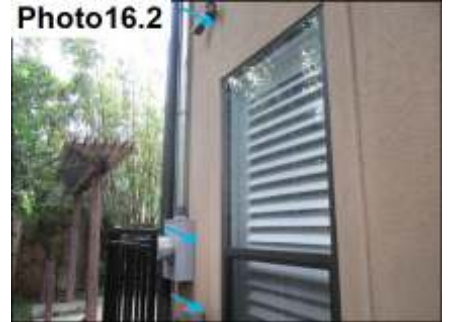
Photo16.2

Penetration Sealants/ Maintain

Grid Location	Item Description	Moisture Readings	Substrate Condition	Observations
Blue Arrows	Penetration Sealants			The penetration sealants are present in this location. The inspector states that this is a positive detail and suggests to maintain all sealants in an effort to prevent moisture intrusion. Please refer to photos #16.2, #16.3, #16.4, #16.5 and #16.6 for more detail.

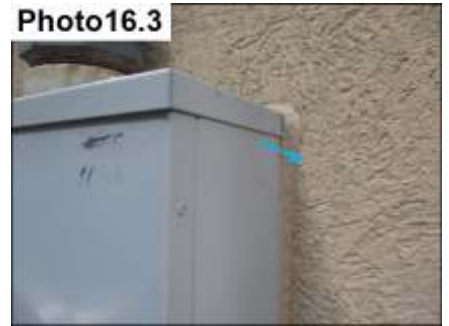
Photo16.3

Penetration Sealants/ Maintain

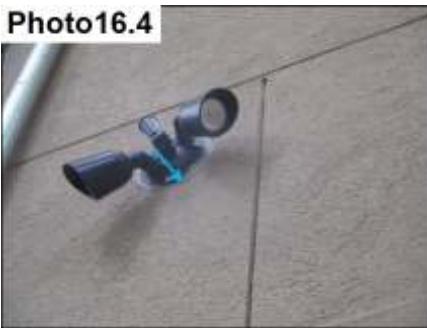
Photo16.4

Penetration Sealants/ Maintain

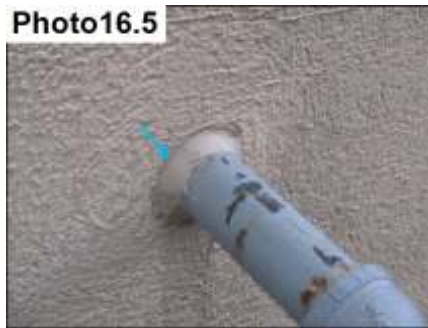
Photo16.5

Penetration Sealants/ Maintain

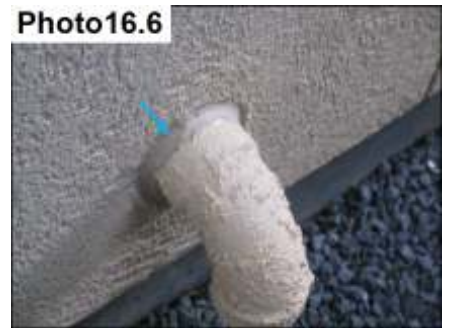
Photo16.6

Penetration Sealants/ Maintain

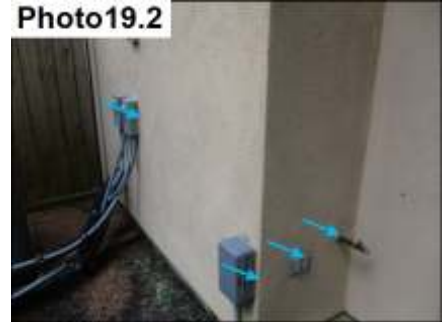
Photo19.2

Penetration Sealants/ Maintain

Grid Location	Item Description	Moisture Readings	Substrate Condition	Observations
Blue Arrows	Penetration Sealants			The penetration sealants are present in this location. The inspector states that this is a positive detail and suggests to maintain all sealants in an effort to prevent moisture intrusion. Please refer to photos #19.2, #19.3, #19.4, #19.5 and #19.6 for more detail.

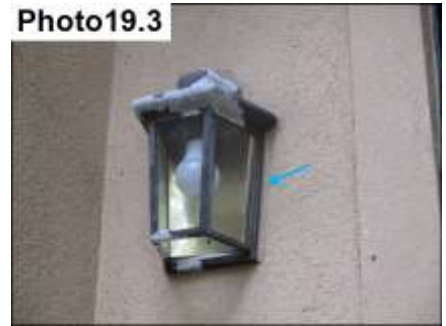
Photo19.3

Penetration Sealants/ Maintain

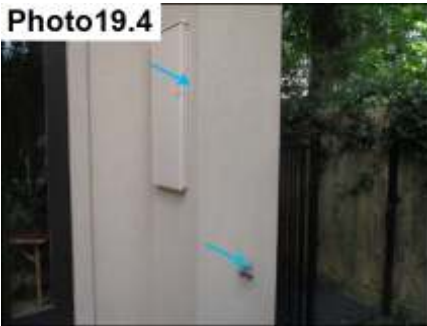
Photo19.4

Penetration Sealants/ Maintain

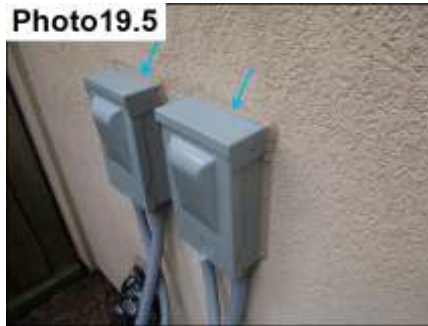
Photo19.5

Penetration Sealants/ Maintain

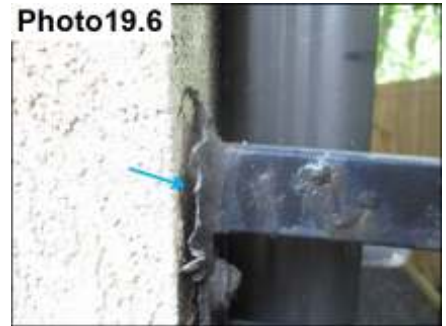
Photo19.6

Penetration Sealants/ Maintain

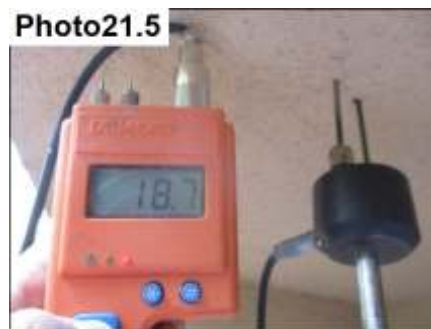
Moisture Probe/ Bottom Wall

Grid Location	Item Description	Moisture Readings	Substrate Condition	Observations
Blue Arrows	Window Sealants			The window sealants are present in this location. The inspector states that this is a positive detail and suggests to maintain all sealants in an effort to prevent moisture intrusion. Please refer to photos #21.2, #21.3 and #21.4 for more detail.
D6	Left Wall	28%	Firm	A moisture probe was made at the left wall. An elevated moisture reading was noted with a firm substrate.
I6	Right Wall	18%	Firm	A moisture probe was made at the right wall. The substrate was firm with no damage noted at this time.
E4	Bottom Wall	18%	Firm	A moisture probe was made at the bottom wall. The substrate was firm with no damage noted at this time. Please refer to photo #21.5 and #21.6 for more detail.
H3	Bottom Wall	16%	Firm	A moisture probe was made at the bottom wall. The substrate was firm with no damage noted at this time. Please refer to photo #21.6 and #21.6 for more detail.

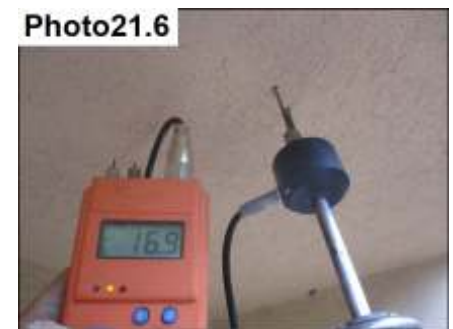
Moisture Probe/ Bottom Wall
