Home Inspection
4625 Cherry St
Santa Fe, TX. 77510

PROPERTY INSPECTION REPORT

Concerning: 4625 Cherry St, Santa Fe, TX 77510
(Address or Other Identification of Inspected Property)

By: James Ezell, Lic #21864 04/17/2020
(Name and License Number of Inspector) (Date)

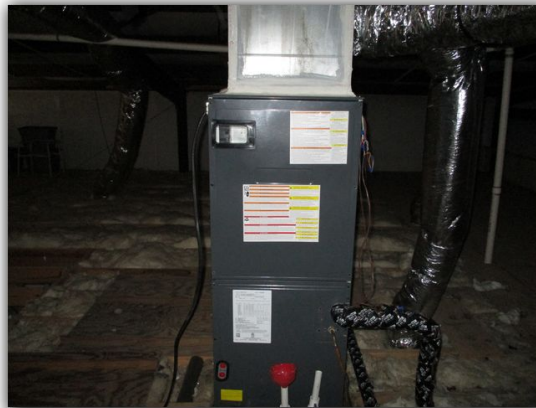
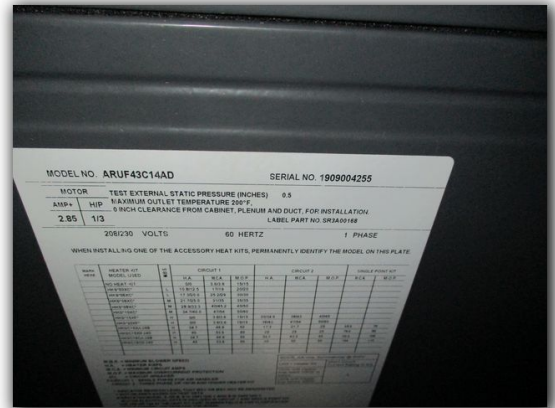
B. Cooling Equipment

Unit #1:
 Supply Air Temp: 72 °F Return Air Temp: 54 °F Temp. Differential: 18 °F

- The A/C unit appears to be in good working condition at this time. It is recommended that the HVAC system be cleaned and serviced annually by a licensed HVAC Service Technician.
