PROPERTY INSPECTION REPORT

Prepared For: Homer Balderas
(Name of Client)

Concerning: 4315 Walden Terrace Humble, Tx. 77396
(Address or Other Identification of Inspected Property)

By: Arturo Marquez TREC PI#2685 08/01/2019
(Name and License Number of Inspector) (Date)

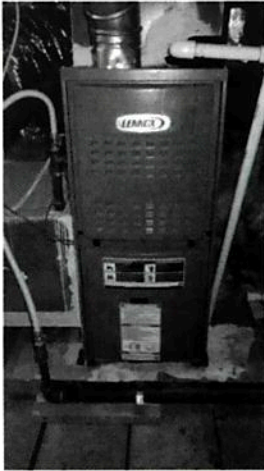
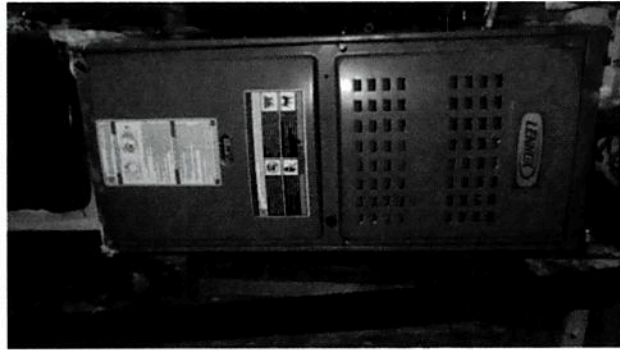
Comments: Both units were turned on and observed currently operable.
