# Confidential Inspection Report

LOCATED AT:  
3219 Tamara Creek Ln  
Pearland, Texas 77584

INSPECTED ON:  
Monday, December 26, 2016

# PROPERTY INSPECTION REPORT

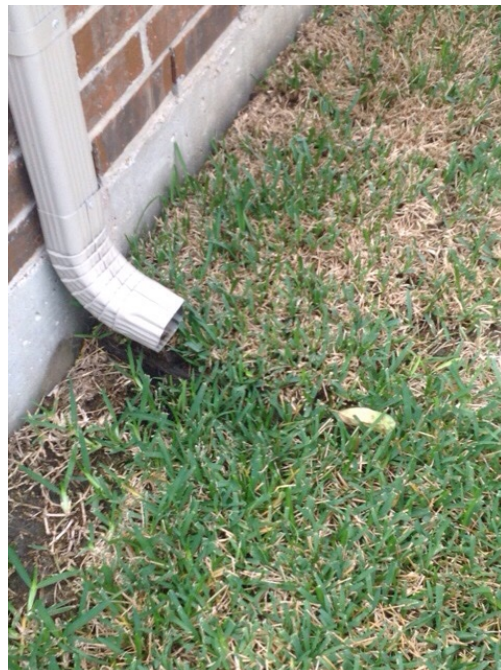
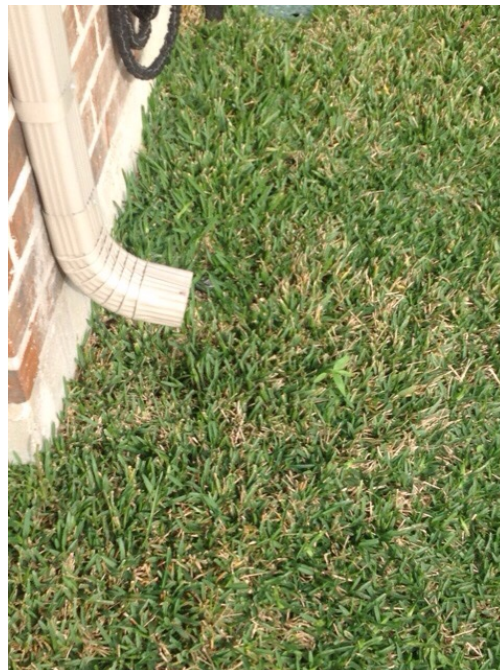
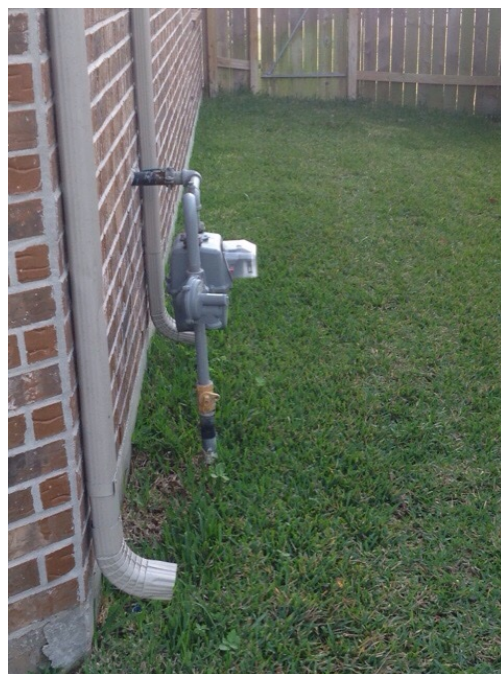
An examination of the grounds revealed standing water on the left side of home. The water does not appear to be directly affecting the structure, however, it is indicative of poorly drained and/or moisture retentive soil.

Splash blocks, directing water away from the foundation, were not at the base of every downspout. We recommend that a splash block be installed for every downspout.

Runoff water from the roof discharges next to the house. We recommend the downspouts be routed sufficiently away from the structure to prevent puddling, pooling, and saturation of the soil around the building.

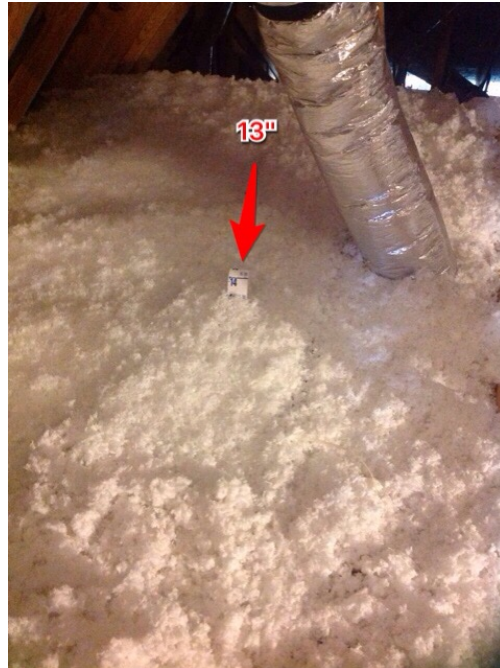
Due to access limitations, the insulation was only spot checked.

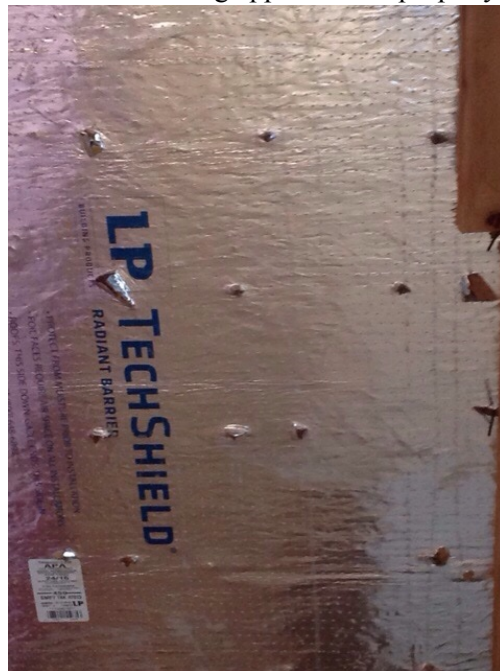
The roof sheathing appears to be properly installed and in good condition.

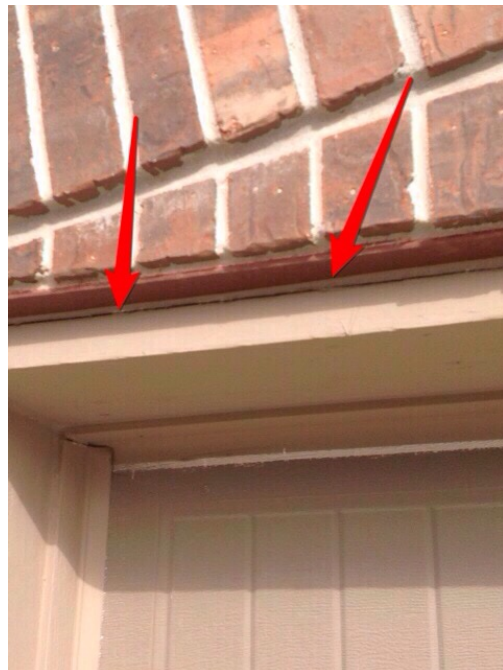
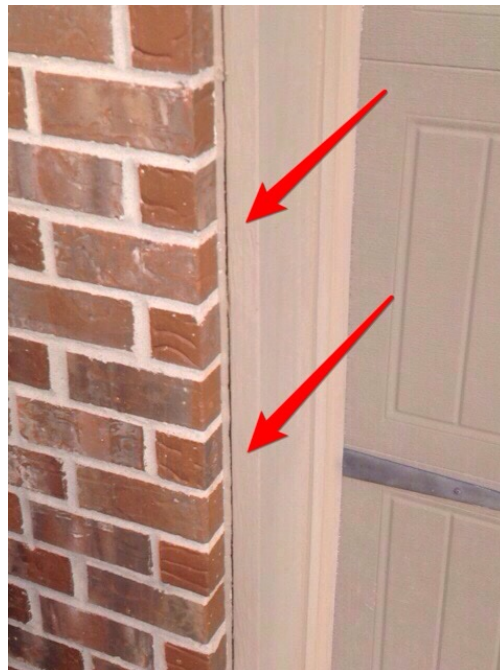
In this case, the veneer has pulled away from the building and/or has become unbonded from the wood frame. This is largely an aesthetic consideration, but we recommend sealing or covering gaps to prevent moisture and pest penetration.

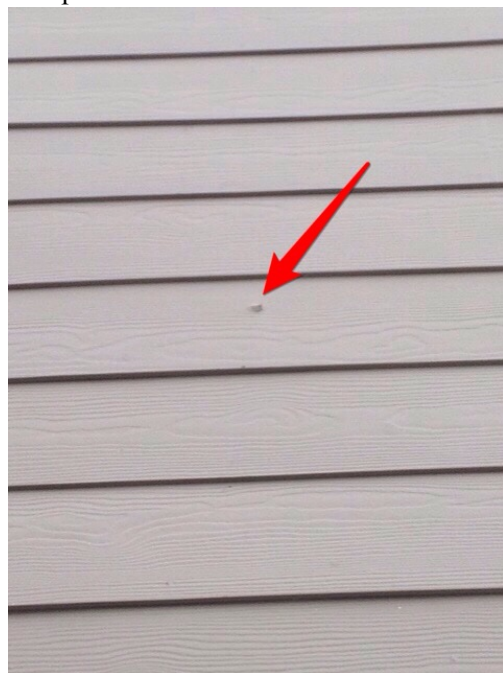
The hardboard siding appears to be properly installed and generally in good condition, with exceptions noted below.

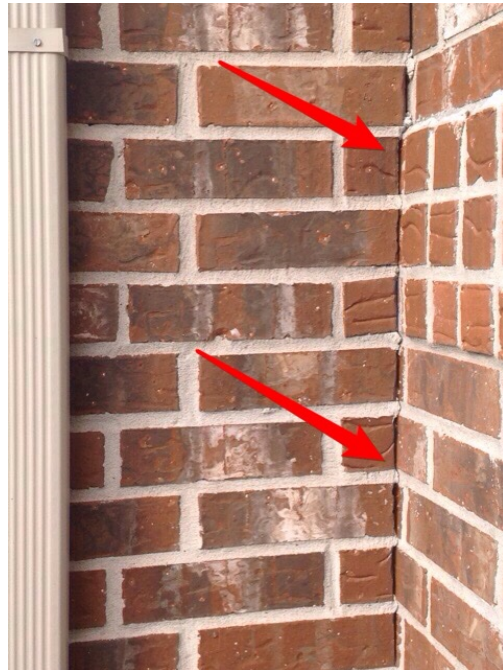
The mortar is deteriorated in some areas. To help prevent further damage, we recommend the mortar be repaired or 'pointed up'.

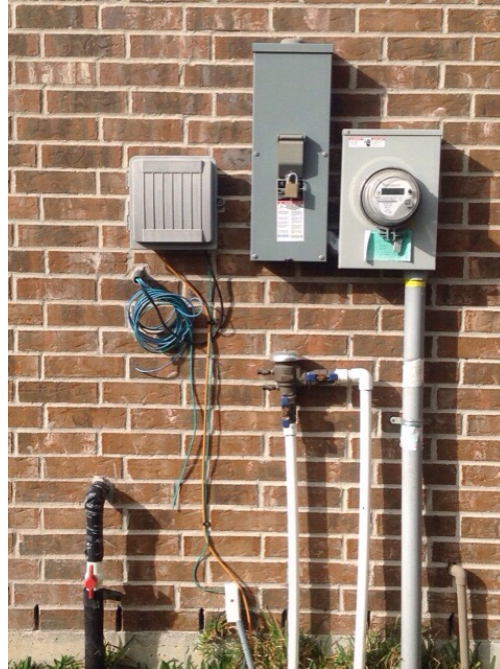
The meter and main electrical service panel are outside on the right side of the building.

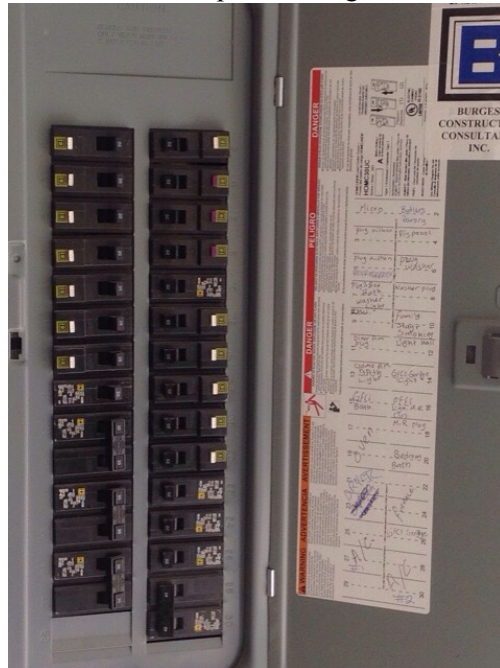
The main service panel is in good condition with circuitry installed and fused correctly.

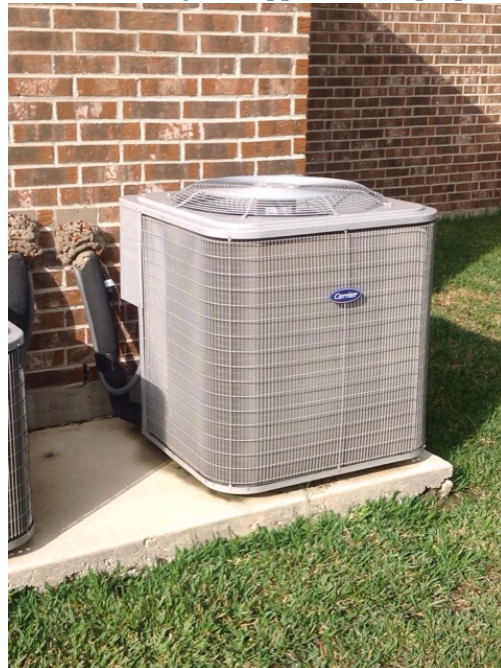
The condensing unit appears to be properly installed and in serviceable condition.

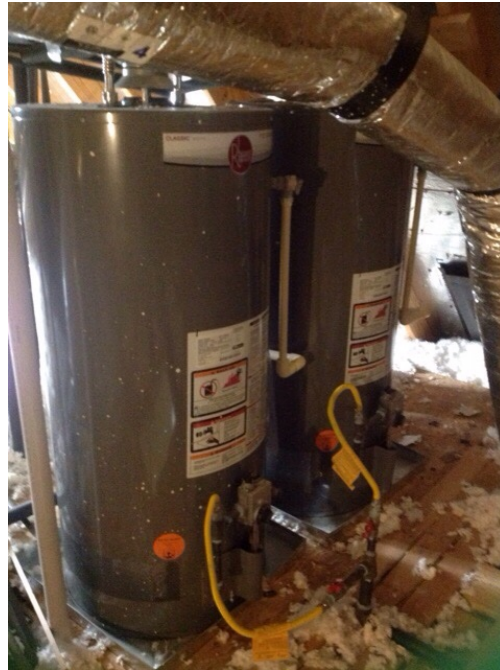
*Location:* In the attic

This is a newer water heater, was operating and with routine maintenance should be reliable for a number of years. However the insulation could block the drain.
