PROPERTY INSPECTION REPORT

Concerning: 27906 Skyhaven Lane, Fulshear, TX 77441
(Address of Inspected Property)

By: Jason Fielding, 21810 10/08/2018
(Name and License Number of Inspector) (Date)

A re-inspection was performed on 7/3/2019 at the request of the buyer to include items marked as deficient on the initial report.

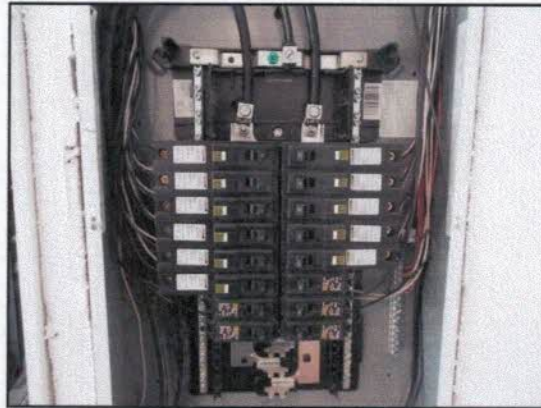
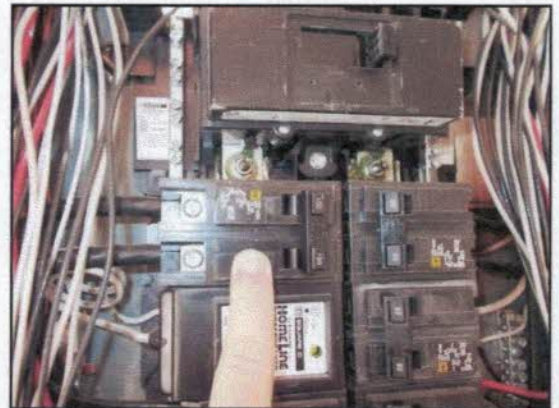
100 AMP ELECTRICAL SUB PANEL LOCATED AT GARAGE

No significant deficiencies or anomalies observed at the time of inspection.

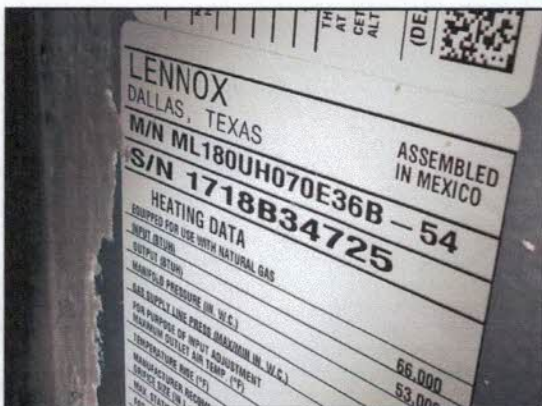
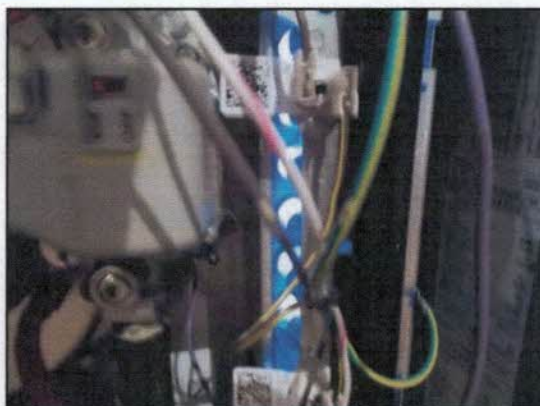
HEATING UNIT: 2ND FLOOR (2018) LENNOX

Age: NEW

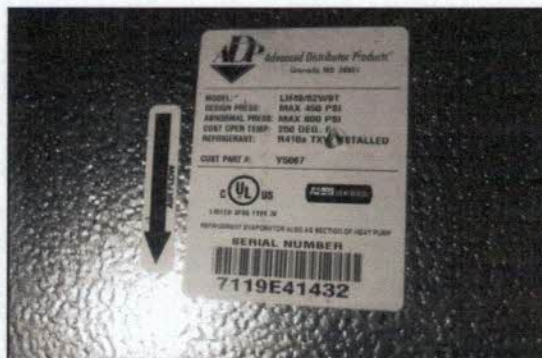
(2019) ADP 5 TON

Evaporator coil has been replaced in home, homeowner disclosed replacement.

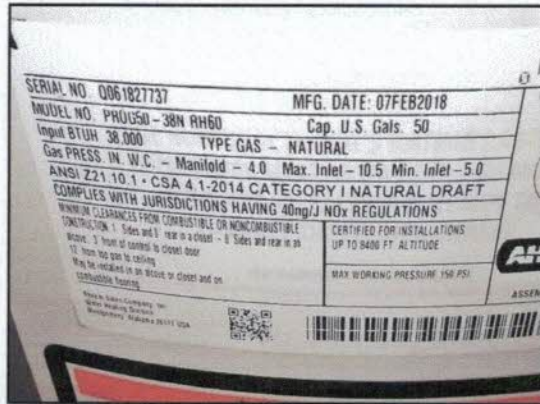
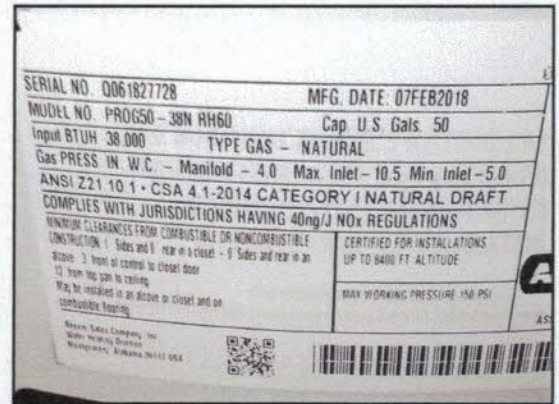
WATER HEATING UNIT(S): 2 - (2018) RHEEM 50 GALLON

No significant deficiencies or anomalies observed at the time of inspection.
