Texas Home Auditors

Inspection Report For:

7210 Stewart Street Hitchcock, Texas 77563

PROPERTY INSPECTION REPORT

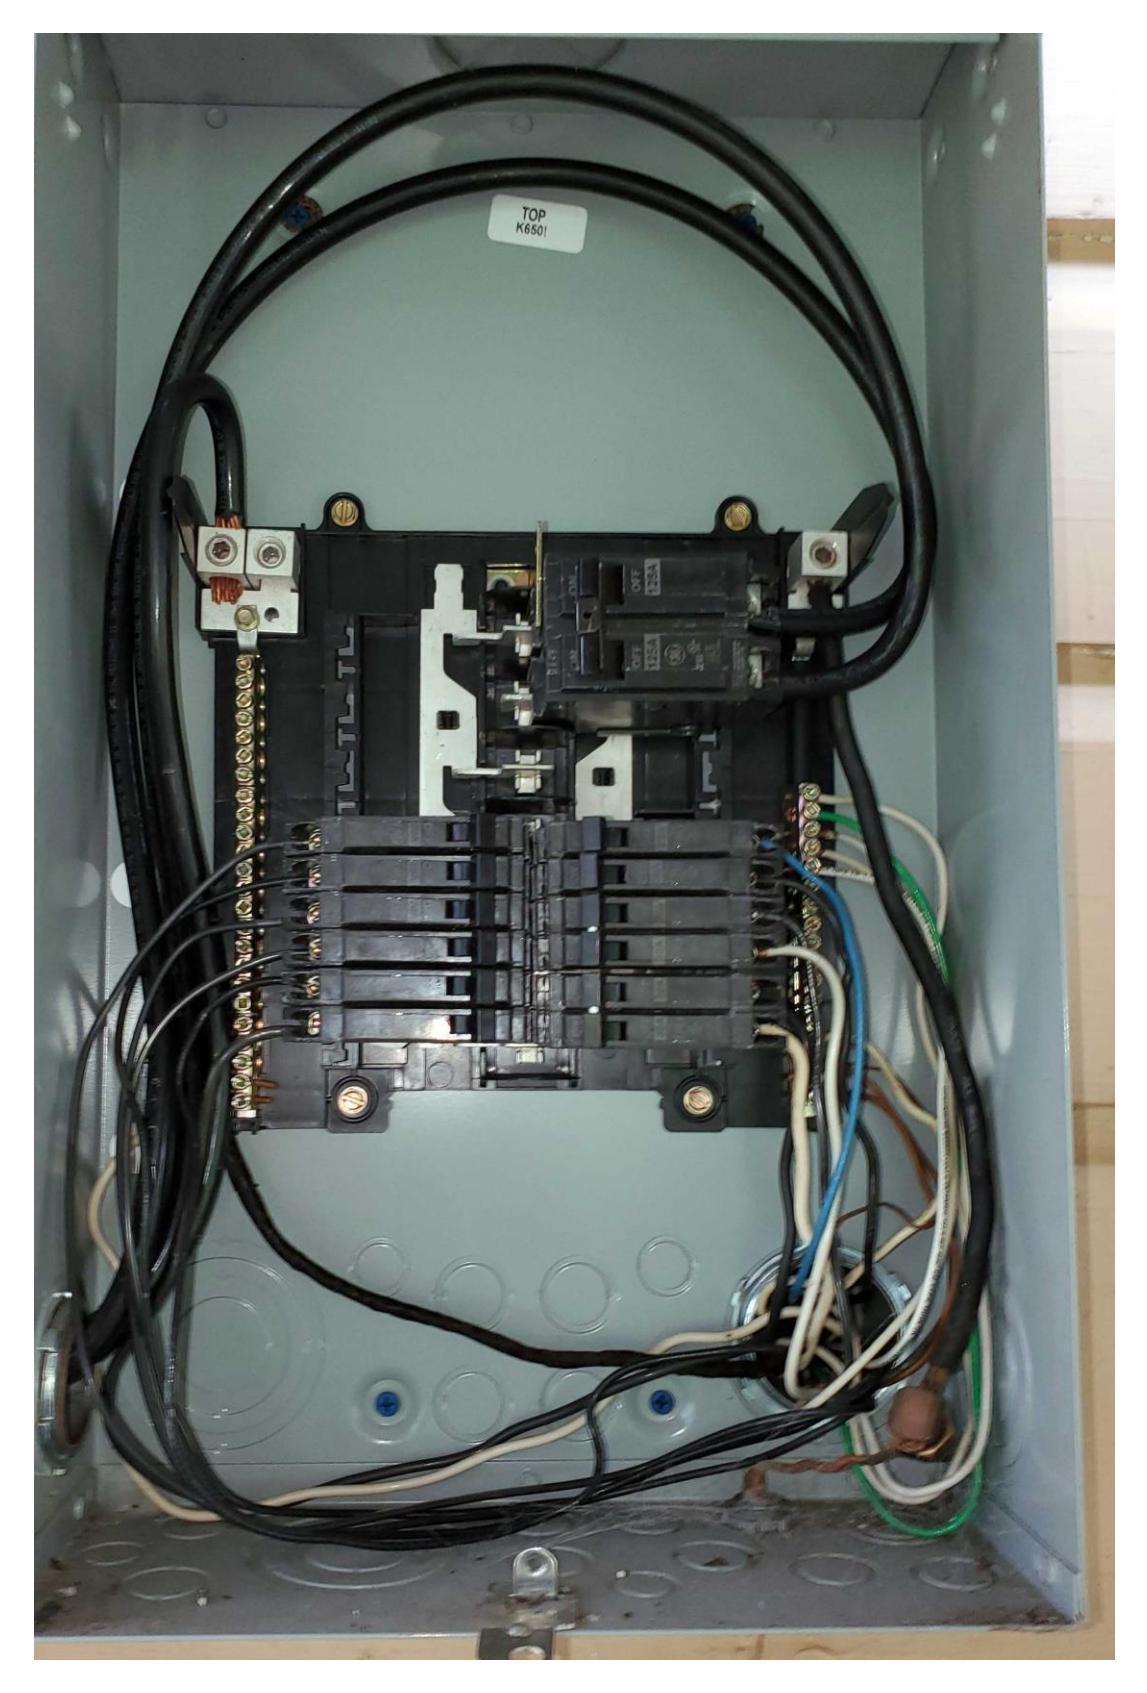
Property Identification: Robert Fuentes Date: 2/17/2020 Main Panel

Location: back left corner of the house Main disconnect location: main panel Main disconnect size: 125 amp Grounded: unknown not visable

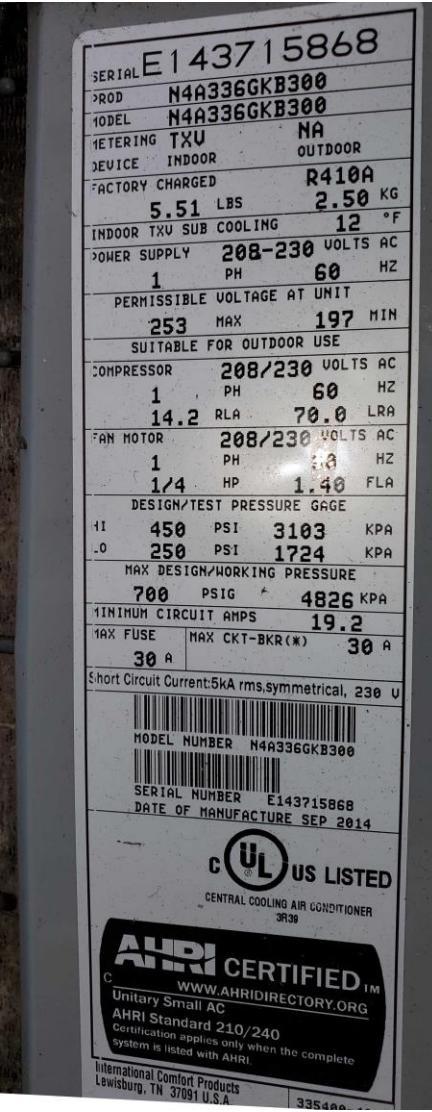
Supply air temperature: 51°F return air temperature: 66°F temperature differential: 15 °F

A/C condensing unit specifies maximum 30 <u>amp</u> breaker. Breaker servicing A/C condensing unit is Unknown <u>amp</u>.

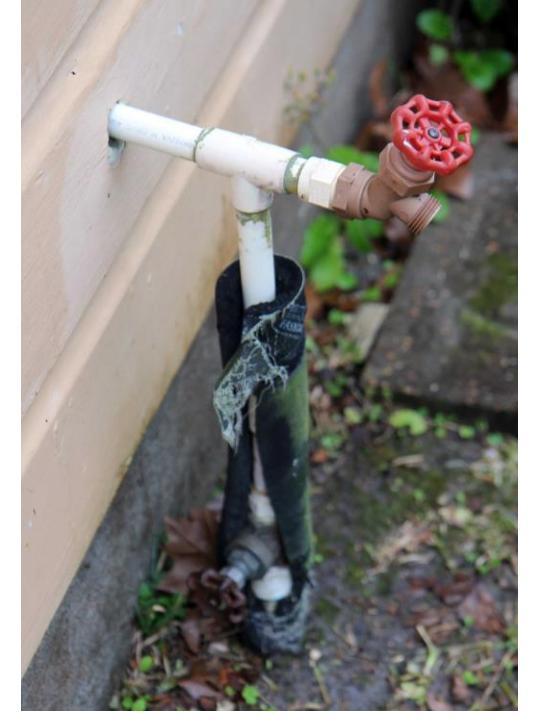
Static water pressure reading: 51 psi Water entry piping: plastic Interior water lines: plastic Water flow: satisfactory
