PROPERTY INSPECTION REPORT

Concerning: 7773 High Village Dr, Houston TX 77095
(Address or Other Identification of Inspected Property)

By: Charles Pyle - TREC 20638 03/09/2020 9:00 am
(Name and License Number of Inspector) (Date)

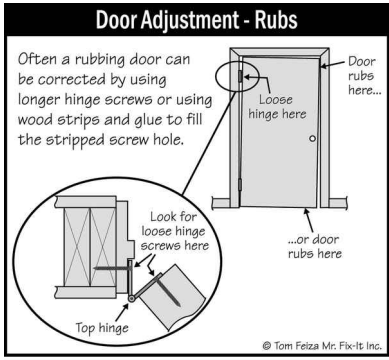
Door may be difficult to open or close. When not severe, typical repair consists of sanding down offending sides or hinge adjustments..

Recommendation: Contact a handyman or DIY project

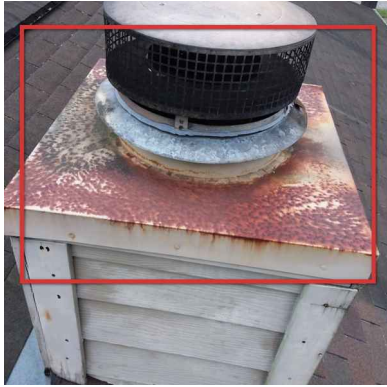
Corrosion and/or deterioration noted at chimney cap. Consider removing corrosion and sealing with a corrosion resistant sealant or paint.

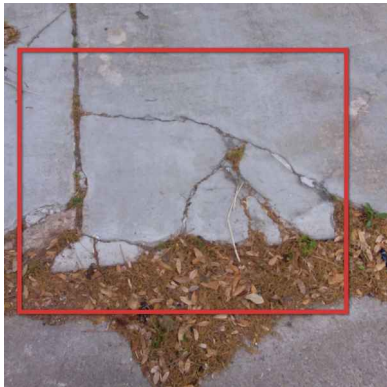
Driveway

Surface cracks observed at concrete flat works. Cracks are considered typical due to construction type and expansive soils. Seal cracks and monitor cracks. Example: driveway, walkways and/or garage floor.

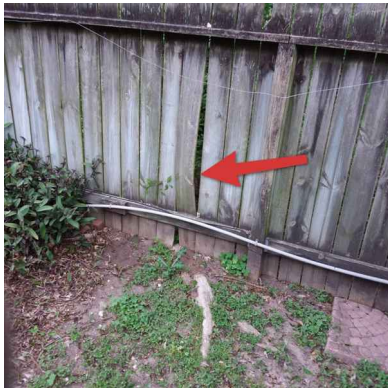
Loose, damaged or improperly secured pickets noted.

Recommendation: Contact a handyman or DIY project

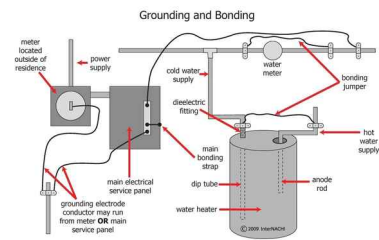
A bond wire was added near the gas meter. The clamp was installed over the pipe finish or sealant. This will affect the continuity and performance. Recommend removing paint or sealant as needed.

Recommendation: Contact a qualified electrical contractor.

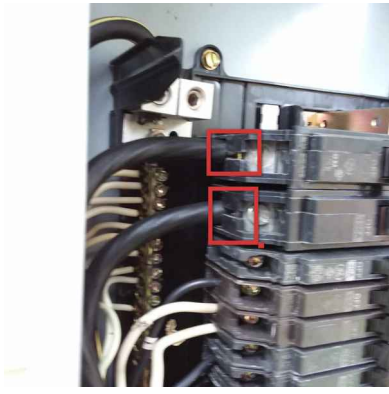
There was no anti-oxidant visible on the aluminum entrance connections. TREC standards require that a lack of anti-oxidant paste be reported as a deficiency.

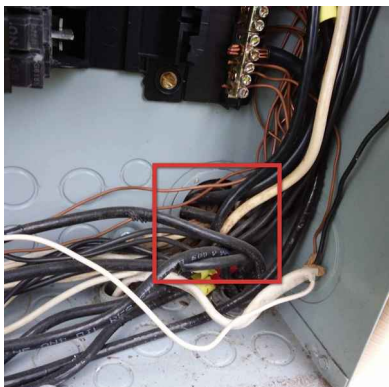
Electrical clamp is missing or improperly secured. Clamps provide strain relief as well as protecting the conductors where they pass through sharp surfaces.

Recommendation: Contact a qualified electrical contractor.

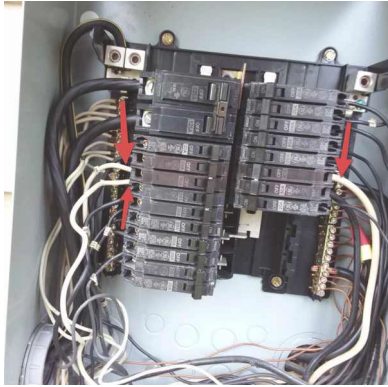
White (neutral) wires not re- identified as voltage carrying conductors. Standard building practices require that any color conductor, other than black and red, be permanently re-identified when used as a "hot" (voltage carrying conductor. Consider apply tape or use a marker to re identify the white wire as a voltage supplying wire.

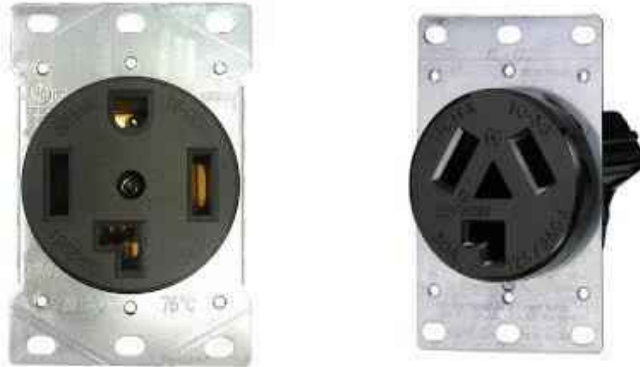
3 prong (2 hot and 1 neutral wire) outlet installed for dryer. This is consistent with installation practices for the era in which this home was constructed. Current standards require that an appliance circuit shall be equipped with 4 conductors. Buyer should be aware that late model appliances will be equipped with a 4 prong outlet (2 hot's, 1 neutral and 1 ground wire) and will not work with a 3 prong outlet.

Recommendation: Contact a qualified professional.

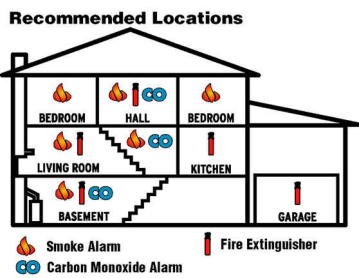
Carbon monoxide detector is not present or improperly installed. Current standards require that any home equipped with gas appliances and/or an attached garage must have working CO detectors. CO detectors should be located outside all sleeping areas and on every level of the home.

Recommendation: Contact a handyman or DIY project

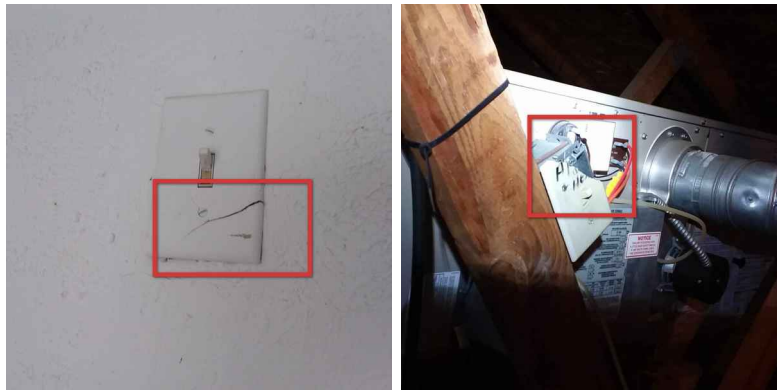
Electrical lighting cover is missing, damaged or deteriorated. Consider replacement to prevent accidental contact with the energized conductors.

Recommendation: Contact a handyman or DIY project

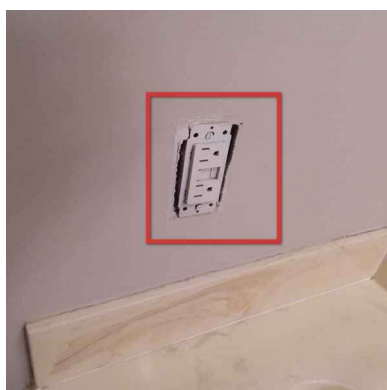
Electrical outlet cover is loose, missing or damaged. All energized and ungrounded conductors and components should be concealed within a non combustibile junction box for occupant safety.

Note from seller: Cover has been replaced

Recommendation: Contact a handyman or DIY project

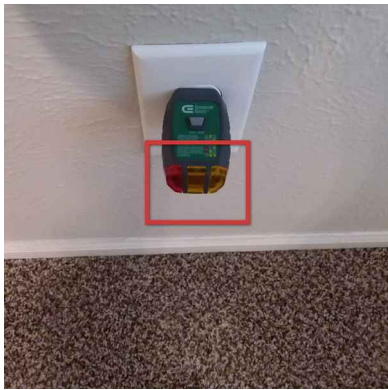
Electrical Tester indicates outlet has no power. Consider further evaluation and repair prior to use.

Recommendation: Contact a qualified electrical contractor.

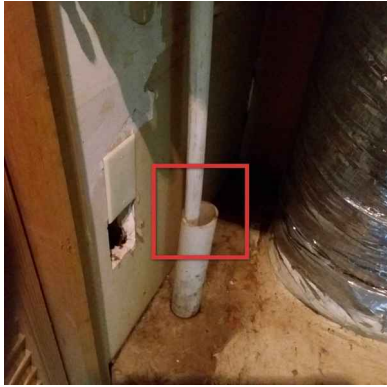
The condensate discharge line is not sealed at the connection to the waste line in the attic. If the waste line becomes clogged, the condensate will discharge within the attic space. Current standards require that the condensate line shall discharge within an approved waste receptor via an air gap. A common installation method is to connect to the tail piece below a bathroom sink.

Recommendation: Contact a qualified HVAC professional.

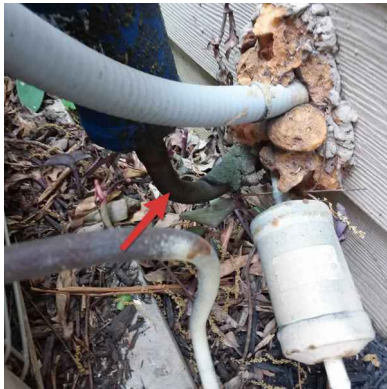
Missing or damaged insulation on refrigerant line can cause energy loss and condensation.

Recommendation: Contact a qualified HVAC professional.

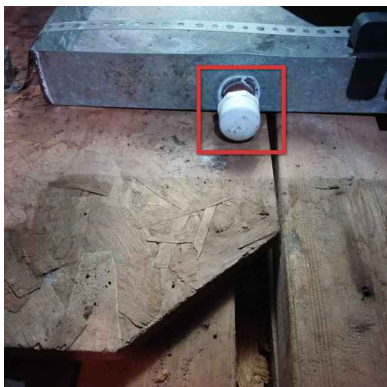
Drain pan drain line capped.

Recommendation: Contact a qualified heating and cooling contractor

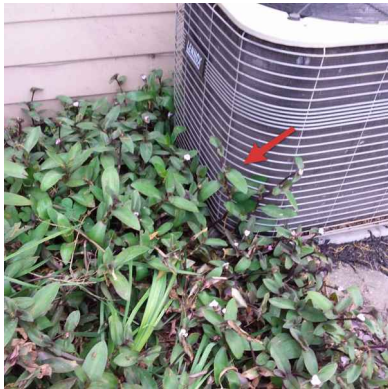
Airflow is blocked by vegetation, fence or other structure. May restrict the amount of airflow over the condensing coil. If less air flows over the coil, less heat is removed. That means the whole cycle warms up a bit, and your AC works harder to keep your home cool. Manufacturer's installation instructions may vary. The most common clearance requirement is 12" between one condenser unit and anything that blocks or restricts the air, and that twice that (24") between two units.

Recommendation: Contact a qualified professional.

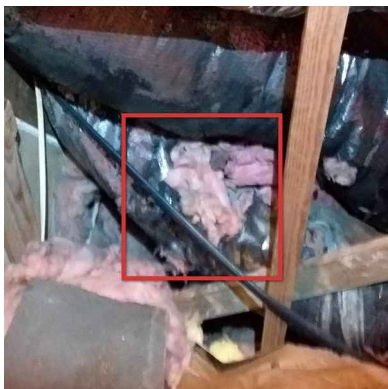
Physical damage observed at supply or return air ducts. This type of damage may restrict airflow and negatively affect the system performance.

Recommendation: Contact a qualified HVAC professional.

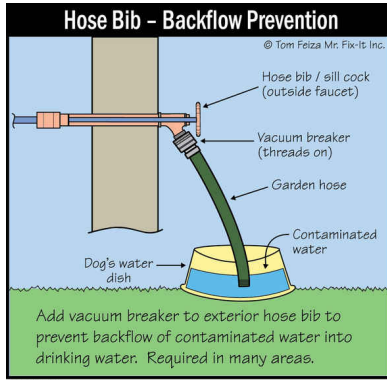
Anti siphon devices not present or improperly installed. Anti siphon / backflow prevention devices are vacuum breakers that prevent contaminated water from entering the potable water system. Items may be purchased at any hardware store and screwed in place before installing a hose.

Recommendation: Contact a handyman or DIY project

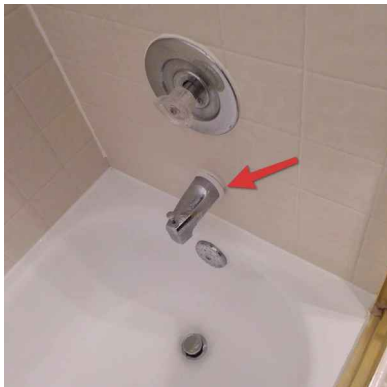
Plumbing fixture or basin was improperly secured. Current standards require that all supply and disposal fixtures and components must be properly secured to provide strain relief and prevent damage to the components. Additionally all fixtures and components shall be properly sealed to prevent moisture penetration and/or damage beyond the intended surfaces.

Recommendation: Contact a handyman or DIY project

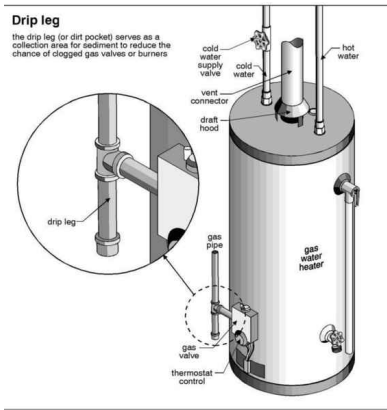
Sediment traps missing or improperly installed at appliance gas supply piping. To prevent sediment (trash or condensate) from entering the appliance, traps must be installed in such a manner that the gas must change directions at the trap. See illustration.

Recommendation: Contact a handyman or DIY project

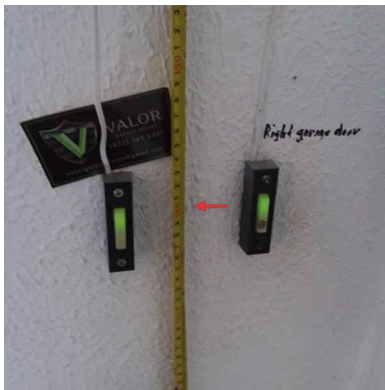
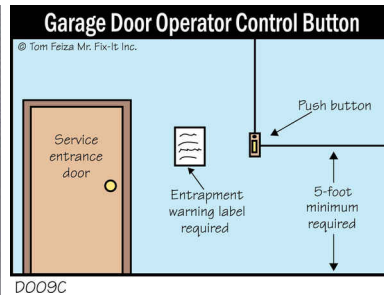
Control button mounted too low. Current standards require that the button be installed no less than 60 inches above the garage floor. Buttons should be mounted to prevent operation by small children.

Recommendation: Contact a handyman or DIY project

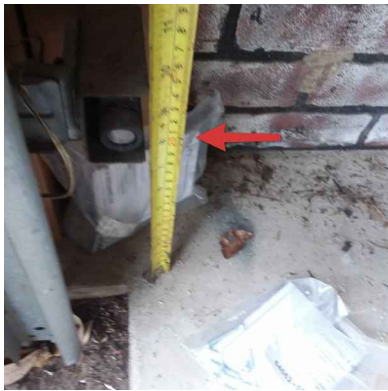
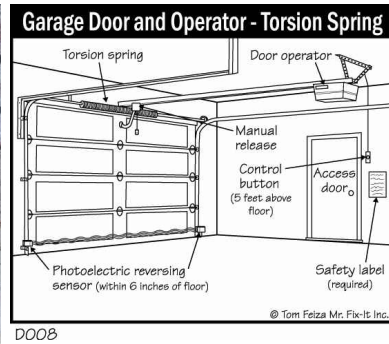
4: Safety Sensor Improper

Safety reversing sensor is not mounted in its correct location. Safety reversing sensors should be installed no higher than 6 inches above the garage floor to protect children and pets.

Recommendation: Contact a handyman or DIY project

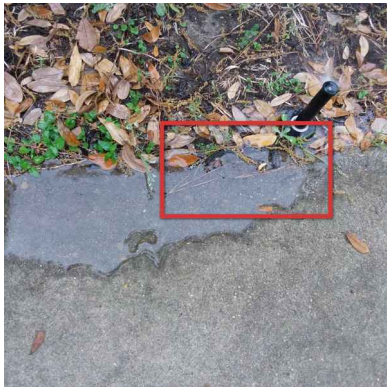
1: Leak - General

Leak observed below grade. This may indicate a broken or stuck spray head or issues with the underground supply system. Consider contacting a licensed and qualified irrigation technician evaluate system and repair as needed.

Recommendation: Contact a qualified landscaping contractor
