PROPERTY INSPECTION REPORT

Prepared For: WADE & BAILEY DILLENBECK
(Name of Client)

Concerning: 16131 RIDGE PARK
(Address or Other Identification of Inspected Property)

By: DON MIDURA TREC PI # 375 5/11/2020
(Name and License Number of Inspector) (Date)

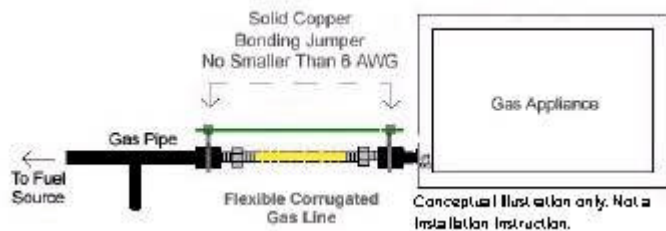
Install bonding jumpers at all metal gas piping interrupted by metal flex lines – (the NEC Section 250-104(b) reads as follows: "Metal Gas Piping. Each aboveground portion of a gas piping system upstream from the equipment shutoff valve shall be electrically continuous and bonded to the grounding electrode system)."

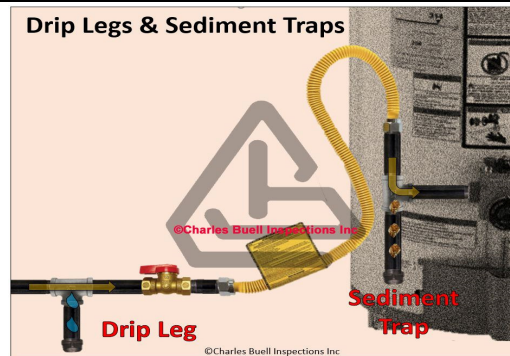
- 96. Heavy rust / corrosion is apparent at the burner assembly and in the combustion chamber with a smoky char at the exterior of the tank at the access port to the burner assembly.
- 97. Install dielectric fittings for the water lines top of the tank and replace corroded piping.
- 98. Review the information in the Main Body of the Report regarding T&P valve maintenance.
- 99. Replacement of the tank is recommended

*Install a sediment trap
