PROPERTY INSPECTION REPORT

Concerning: 8426 Garden Parks Dr, Houston TX 77075

By: Richard Kinder - Trec #21699

01/15/2020 9:00 am

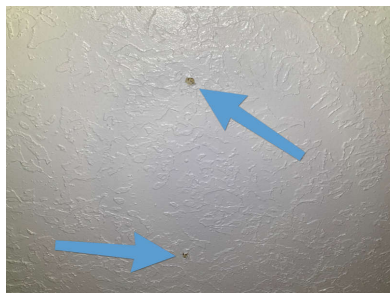
Nail pops were observed on the interior ceilings.

Recommendation: Contact a qualified professional.

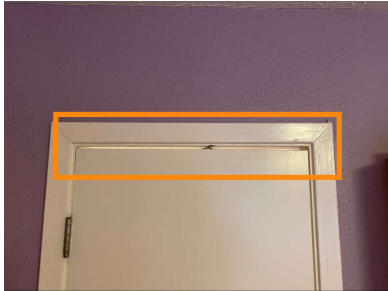
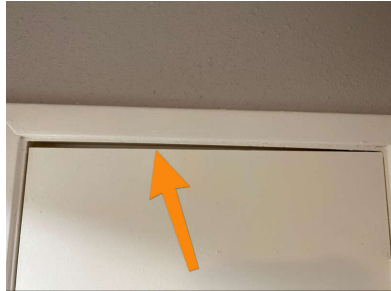
Binding, out-of-square, non-latching, warped, and/or twisted doors and/or frames were observed. This can be a sign of structural movement.

Recommendation: Contact a qualified professional.

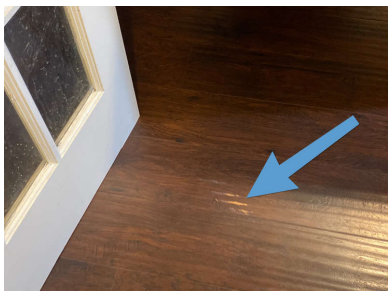
Office

One or more doors were observed to be rubbing the interior flooring when operated.

Recommendation: Contact a qualified professional.

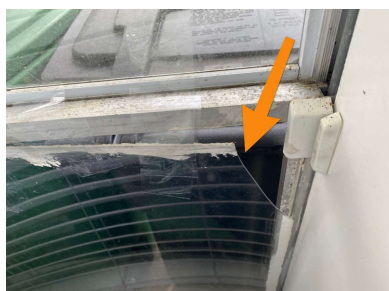
Cracked/damaged window glazing was observed.

Recommendation: Contact a qualified window repair/installation contractor.

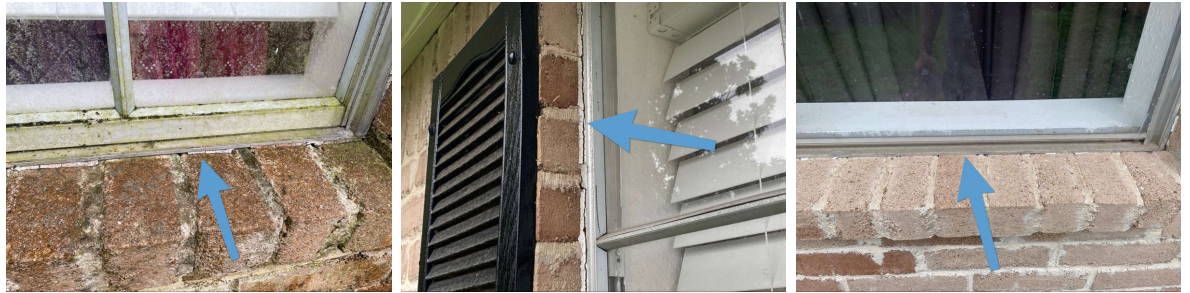
Cracking, deteriorated, and/or missing caulking/sealant was noted around the interior/exterior of the windows.

Recommendation: Contact a qualified professional.

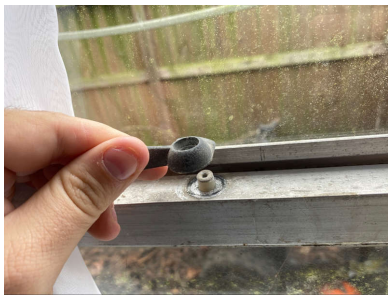
Broken/missing locking mechanisms were observed on one or more windows.

Recommendation: Contact a qualified professional.

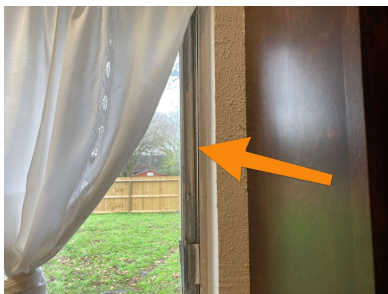
Kitchen

One or more windows did not fully close.

Recommendation: Contact a qualified professional.

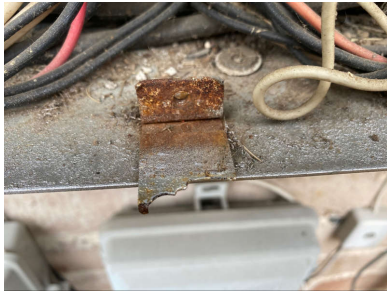
The panel latch was observed to be damaged/broken.

Recommendation: Contact a qualified professional.

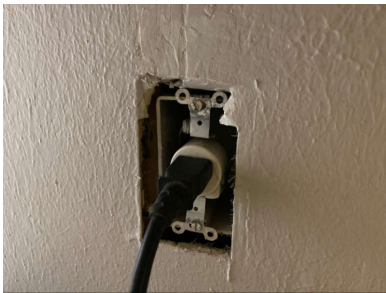
Missing receptacle cover plates should be replaced.

Recommendation: Contact a qualified electrical contractor.

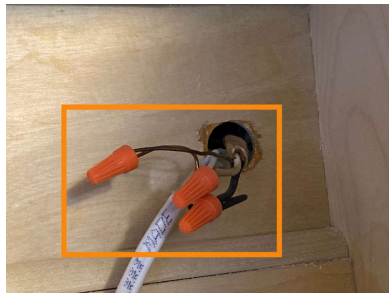
Improperly terminated and/or loose electrical conductors were observed. Conductors should be properly secured and terminated in a junction box with a cover installed to protect against potential shock.

Recommendation: Contact a qualified professional.

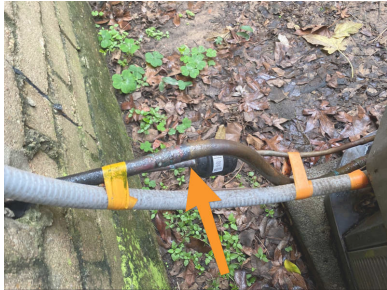
Cracking, deteriorated, damaged, and/or missing insulation was observed on the cooling system refrigerant line.

Recommendation: Contact a qualified professional.

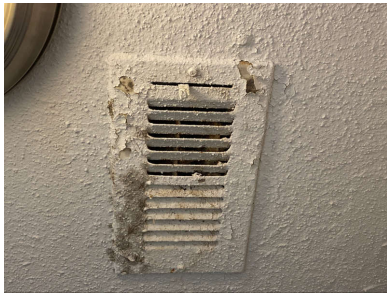
What appeared to be organic growth was observed on various output registers.

Recommendation: Contact a qualified professional.

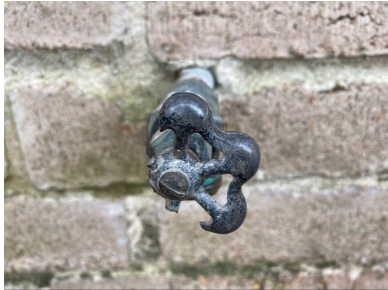
One or more exterior faucet handles were observed to be broken/missing. These faucets were unable to be tested/operated.

Recommendation: Contact a qualified professional.

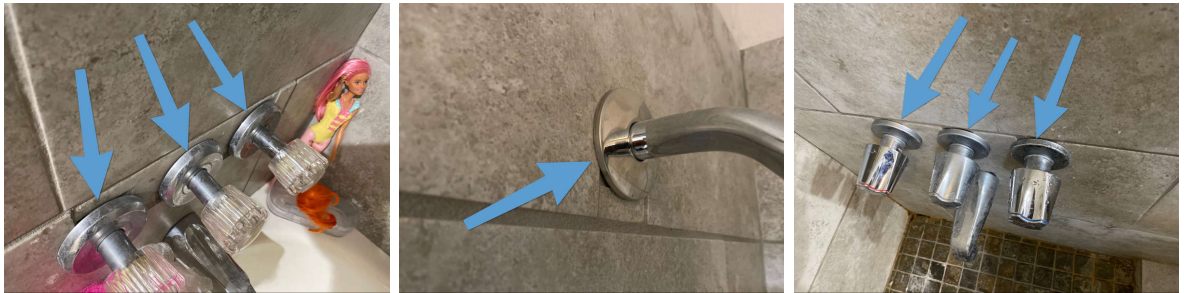
Cracking, deteriorated, and/or missing sealant was observed around plumbing fixtures.

Recommendation: Contact a qualified professional.

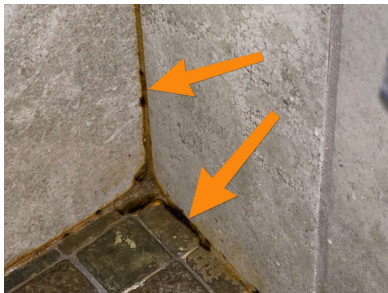
Master Bathroom

What appeared to be organic growth was observed in/on bathtub/shower enclosures.

Recommendation: Contact a qualified professional.

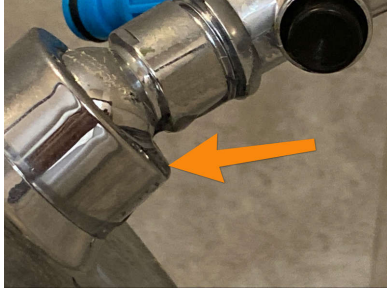
Master Bathroom

The shower head was observed to be leaking when operated.

Recommendation: Contact a qualified plumbing contractor.

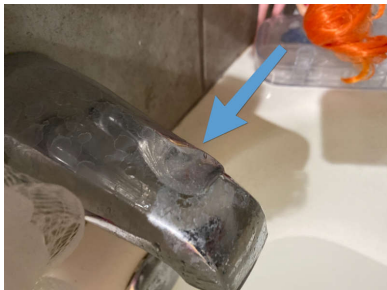
The bathtub faucet in bathroom #1 was observed to be damaged.

Recommendation: Contact a qualified professional.

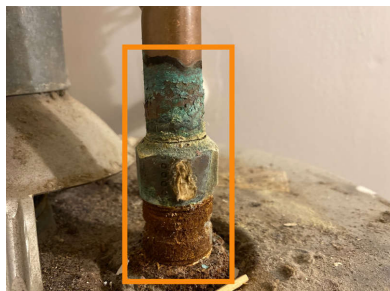
Rust/Corrosion was observed on areas of the water lines at the water heater. Overtime rust/corrosion can eat away at the water lines and cause leaks.

Recommendation: Contact a qualified plumbing contractor.
