BRYAN & BRYAN INSPECTIONS

Inspection Report For:
8426 Garden Parks Drive, Houston, TX 77075

Inspection Date: 9/14/2017

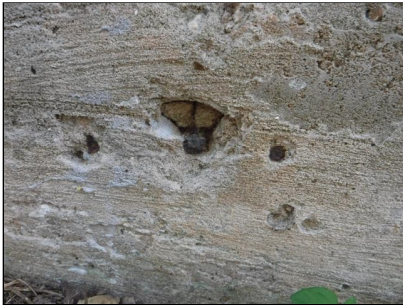
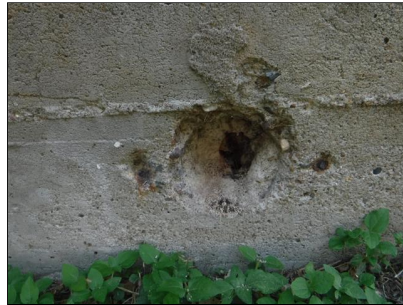
(2) The ends of post tension cables are not properly sealed. Seal these areas to prevent further spalling of surrounding concrete and possible future foundation performance.

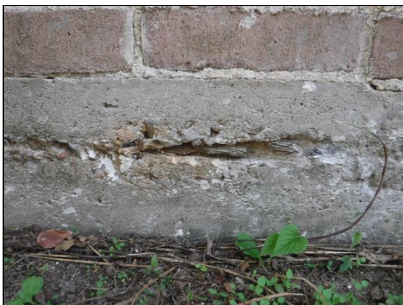
A. Item 3(Picture)

(3) Rebar is exposed along the foundation perimeter. Remedy these areas as needed to prevent further deterioration.

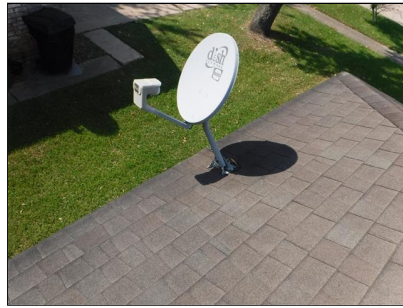
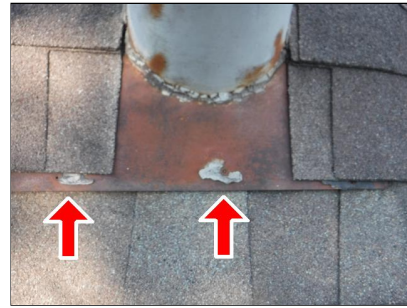
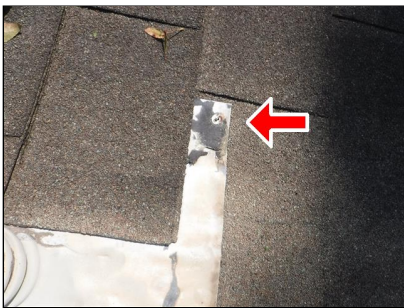
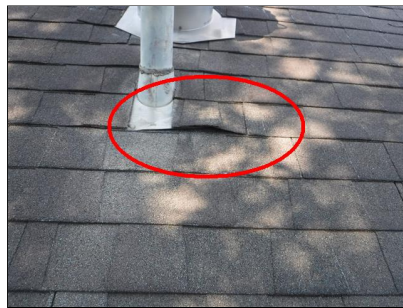
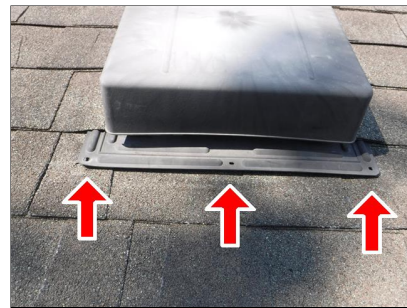
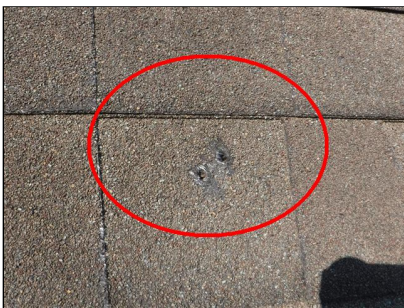
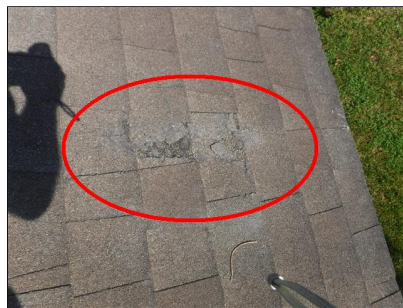
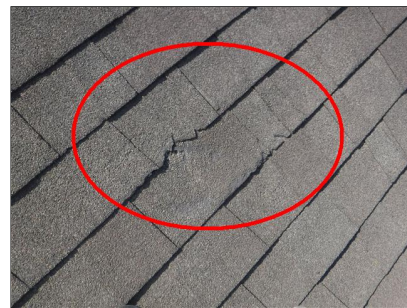
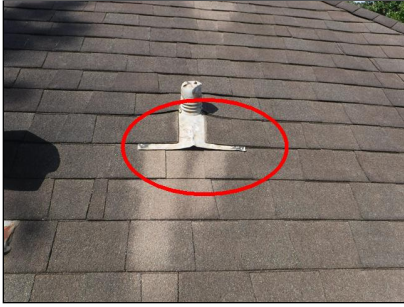
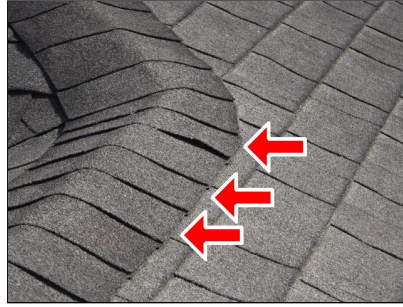
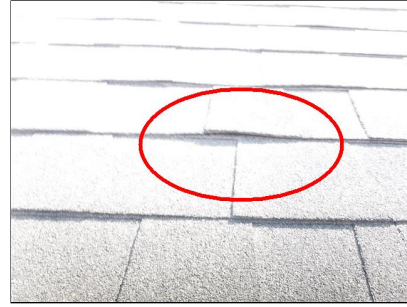
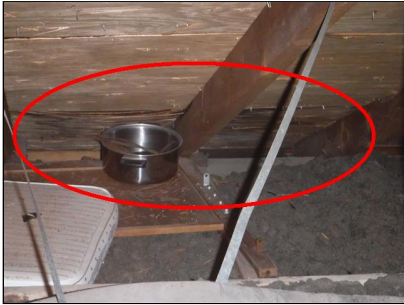
(2) Further evaluation of the roof covering is recommended. Multiple deficiencies were observed including, but not limited to, the following; popped up nails, excessive granule loss, moisture staining on roof decking indicating leaks, exposed fasteners, torn shingles, damaged shingles, wind lift, rusted flashings, satellite dish on roof, soft sections of roof decking cupping/curling shingles,. Consult with a qualified roofing contractor to determine the best method of remedy and estimates for repairs and/or replacement.

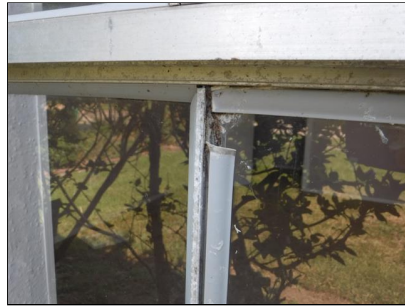
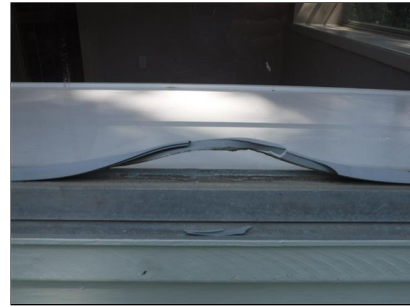
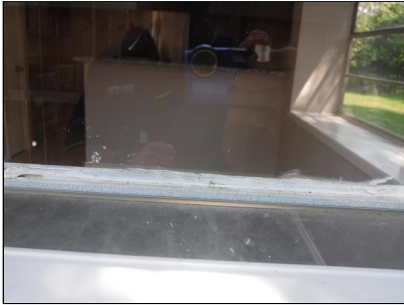
(2) Damaged/missing plastic trim was observed around windows.
Location(s): Multiple Locations

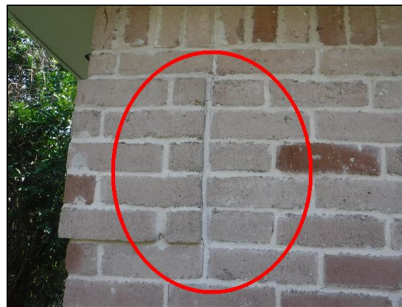
E. Item 3(Picture)

(2) Hairline cracks were observed in the masonry siding. Cracks may be the result of thermal expansion of the veneer and/or normal movement. Monitor and/or seal as needed.

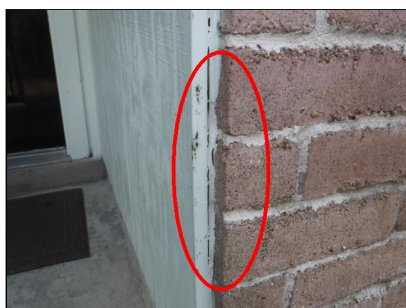
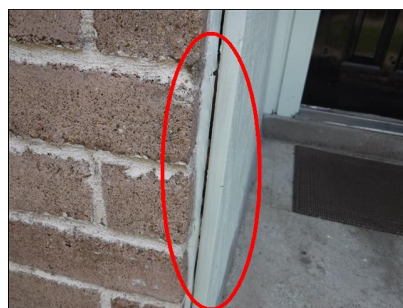
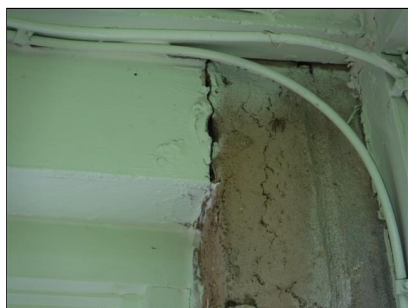
(5) Separation in caulking at trim was observed. Seal as needed to prevent moisture between the trim and siding material.

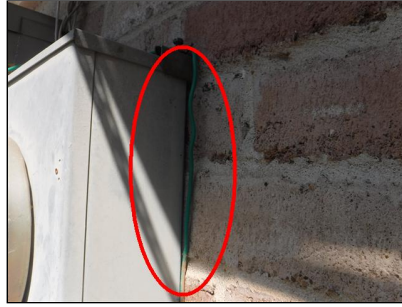
E. Item 12(Picture)

(7) Ensure meter and panel boxes are sealed to exterior wall to prevent moisture and/or pest intrusion.

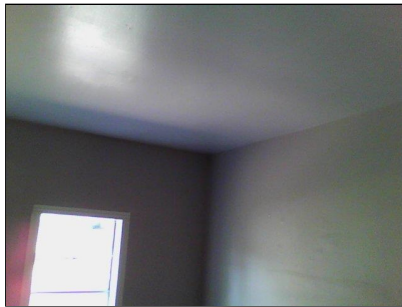
F. Item 4(Picture)

(2) Pillowing/sagging in the drywall ceiling was observed. This is common in older homes due to undersized drywall and/or improper spacing on ceiling joists. This is considered cosmetic. If further evaluation is desired, consult with a qualified contractor.

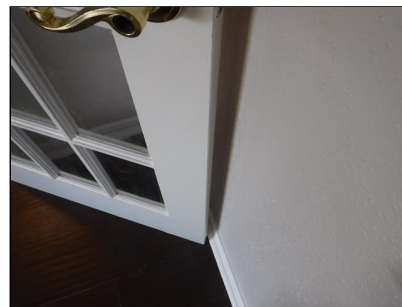
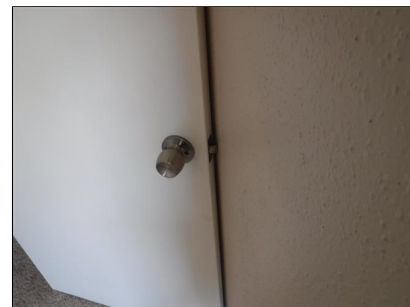
(2) Door stops are missing/need adjustment to prevent doors from hitting other interior components.
Location(s): Multiple Locations

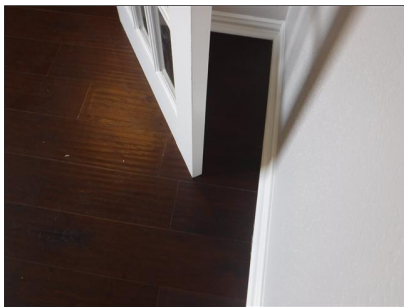
G. Item 6(Picture)

(4) Door catches on the flooring material when opened.

Location(s): Den/Study

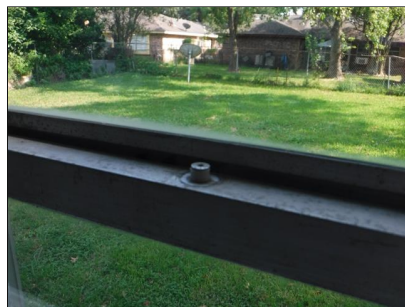
H. Item 10(Picture)

(4) Missing/damaged window latches were observed. Replacement is recommended to properly secure windows.

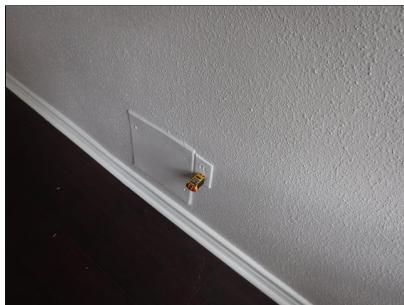
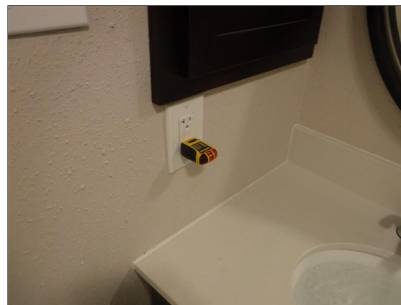
(4) No power was observed to receptacle(s) at the time of inspection. The cause could not be determined. Evaluation by a qualified electrician is recommended.

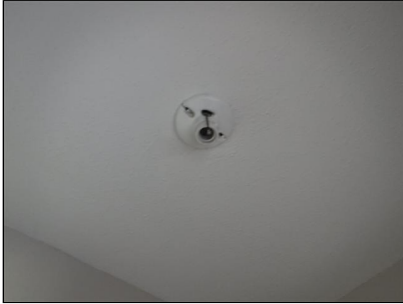
B. Item 8(Picture)

(5) Missing light bulb(s) were observed. Replace as needed.
Location(s): Closet

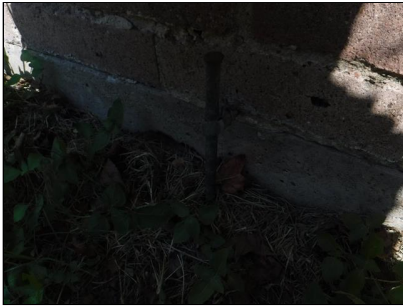
A. Item 2(Picture)

(2) **Note:** Verification of the total length of the grounding rod is beyond the scope of the inspection. Current building standards require minimum depth of 8 feet.

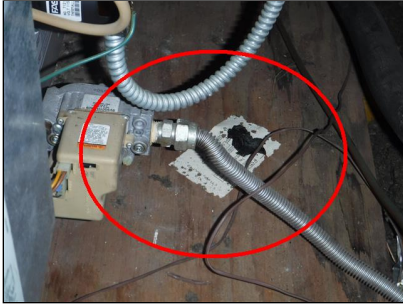
A. Item 2(Picture)

(3) Gas line drip-leg is not installed at the gas branch line (near gas valve) as specified in the manufacturers installation guidelines.

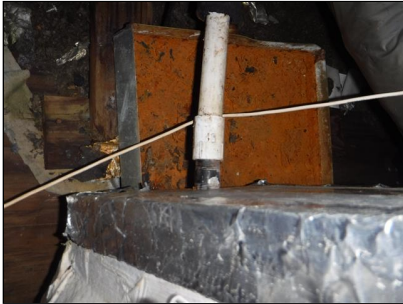
B. Item 4(Picture)

(4) Rusting in the evaporator condensate overflow pan indicates possible blockage of the condensate drain line(s) and a dirty evaporating system: service of the system is recommended.

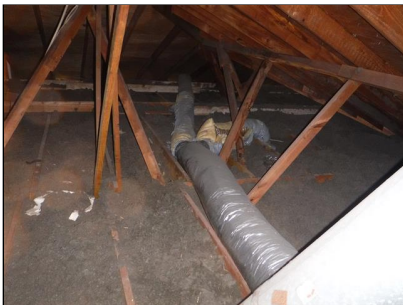
C. Item 1(Picture)

(1) Sections of ducting are resting on the attic insulation which compresses the insulation: hang affected ducting where possible.

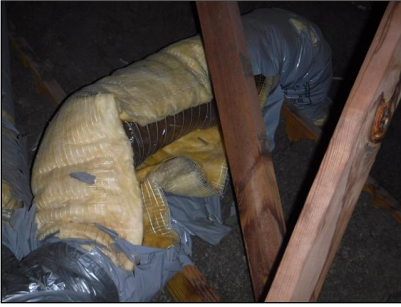
C. Item 2(Picture)

(2) Observed damaged ducting in the attic.

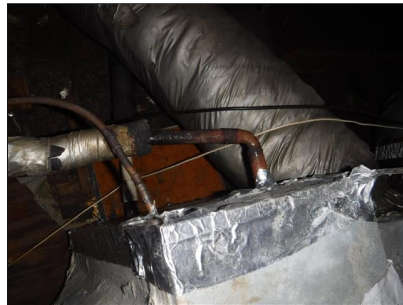
B. Item 3(Picture)

(2) The insulation around the refrigerant line is missing/deteriorated. Replacement of the insulation around the refrigerant line is recommended to prevent condensation build-up and decreased system performance.

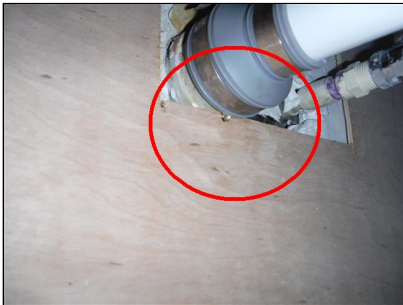
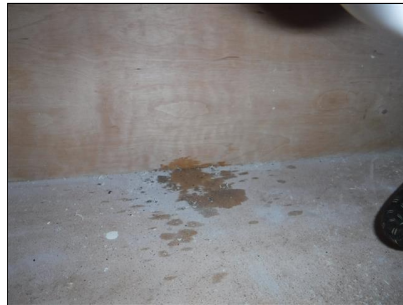
(1) Leaking was observed at the drain line fittings. Evaluate and remedy as needed.

Location(s): Kitchen Sink

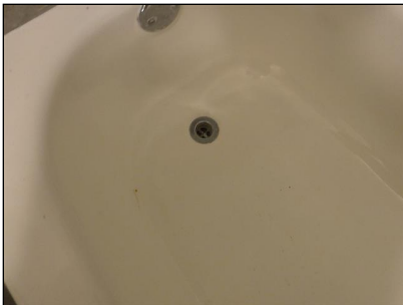
B. Item 3(Picture)

(2) The bathtub drain stop is missing; replace.

Location(s): Hall Bath

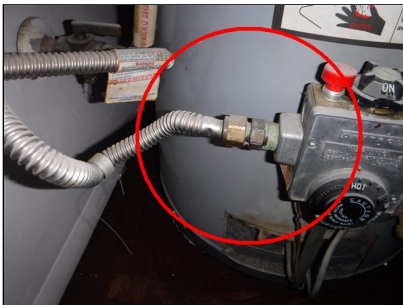
C. Item 2(Picture)

(3) There is no sediment drip leg installed near the gas branch line (before the gas regulator) to catch moisture from the gas line before reaching the gas regulator.

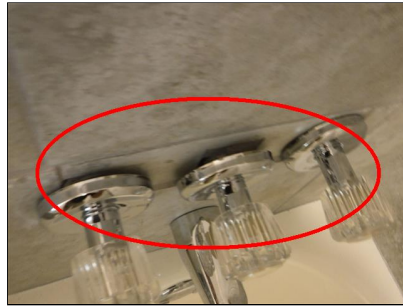
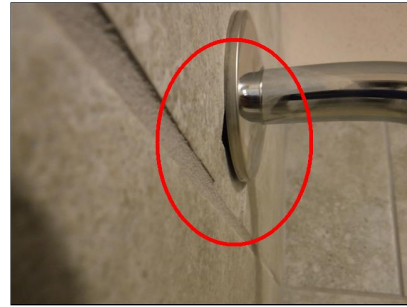
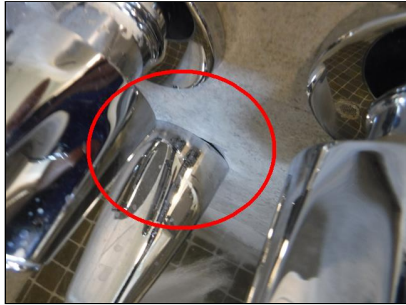
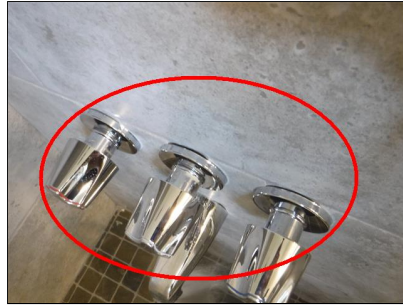
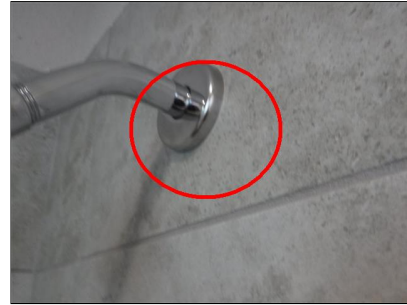
(3) The escutcheon plate(s) and tub spigot are not properly sealed to the wall to prevent moisture intrusion.
Location(s): Master Bath Hall Bath

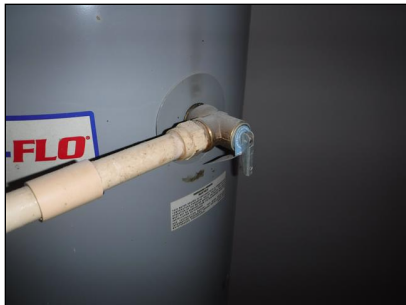
C. Item 6(Picture)

(7) **Note:** The manufacturer recommends replacement of the TPR valve every three years to ensure proper emergency function. Inspection company does not test TPR valves due to safety hazard or possible damage to unit.

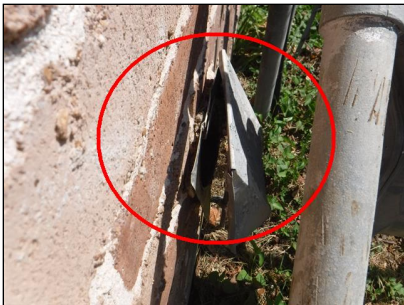
H. Item 1(Picture)

The dryer exhaust cover is damaged.

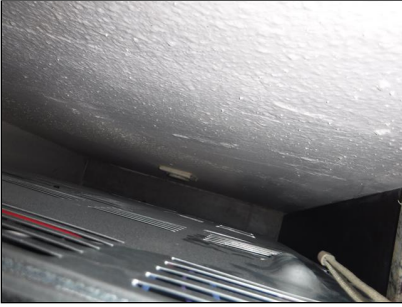
D. Item 1(Picture)

(1) **Note:** The unit was not installed at the time of the inspection.

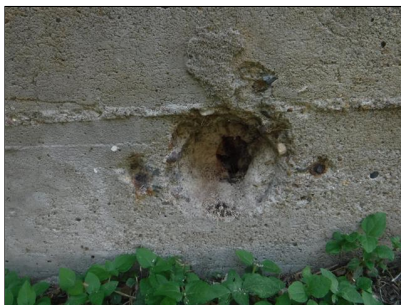
A. Item 2(Picture)

(2) The ends of post tension cables are not properly sealed. Seal these areas to prevent further spalling of surrounding concrete and possible future foundation performance.

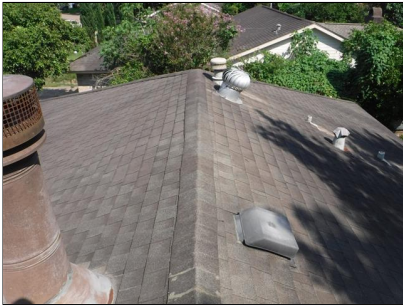
C. Item 1(Picture)

(1) **General Photo of Roof Covering**

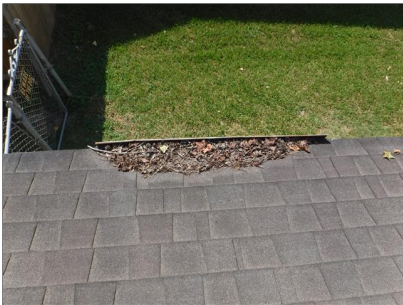
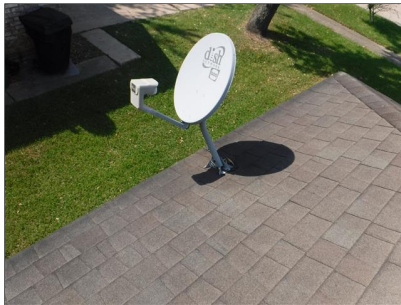
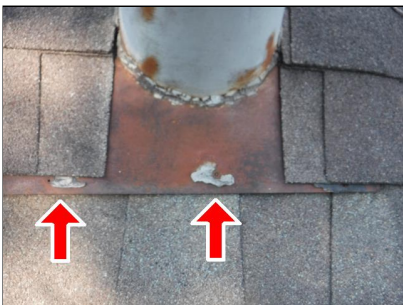
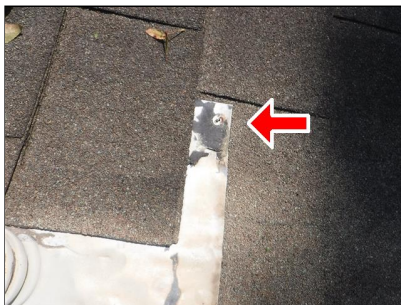
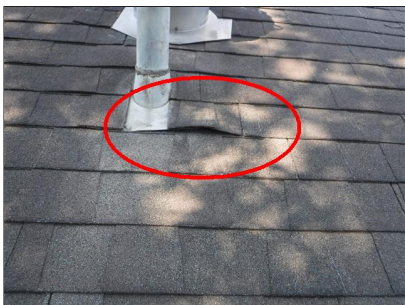
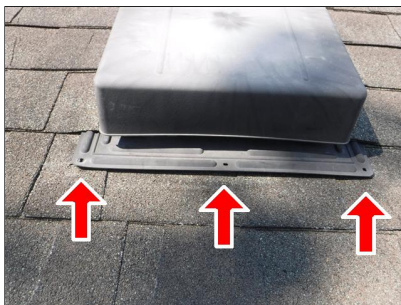
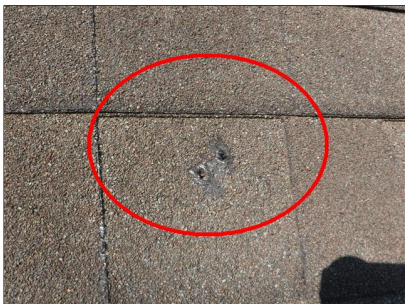
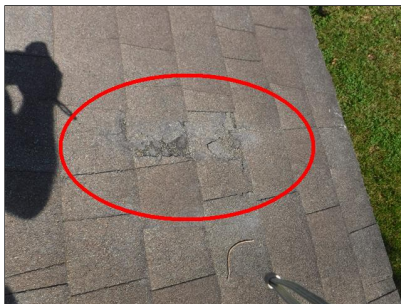
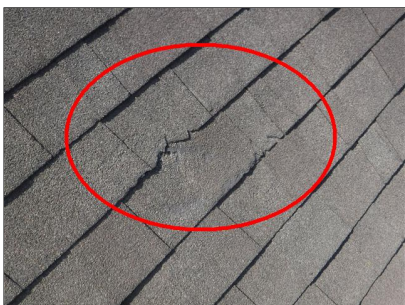
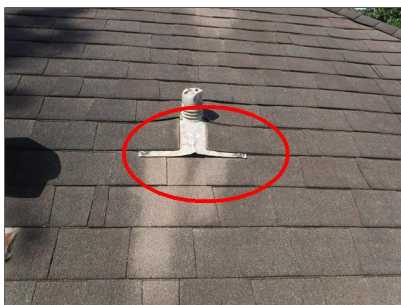
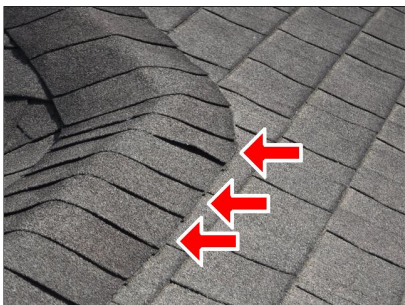
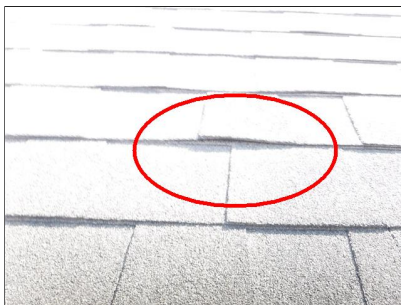
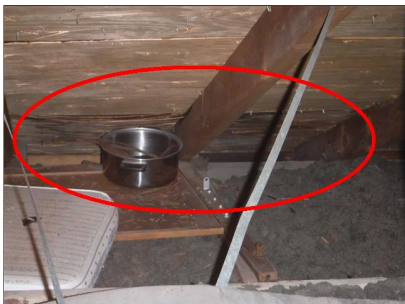
(2) Further evaluation of the roof covering is recommended. Multiple deficiencies were observed including, but not limited to, the following; popped up nails, excessive granule loss, moisture staining on roof decking indicating leaks, exposed fasteners, torn shingles, damaged shingles, wind lift, rusted flashings, satellite dish on roof, soft sections of roof decking cupping/curling shingles,. Consult with a qualified roofing contractor to determine the best method of remedy and estimates for repairs and/or replacement.

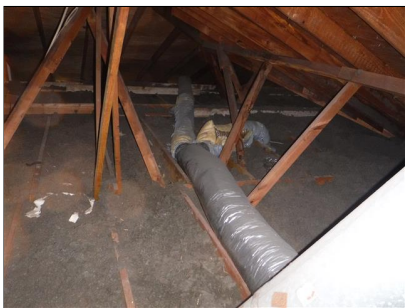
D. Item 1(Picture)

(1) **General Photo of Attic Space**

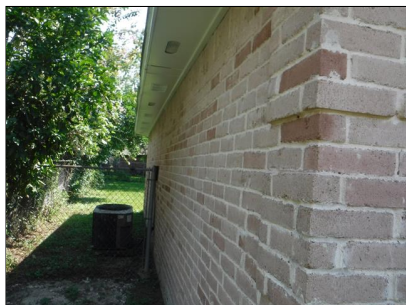
E. Item 1(Picture)

(1) General Photo of the Exterior

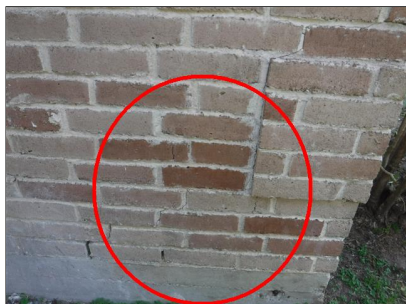
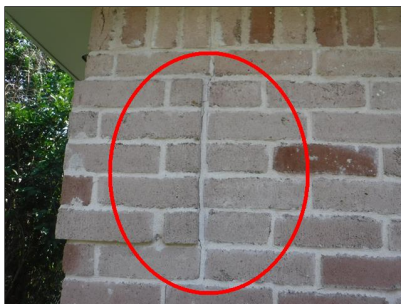
(2) Hairline cracks were observed in the masonry siding. Cracks may be the result of thermal expansion of the veneer and/or normal movement. Monitor and/or seal as needed.

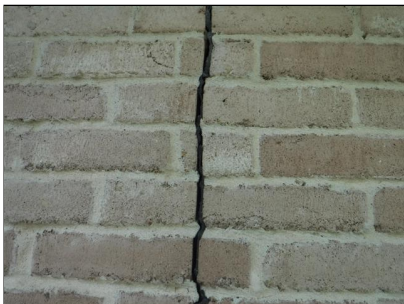
E. Item 4(Picture)

(3) Sealant in the expansion joints around the home is missing and/or deteriorated. Sealing between the brick veneer walls is recommended to prevent moisture and/or pest intrusion.

Location(s): Left Side of Home,

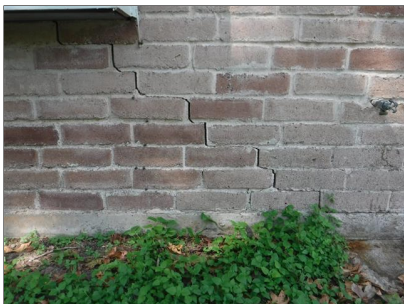
E. Item 5(Picture)

(4) Stress cracks were observed in the exterior brick veneer. The cracks noted are consistent with the structural settlement of the home. Seal as needed or consult with a qualified brick mason to determine the best method of remedy.

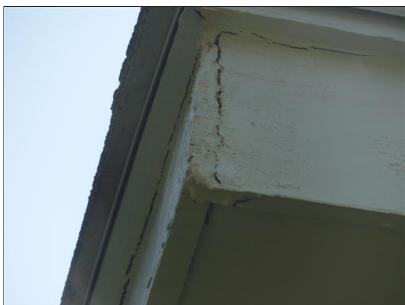
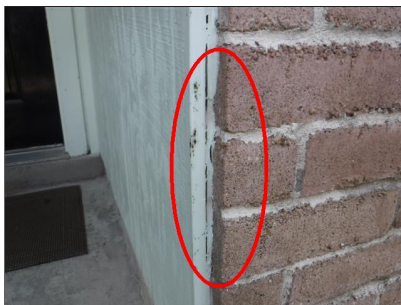
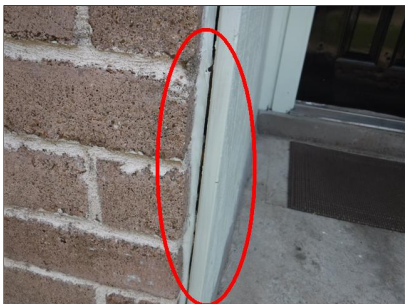
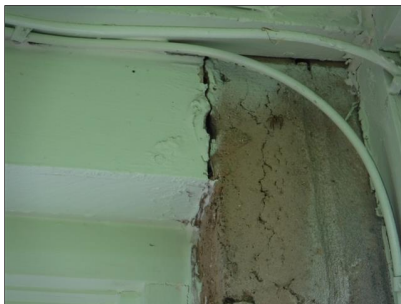
(5) Separation in caulking at trim was observed. Seal as needed to prevent moisture between the trim and siding material.

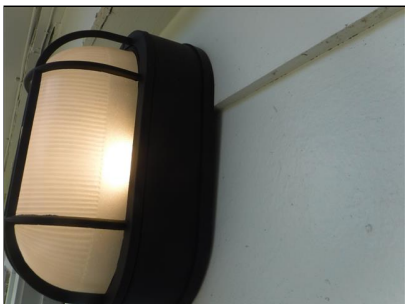
E. Item 10(Picture)

(6) Seal (caulk) the gap between exterior wall mounted light fixtures and the exterior wall to prevent water intrusion.

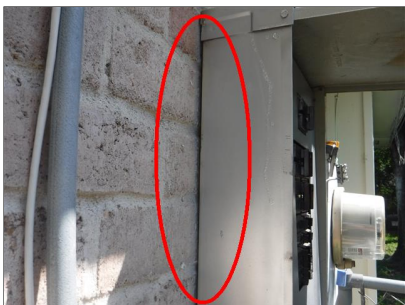
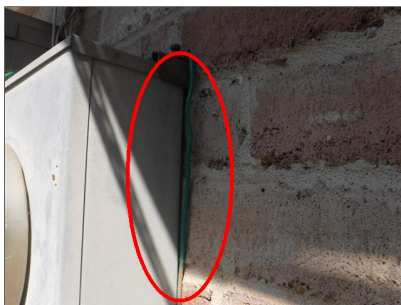
(7) Ensure meter and panel boxes are sealed to exterior wall to prevent moisture and/or pest intrusion.

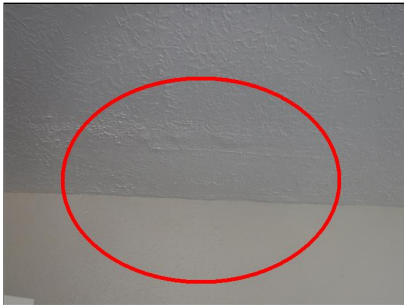
(1) **Note:** Previous repairs were observed at the ceiling. The cause could not be determined. Request any repair documentation and/or explanation from the seller owner for the repair.

Location(s):Random Areas

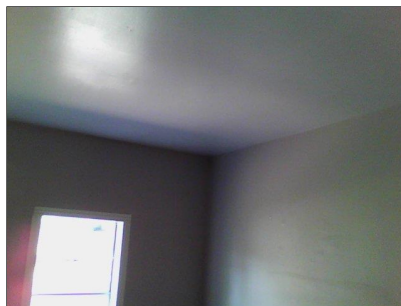
F. Item 4(Picture)

(2) Pillowing/sagging in the drywall ceiling was observed. This is common in older homes due to undersized drywall and/or improper spacing on ceiling joists. This is considered cosmetic. If further evaluation is desired, consult with a qualified contractor.

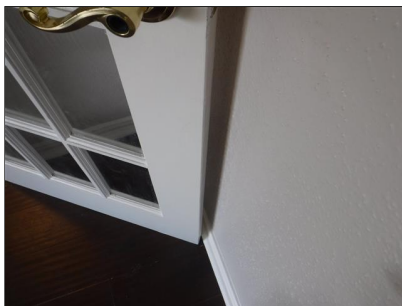
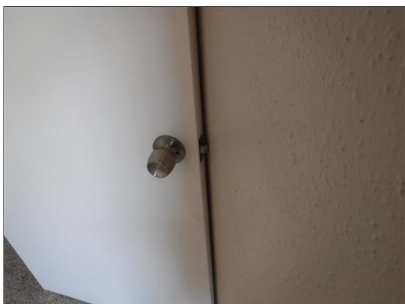
(2) Door stops are missing/need adjustment to prevent doors from hitting other interior components.

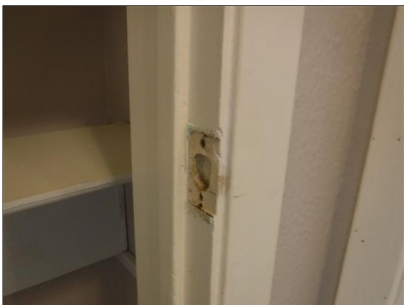
G. Item 5(Picture)

(3) Door striker plate is missing.

Location(s): Closet

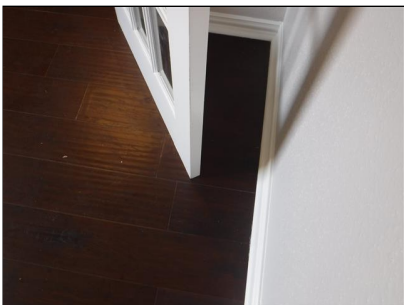
G. Item 6(Picture)

(4) Door catches on the flooring material when opened.

Location(s): Den/Study

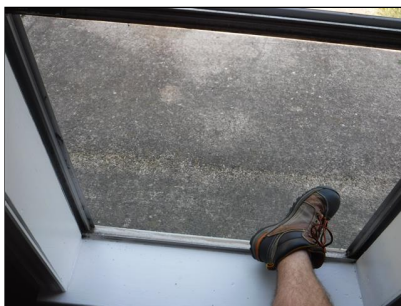
H. Item 2(Picture)

(1) Screens were observed damaged/missing.

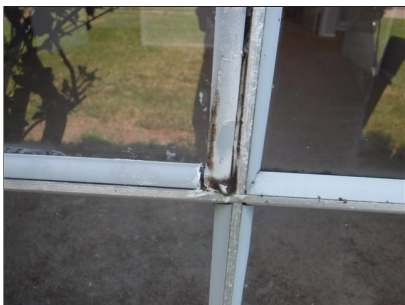
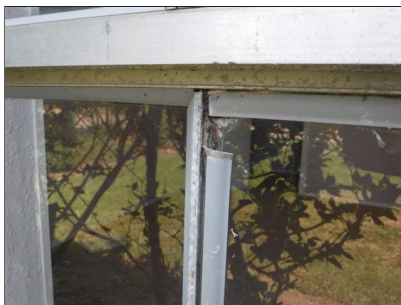
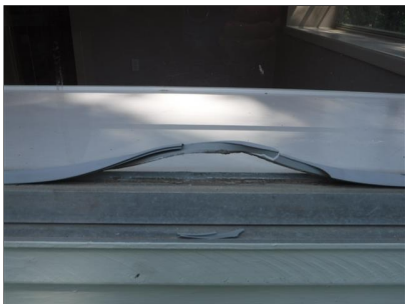
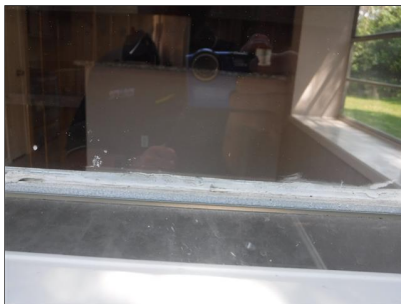
(2) Damaged/missing plastic trim was observed around windows.

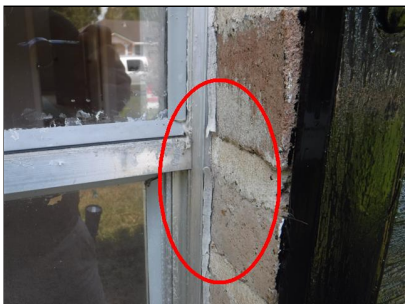
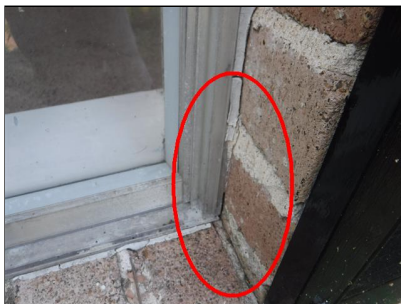
(3) Window caulk is showing signs of deterioration.

Location(s): Multiple Locations

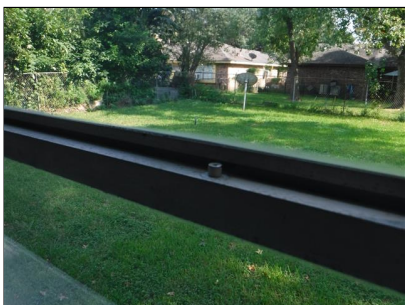
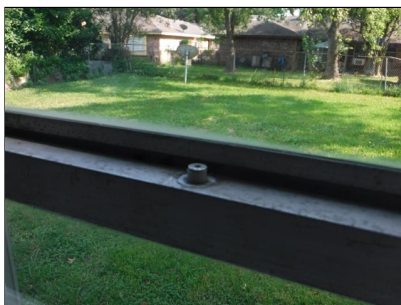
(4) Missing/damaged window latches were observed. Replacement is recommended to properly secure windows.

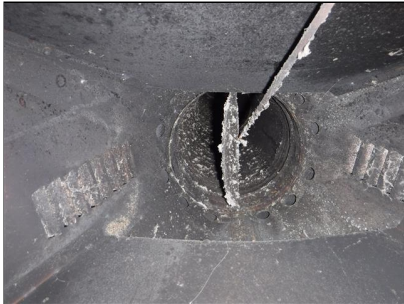
J. Item 1(Picture)

Creosote build up was noted in fireplace and chimney. Cleaning and reinspection by a chimney sweep are needed.

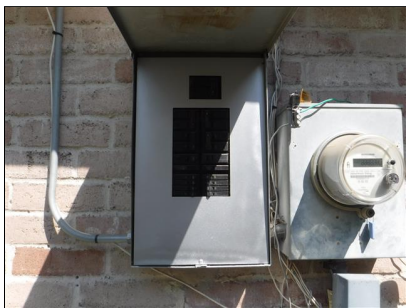
A. Item 1(Picture)

(1) **General Photo of the Distribution Panel**

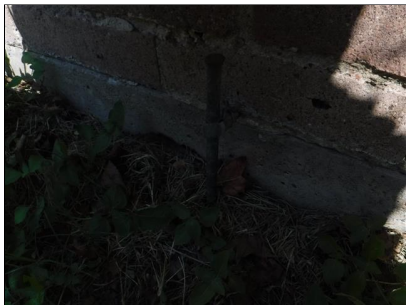
A. Item 2(Picture)

(2) **Note:** Verification of the total length of the grounding rod is beyond the scope of the inspection. Current building standards require minimum depth of 8 feet.

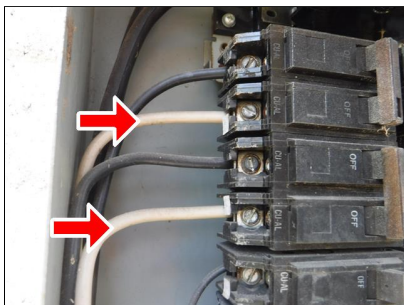
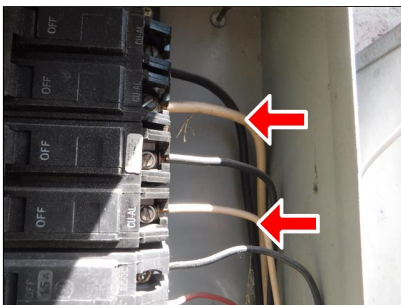
(3) White wires connected to breakers should be marked as hot with black or red electrical tape.

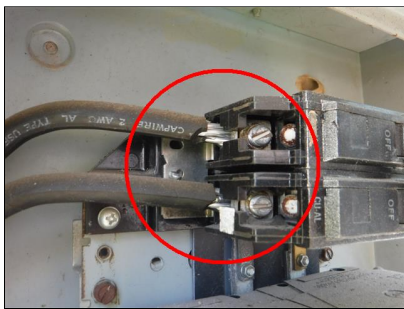
A. Item 6(Picture)

(5) There does not appear to be any antioxidant paste on the aluminum service wires.

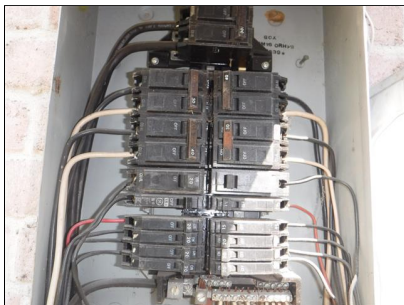
A. Item 8(Picture)

(7) Arc-fault safety protection is not installed for all of the living and bedroom areas. This protection was required by the National Electric code for homes built after 2008. The Texas Real Estate Commission requires inspectors to list as "deficient" any arc-fault protection not installed in these areas; regardless of the homes age.

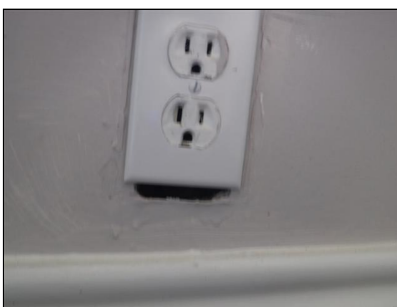
B. Item 2(Picture)

(1) Several outlets in the home are loose in the wall. For safety purposes, recommend evaluation of all outlets to insure they are tight to prevent overheating and electrical hazards.

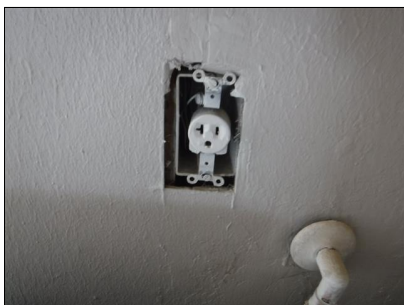
B. Item 3(Picture)

(2) Missing receptacle cover(s) were observed. Installation of covers is recommended for safety.

Location(s): Utility Room

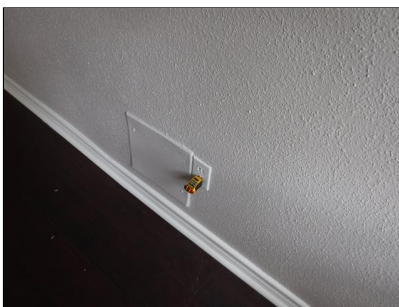
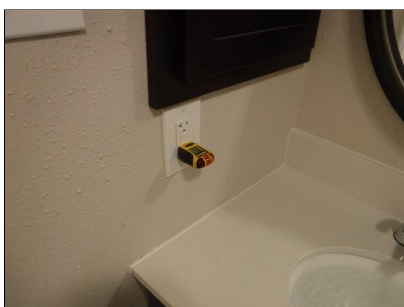
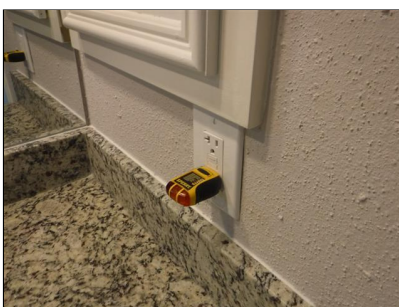
(4) No power was observed to receptacle(s) at the time of inspection. The cause could not be determined. Evaluation by a qualified electrician is recommended.

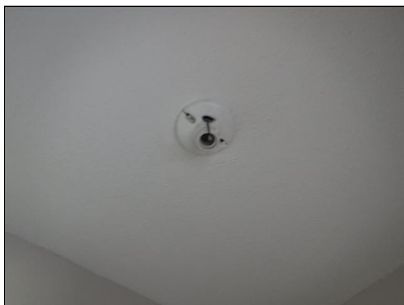
B. Item 8(Picture)

(5) Missing light bulb(s) were observed. Replace as needed.

Location(s): Closet

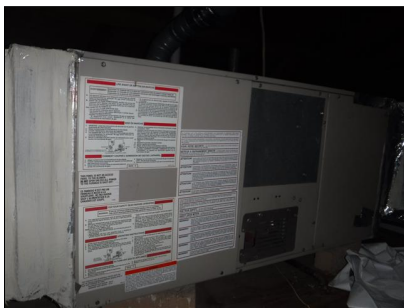
A. Item 1(Picture)

(1) General Photo of Furnace Unit

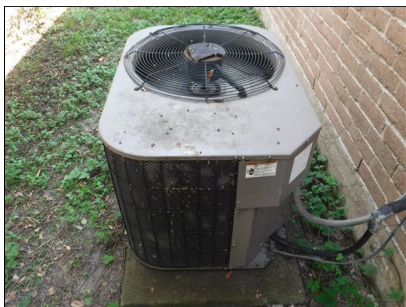
B. Item 1(Picture)

(1) General Photo of Exterior Condenser

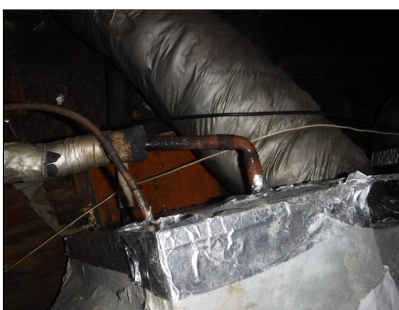
B. Item 3(Picture)

(2) The insulation around the refrigerant line is missing/deteriorated. Replacement of the insulation around the refrigerant line is recommended to prevent condensation build-up and decreased system performance.

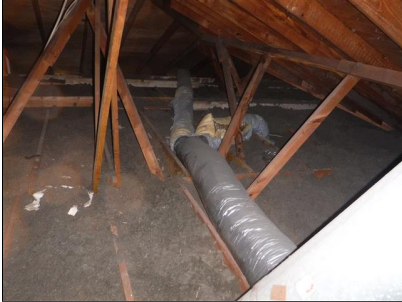
C. Item 1(Picture)

(1) Sections of ducting are resting on the attic insulation which compresses the insulation: hang affected ducting where possible.

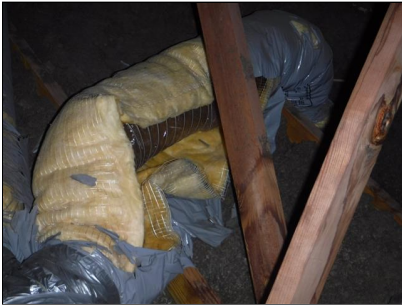
C. Item 2(Picture)

(2) Observed damaged ducting in the attic.

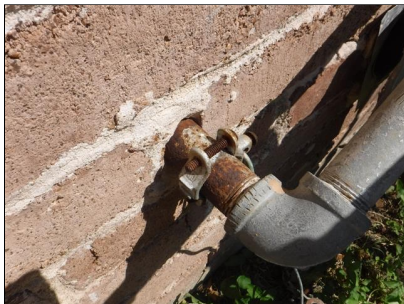
A. Item 1(Picture)

(2) Rusting was observed on the gas service line from the meter into the home. Proper preparation and paint is recommended to prevent further deterioration, or if further evaluation is desired, consult with a qualified plumber.

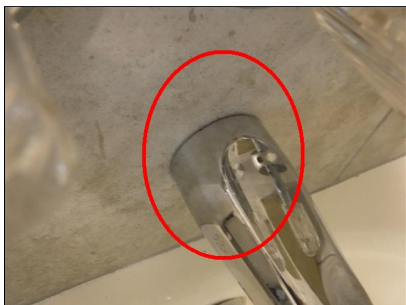
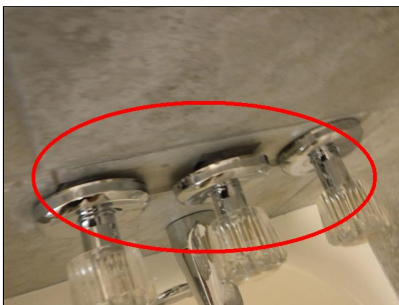
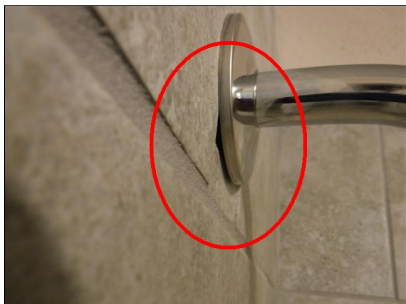
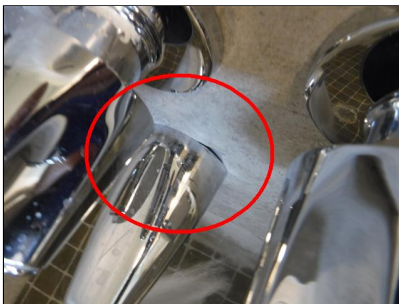
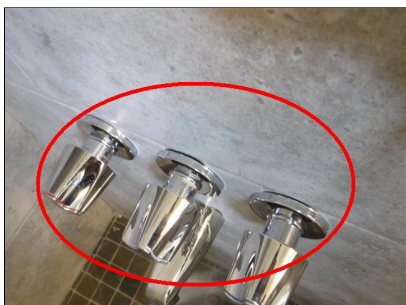
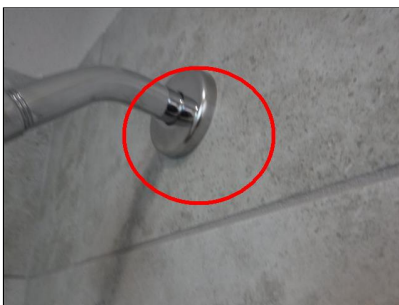
(3) The escutcheon plate(s) and tub spigot are not properly sealed to the wall to prevent moisture intrusion.

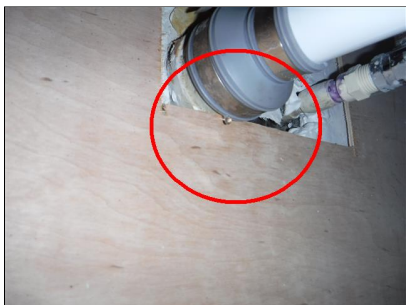
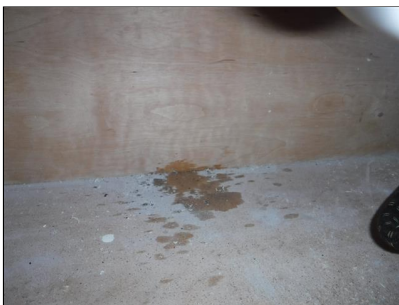
(1) Leaking was observed at the drain line fittings. Evaluate and remedy as needed.

Location(s): Kitchen Sink

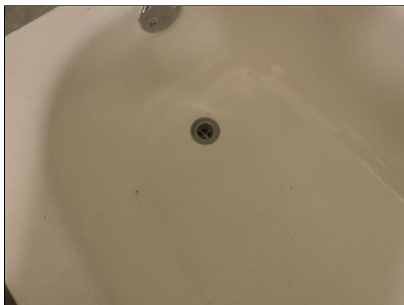
B. Item 3(Picture)

(2) The bathtub drain stop is missing; replace.

Location(s): Hall Bath

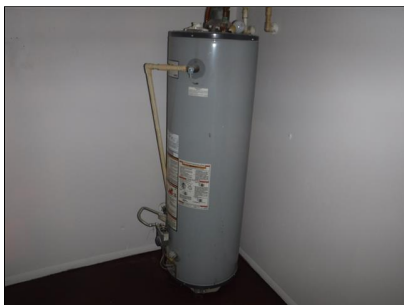
C. Item 1(Picture)

(1) **General Photo of the Water Heater**

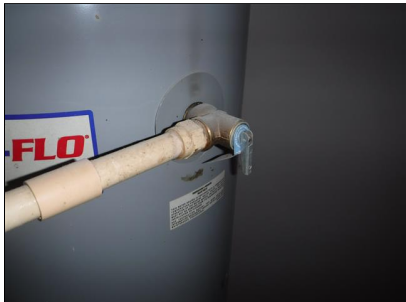
C. Item 6(Picture)

(6) Installation of an emergency overflow pan and proper drain line is recommended under the water heater to prevent damage to interior components in the event of a leak.

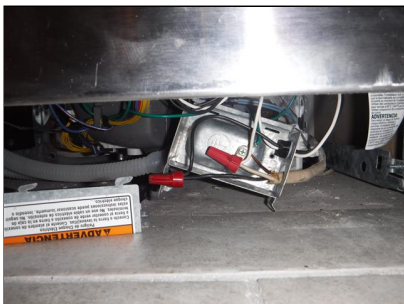
A. Item 1(Picture)

Exposed wire splices were observed at the dishwasher inside the cabinet. The wire splices should be sealed in a junction box for safety.

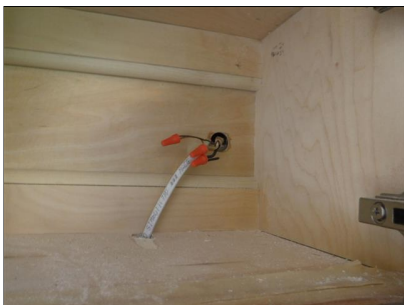
C. Item 1(Picture)

Exposed wire splices should be inside a covered junction box.

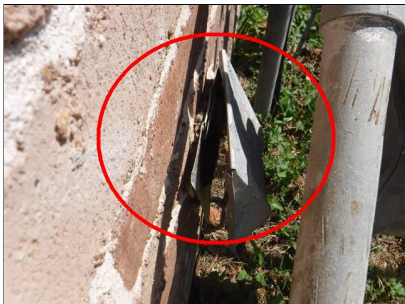
H. Item 1(Picture)

The dryer exhaust cover is damaged.
