Inspection Report

Property Address:
722 Last Arrow Dr
Houston TX 77079

PROPERTY INSPECTION REPORT

722 Last Arrow Dr, Houston, TX 77079

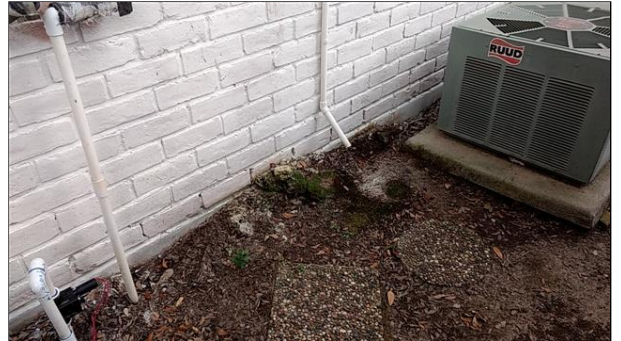
right

- High soil levels were observed at the foundation walls in various locations. A minimum of four inches of foundation wall should be exposed under the brick veneer and a minimum of six inches of foundation wall should be exposed under the wood surfaces. High soil levels are conducive to wood destroying insect infestation, and possible water penetration into the home. When repaired, the grade should slope downward away from the home directing runoff away from the foundation. Improvements should be undertaken by professional landscaper.

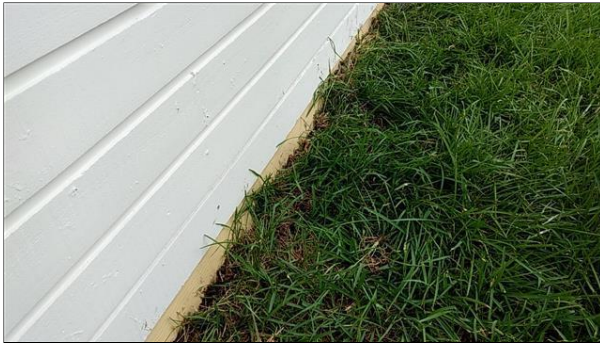
garage

grading, soil and grass
fixed

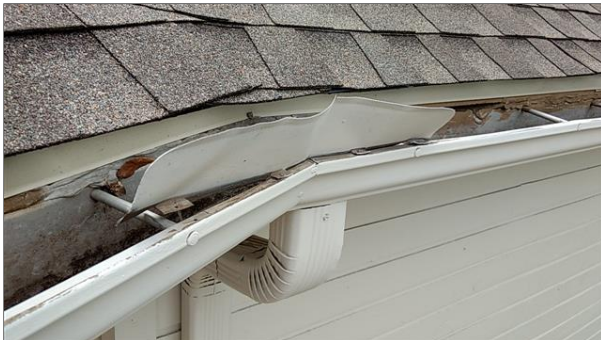
- Gutter splash guard along breezeway is loose and needs to be secured.

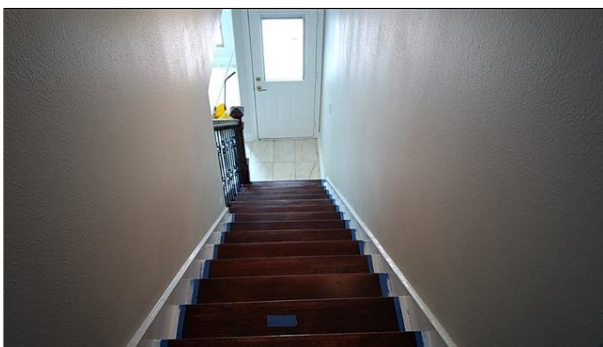
- The stair railing does not have a "graspable" hand rail that is continuous from the bottom to the top of the stairs. .

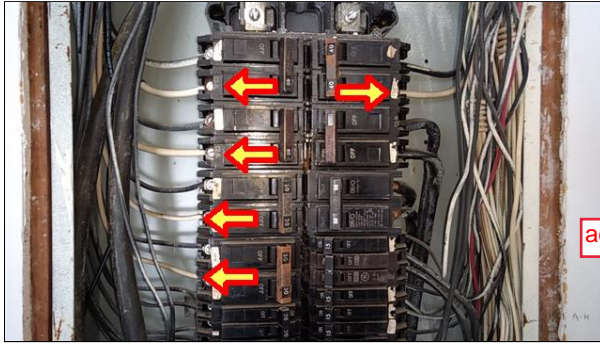
addressed

- Breakers in the main panel enclosure are not properly labeled.
- Screws to secure the deadfront (cover) main panel enclosure are missing. Blunt tip screws designed for this purpose should be installed. Pointed screws are not allowed.
- The breaker serving the second level air conditioning condensing unit is over sized. The breaker serving the appliances is rated at 60 amps. The maximum size breaker allowed by the appliance manufacture is 35 amps.
- The breaker serving the first level air conditioning condensing unit is over sized. The breaker serving the appliances is rated at 60 amps. The maximum size breaker allowed by the appliance manufacture is 50 amps.

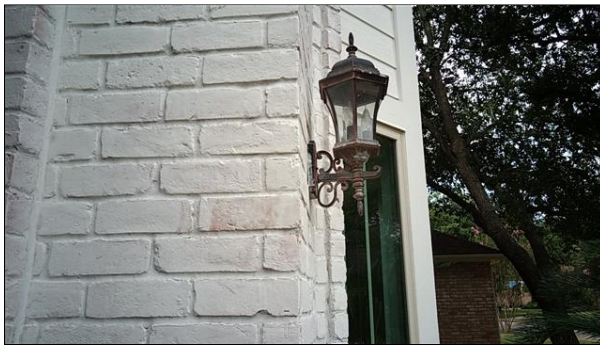
- Two light fixture(s) at the front of the home are inoperative. If the fixture does not work after replacing the bulbs, a licensed electrician should be consulted.

addressed

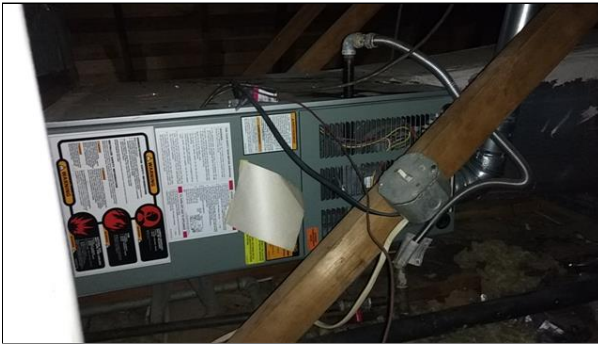
Unit photo second level

addressed

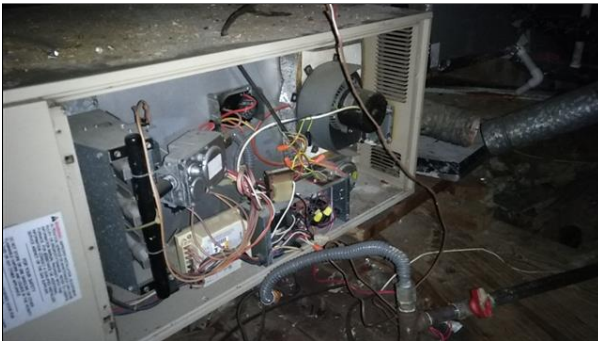
Unit photo first level

addressed

- The gas utility was off at the time of inspection preventing the furnace from being inspected while operating.
- The vent connector is disconnected at the furnace for the first level of home. This condition is a safety hazard that should be corrected.

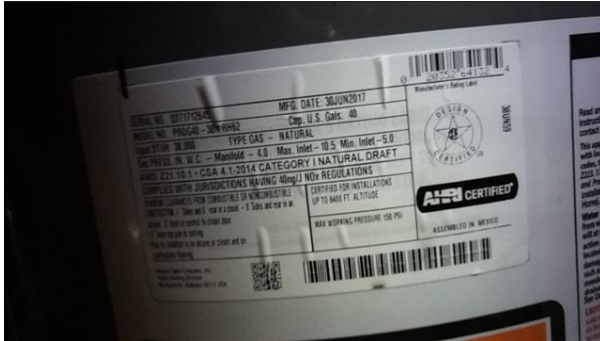
- The gas utility was off at the time of inspection preventing the water heater from being inspected while operating. The water heater(s) appears to be installed properly.

addressed

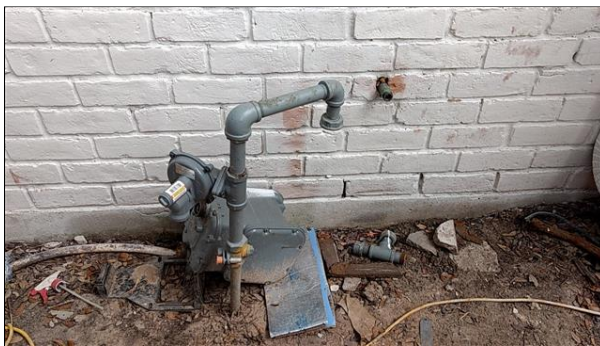
- The gas utility was shut off at the time of inspection. This prevents inspection of any gas fueled appliances or gas related plumbing. In some cases the gas provider may require a static pressure test by licensed plumber before the gas service can be restore.

addressed

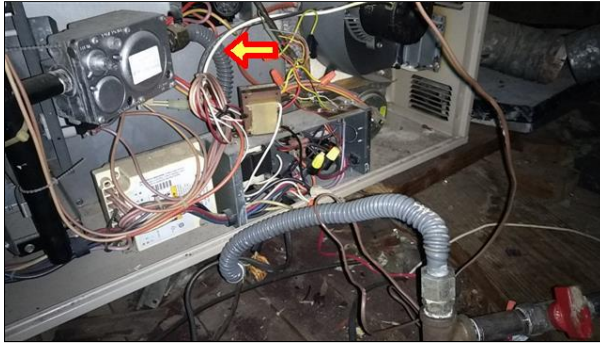
- One furnace(s) are plumbed with the flexible gas connector passing through furnace case. The flexible connector is not rated for this installation method. Hard piping should be plumbed to the exterior of the furnace and the flexible connector connected at the exterior of the furnace.

addressed
