# Property Inspection Report

1623 Cantrell Blvd,  
Conroe, TX 77301

Cory Alan Haddox, P.E.

Issued: 17 February 2017

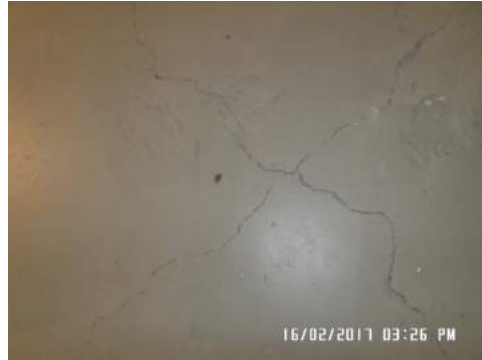
*Photo 4*

1. Exposed reinforcement was noted at the front of the right garage door. See Photo 1.
2. Cracks were found throughout the garage floor. See Photos 2 through 4.
3. A few cracks were observed on the back left of the foundation. See Photo 5.
4. Cracks were noted at the front patio. See Photos 6 and 7.

It is the opinion of the inspector that the foundation was found to be performing as expected for the age of the house. However, the distresses noted here, as well as the separations in the drywall, should be monitored for further movement. As well, the grading and drainage should be improved around the house to ensure water does stand adjacent to the foundation.

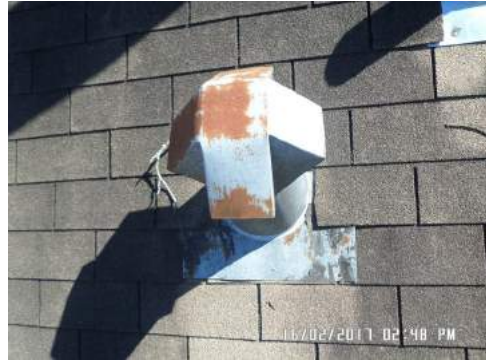
*Photo 15*

1. Some damaged and deteriorated shingles, with exposed and rusted nails, were noted. See Photos 12 through 14.
2. Some of the vents were found to be deteriorated and rusted with exposed and rusted nails. See Photos 15 through 18.
3. Signs of shingle replacement were observed in a few locations. See Photos 19 through 22.
4. The cover for the entry point for the electrical service was noted to be rusted. See Photo 23.
5. The flashing around the chimney was found to be deteriorated and rusted, especially on the top side. As well, the caulk on this flashing was observed to be deteriorated. See Photos 24 through 26.
6. The flashing on the bottom side of the chimney was noted to be painted, however, the nails were found to not be covered with caulk properly. This could allow the nails to rust prematurely. See Photo 27.

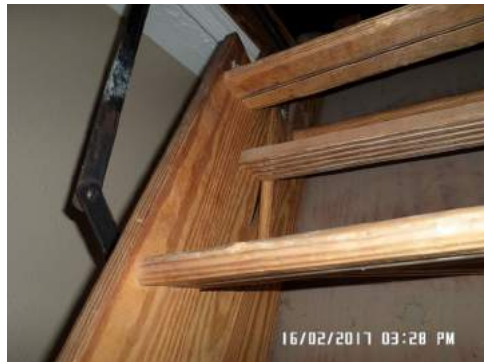
Photo 28

1. The attic temperature was observed to be higher than expected. This is an indication of poor ventilation and insulation. Improvements to the insulation and ventilation could improve the efficiency of the house.
2. The attic ladder was found to be damaged. See Photo 28.
3. The insulation was noted to be missing or out of place in many places throughout the attic. See Photos 29 through 33.
4. Some of the framing was observed to not be secured properly. See Photo 34.
5. The screen on the right louver was found to be damaged. See Photo 35.

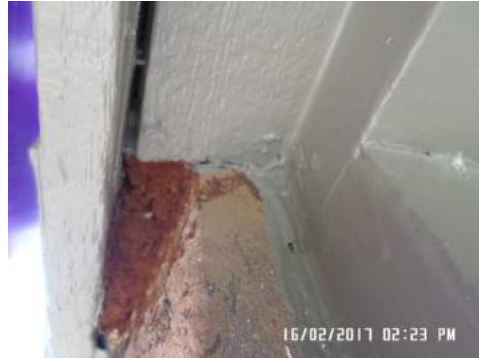
*Photo 36*

1. The trim at the garage door was found to be separated. Some of these separations were found to be filled with expandable foam. See Photos 36 and 37.
2. Several brick and mortar separations and repairs of brick separations were noted on the exterior of the house. See Photos 38 through 49.
3. Some of the bricks were observed to be deteriorated and to have voids in the mortar. See Photos 50 through 54.
4. The tile grout in the guest bathroom was found to be separated. See Photos 55 through 59.
5. A few drywall separations were noted throughout the house. See Photo 60.

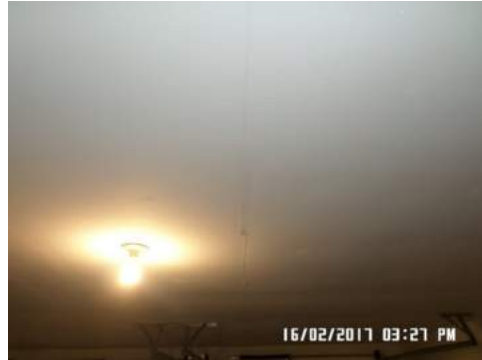
*Photo 66*

1. The tile at the back door was found to be damaged. See Photo 61.
2. A few ceiling drywall separations were noted. See Photos 62 through 65.
3. The area around one of the ceiling vents was observed to have some discoloration and to not be flush with the ceiling. See Photo 65.
4. The ceiling drywall in the garage was found to have some separations. See Photos 66 and 67.

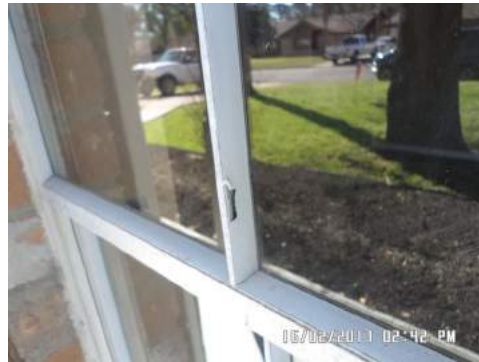
*Photo 69*

1. Screens were noted to be missing from the windows.
2. Expandable foam was found to be used at a window on the right side of the house. See Photo 68.
3. Some of the window seals, although recently replaced, were found to be damaged in a few places. See Photo 69.

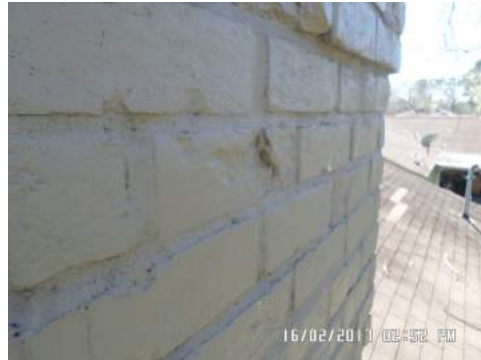
Photo 71

1. The bricks on the chimney were found to be deteriorated and damaged in multiple places. See Photos 70 through 73.
2. The top section of the flue and chimney cap were observed to have been recently replaced. See Photo 74.
3. The mortar chimney cap was noted to be damaged at the corners. See Photos 75 through 77.
4. Debris and rust were found on the inside of the fireplace. See Photos 78 and 79.
5. It is recommended to have the fireplace cleaned and serviced before use.

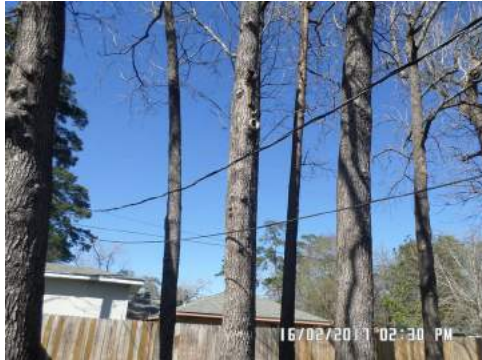
1. The service cables were noted to not have a definite drip loop. See Photo 80 and Drawing 1.
2. Also, the service cables were observed to be lower than expected across the back yard. See Photo 81 and Drawing 2.
3. The meter box was noted to be quite rusted. See Photo 82.
4. This 100 amp panel was found to be Brand Sylvania, most likely original to the house, and was noted to located at the back left corner of the house. See Photo 83.
5. The breakers were observed to not be labeled. See Photo 83.
6. A large amount of pest debris was noted to be built up in the bottom of the panel cabinet. See Photo 84.
7. It is recommended to have the panel, meter box and service cables further evaluated by a qualified electrician.

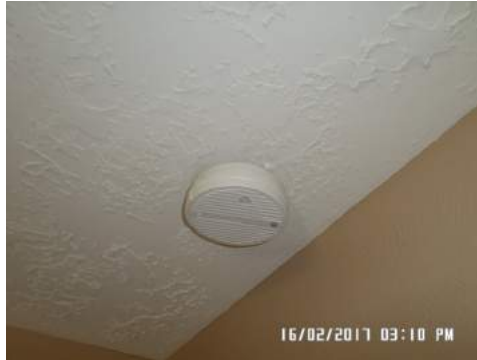
*Photo 88*

6. The smoke detector in the front right bedroom was observed to not be secured to the ceiling properly. See Photo 88.
7. The receptacle to the left of the back door was found to not be flush with the wall. See Photo 89.

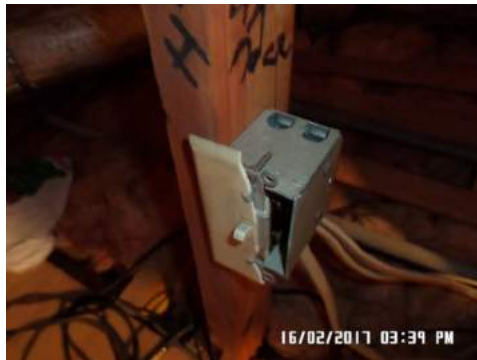
*Photo 90*

8. The GFCI receptacle in the master bathroom was noted to not be grounded.
9. A switch in the attic was observed to have a damaged cover. See Photo 90.

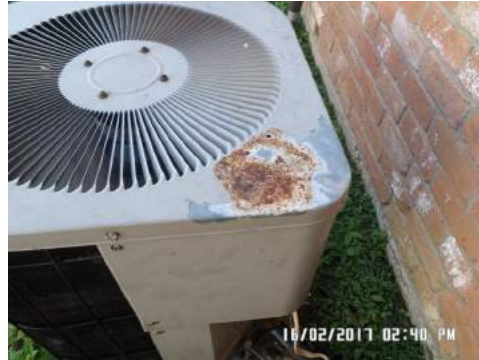
Photo 93

1. The exterior AC unit was observed to have been manufactured in 1995. See Photo 92.
2. Rust was noted on top of the exterior AC unit. See Photo 93.
3. Interior electrical cables were found to used to power the exterior AC unit. Exterior cabling should be used, or interior cabling should be shielded. See Photo 94.
4. Some rust was observed to be in the overflow pan under the AC unit in the attic. See Photo 95.
5. It is recommended that both the heating and cooling systems be serviced before use and annually thereafter.

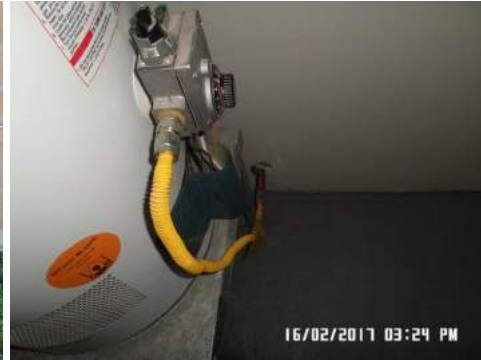
Photo 99

1. No shut off valve was found for the gas supply system. This could be a safety hazard.
2. The gas supply system was observed to not be bonded. See Photos 98 through 100.
3. The guest bathroom toilet valve was noted to be corroded. See Photo 101.

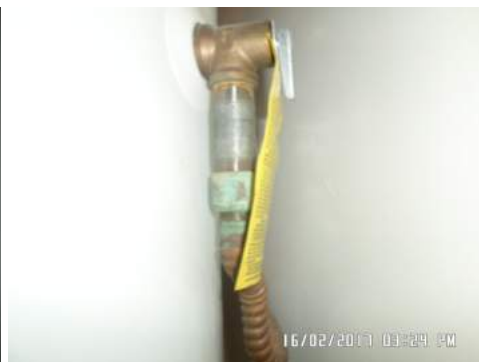
Photo 103

1. The water heater was found to have been manufactured in 2009. The life expectancy of a typical gas water heater is 9 to 12 years. See Photo 102.
2. The piping at the temperature and pressure relief valve was observed to be corroded. See Photo 103.
3. As well, one of the pipe connections on the top of the heater was noted to be corroded. See Photo 104.
