TEXAS REAL ESTATE CONSUMER NOTICE CONCERNING HAZARDS OR DEFICIENCIES

Joseph and Cara Stogner, 3318 S. Lake Village Drive, Katy, TX 77450

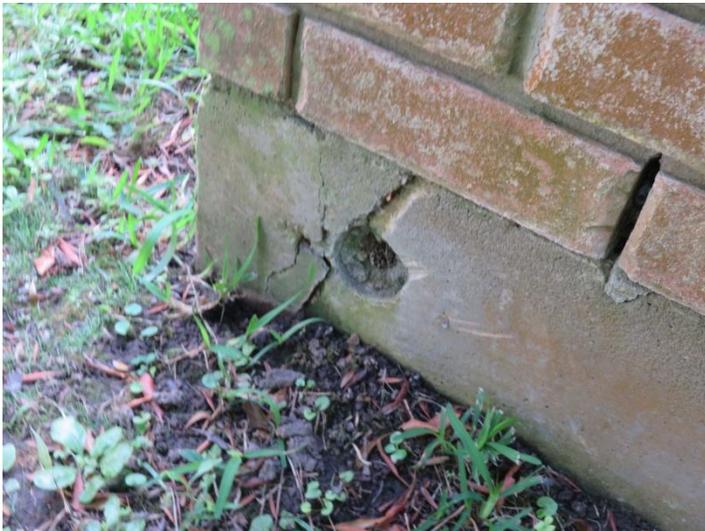
Example at the right rear corner of the home

- “Corner pops or shears” may be present at one of more exterior concrete corners of the home. In the opinion of the inspector, these pops are common in Texas construction and do not normally reduce the strength of the foundation nor do they necessarily mean that structural integrity has been compromised. Post tension cables and/or structural re-bar installed behind the shears may be subject to water exposure, rust and deterioration. The corner pops/shears should be sealed. Any concerns should be addressed to a P.E. or structural engineer.

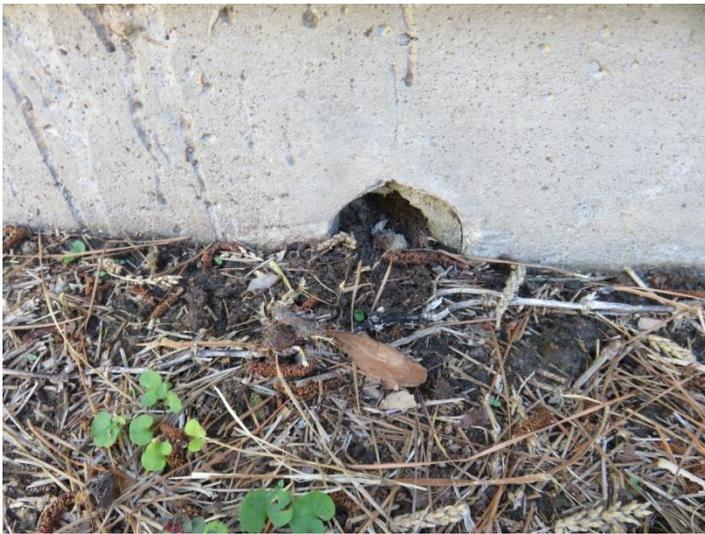
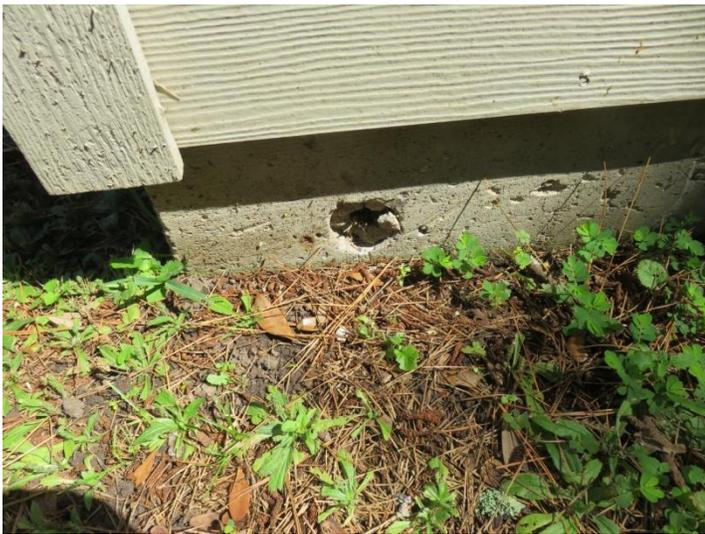
Examples at the rear and side of the garage (4) and at the right rear corner/right side of the home (3)

- Post tension foundation cable ends about the home are exposed. Allowing these cable ends to remain exposed to moisture and weather elements could eventually cause the cable to weaken and possibly lose strength. Evaluation by a professional foundation contractor familiar with decay of post tensions cables may be required. All exposed cable ends should be properly covered/protected to prevent further deterioration.

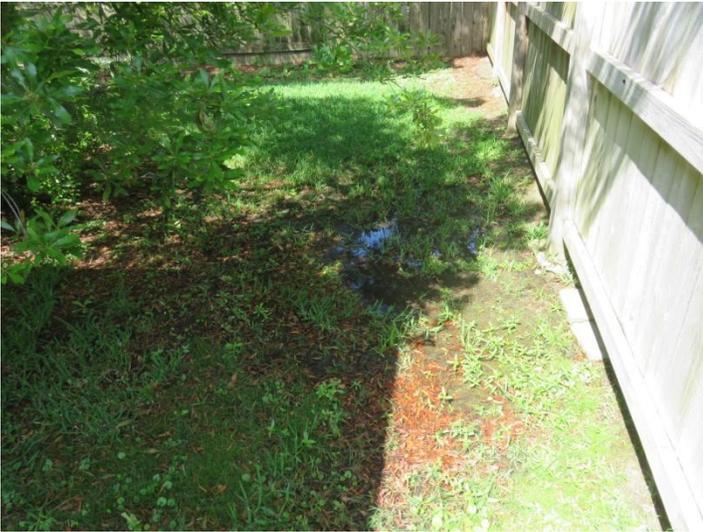
- At the right rear corner of the home ponding of water is noted.

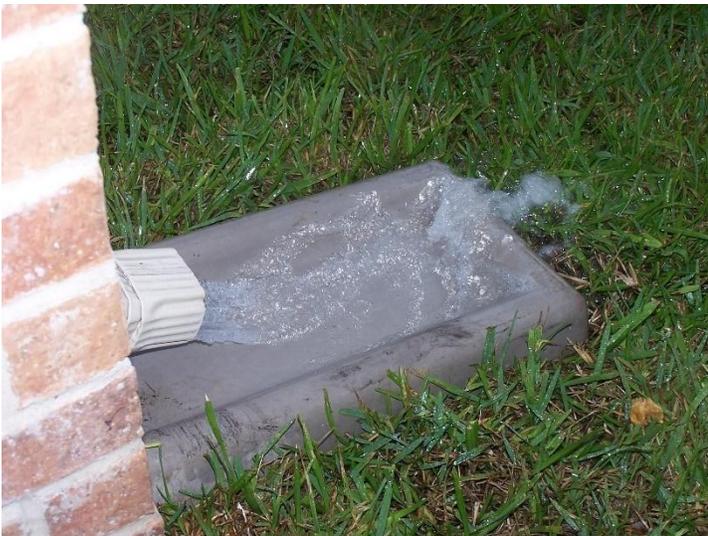
Example of a downspout splash back in action and current installation examples

- Downspout splash backs should be installed at the delivery point of each rain downspout. Splash backs should be positioned so that the high side or “block” is positioned away from the home and not against the foundation. They prevent rushing water from eroding the soil and provide an increased directional flow of water away from the home and foundation.

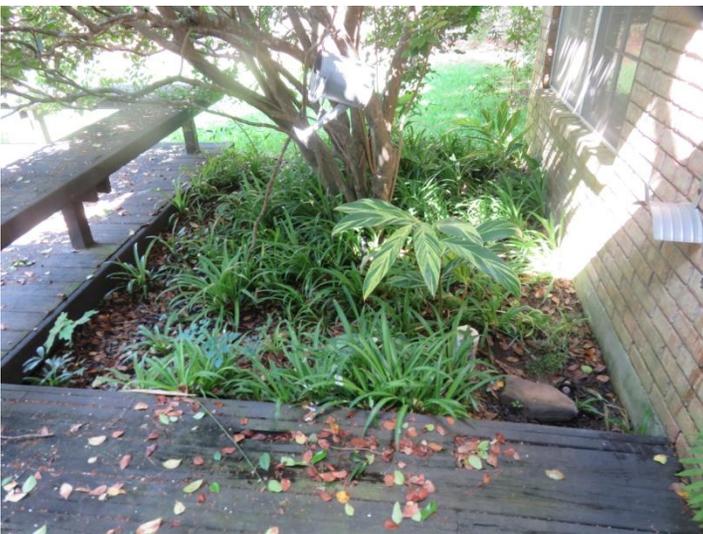
➤ At the area adjacent to the rear deck drainage requires improvement.

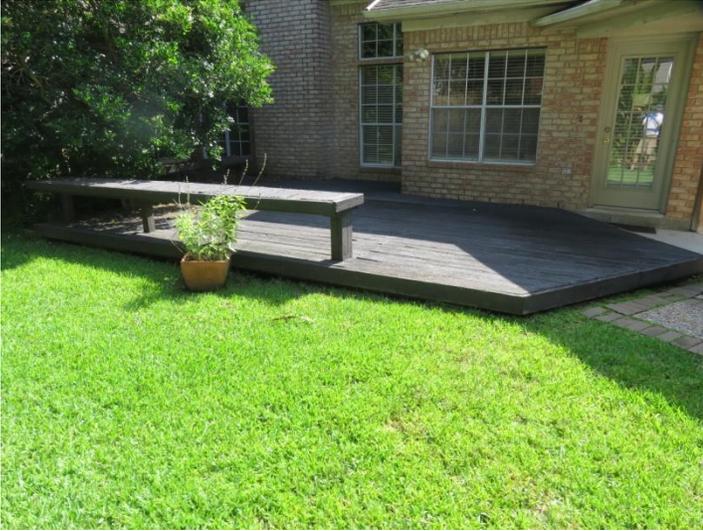
- The deck may inhibit drainage at the back of the house and outside the Master bathroom.

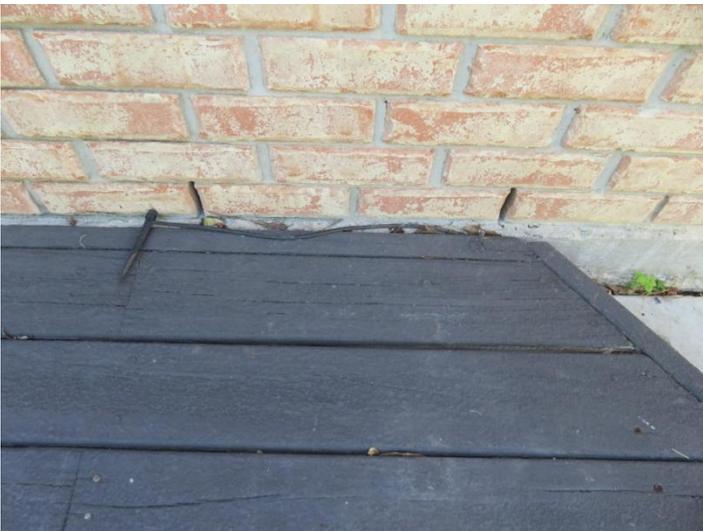
- The deck is of equal height as the foundation weep holes which could cause water to flow into the weep holes affecting the interior of the home.

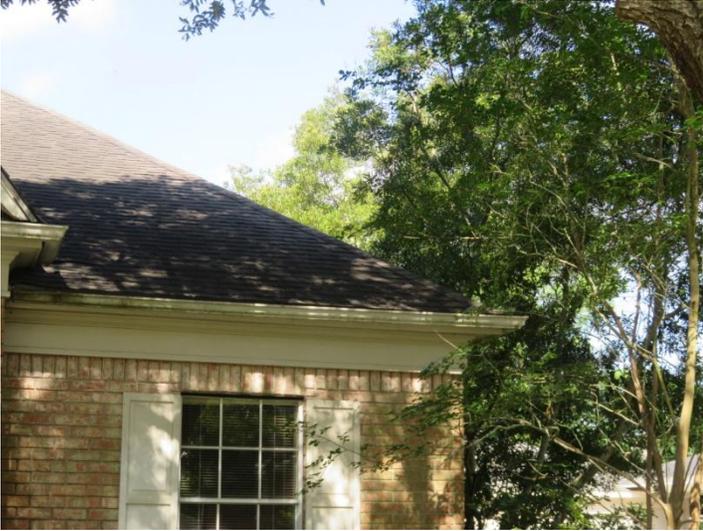
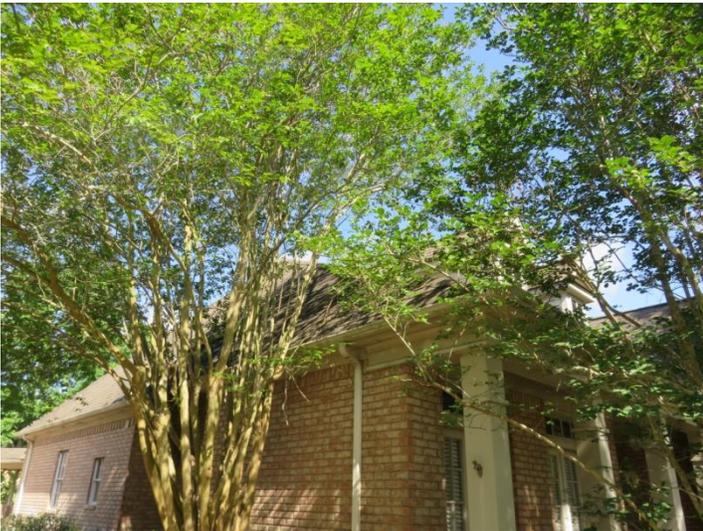
Examples

- Trees are too close to the home and foundation. Branches raking across wall and roof surfaces can damage these areas. Roots in close proximity to the home and foundation can cause the foundation to fail due to their thirst for water in the areas. A landscaping professional should be engaged to evaluate and suggest remedies to these issues.

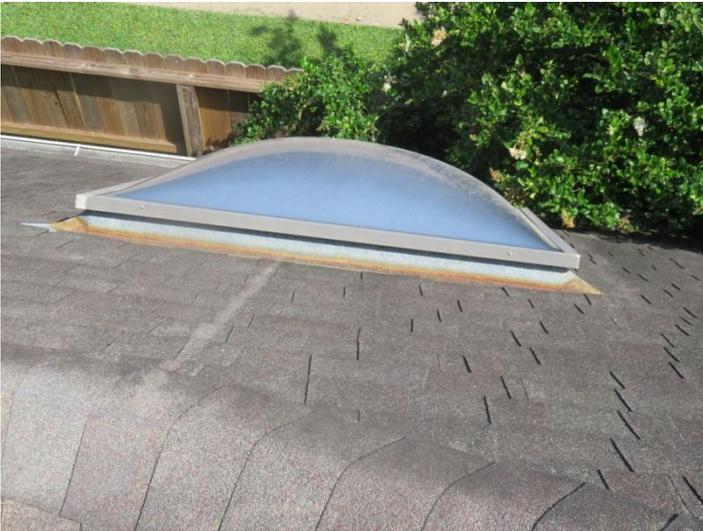
- Flashing at the skylight above the Master bathroom is rusting.

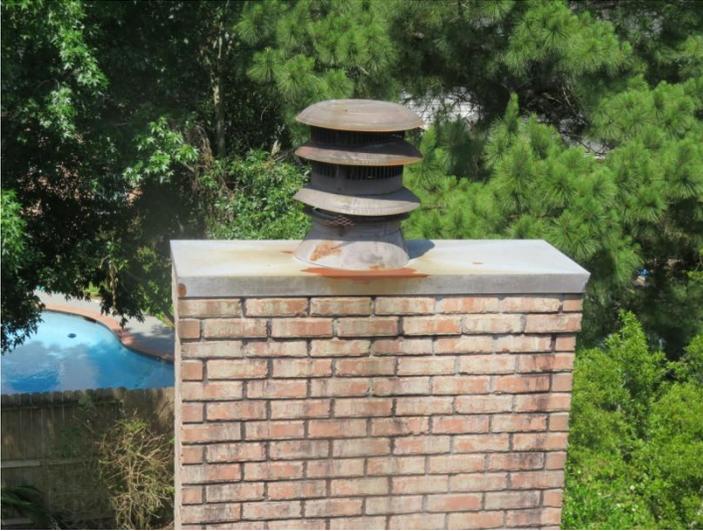
- The chimney cap is rusting.

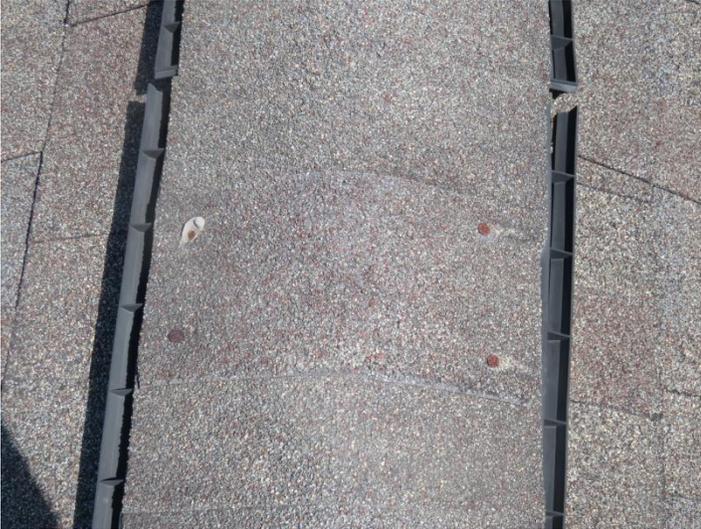
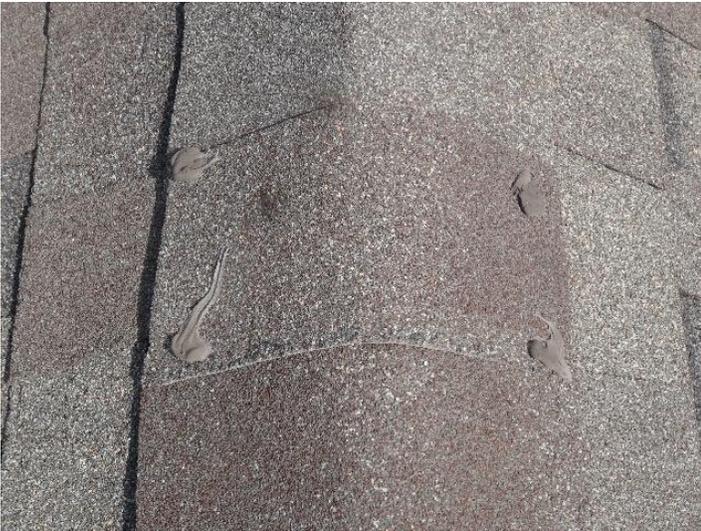
- Nails exposed to weather and moisture will rust and fail prematurely creating the potential for shingle elevation and movement. Weather protective caulk or other appropriate roofing material should be applied to the nails.

Current and required application

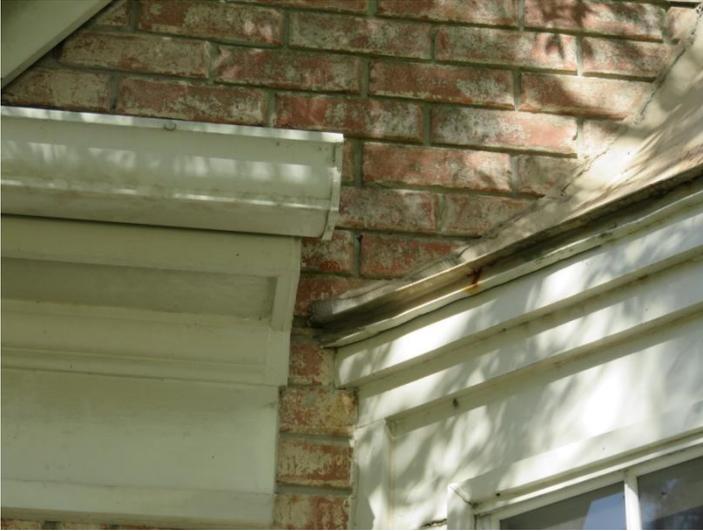
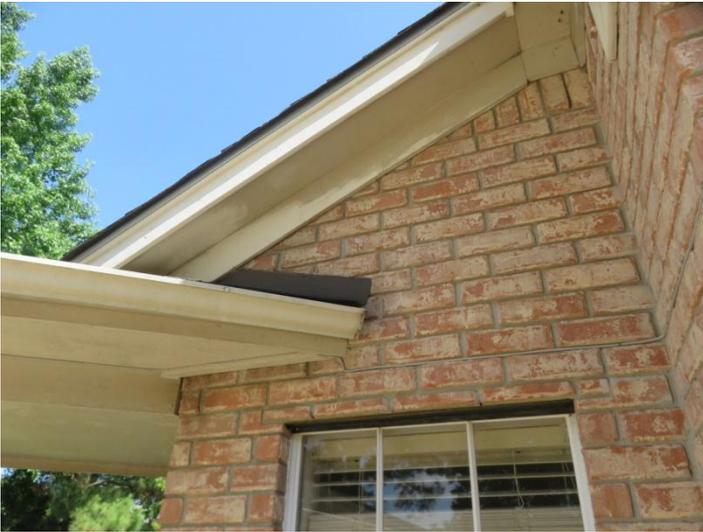
Examples around the home roof lacking this flashing

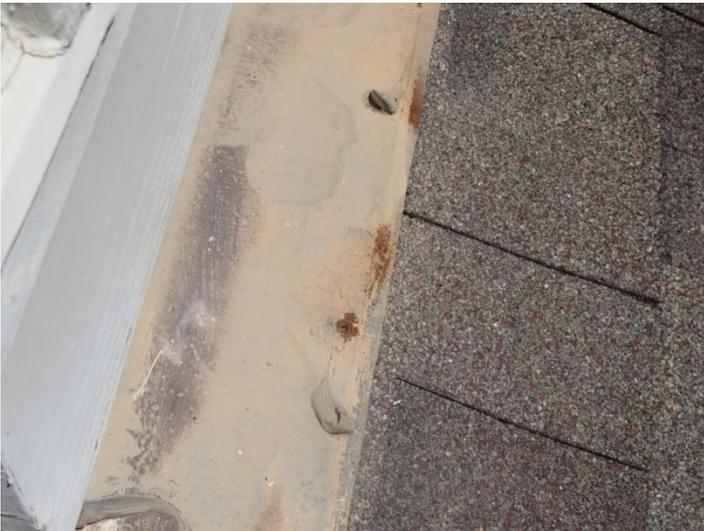
➤ Front dormer flashing displays rust.

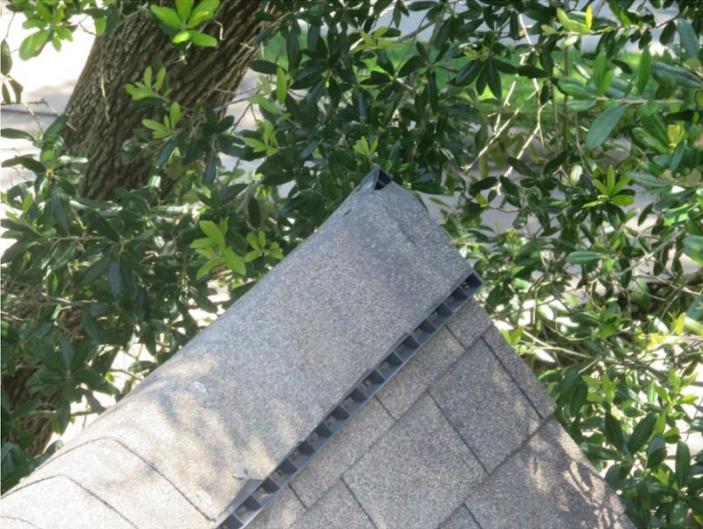
- At the front right dormer peak shingles are damaged/opening in roof.

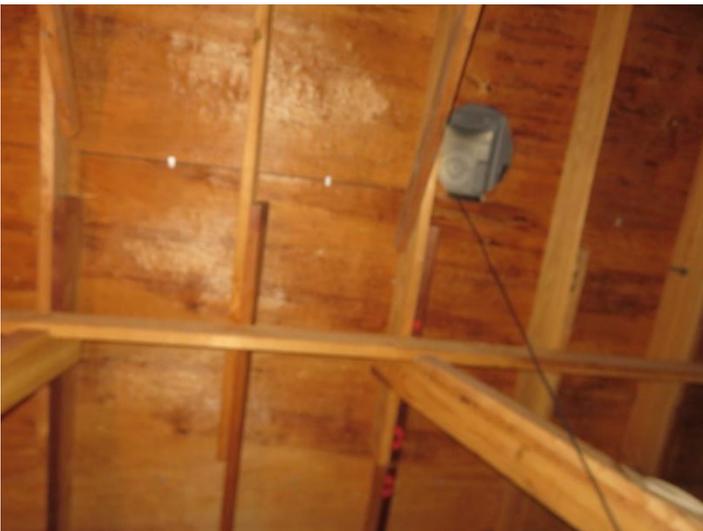
- To the right of the furnace it appears that there may have been/is a leak as indicated by water staining.

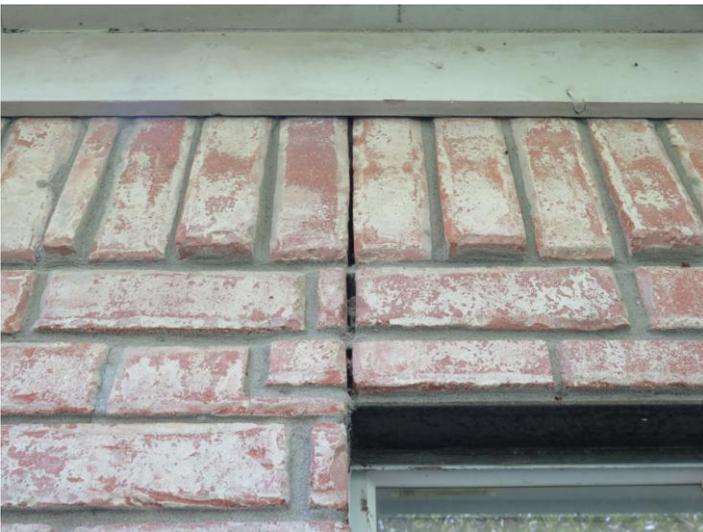
- At the right rear wall an open expansion joint requires filling.

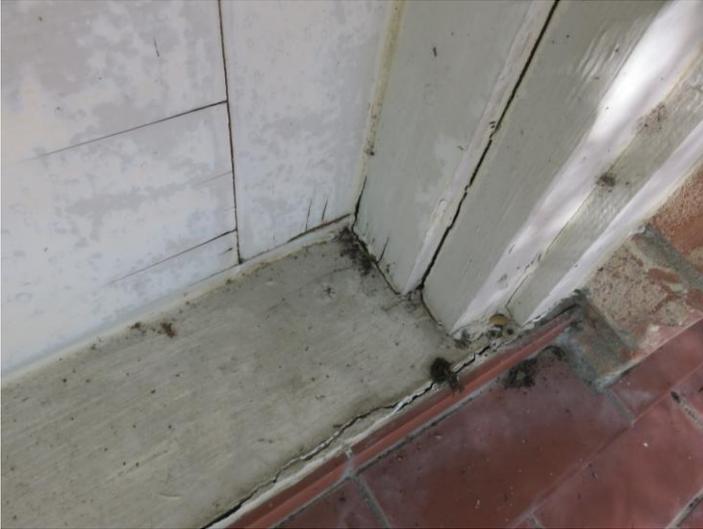
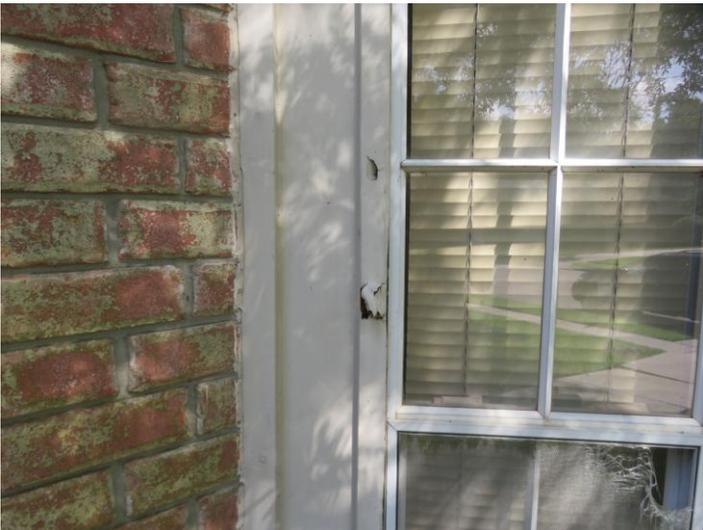
Examples

- Around the house, especially in the front, trim and framing materials display deterioration.

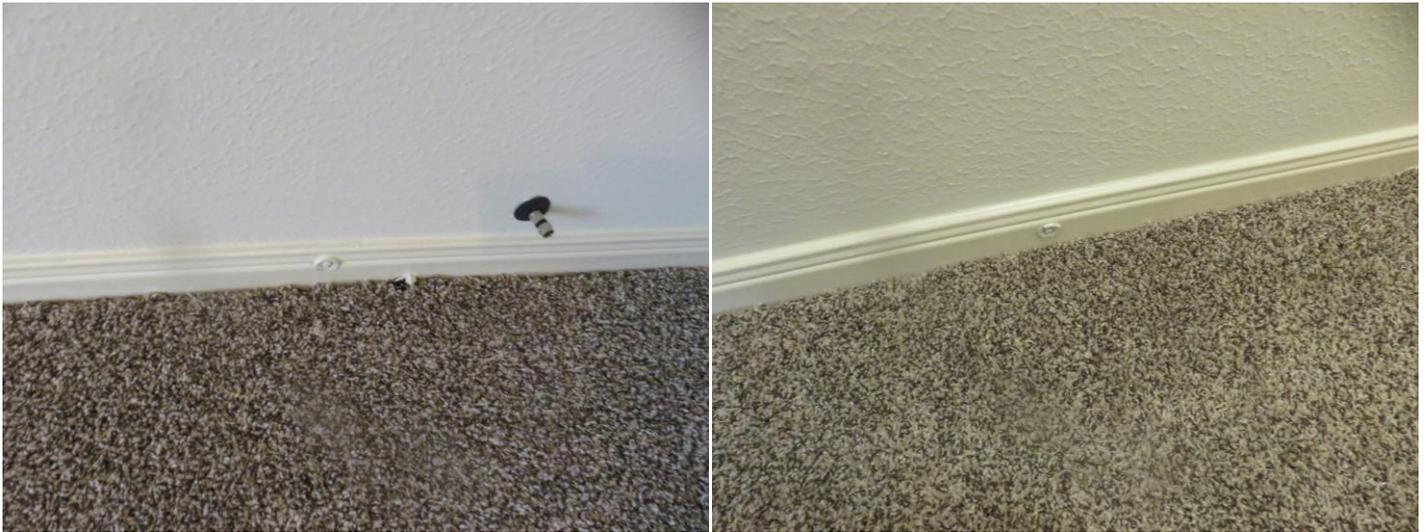
Examples

- Doors lacking stoppers should be so supplied.

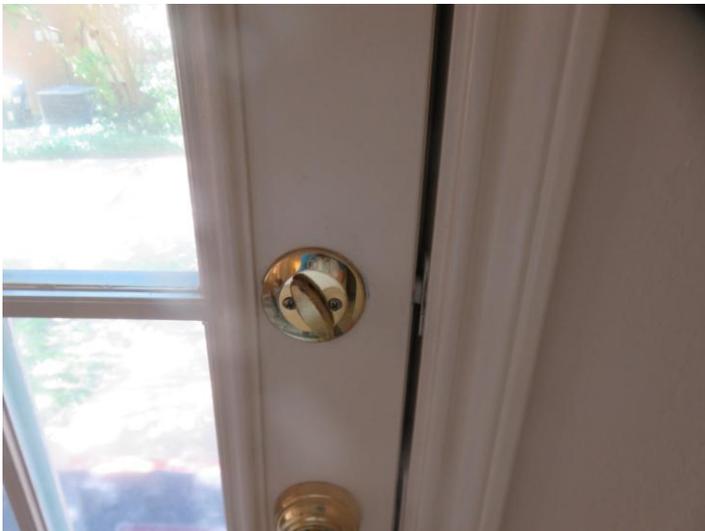
- The left side porch door was unable to be opened.

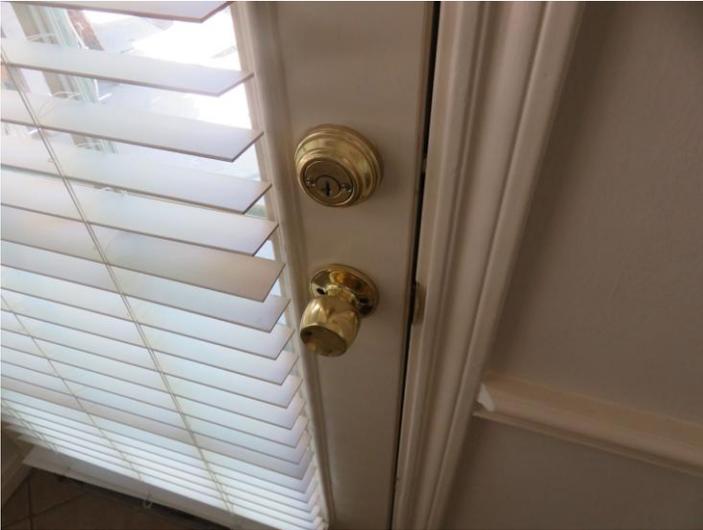
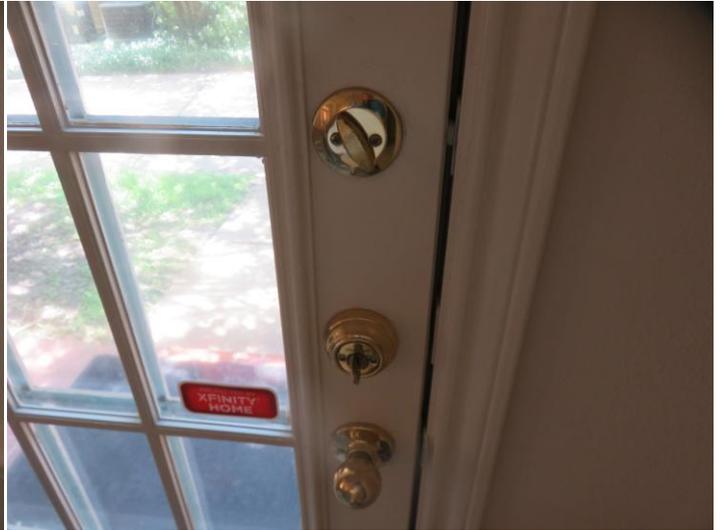
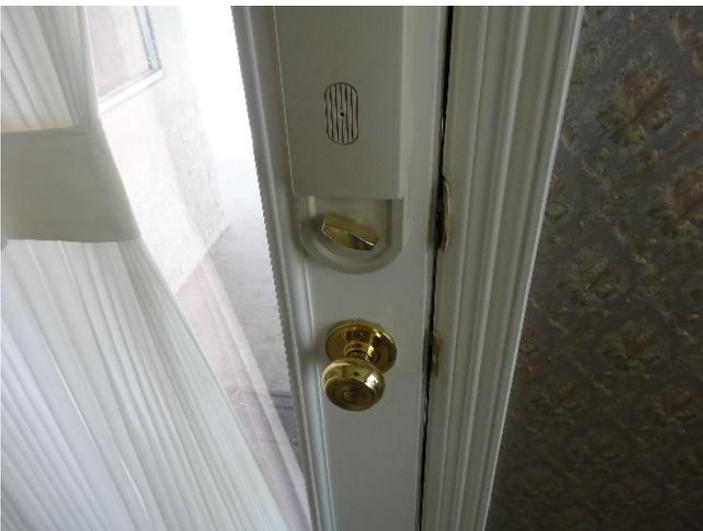
Current and recommended installation

- Doors that are lockable by a double dead bolt lock are not advised and threaten occupants with entrapment. The need for a key or other tool to open a door to exit the home limits the occupant's means of egress if the key or tool is not immediately available. The use of a single dead bolt lock on the interior side is required. IRC {311.2}.

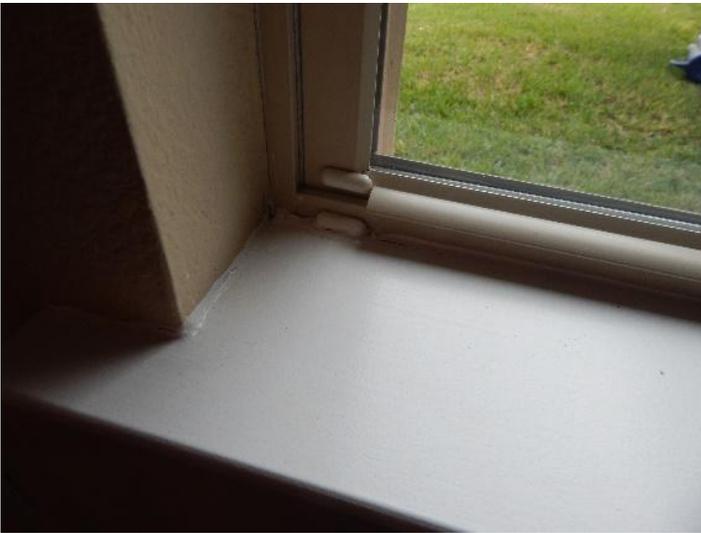
Example

- Windows that have had its frame bored for the insertion of a security alarm contact or other apparatus effectively negates the manufacturers window warranty. Side mounted contacts glued to the window are preferred. Maintain contacts with full sealant.

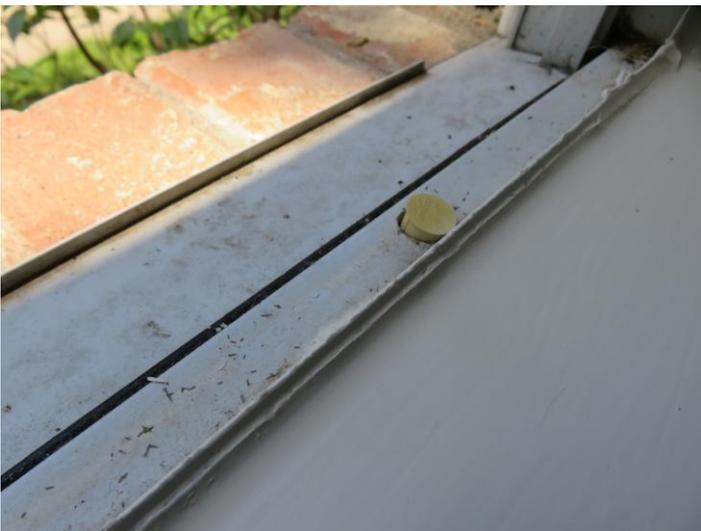
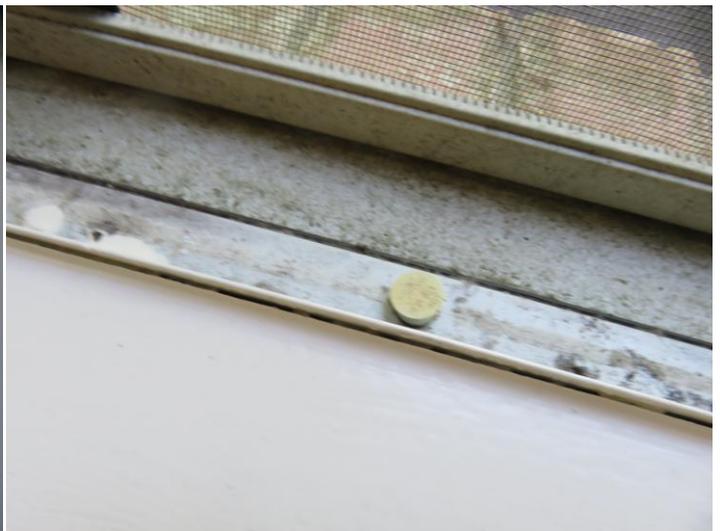
Current installation examples

In the opinion of the inspector, accessible windows did not appear to be installed but functioning as intended at the time of this inspection as noted by example(s):

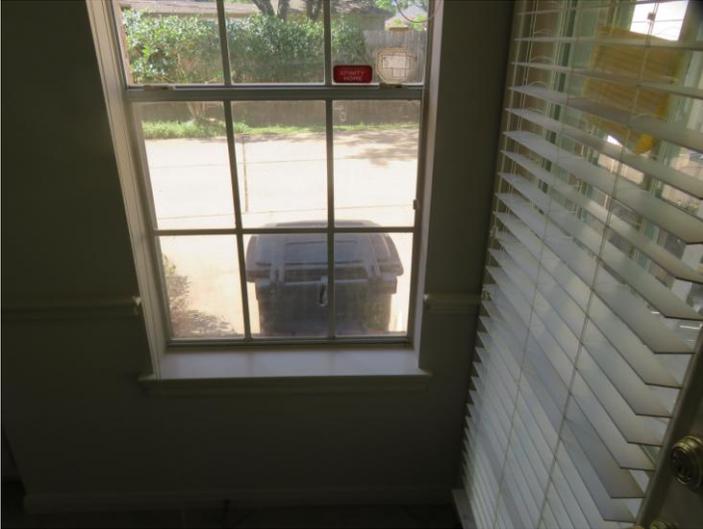
- The window to the left of the rear entry door (<3') is required to be safety glass.

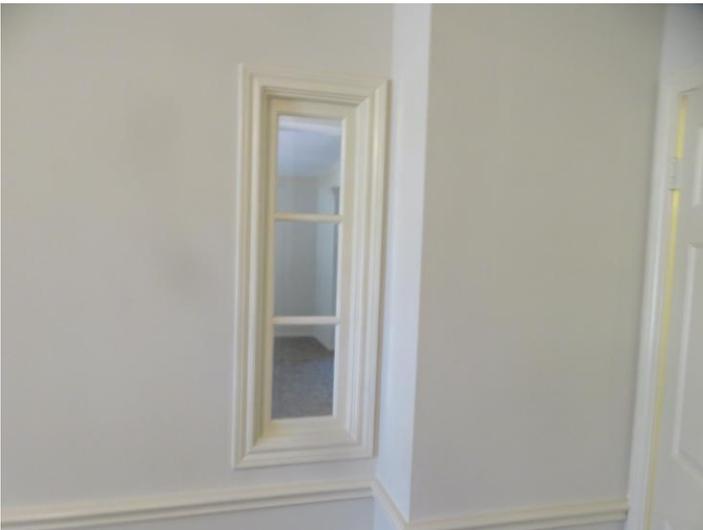
- The window/glass at the right foyer/center front bedroom is required to be safety glass.

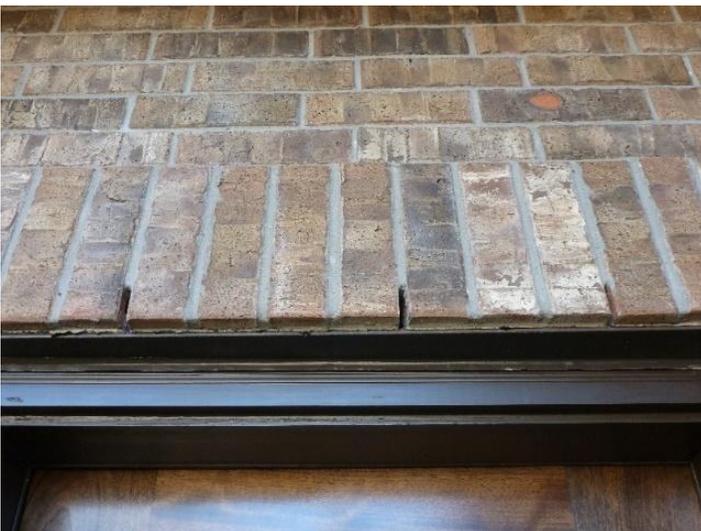
Weep hole example and current installation examples

- Windows with brick walls supported by steel lintels will rust if condensation/water is allowed to accumulate or penetrate behind the wall of brick. The top of the lintel should be installed with flashing between the bottom of the first row of brick and the lintel. **[IRC - 703.7.5]**. It could not be ascertained to what degree, if any, flashing is installed in this manner. Weep holes can be provided by drilling/removing a portion of the mortar between bricks at the top of the lintel. Weep holes are required to be 3/16" in width and installed in pairs above a window and/or at least within 33" of each other. [IRC - 703.7.6]. Rusting lintels should be scraped and painted with a rust preventing paint.

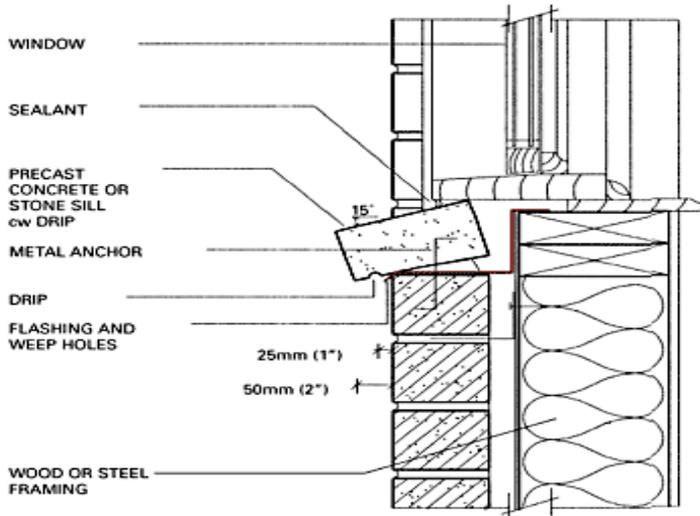
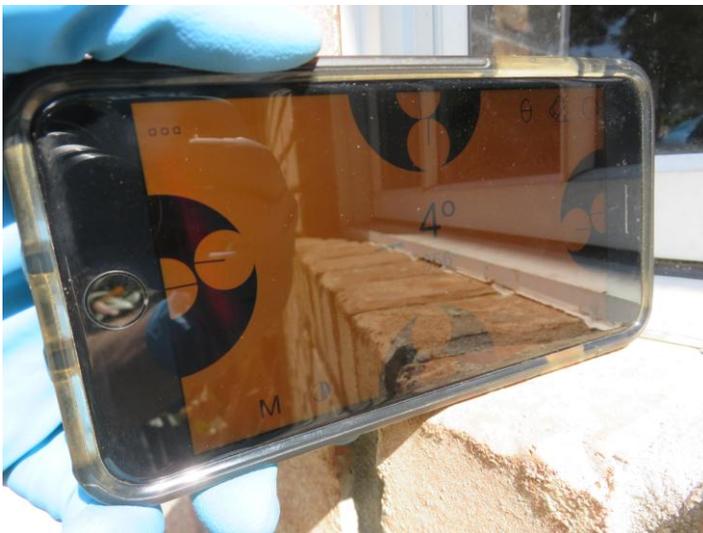
Illustration and current example

- Exterior window sills are required to be installed to slope at least at a 15* angle away from the home/window to properly drain/shed water away from the home. Maintain window caulk/sealant to assist in preventing window leakage.

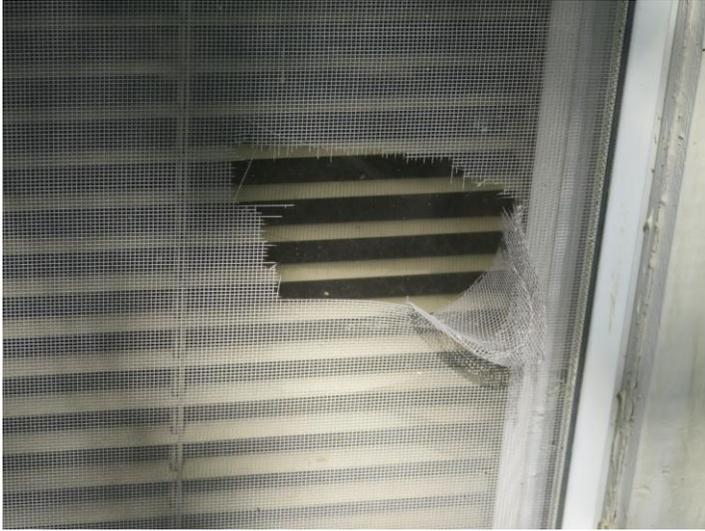
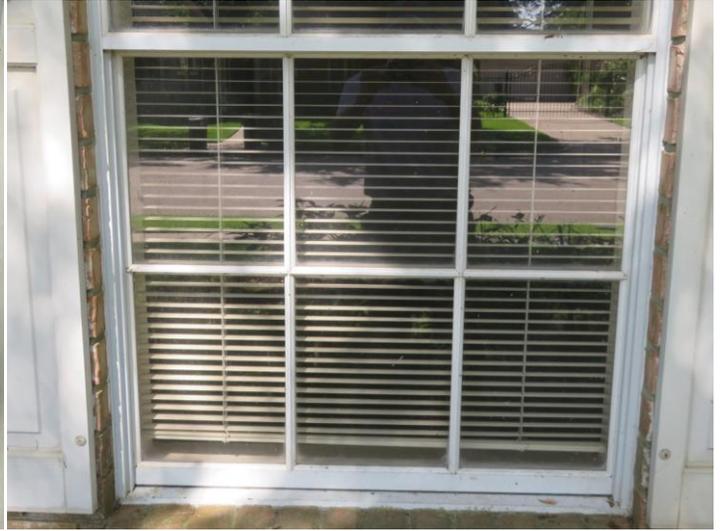
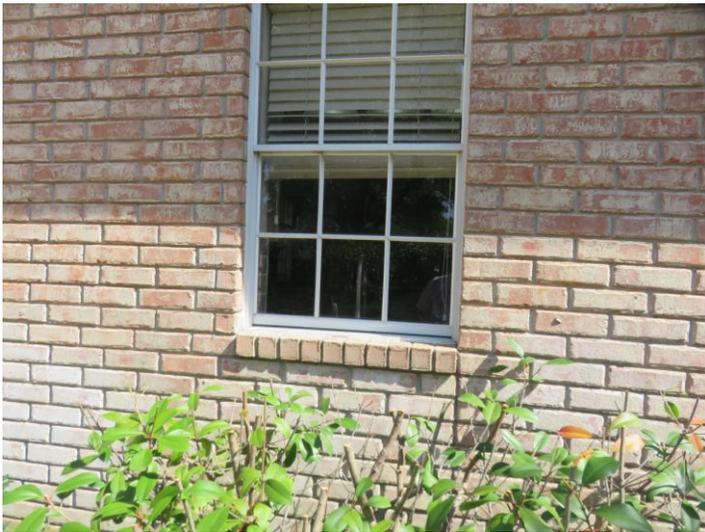
Examples

- Some windows lack screens or have torn screens.

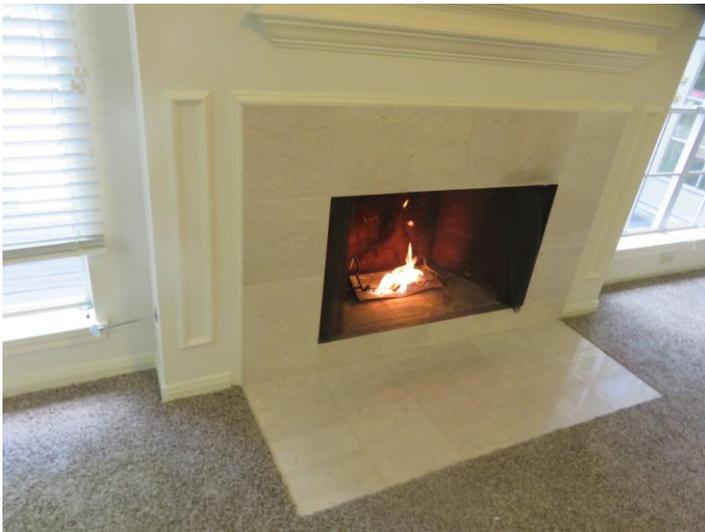
The fireplace in the family room is a natural gas assisted appliance having its emergency gas valve to the left on the adjacent wall. The fireplace was tested for functionality and the presence of natural gas leaks. In the opinion of the inspector, no gas leaks were detected and the appliance appeared to be installed and functioning as intended at the time of the inspection.

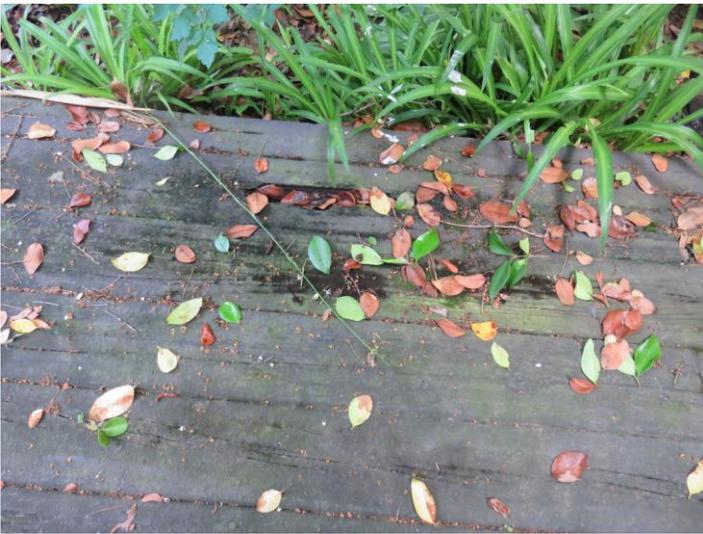
Examples

- In the opinion of the inspector the wooden decks appeared in below average condition displays deterioration, splintering and the potential of retaining water beneath them.

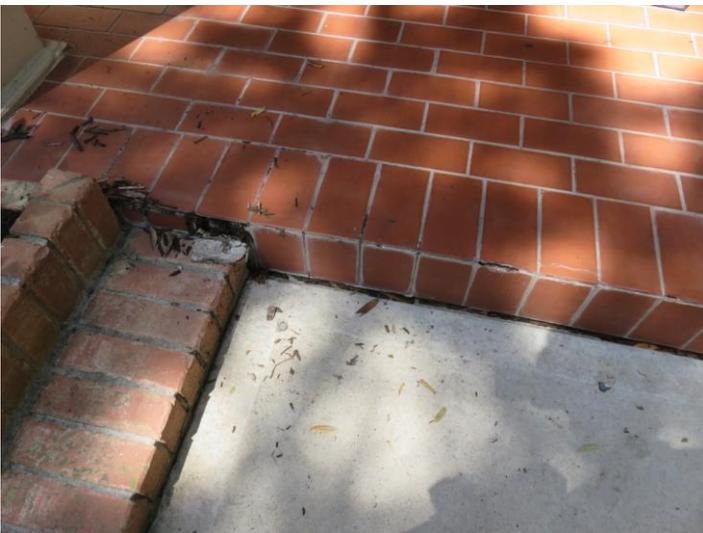
- The front and left side porches display loss of tile.

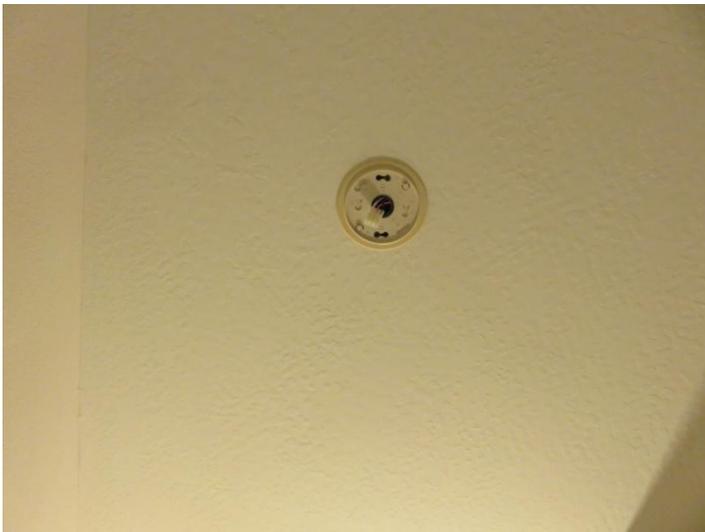
- TX State Law requires bedrooms, and rooms that will be utilized as sleeping rooms, to be equipped with smoke detectors. Current requirements also require smoke detectors in hallways outside the bedrooms and in the general living areas of the home (all floors). Hard wired, rather than battery operated, smoke detectors are required in all instances and must be synchronized and sequential in their operation with sufficient audible resonance to alert all bedrooms and residents of the home in the event of fire outbreak. Monthly inspection and testing of these appliances is recommended. Do not install smoke detectors within 3' of climate control vents or ceiling fans. IRC {314.3}.

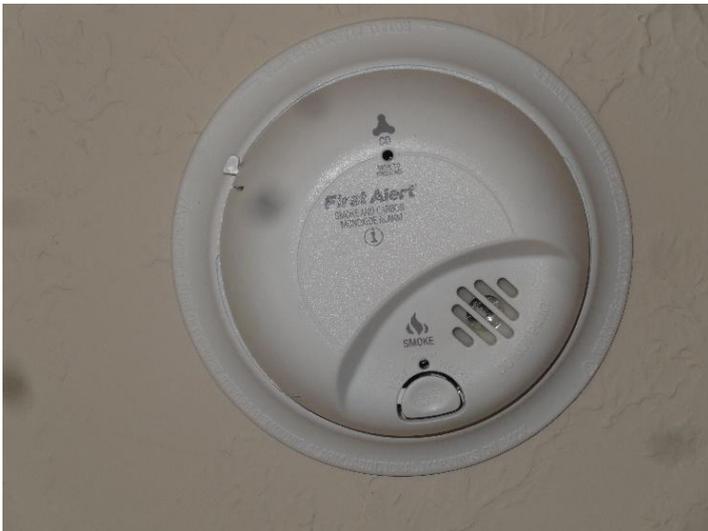
Example

- Carbon Monoxide detectors provide advance warning of this colorless, odorless gas just as smoke detectors provide advance warning of smoke and combustible conditions. Placement of these detectors in the hallway of the home immediately outside each bedroom, on each floor and in accordance with manufacturer recommendations is a required fire safety precaution. The CO detectors are required to be interconnected with the smoke detectors. IRC {315.1}

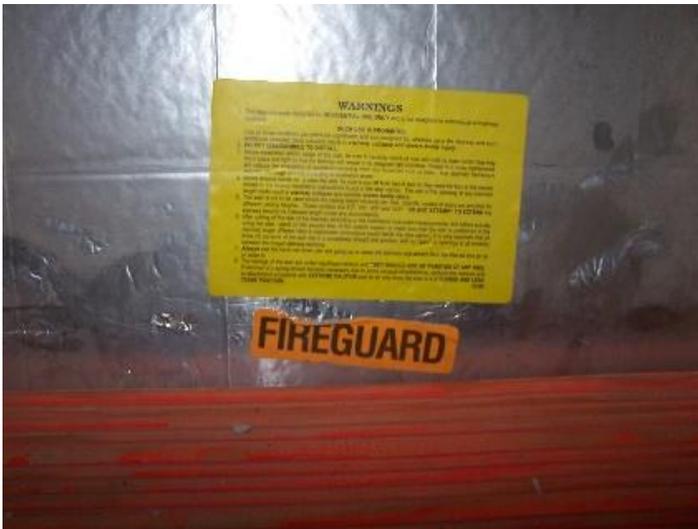
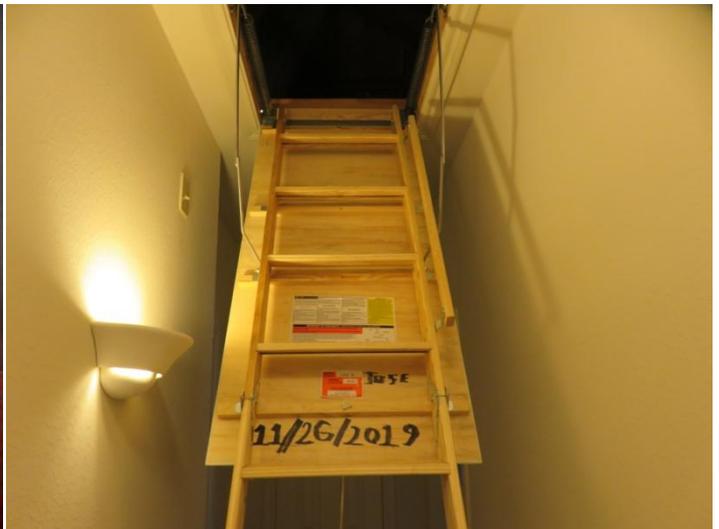
Examples of fire rated/insulated attic pull down stairs include and current installation

- Pull down attic stairs in the home are required to be clad with insulation to form a barrier between the attic and living area of at least R-30 equal to the rating of currently required attic insulation at living area attic fronting ceilings. It is advisable to install fire rated stairs to provide a fire barrier between the attic and living space.

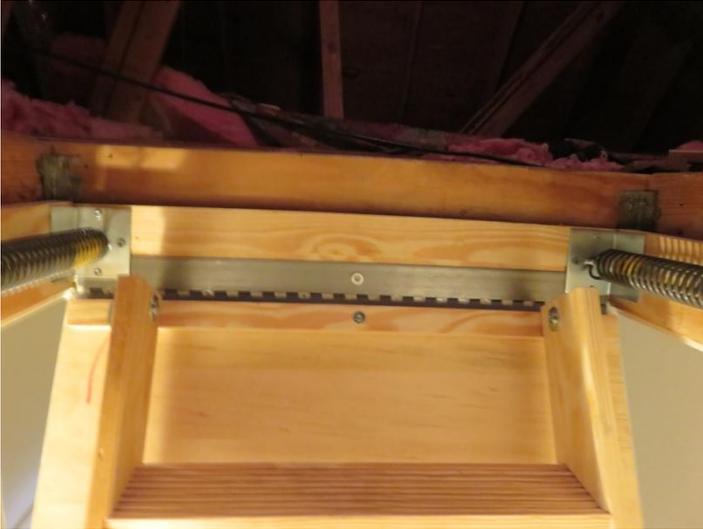
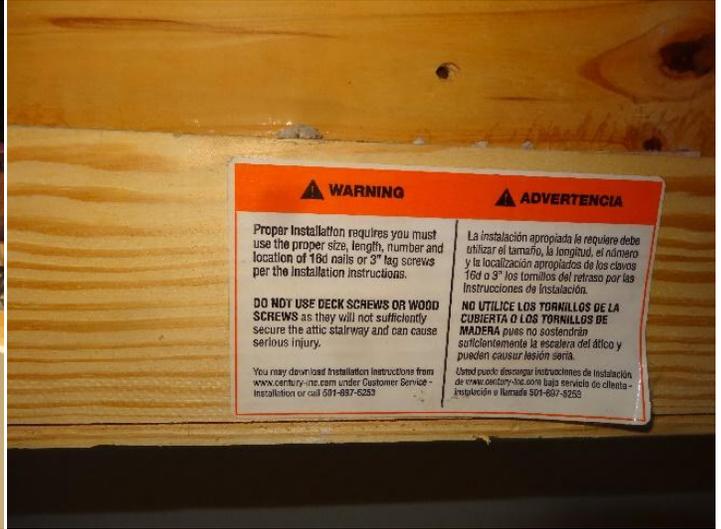
Current and statement of requirements

- The attic stairs are not properly secured. Securing the frame of the attic stairs to the home requires the use of either 16D nails and/or ¼ X 3” lag bolts.

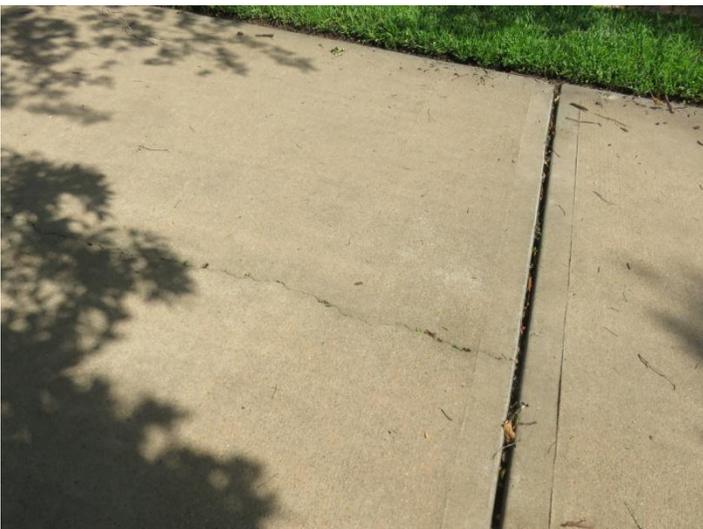
Example

- The driveway displays cracks and loss of expansion joint materials.

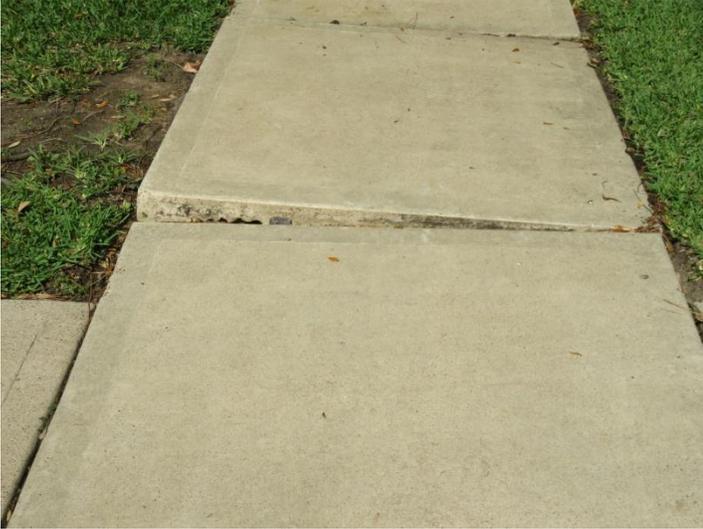
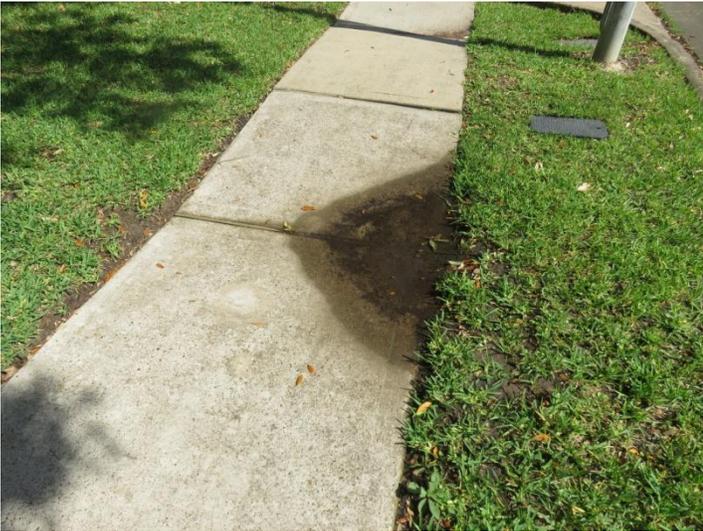
- The front sidewalk displays elevated/uneven surfaces and a dip where soils have been washed out from beneath the walkway.

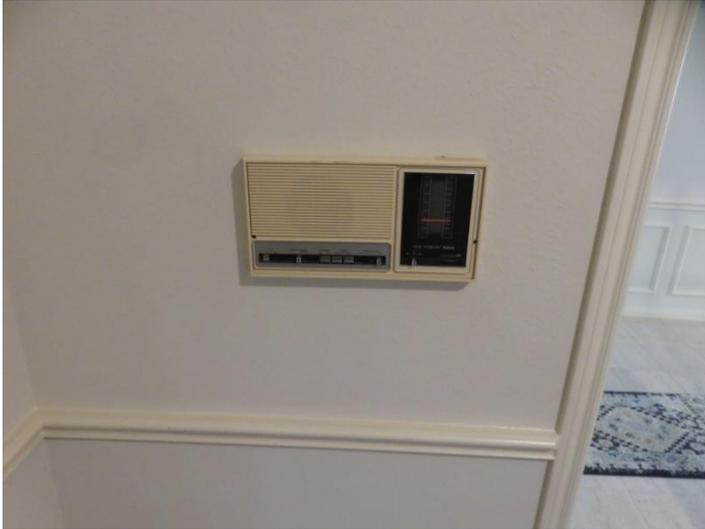
✚ The intercom system was not tested/inspected.

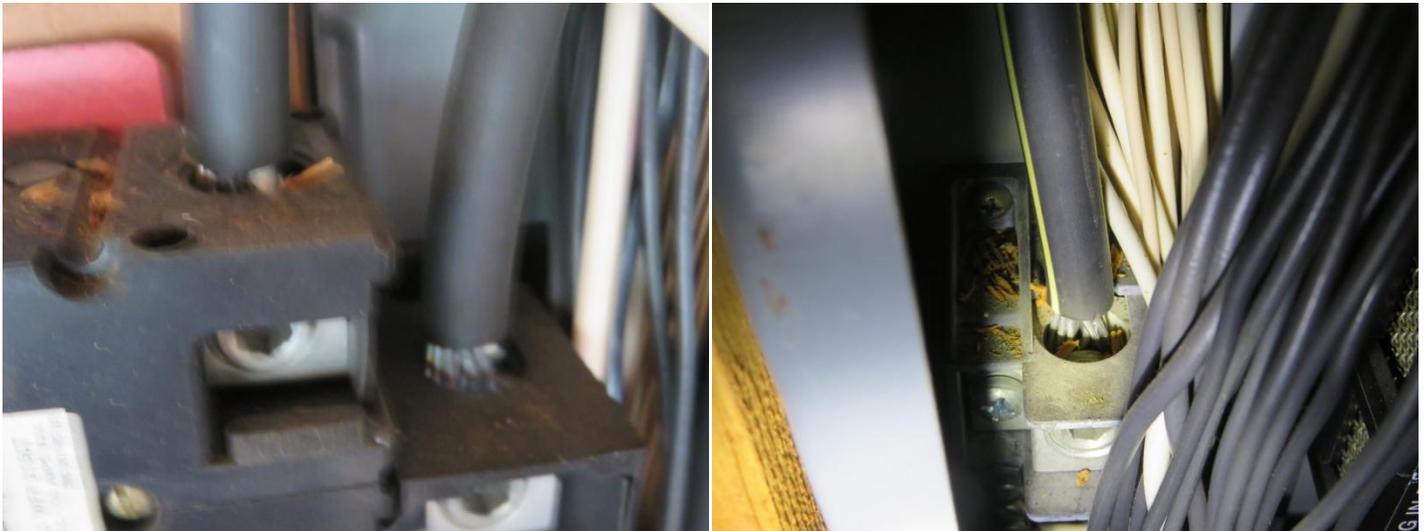
Current and required installation

- Aluminum service wiring requires anti-oxidizing agent at entry points to the main breaker and neutral bar.

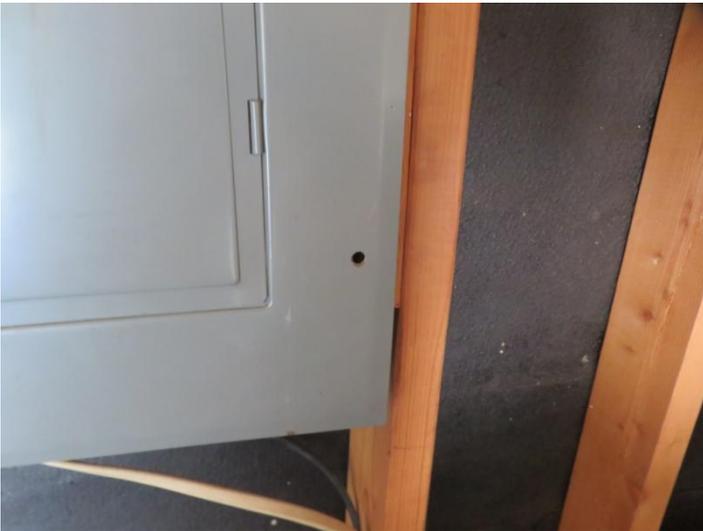
- All screws are required to secure the dead front to the panel.
