TEXAS REAL ESTATE CONSUMER NOTICE CONCERNING HAZARDS OR DEFICIENCIES

Joseph and Cara Stogner, 3318 S. Lake Village Drive, Katy, TX 77450

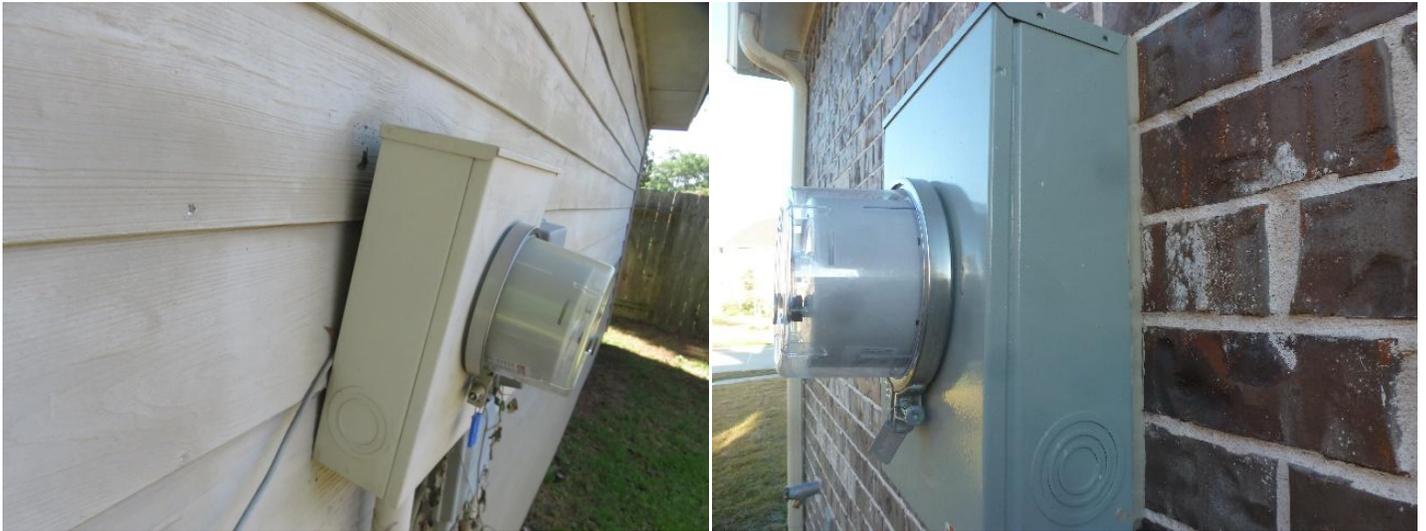
Current installation and example of recommended caulking

- The electric panel box(s) should be secured to the structure and caulked around its perimeter (including between panels) to assist in preventing water from accumulating behind the box at the porous wall substrate creating the potential for wall damage.

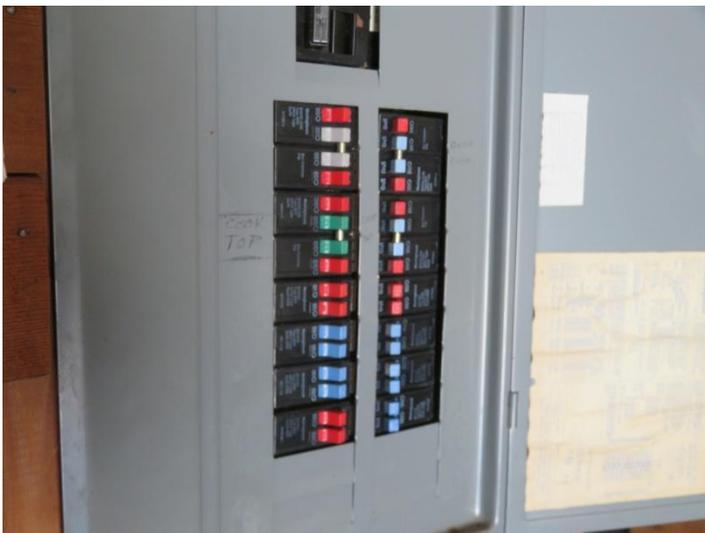
- Individual circuit breakers for the home are not labeled in the service entrance panel for specific areas, fixtures and/or appliance as required. General labeling is prohibited. The purpose of an accurate and legible circuit breaker directory is to provide clear identification of the breakers that may need to be operated by service personnel or others who may need to operate a breaker in an emergency. (NEC 408.4)

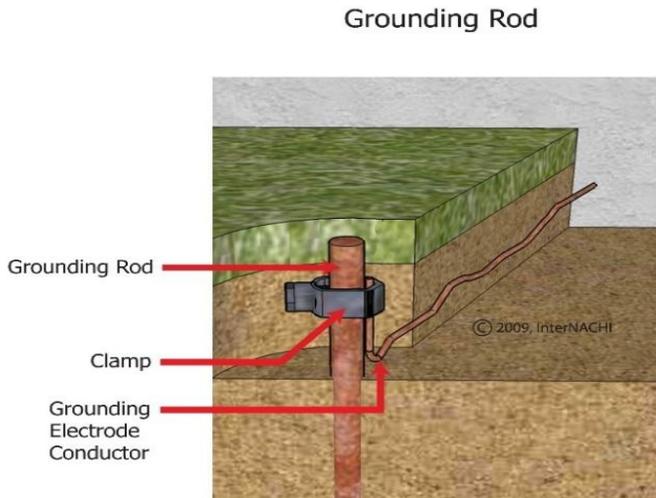
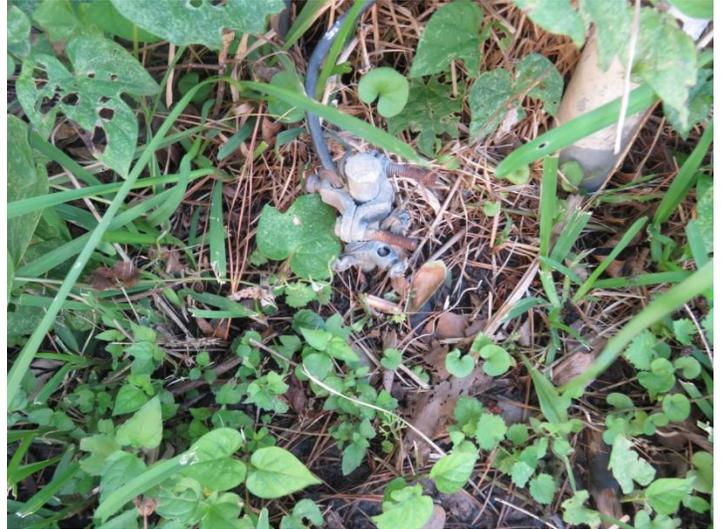
Illustration and current installation

- The electric system grounding rod is required to be 8' long (not verified) and should be fully driven into the ground to provide optimum grounding connection to earth and to prevent it being accidentally damaged or personal injury result from contact.

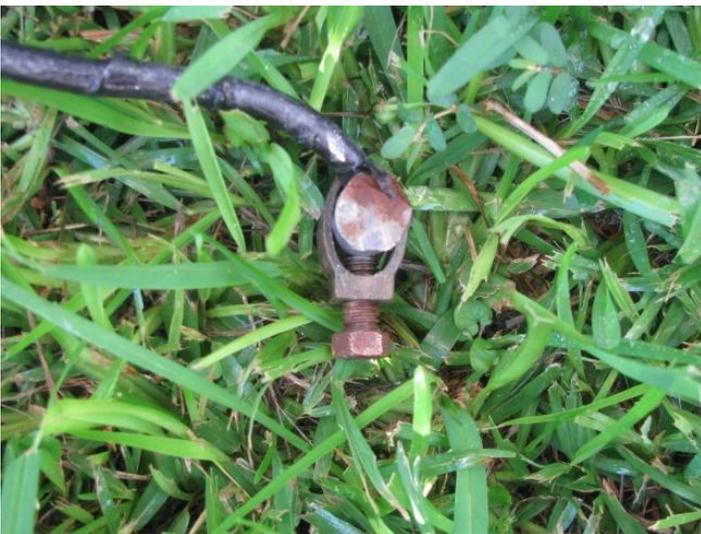
Example of an acorn clamp and current installation

- The installed grounding clamp at the ground rod is for use in a natural gas pipe application. Grounding rods are required to have an acorn grounding clamp.

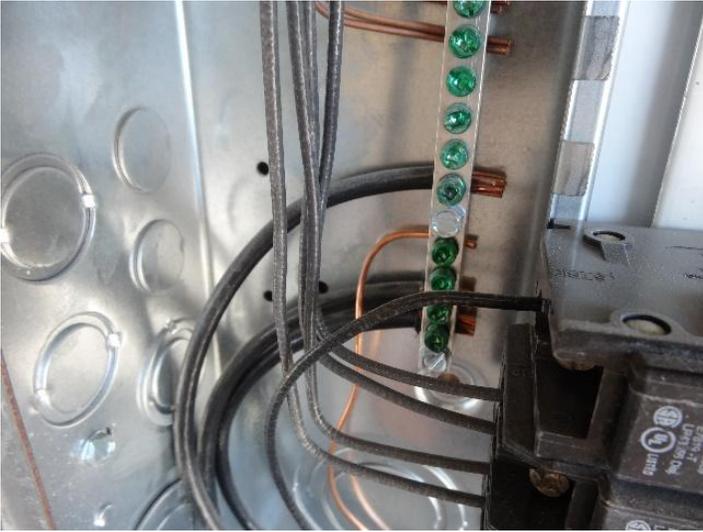
Required example

- Panels are required to have at least 2 points of grounding to earth via ground cables.

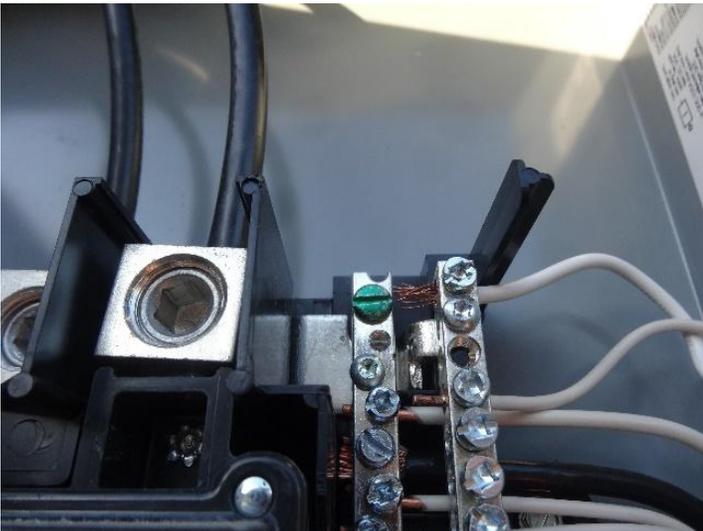
Example installation

- The ground and neutral bar, required to be in contact with the panel, do not appear to be. Normally a green grounding screw inserted in the bar at the top through the hole provided is present.

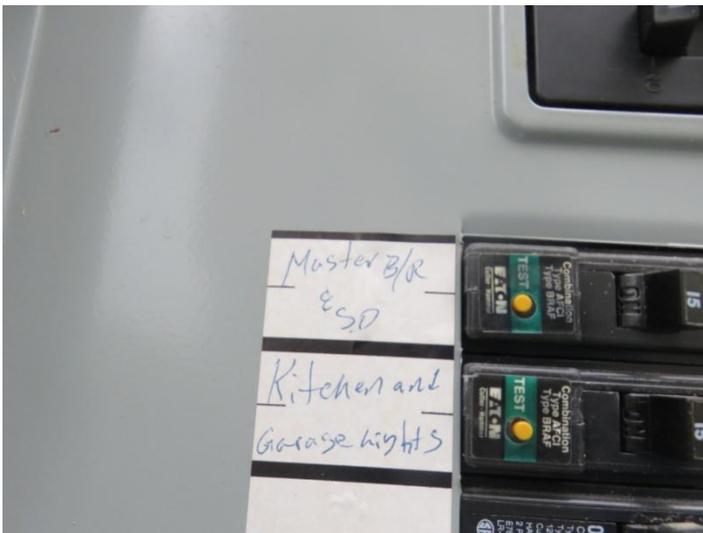
Example

As of approximately 1/1/2008, all electrical fixtures, outlets, switches and smoke detectors in the home wired to single-pole 15 or 20 AMP circuit breakers {3902.11/IRC}, other than those apparatus protected by GFCI or GFCI/AFCI combination safety device, are required to be wired to AFCI safety circuit breakers in the main panel. Arc Fault Circuit Interrupt's are not installed as per the construction date of this home but can be added for fire safety coverage.

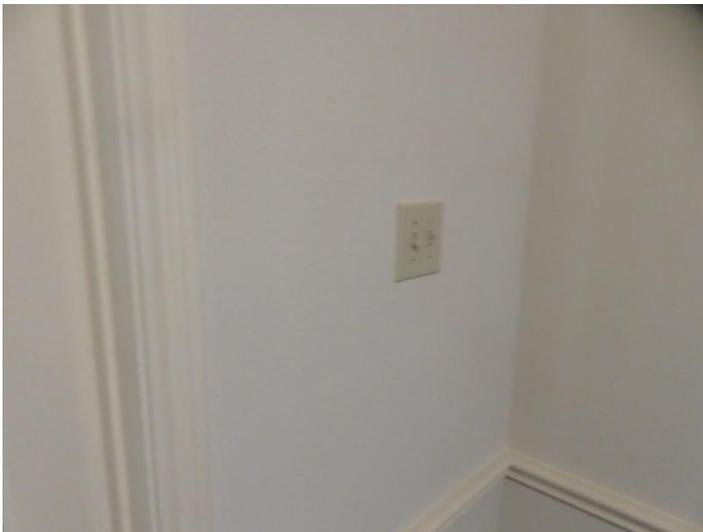
- The light and fan switches in the office are wired in reverse. The light switch should always be the first switch to contact at entry to a room.

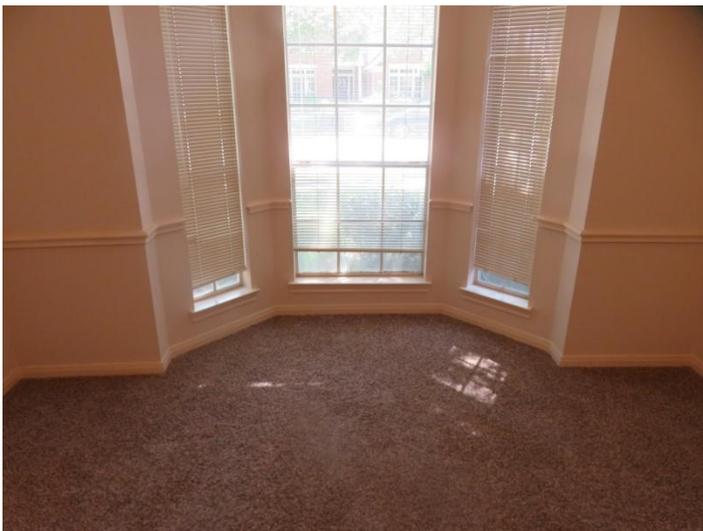
- An outlet at the front wall of the center front bedroom has been omitted.

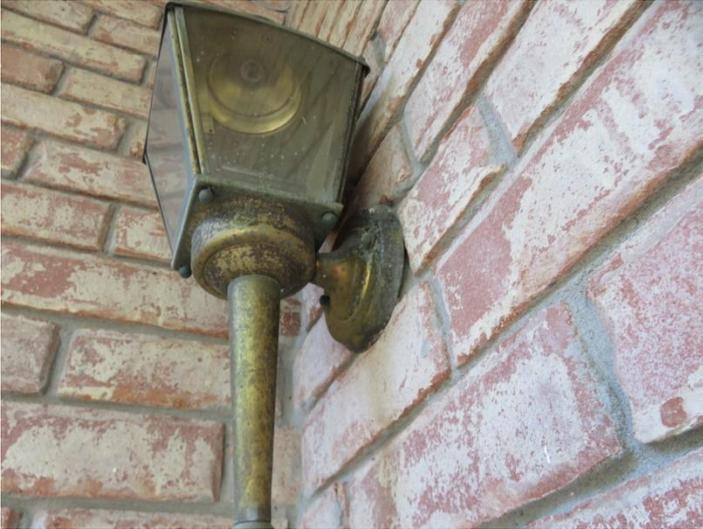
Example

- All exterior fixtures should be sealed/caulked around their perimeter.

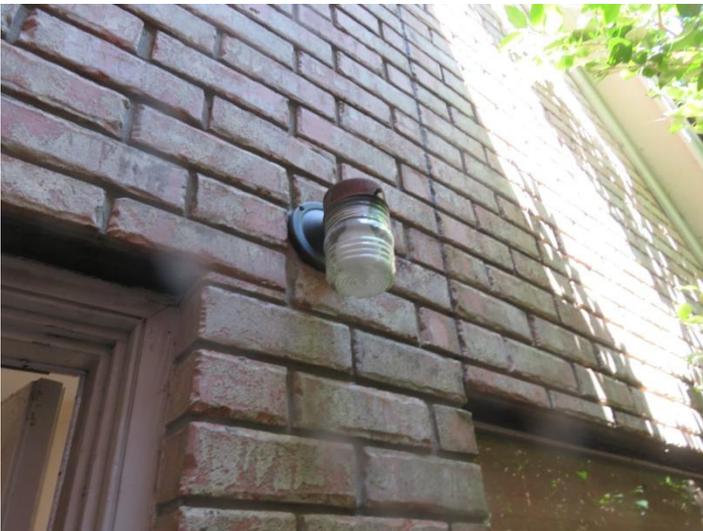
- A light fixture at the bathroom atrium did not illuminate.

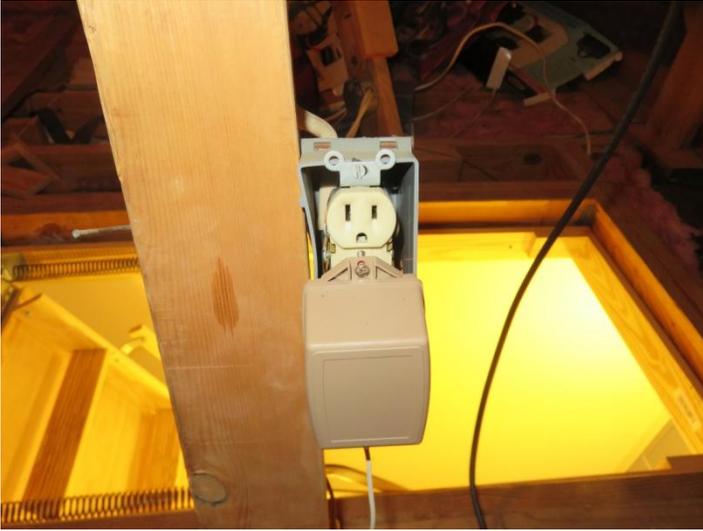
Example in the attic

- All light switches and outlets are required to be provided a safety cover plate.

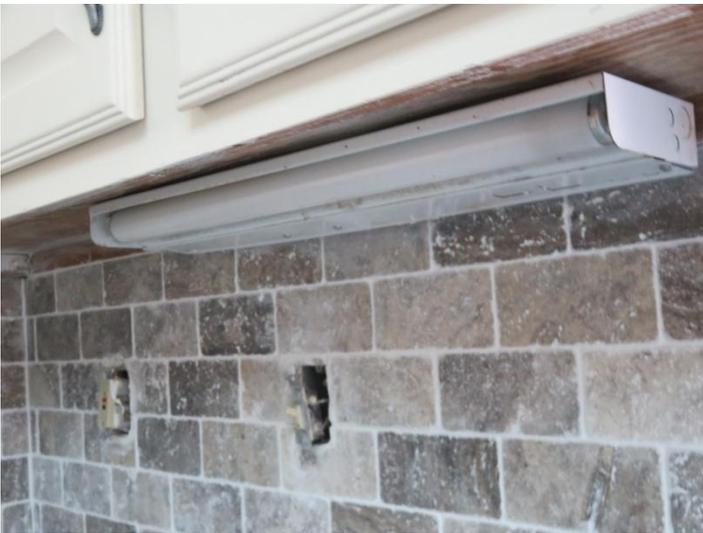
- The left kitchen under-cabinet light did not illuminate.

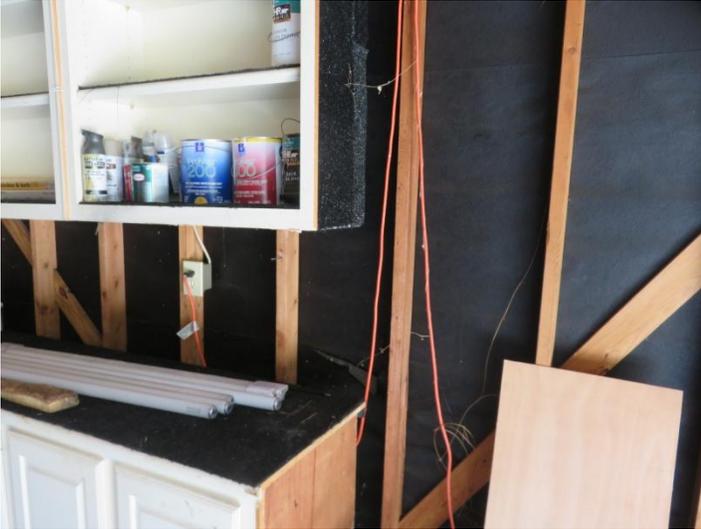
- Extension cords are intended for use as temporary devices. The use of temporary cords as permanent fixtures is a safety hazard. The use of extension cords as a permanent electrical accommodation in the garage or elsewhere should be avoided.

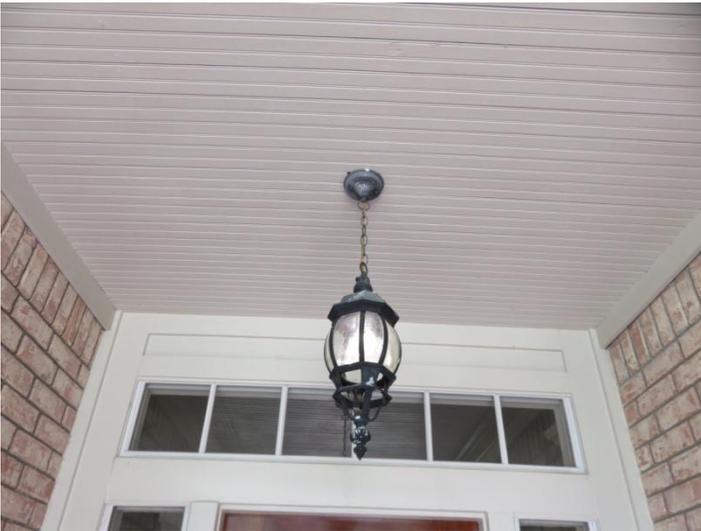
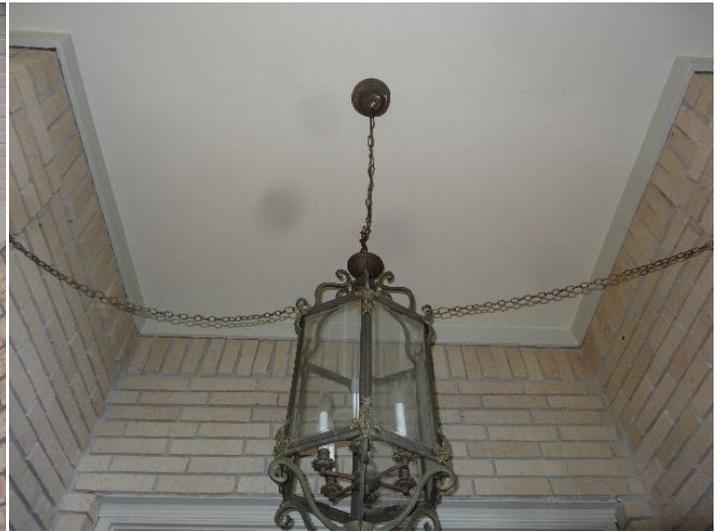
Current and recommended installation

- The front porch light fixture should be secured by cord or chain to prevent swaying.

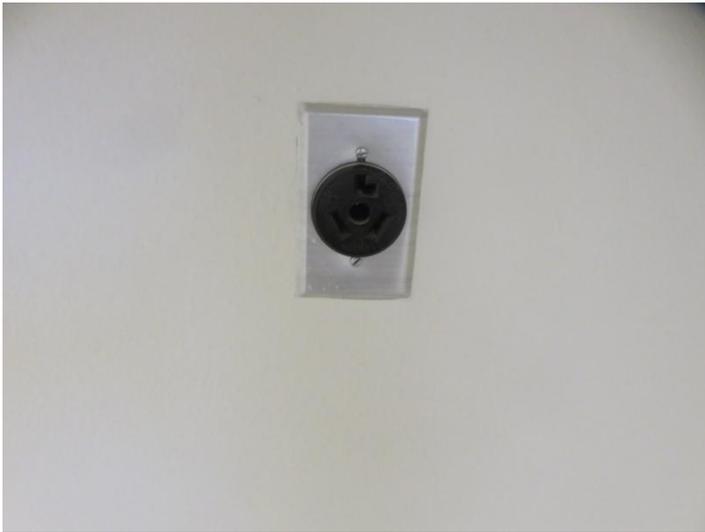
- The laundry room currently exhibits an outlet for the electric dryer with a 3-prong apparatus/outlet. Newer model electric dryers employ a 4-prong plug necessitating an electrical change-out of the current outlet if an electric dryer is to be used.

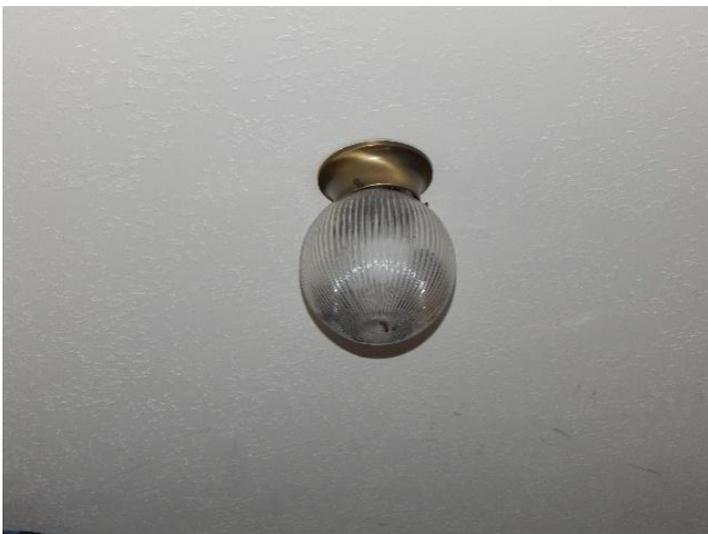
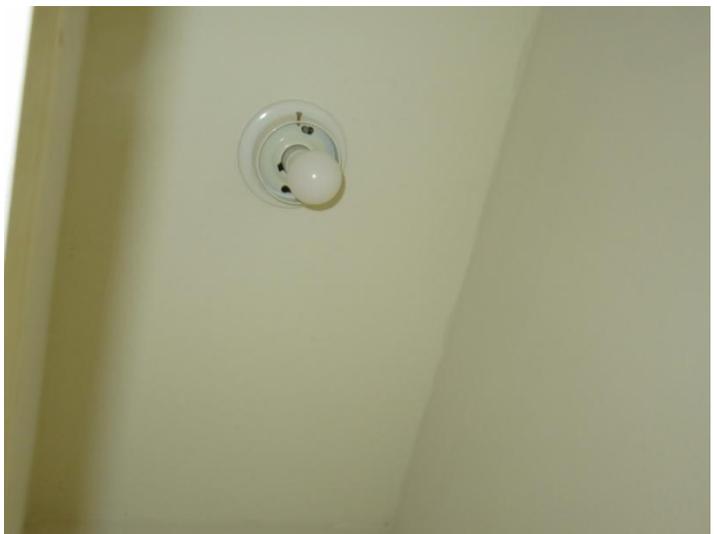
Example of a globe and current installation example in the kitchen

- Closet lighting displays unprotected/incandescent bulbs that are unprotected by a globe. Should combustible storage be placed within 12” of one of the bulbs, a fire could ensue. These lighting fixtures should be replaced by fixtures having a globe surrounding the bulb.

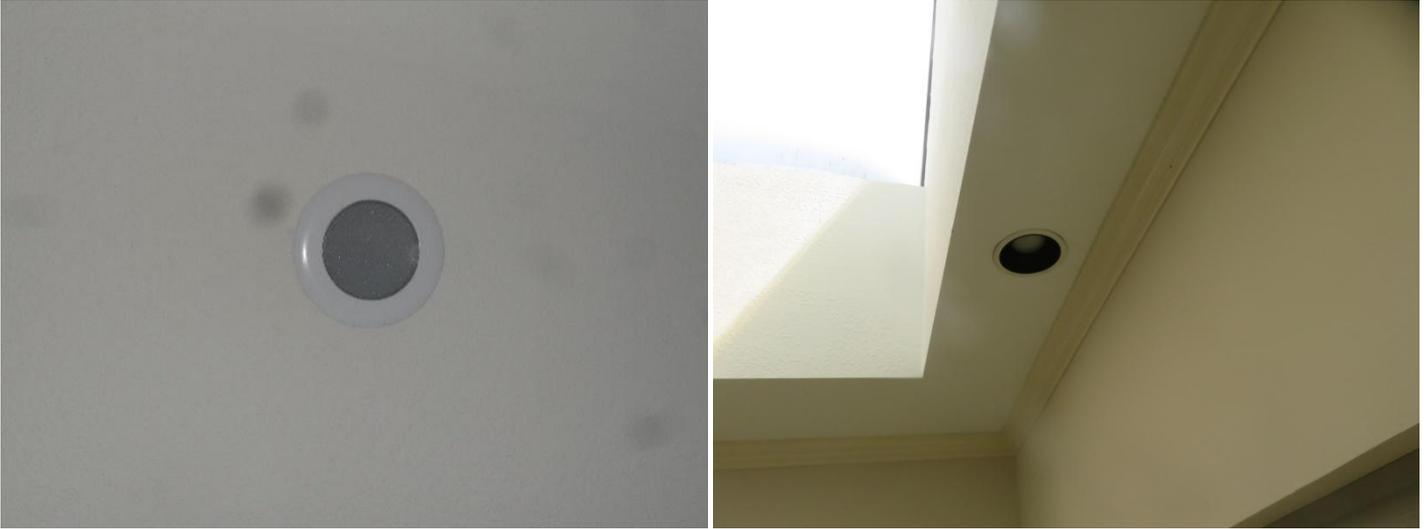
Example and current installation above the Master bathroom jetted tub

- Unprotected/open light fixture at bathroom tub/shower ceilings are prohibited due to the accessibility of water to persons using the facility. An electrocution hazard is present. A sealed lens fixture is required.

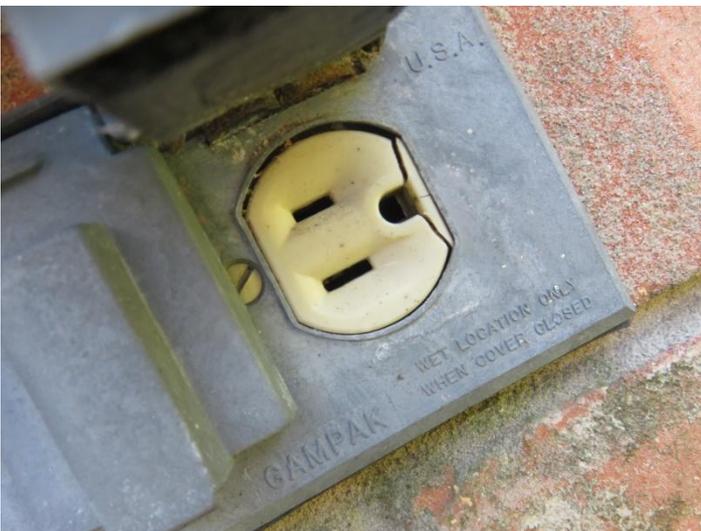
- The right half of the outlet at the AC condensing unit is cracked.

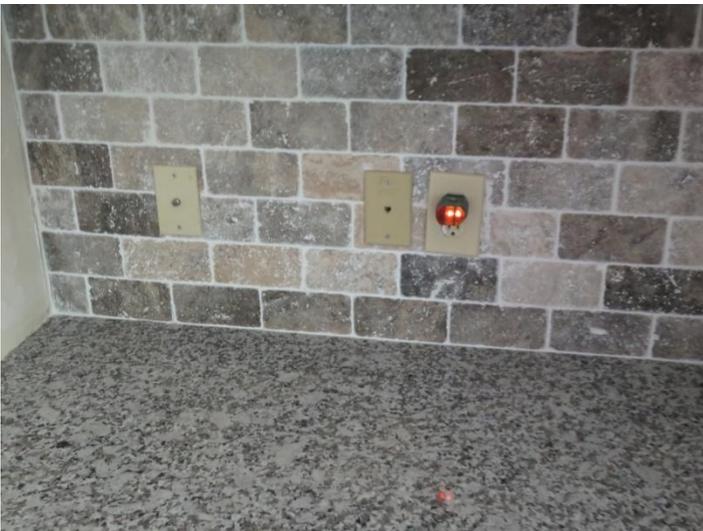
- All 15 – 20 AMP kitchen countertop outlets are required to be GFCI safety rated/protected. As of 9/2014, this includes the dishwasher and disposal outlets, if accessible - IRC{210.8(D)}.
- The outlet to the right of the oven is not GFCI rated as required.

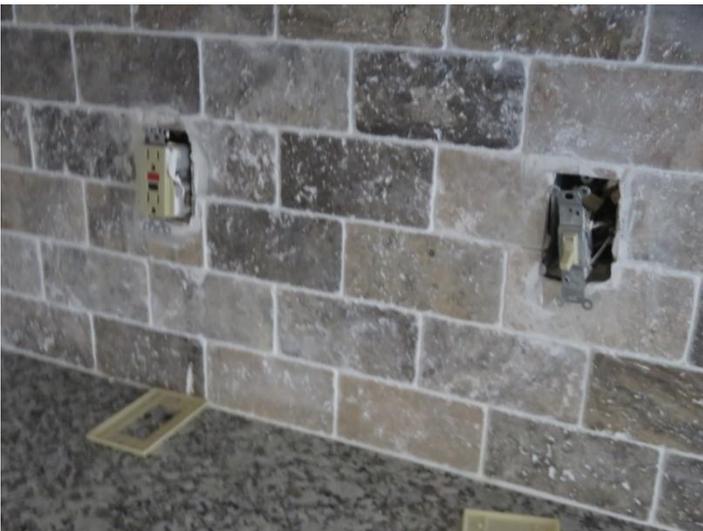
- All outlets and light switches are required to have safety cover plates.

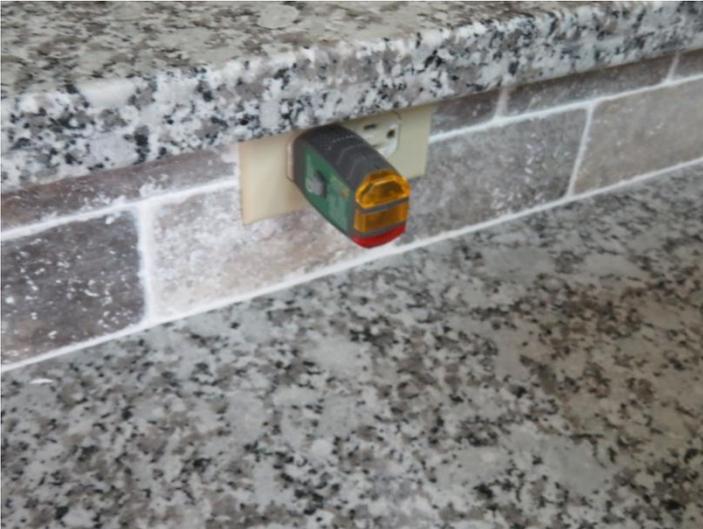
- The outlet at the bar sink lacked power and is required to be GFCI rated. Additionally an additional outlet is required at the far left of the bar sink.

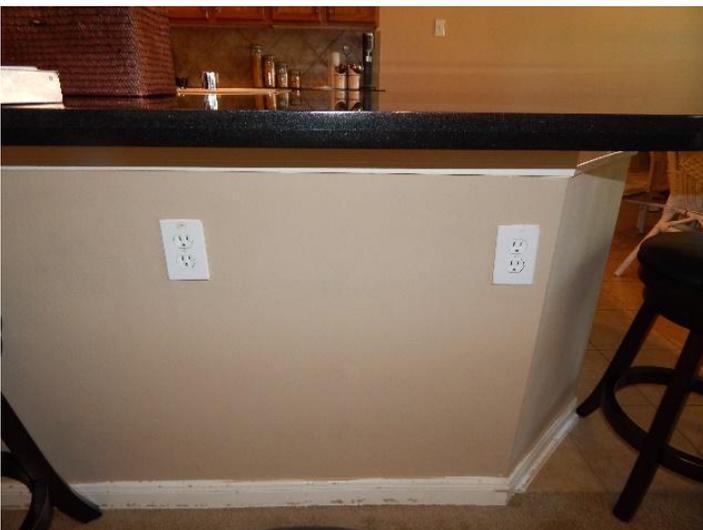
Required and current installation

- As of 9/2014, all 15 – 20 AMP laundry room outlets are required to be GFCI and AFCI safety rated/protected - IRC{210.8(A)(9)}
- The outlet(s) on the family room side/dining side of the kitchen sink countertop are required to be GFCI safety rated and no lower than 12” beneath the countertop for safety of crawling toddlers and smaller children. (IRC 3901.4.5X). While not specifically intended for use at the countertop the outlet is GFCI protected and would undoubtedly be used at the countertop and electrical cords may not reach the outlet of an appliance creating a safety hazard. This outlet lacked power at the time of the inspection.

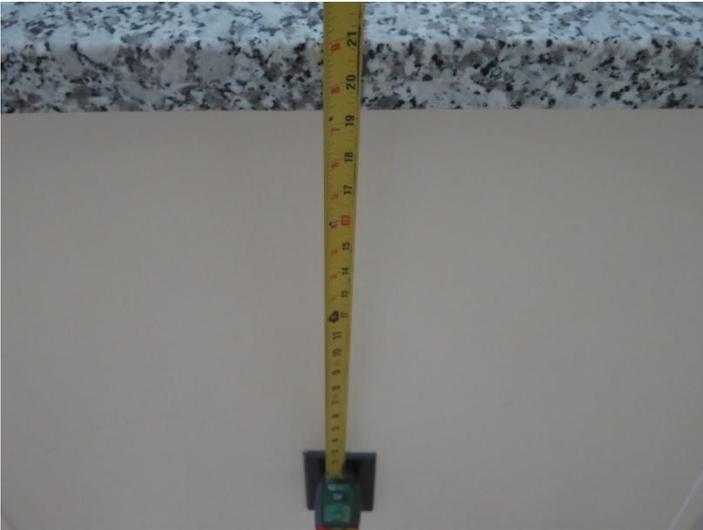
- The island outlet is too low exceeding the 12” maximum threshold below the countertop. This outlet works/has power intermittently.

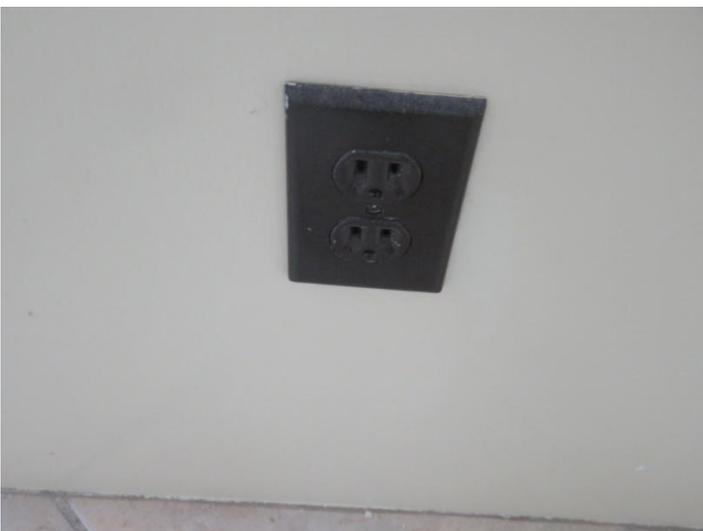
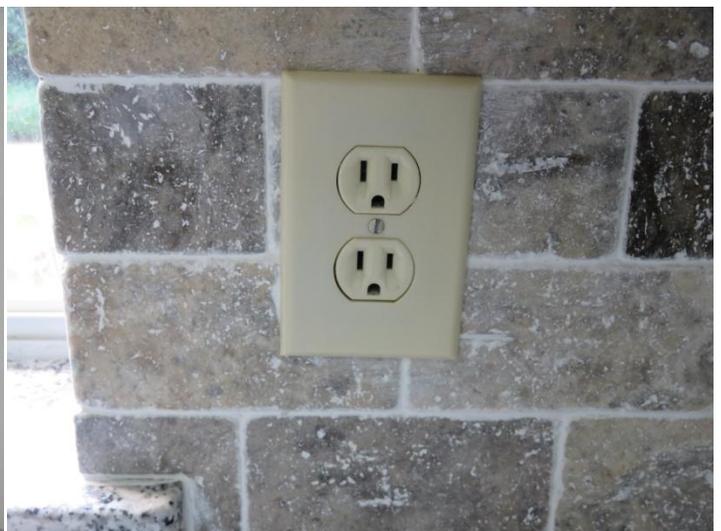
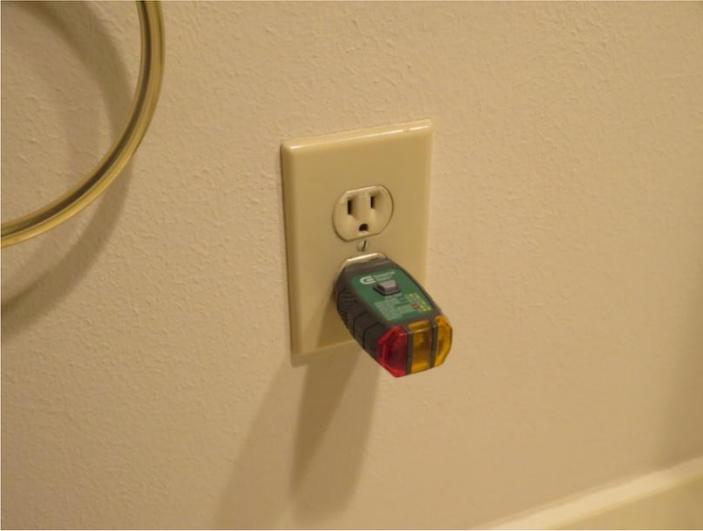
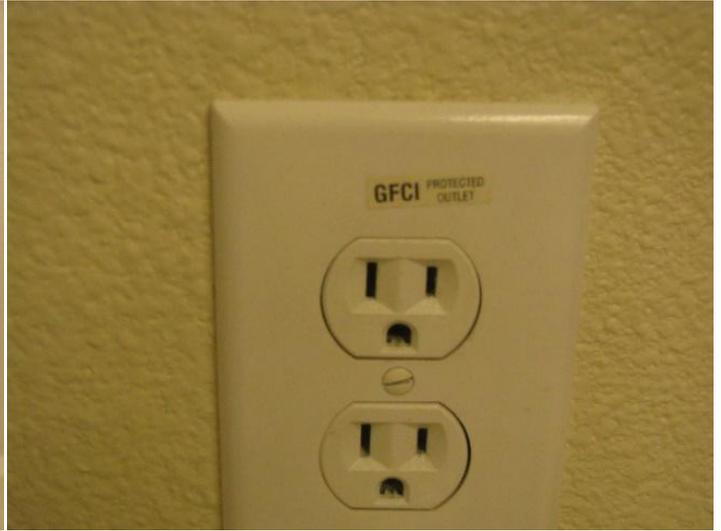
Examples in the kitchen (2), 1ST floor half-bath and labeled example

- All garage outlets are required to be GFCI (Ground Fault Circuit Interrupt) safety rated/protected. As of 2008 this also includes the garage door opener(s) and sprinkler system.
- All GFCI safety outlets should be labeled/marked with the familiar GFCI safety documentation. All garage, kitchen countertop, laundry room, bathroom and exterior outlets are required to be GFCI safety rated and labeled for identification.

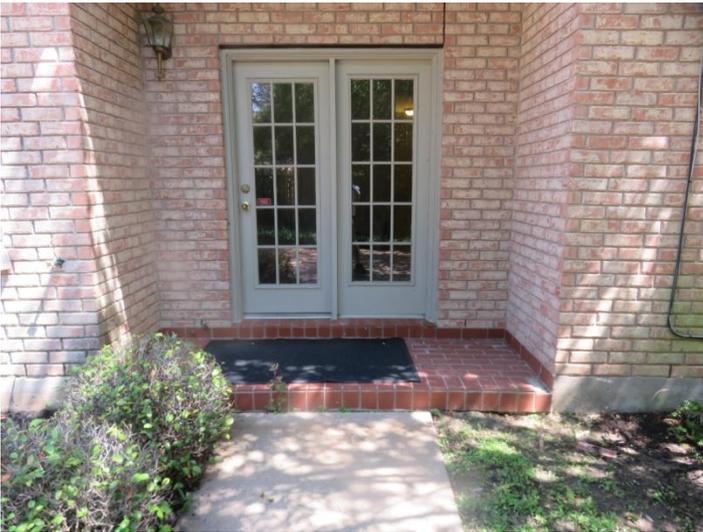
- An outlet (GFCI) is a required installation at the exterior walls of the left side porch and atrium off the Master bathroom.

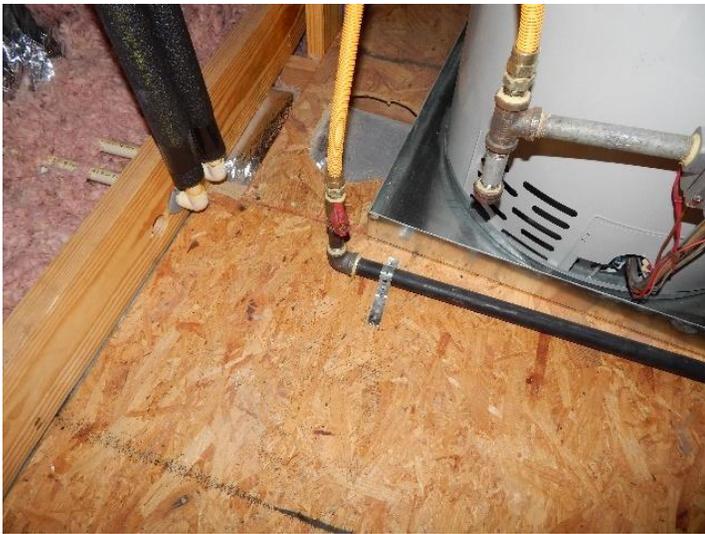
Example of a secured gas supply line

- ✚ Operating a furnace when exterior temperatures are in excess of 70°F can cause permanent damage to the appliance. The furnace, therefore, were not operated. Due to design, heat exchangers are viewed from the draft hood and/or burner areas only and are not fully inspected. It is recommended that you have a HVAC contractor fully inspect and report on the internal condition of the heat exchanger prior to the end of the option/discovery period.
- The natural gas line for the appliance(s) is required to be secured within 12” of the shut-off valve.

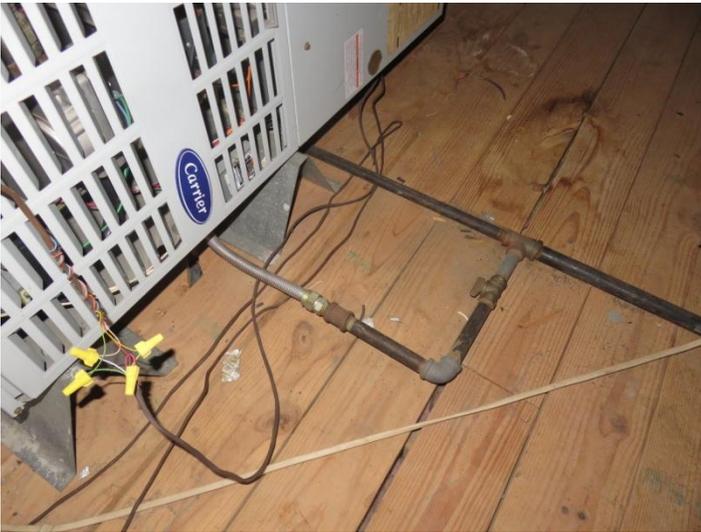
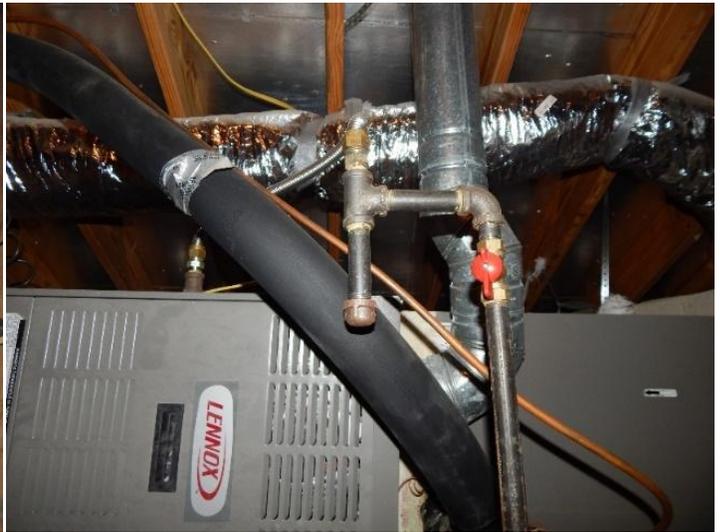
Current installation and an example of a gas line dirt leg/sediment trap

- Standards for natural gas line/pipe installations at furnaces should include natural gas supply lines that are installed with a dirt leg/sediment trap inserted at a point in the supply line just before the regulator and burners. The installation requires a change in direction of the natural gas flow. This dirt leg/sediment is intended to trap condensate and any wayward metal shavings, dirt and dust that could interfere with the normal operation of furnace employing natural gas as fuel.

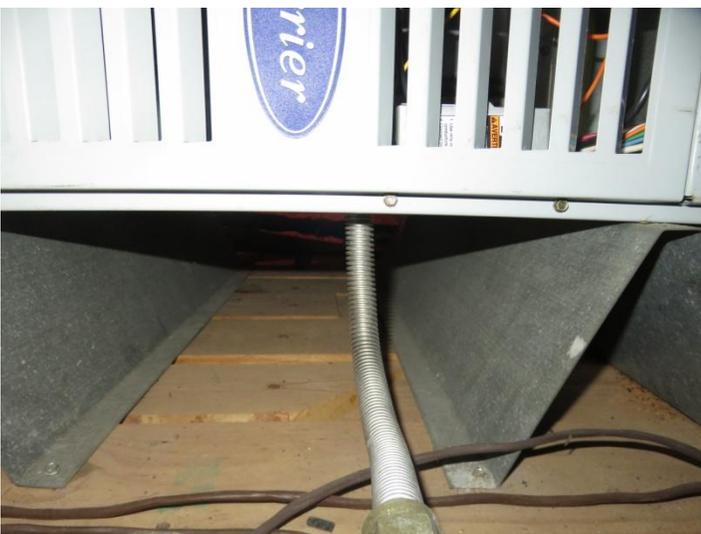
- Hard, black pipe used to connect flexible steel natural gas pipe to the burner should protrude by approximately 2" outside the housing of the furnace appliance. Flexible tubing should not enter the housing of the appliance for connection to the burner.

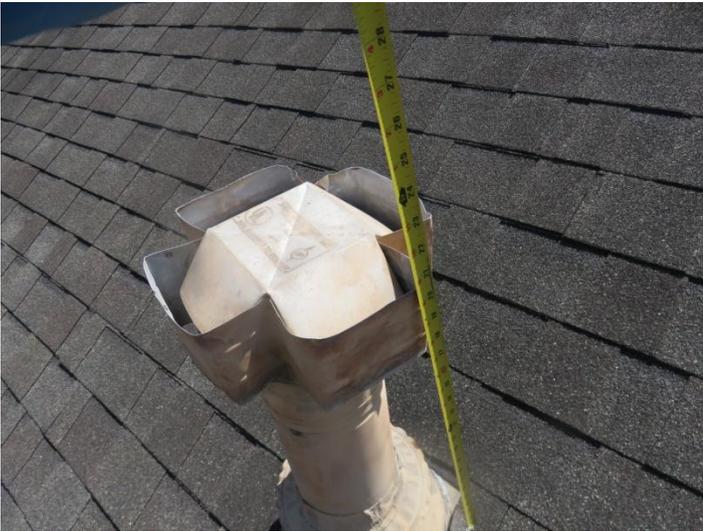
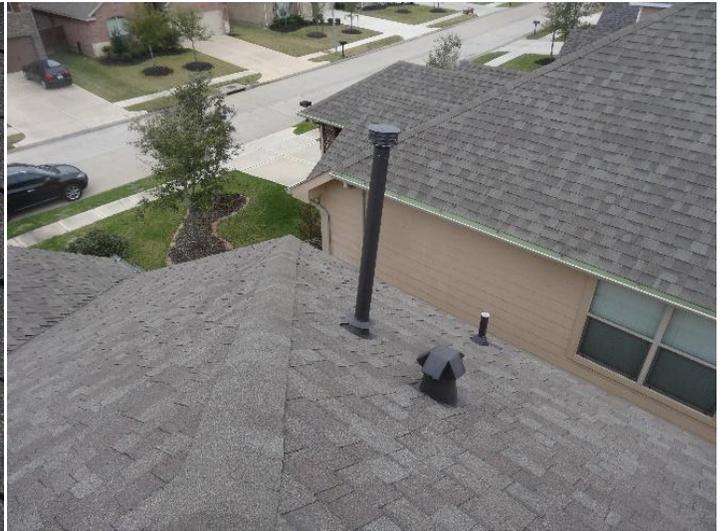
Current installation and required example

- The bottom of the “B” vent exhaust hood for the appliance(s) is required to be at least 24” above the roof deck anywhere within 10’ of any combustible materials and the roof deck. This installation also provides a preventative measure for backflow of gases back to the attic.

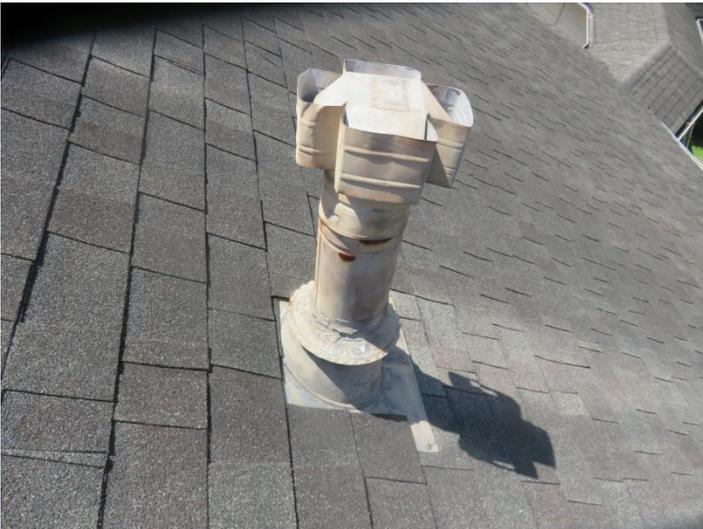
- The furnace flue is rusting.

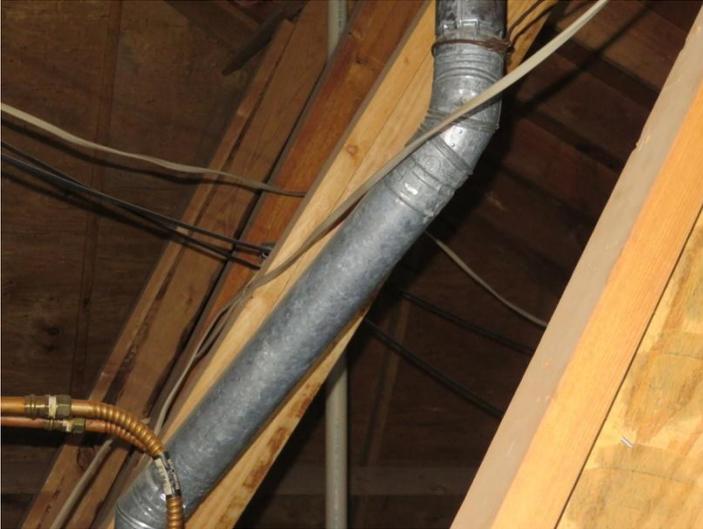
- Electrical wiring is in contact with an exhaust flue.

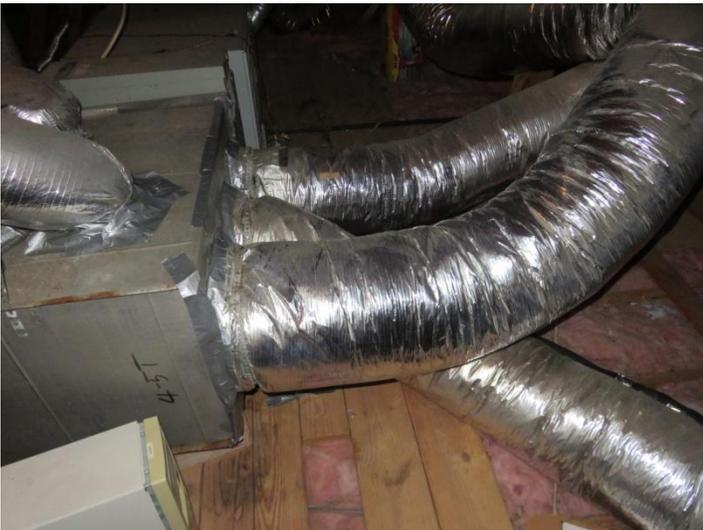
- Direct, unobstructed access/passage to the furnace is required but not provided.

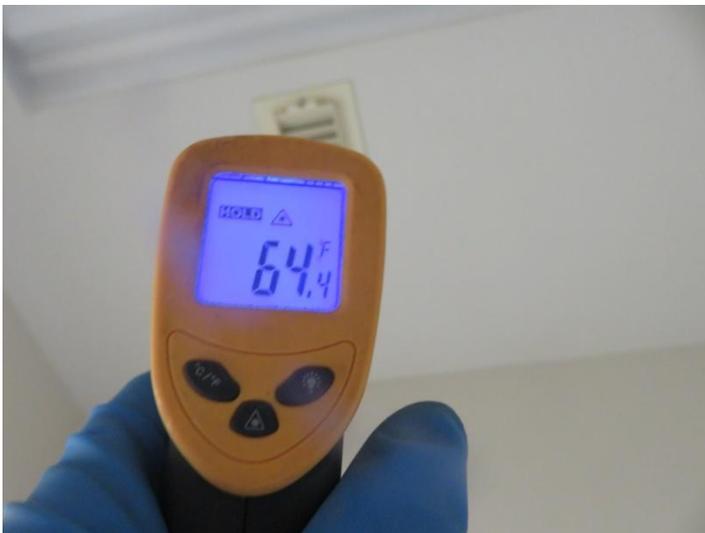
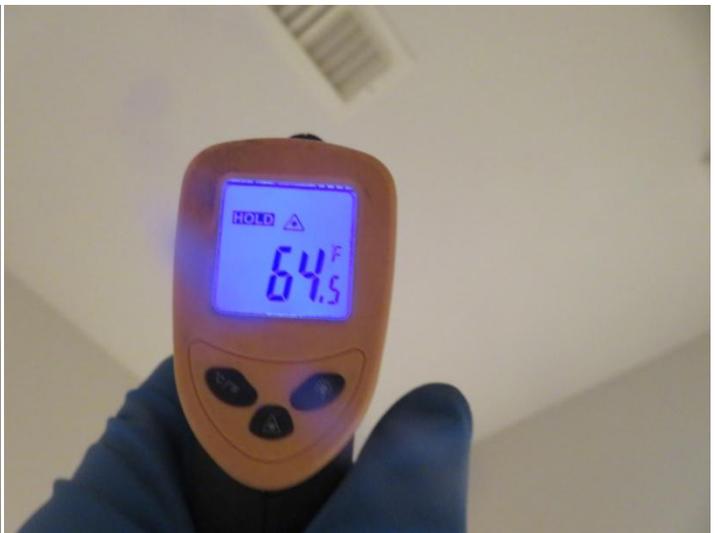
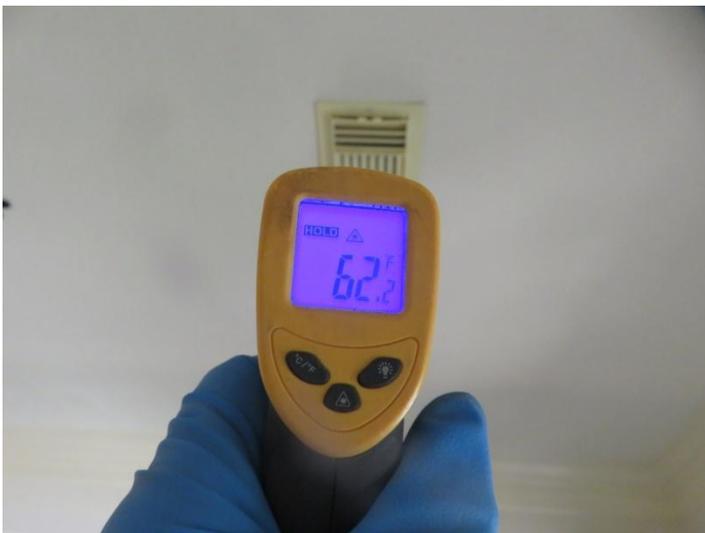
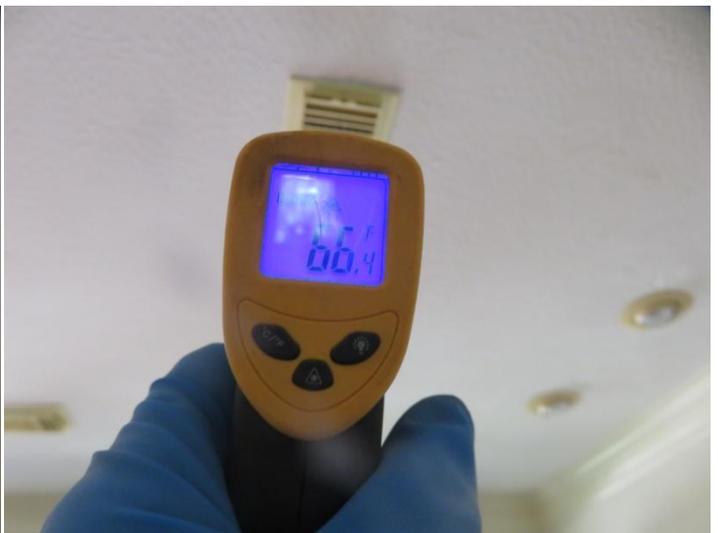
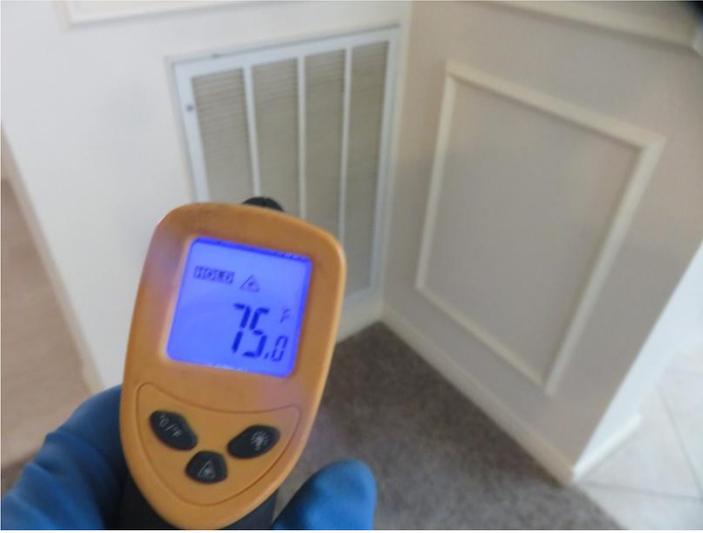
When operationally tested, the temperature differential between supply (conditioned air) and return air measured between 9°F and 13°F throughout the home. This measurement is outside the acceptable range of temperature differential of 16°F to 21°F and the unit did not appear to be installed or functioning as intended at the time of the inspection as noted by example(s):

- Supply (4) and return temperature examples around the house (10°F to 13°F temperature differential)

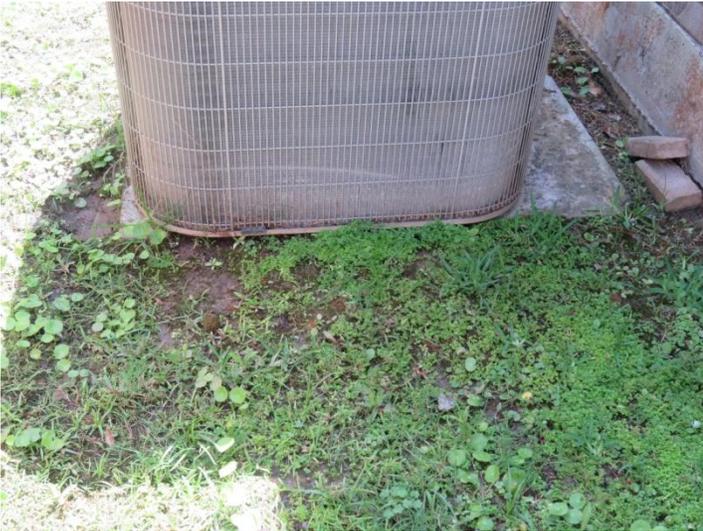
- The AC condensing unit should be elevated at least 3” above ground level to assist in keeping high water from contact.

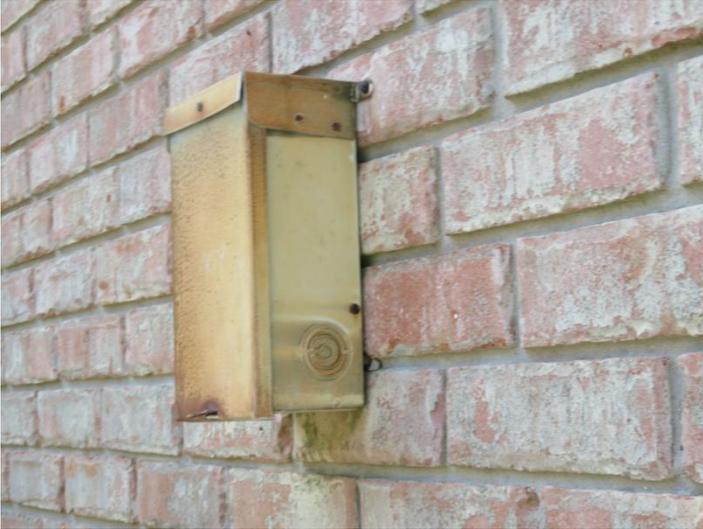
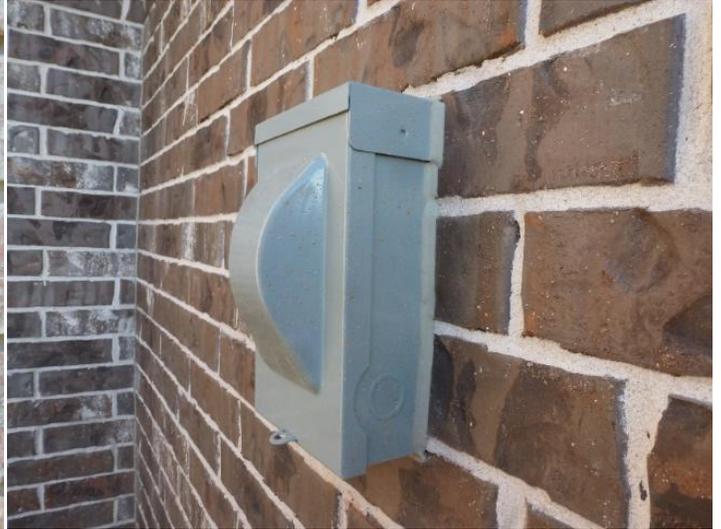
Current and recommended installation

- The mechanic disconnect breaker panel(s) should be caulked around its/their perimeter to prevent water and insect penetration into the wall cavity behind the box(s).

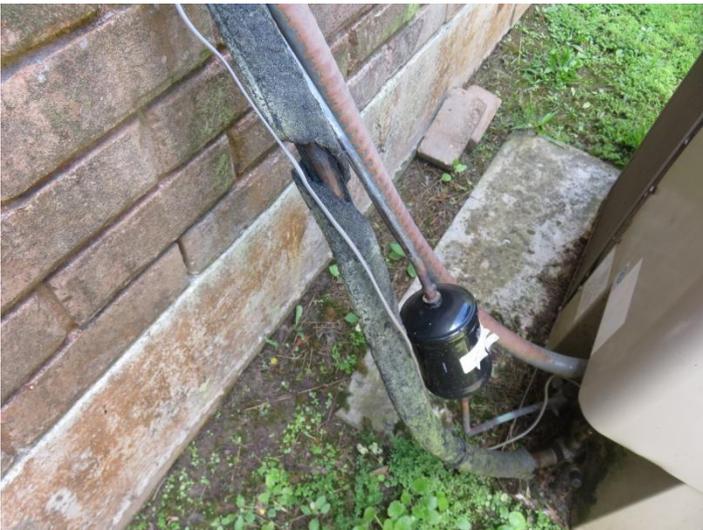
- The exterior condenser unit(s) displays refrigerant line/suction line insulation that is in below average condition. This insulation should be replaced to promote higher efficiency of the AC unit(s).

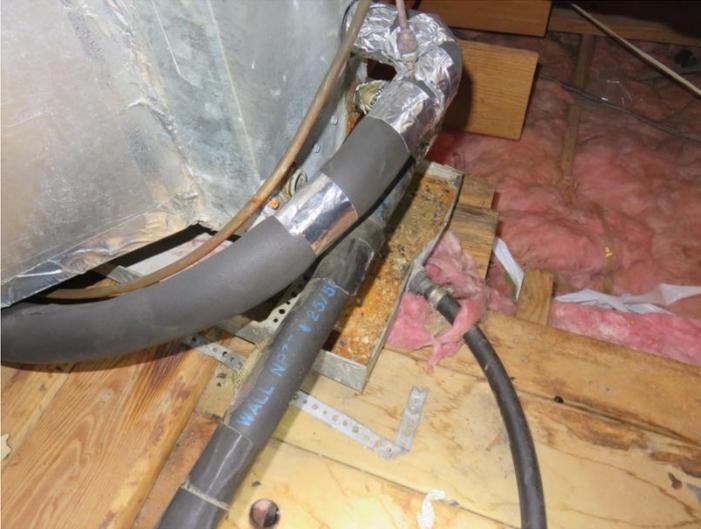
- The evaporator coil drain pan is significantly rusty.

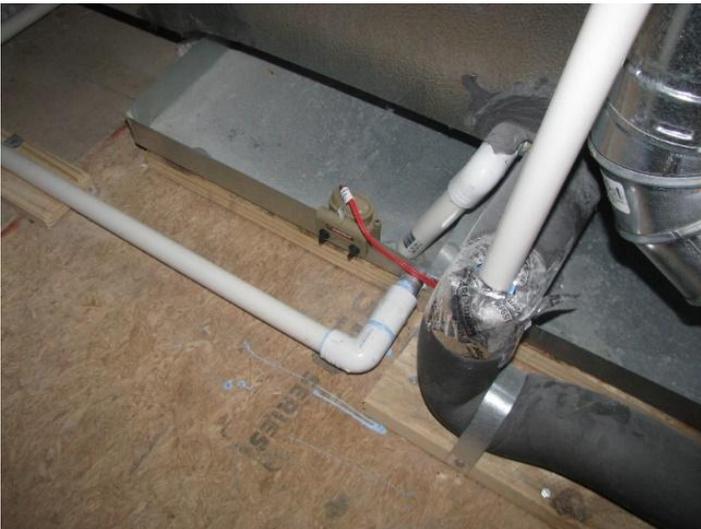
Example of a float-switch

- AC evaporator coil overflow pan shall be equipped with a water detection device in the primary drain line that will shut off the equipment should the drain line be blocked. (IRC M1411.3.1). It is recommended that the evaporator coil condensate auxiliary drip pan(s) be equipped with a safety float-switch sensor that will shut-off the AC equipment in the event condensate enters the pan.
